# Greystones Farm Bourton-on-the-Water Gloucestershire

*Archaeological Watching Brief*

CA Project: CR1090  
CA Report: CR1090\_1

June 2023

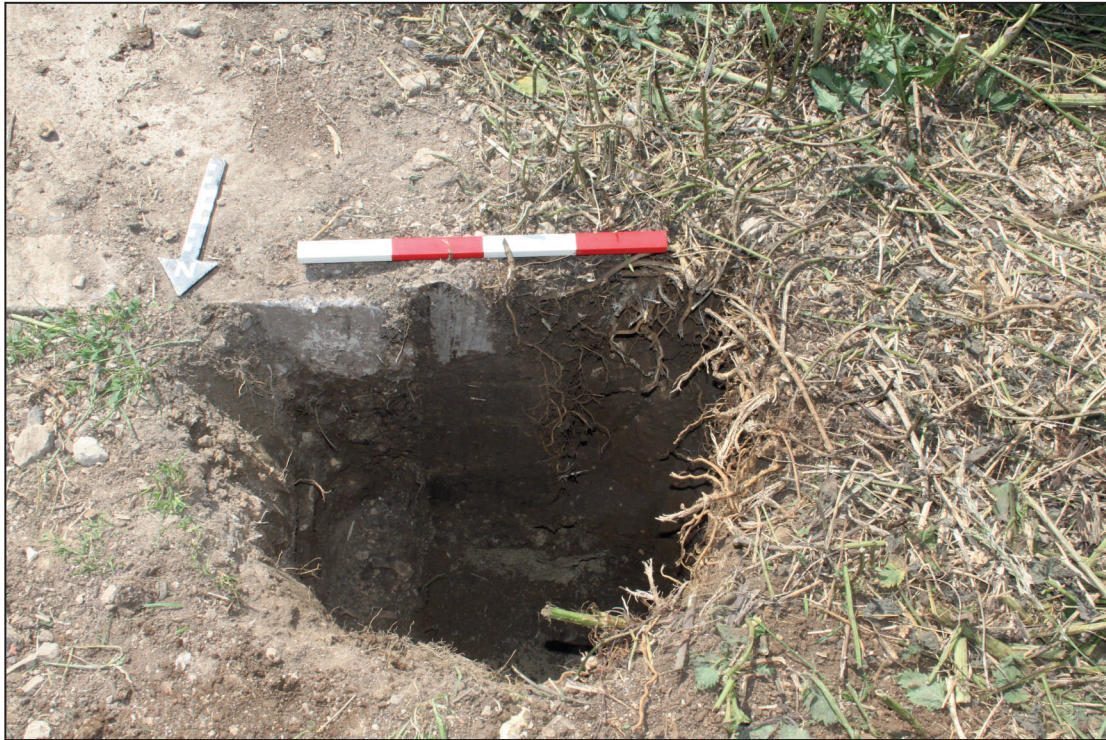
5.4. These trenches were located in the north-western part of the scheduled area. They were excavated to depths of between 0.7m and 0.9m bpgl without encountering the natural geological substrate. Trenches 5, 6, 8 and 10 were located along one of the northern enclosure ramparts and the earliest layer encountered in each trench comprised a very stony deposit. The nature of this material remains unclear given the limited nature of the groundworks undertaken, however it remains possible that it represents parts of the rampart associated with the Camp. In trenches 7 and 9 the earliest deposit encountered was clay silt subsoil. The subsoil and the observed stony deposit were sealed by an average of 0.2m of topsoil.

Trench 10, post-excitation, looking south (0.4m scale)

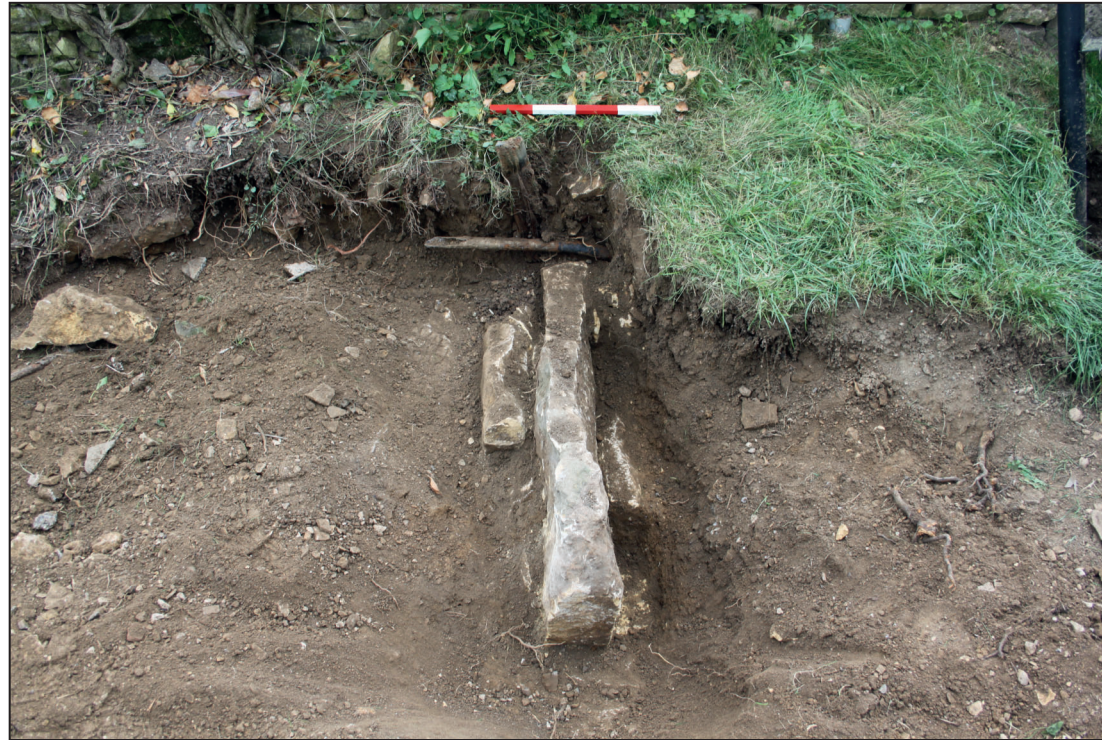
5.5. These trenches were located in the south-eastern corner of the site, at the boundary with Cemetery Lane. The trenches were excavated to a depth of 0.6m bpgl without encountering the natural geological substrate. The footings of a north-west/south-east aligned wall, 1302 (see Fig. 4), were identified in Trench 13. The wall was constructed from large limestone slabs bonded by concrete. The use of concrete to bond the stones at the base of the footings appears to indicate a modern date of construction for the wall.

Trench 13, wall footings 1302, looking south-east (0.4m scale)

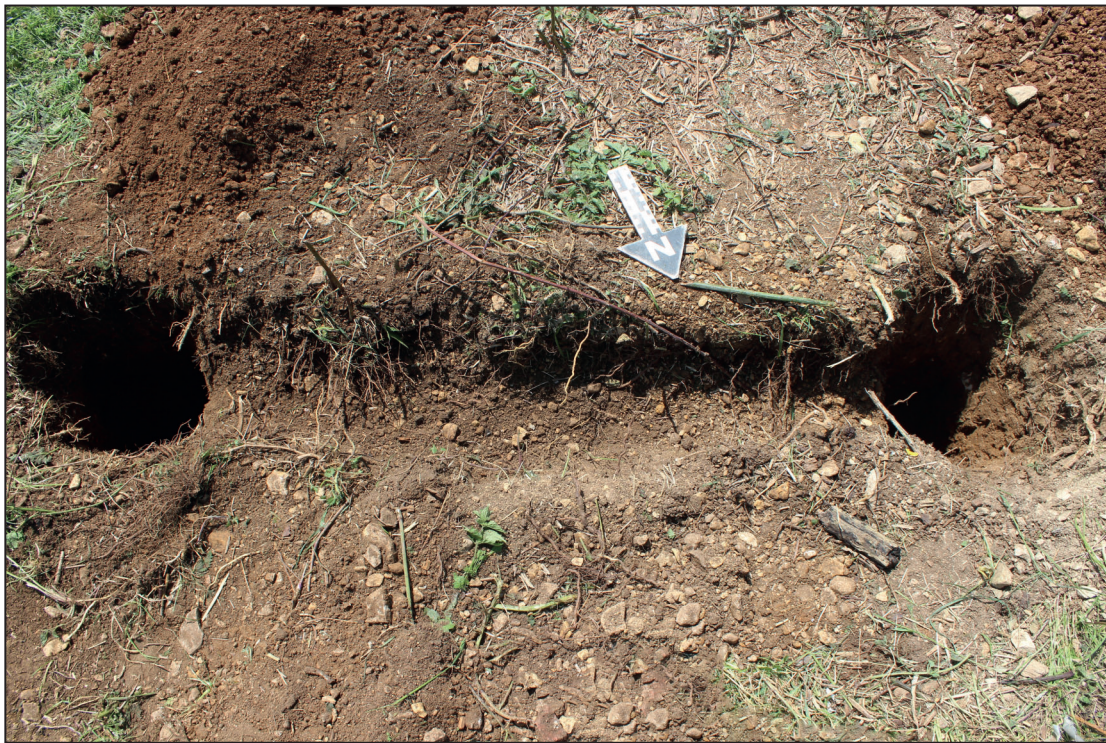
- 5.6. These trenches were located in the south-western part of the site, around the existing Greystones Farmyard. Trenches 11 and 14, located to the west of the farmyard, were excavated to 0.7m bpgl without encountering the natural geological substrate. In Trench 11 the subsoil, 1101, was overlain by a thin layer of topsoil, 1100, while in Trench 14 the topsoil was truncated away by a construction cut for the previous gate.
- 5.7. In Trenches 17–19, located to the east of the farmyard, the natural geological substrate, comprising yellow gravel, was encountered at a typical depth of 0.5m bpgl. This was overlain by up to 0.25m of subsoil, which was covered by a yellow gravel ground consolidation deposit. This was in turn sealed by up to 0.15m of topsoil that had built up around the existing fence lines.

Trench 18, post-excitation, looking south-west

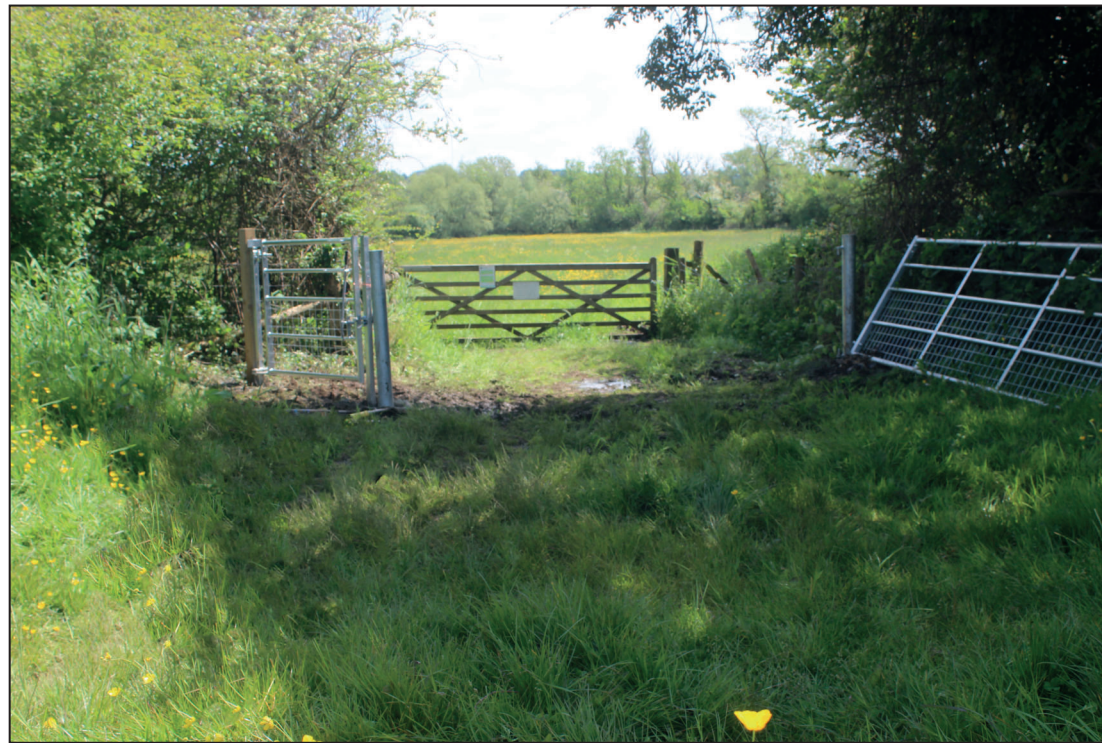
- 5.8. These trenches were located in the north-eastern part of the scheduled area, within the annex enclosure of the *oppidum*. Both trenches were located within low-lying, marshy areas and the rapid ingress of groundwater hampered clear observation. In Trench 20, stony material likely to be the natural geological substrate, 2002, was encountered at a depth of 0.65m bpgl. It was overlain by 0.5m of subsoil, 2001, which was in turn covered by a 0.15m thick deposit of topsoil, 2000. Trench 21 was excavated to a depth of 0.9m bpgl without encountering the natural geological substrate. An alluvial clay deposit, 2103, was encountered at 0.7m bpgl and was overlain by a dark peaty layer, 2102, measuring 0.3m in thickness, that was rich in organic material. This was overlain by 0.25m in thickness of gravel consolidation deposit, 2101, within the existing gateway, which was in turn covered by a layer of trample-derived topsoil, 2100.

General view of gates in Trench 21, after installation, looking east

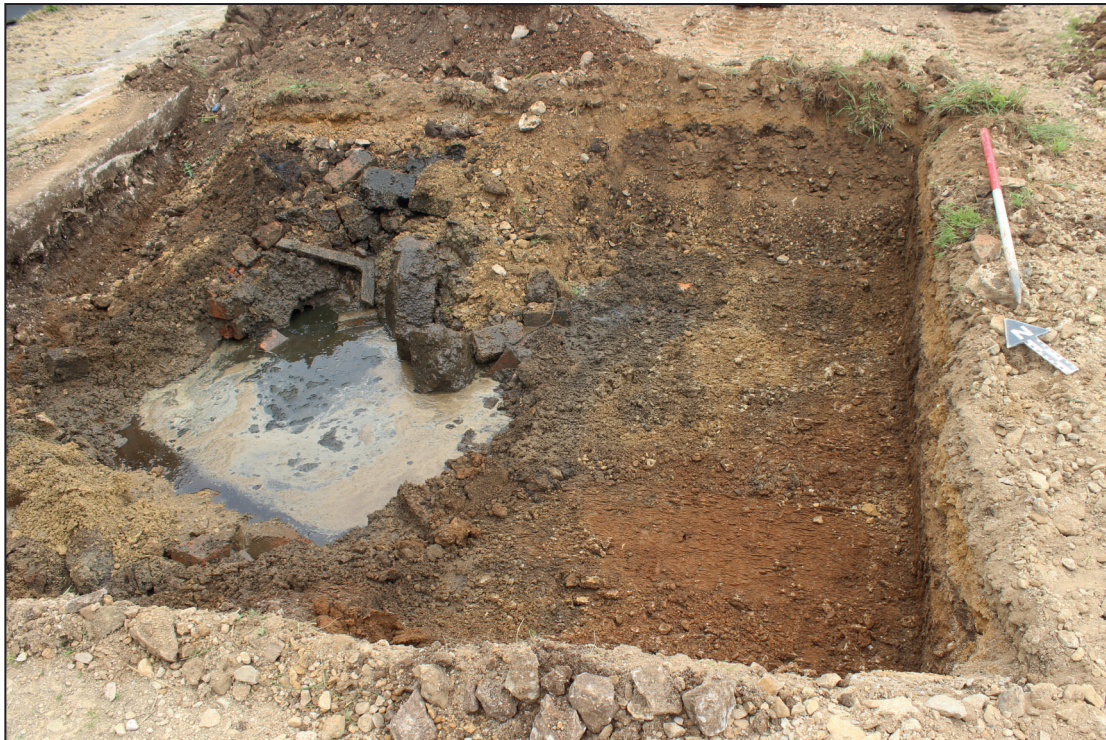
- 5.9. Trench 15 was located in the eastern part of the existing farmyard and was excavated to enlarge an existing brick-lined soakaway. The majority of the trench revealed truncation caused by the previous installation of the soakaway, however stratigraphy was preserved around the southern and eastern margins of the trench. In these areas the natural geological substrate, 1503, was encountered at a depth of 0.5m bpgl. It was covered by 0.35m in thickness of orange-brown subsoil, 1502, which was in turn sealed by yellow gravel 1501, which represented the existing ground surface.

Trench 15, post-excitation, looking north-east (1m scale)

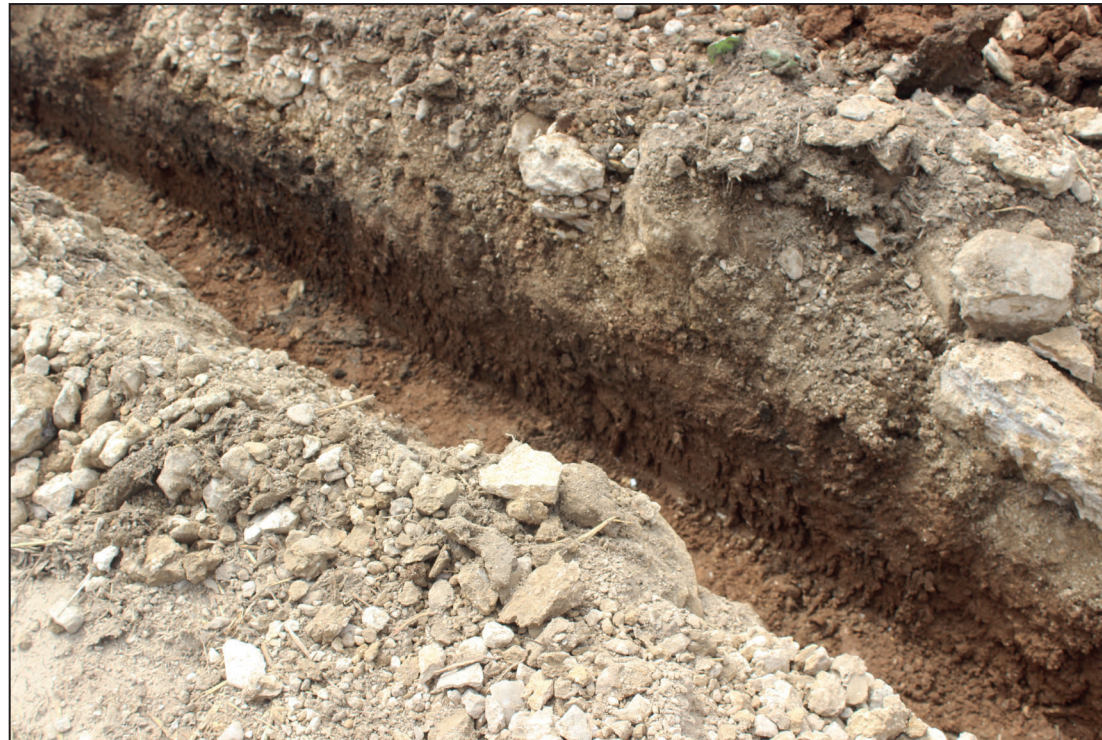
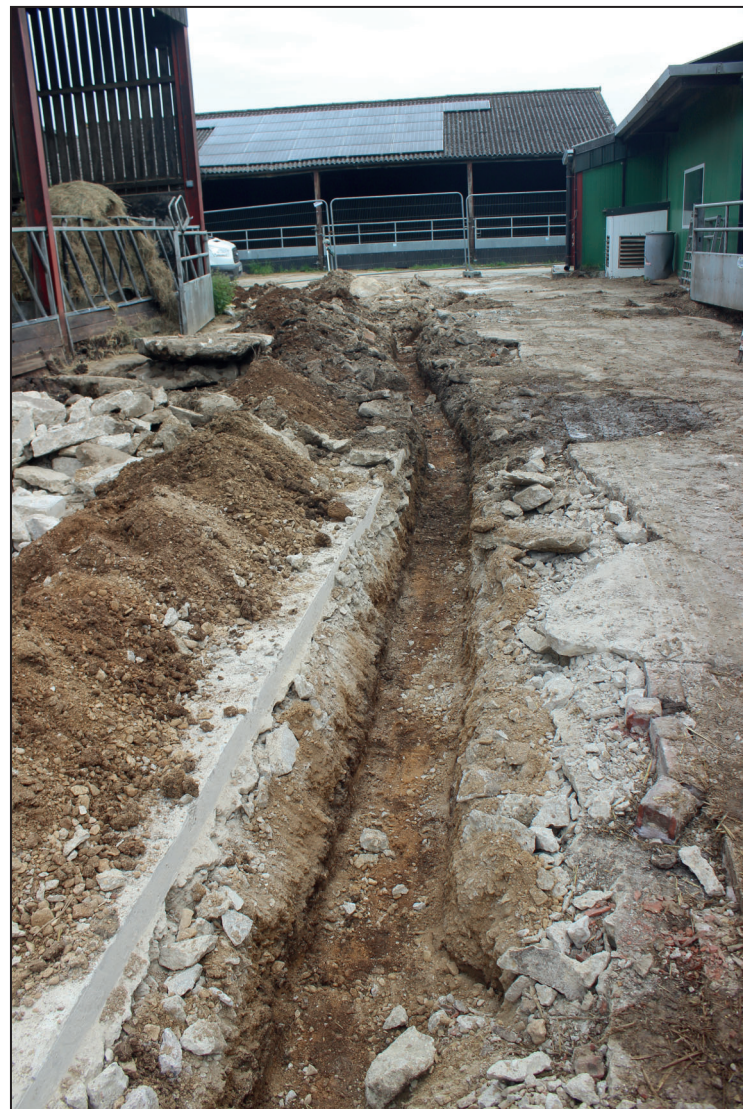
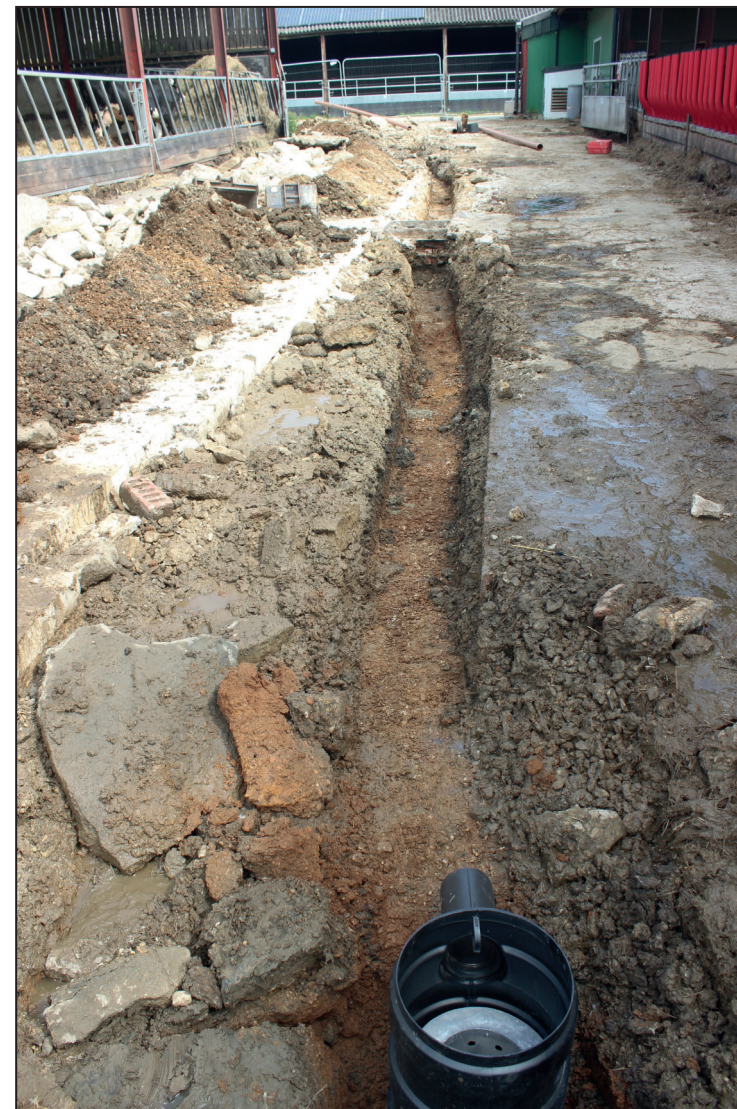
5.10. Trench 16 was located centrally within the existing farmyard and connected a new manhole at the south of the trench to two existing manholes at its northern end. The trench was excavated to a depth of 0.45m bpgl for the majority of its length. The natural geological substrate, 1603, comprising yellow sand and gravel, was encountered intermittently and was not revealed over the full length of the trench, although it was more consistently exposed at the southern end of the trench. The natural substrate was sealed by orange-brown subsoil 1602, which was intermittently overlain by dark brown deposit 1601, containing frequent stone and charcoal inclusions. This was interpreted as a made-ground deposit of a relatively recent origin. The uppermost layer in the trench was concrete ground surface 1600.

6.2. Despite the archaeological potential of the Farmyard (see *Archaeological Background* above) no archaeological deposits were recorded in Trench 16 that may indicate that the Iron Age activity related to the grain storage pits identified in previous excavations does not extend to this area (Dunning 1976, CA 2015b, Rubicon 2018). However, it should be noted that the shallow depth of the drainage trenches meant that the natural substrate was not exposed along the full length of the trench, especially in the northern part of the trench, which was closest to the previous excavations.

Trench 16, during excavation, showing stratigraphy, looking south-west

Trench 16, northern section post-excitation, looking north-east

Trench 16, southern section post-excitation, looking north

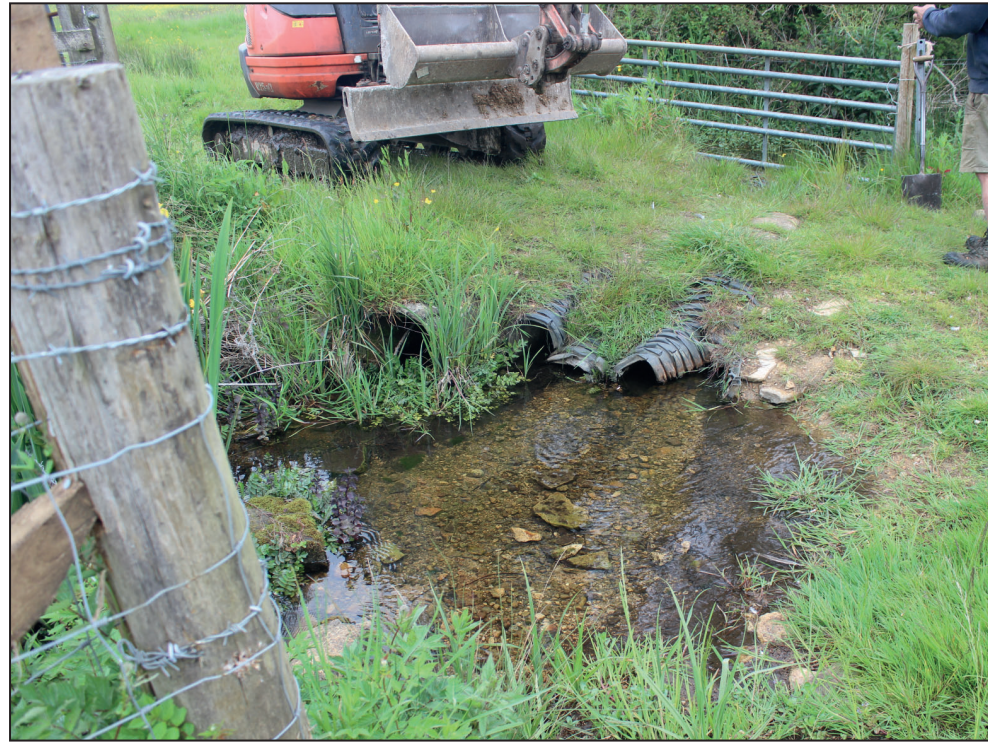
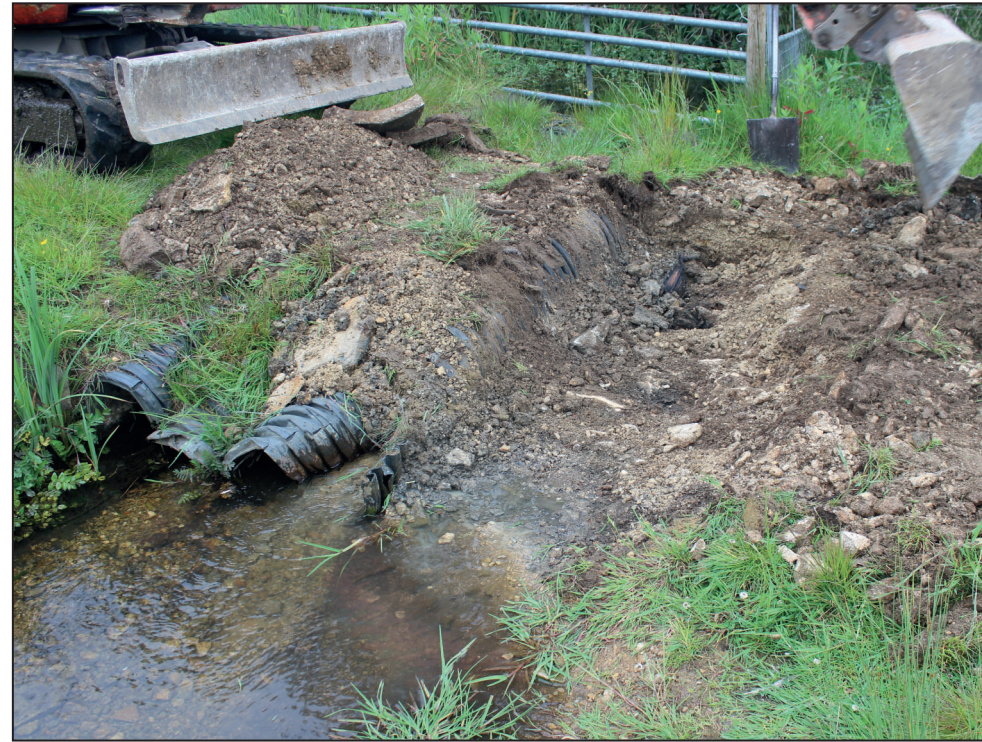
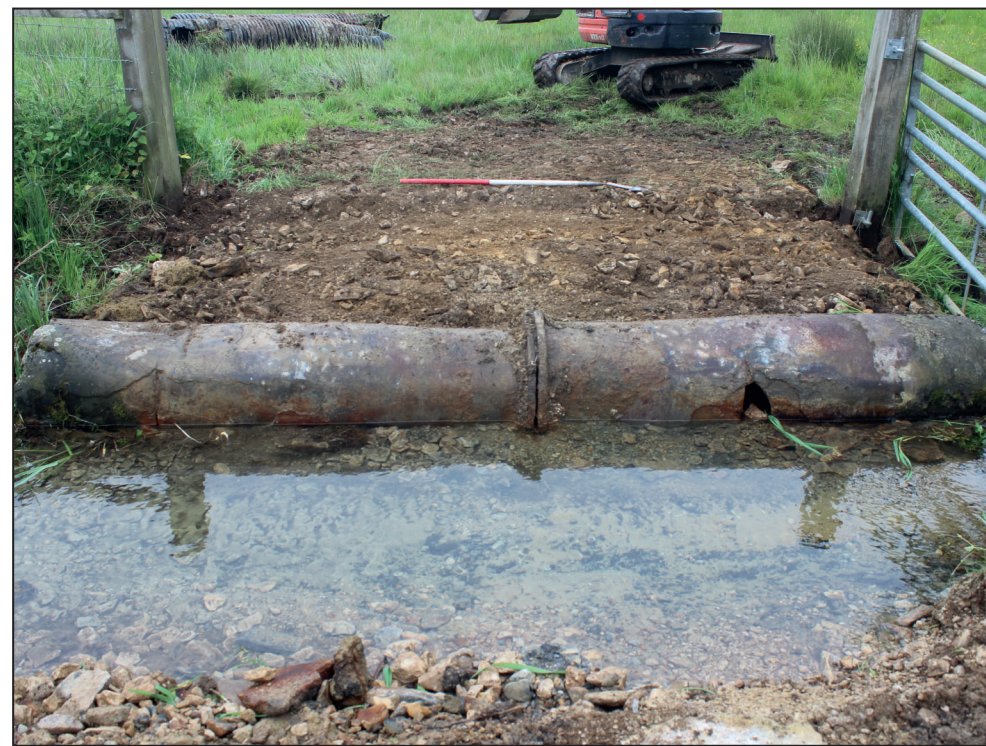
5.11. This trench was located at the eastern edge of the scheduled area, outside the annex enclosure of the *oppidum*. The trench was excavated to a maximum depth of 0.45m bpgl, which was the approximate depth of the stream bed, 2202. This was overlain by made-ground 2201 which comprised mixed stone and concrete rubble and represented infill and consolidation forming a bridge supporting two plastic culvert pipes and an iron pipe. The made ground was covered by a thin layer of turf, 2200.

Trench 22, pre-excavation, looking south-east

Trench 22, during excavation, showing depth of made ground 2201, looking north-west

Trench 22, post-excavation, looking west (1m scale)
