**Rickfield House, Church Road
Liddington
Wiltshire**

Archaeological Watching Brief

CA Project: 3395
CA Report: 11138

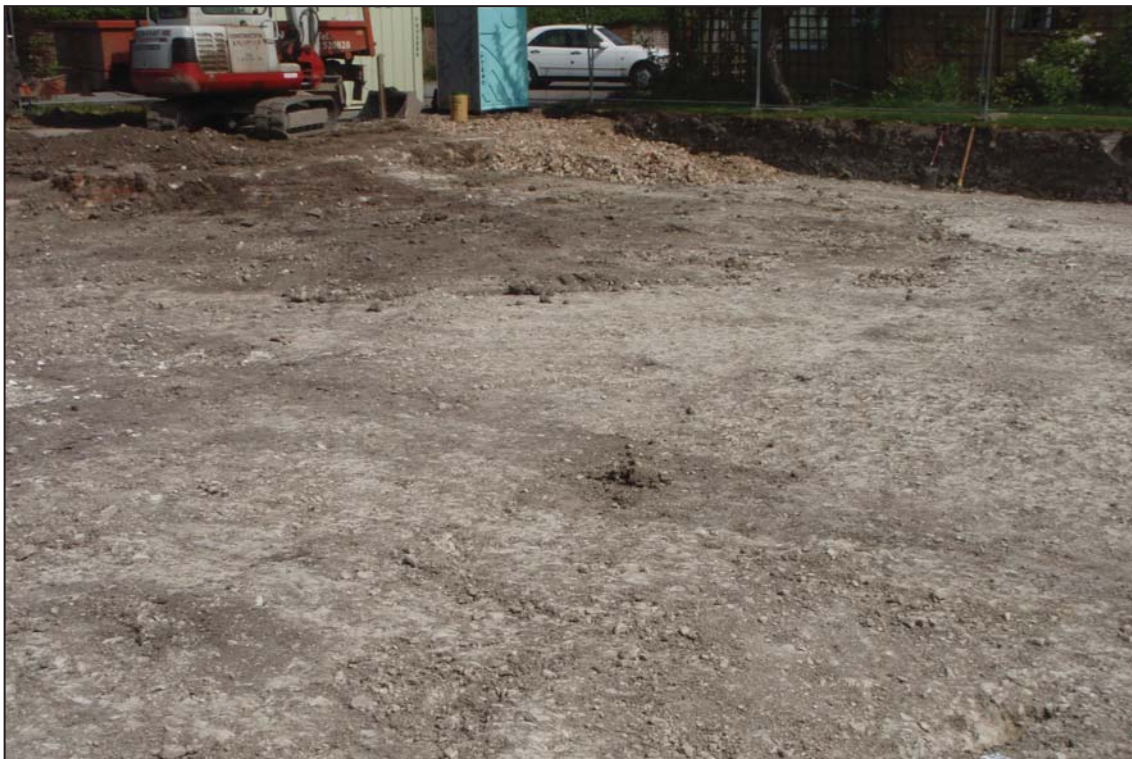
4 View north-east of the eastern part of site, showing ditches 133, 113, 105 and 109

- 2.2 A ditch 103/133 was observed running from north-east to south-west near the eastern limit of the site. The ditch was 0.32m deep and contained a pale grey silty clay basal fill 134 and a dark brownish grey clay secondary fill 104/135. The primary fill was only seen in the south-eastern part of the ditch. A single sherd of Anglo-Saxon pottery was recovered from secondary fill 104, along with a small fragment of animal bone. An undated shallow gully 105/107 appeared to cut ditch 103, although this relationship was not certain. This gully contained a single dark brownish grey clay fill, and terminated just south of the point where it intersected with ditch 103. Gully 105 had a similar alignment to ditch 103/133 and may represent a later phase of that ditch (Figs. 2 & 3)

- 2.3 A further two undated ditches were seen in the development area. A stretch of ditch c. 4.5m long, orientated north west-south east, 113/137, was observed near the centre of the site. It was 0.23m deep and contained a single mid brown clay fill, 114/138. A larger ditch running roughly parallel to ditch 103/133 was also seen. This ditch contained a single homogenous fill 120 of dark grey silty clay (Figs. 2 & 3).

- 2.5 Two pits were identified within the development area. A shallow elongated sub-oval pit 131 was seen c. 1m east of the posthole group. It contained a single brownish grey silty clay fill, 132. A much deeper and more regularly shaped sub-circular pit 109 was seen in the section along the eastern edge of the site. Its basal fill 110 consisted of pale grey clay whilst the secondary fill 111 was a dark brownish grey silty clay. No dating evidence was recovered from either pit.

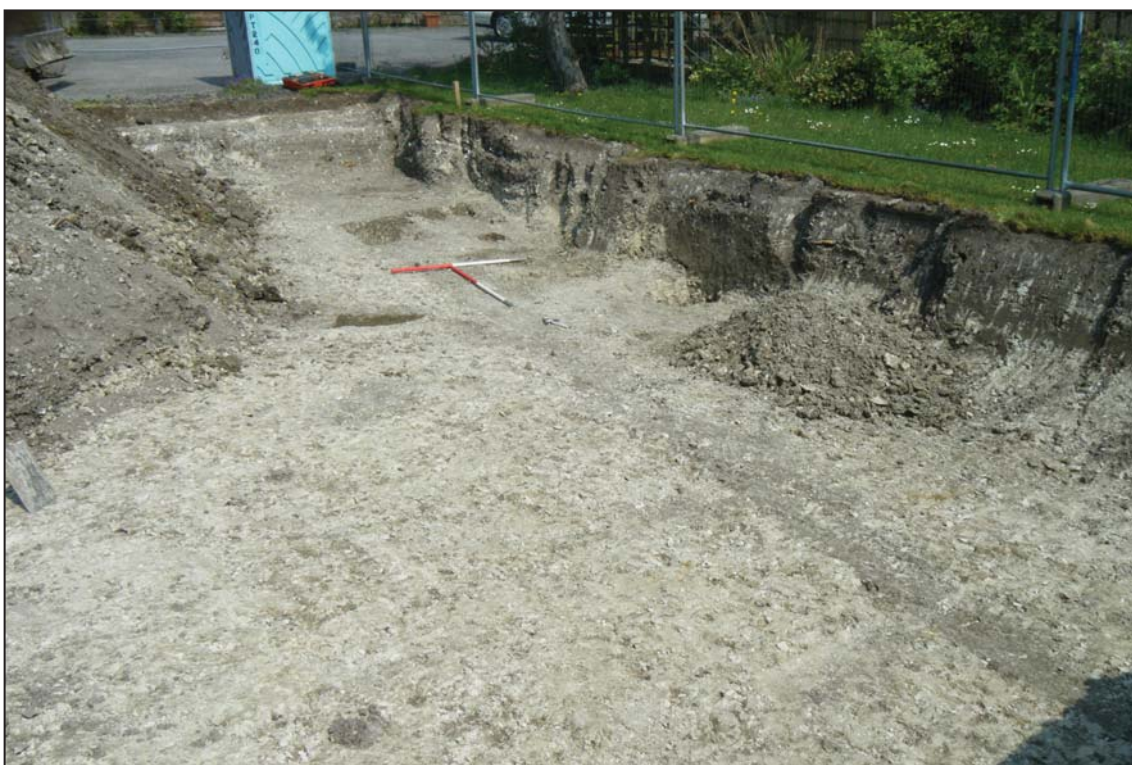
5 View north-east of the south-east part of site, showing ditch 119 and disturbance 140

- 2.1 The natural geological substrate 102, consisting of fragmentary greyish white chalk in a dark grey clay matrix, was revealed over the majority of the site at an average depth of 0.58m below present ground level. All archaeological features were cut into this layer. Natural substrate was not observed in the northern part of the site, where a mixed deposit of dark brown and black sandy-silt 140 was the earliest deposit observed. This material was interpreted as a modern dumped deposit laid down at the time of construction of the septic tank 139, manhole and sewer pipe 112, which exist in this area (Fig. 2).
