**8-16 HIGH STREET
PEWSEY
WILTSHIRE**

HISTORIC BUILDING ASSESSMENT

CA PROJECT: 3327
CA REPORT: 11028

FEBRUARY 2011

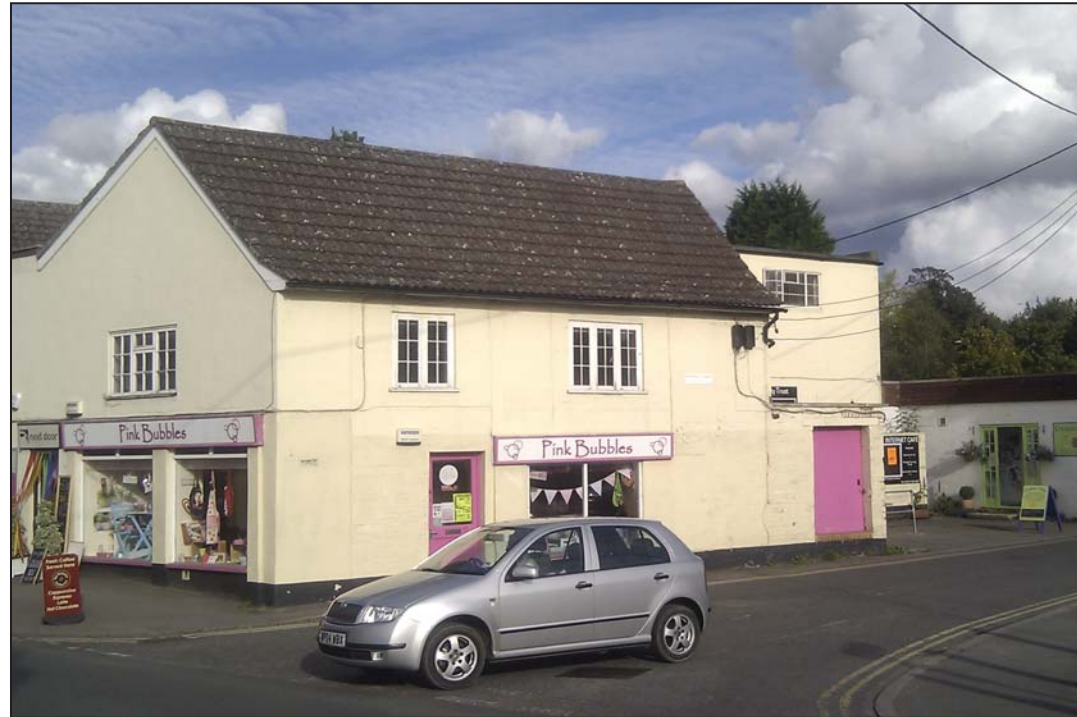
3 General view to east, Block 3 in foreground on Old Ford Lane

- 3.1 The exterior of the block was seen to consist of three basic elements (Figs 2 and 10): Block 1: a modern brick-built and flat roofed range on the south-east (Fig. 3); Block 2: a concrete-block and flat-roofed range (Fig. 5) and Block 3: a brick-built corner block with a double-pitched (M) roof (Figs 3 and 4). In fact the Block 3 was two buildings, the north-eastern part of which appeared to be largely contemporary with Block 2, and clearly later than its south-western neighbour.

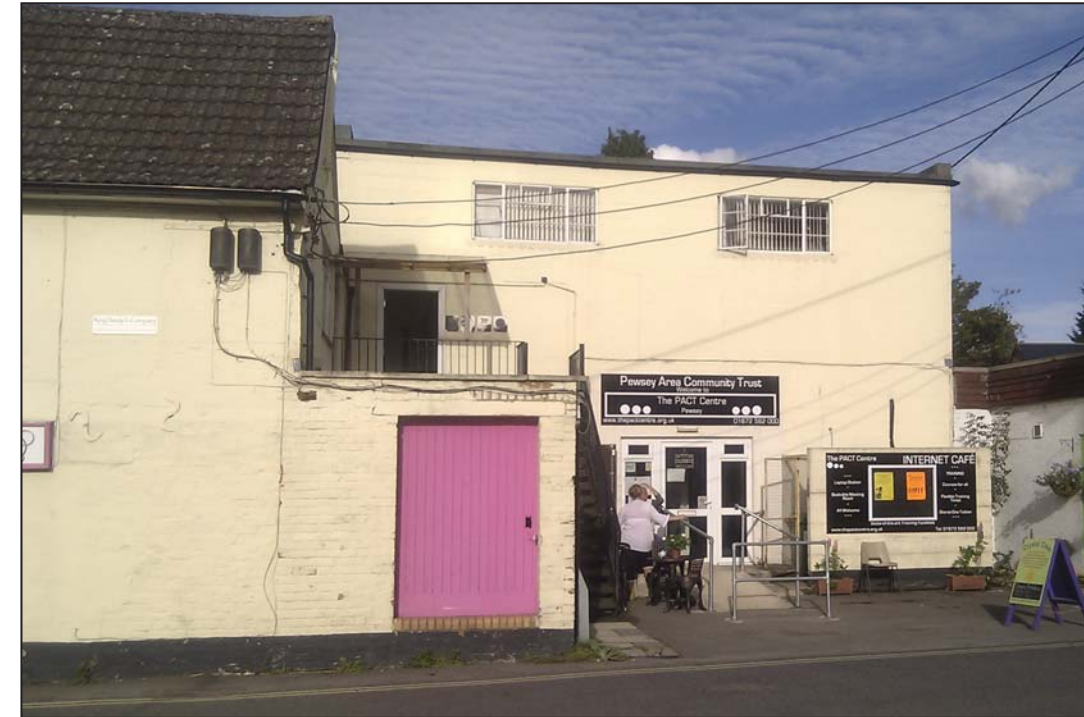
5 The south-west elevation of Block 2, looking north-east, Block 1 to right

- 3.3 This block had flat roofs with a plain parapet, but this was not accessible during the site visit.
- 3.4 Block 1 was single-storey, built of brick, with a tile hung eaves/parapet (Fig. 5). It had clearly replaced a part at least of south-eastern end of Block 1. This was apparent from its incorporation of the north-eastern concrete-block wall and Crittall windows (Fig. 6). It abutted the southern corner of the two-storey section of Block 2. The windows and doors were timber and appeared to be late 20th-century design.

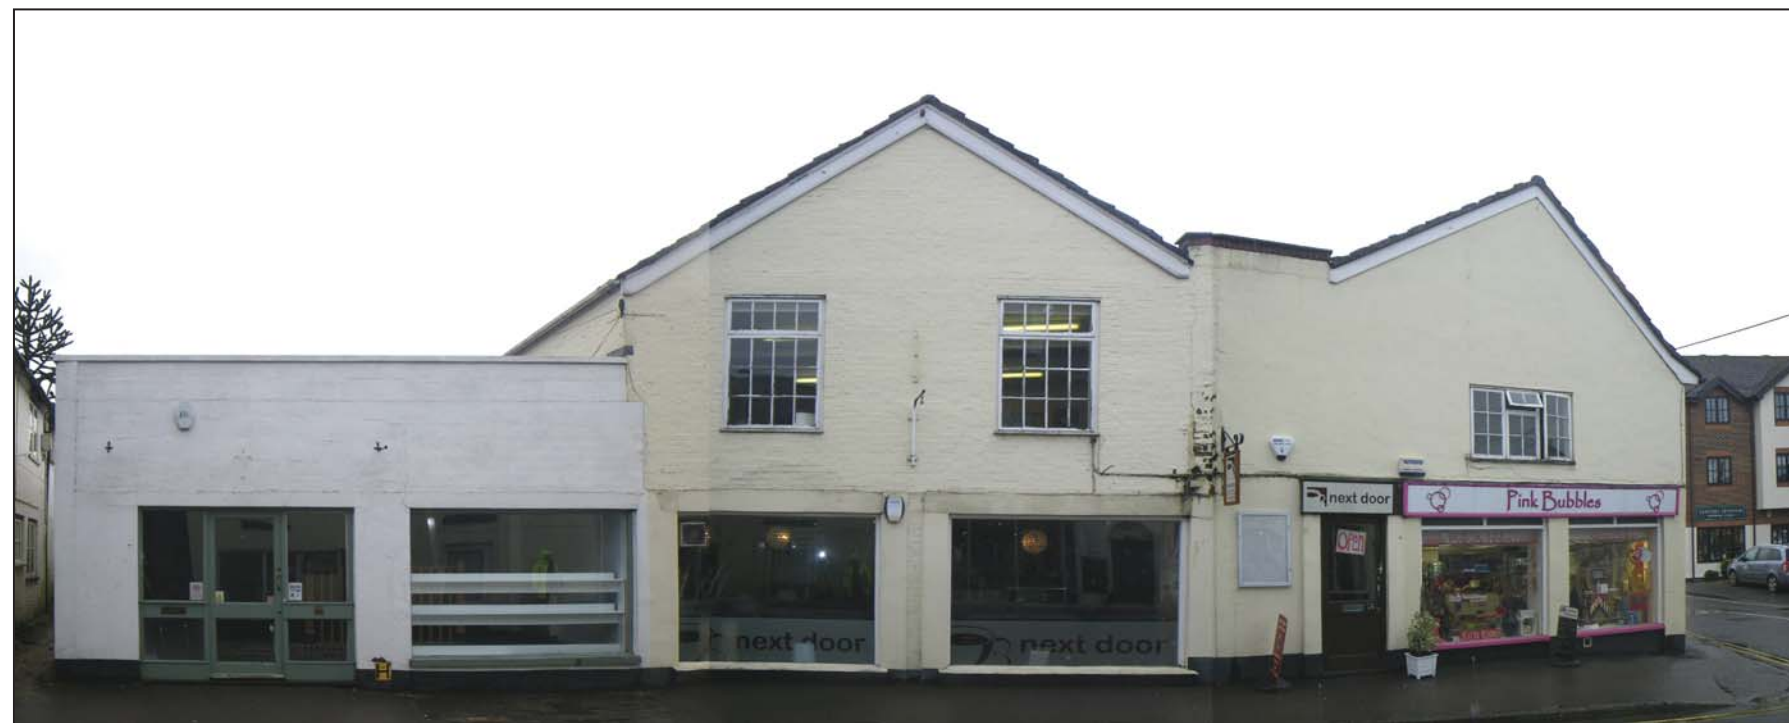
4 Composite view of north-west elevation of Blocks 2 and 3 on Pewsey High Street

- 3.5 Block 3 is the most complex and certainly contains fabric older than the 20th century. The north-eastern part of the block (Block 3a), now containing a café on the ground floor and an office of the first floor, is brick-built but its High Street frontage overrides and therefore ought to post-date the adjacent part of Block 1 (Fig. 4). However, the brick construction and sloping roof suggests an earlier date. In fact it is much more probable that Block 1 was cut into the wall of Block 3 here, probably for structural reasons. Its junction with the corner block proper (Block 3b) is complex, but tells a relatively straightforward story. The present High Street frontage of the corner property has been rebuilt in concrete block at a different alignment from the earlier 20th century building line. However, a small section of the earlier brick frontage wall still survives sandwiched between the more recent work either side. Here it is obvious that the Block 3a butts the older brickwork and overrides it where a brick parapet wall hid the valley where the adjacent sloping roofs met (the rest of this parapet was rebuilt in the late 20th century. The brickwork of this override has cracked above and along the line of the join (Fig. 4).

- 3.6 The two first-floor windows in this elevation appear even later, being modern wooden casements set in existing openings that have been altered and enlarged to take them (Fig. 4).

- 3.24 The north-eastern slope of this roof was removed (probably in the period after 1965) and its angle was flattened (Figs 4 and 16) so that the feet of the rafters were now taken on the wall of the adjacent part of Block 3, not the north-eastern wall of this building. Some timbers, such as the purlins and some common rafters of the phase 3 roof were re-used. Old photographs show stone slate roof covering, and the present concrete double romans must belong to this change in the roof. Common

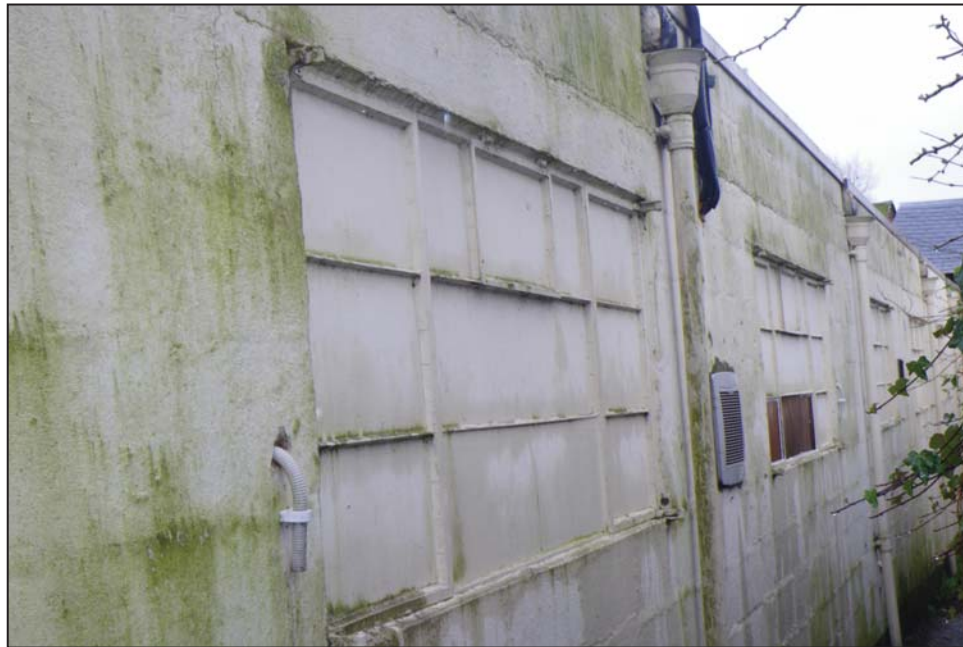
6 Crittall-type windows in the north-east wall of Block 1, looking north

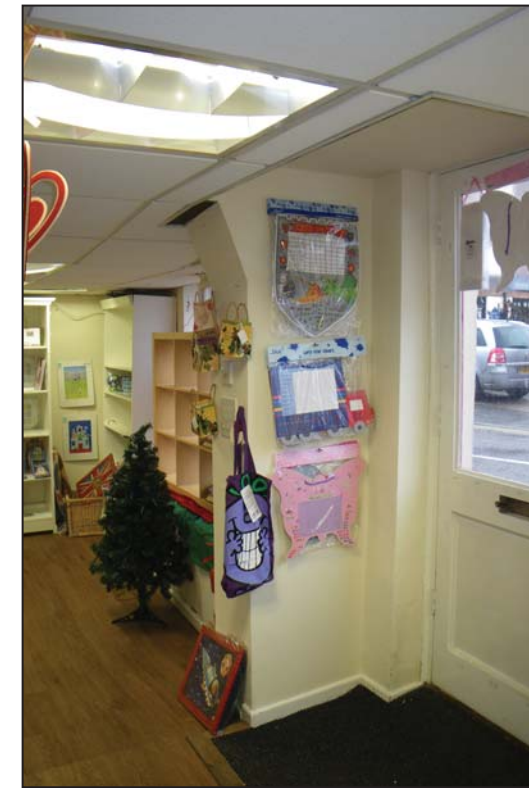
8 The enclosure of a probable structural timber in the shop looking south

- 3.13 However, it was possible to see or infer older features. Just inside the door to the shop was a respond on the south-west wall, enclosed in modern dry lining, this angled in just below the ceiling, suggesting a timber post and brace (Fig. 8). The floor and ceiling both dropped several inches to the south-east of this point. Other timbers were seen at ceiling level on the north-east side, which were girding beams or bressummers (Fig 9, right side). Another deeply-chamfered timber, seen at the rear of Block 3, was an internal ceiling or wall beam (Fig. 9, left side).

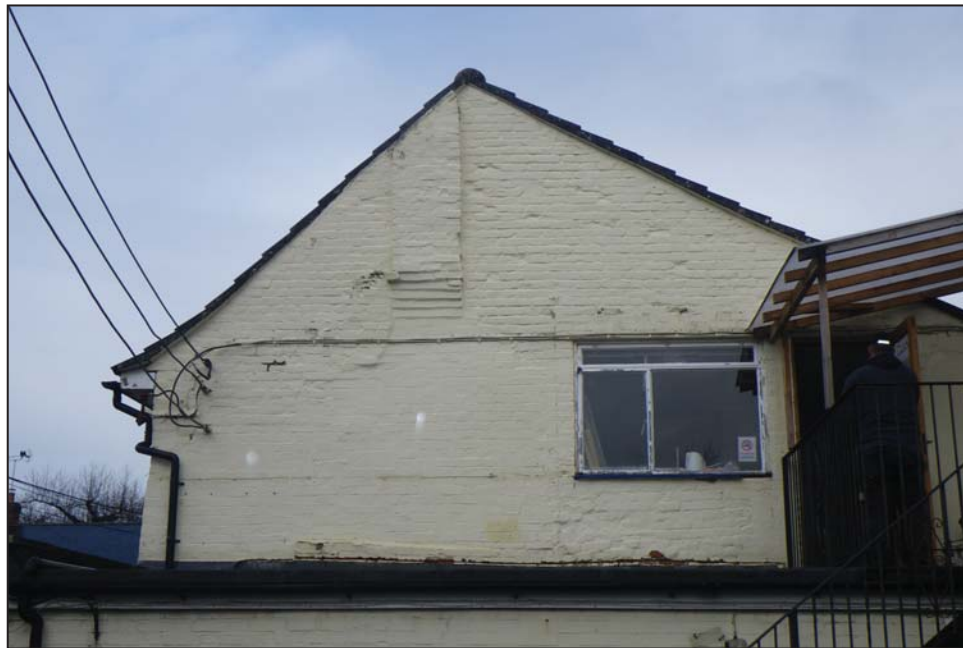
7 The south-east gable end of Block 3b

- 3.10 A gable of roughly the same dimensions as the single-storey extension represented in the south-eastern gable of Block 3b by an area of Flemish bond brickwork with the headers decoratively picked out in dimpled bricks (Fig. 7). Paint coverage obscures the details, but the remains of a brick stack appears to be earlier, and the upper part of the gable either side of it is a recent rebuild. The removal or reworking of a gable-end stack, as well as the alteration of the extension, is the reason for this complexity, but the details need further work to elucidate.

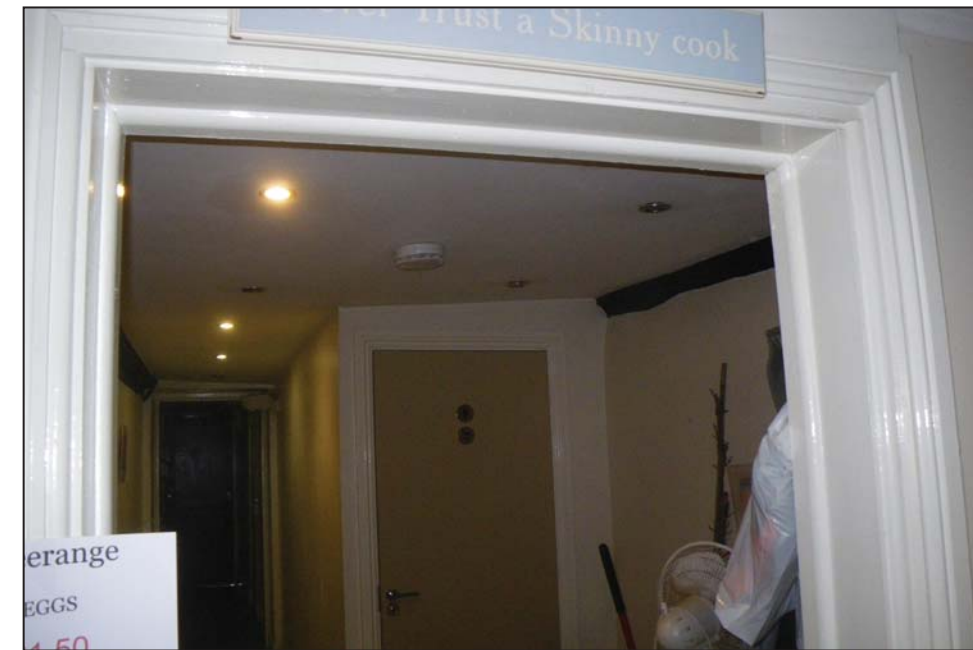
9 In the cafe rear corridor (Block 3a) looking to the south-east showing beams at ceiling level

- 3.17 It was, nevertheless, immediately clear that the roof had a complex structural history and was in part, somewhat older than the external appearance would suggest. The roof clearly indicated that the present form of Block 3b had resulted from the amalgamation of two separate buildings: south-east and north-west. The junction between them was on the line of the timber post inferred on the ground floor and the coincident break in ceiling levels (para 3.12), and the vertical joint in the brickwork seen outside (para 3.8) (Fig. 11). This break was also reflected in the very different appearance of the girding beams in the front and rear parts of the block (para 3.12), cf Figs 9 and 12.

- 3.22 These trusses seemed to have been carried by vertical wall posts. One of these was seen (through a hole in the ceiling over the void containing the stack) supporting the south-west end of the south-eastern truss, but could not be closely examined. It seemed to be jowled. The north-western truss lined up with the inferred post inside the shop at ground floor level (para. 3.12). This could have been of the earlier phase, extended upwards, or replaced. Neither hypothesis can be confirmed at this stage. The brick gable end had a pocket for the purlin of this phase, but the purlin no longer reached as far as the wall. It is, therefore, at least the case that the gable end, whose phasing is not clear, was built when this roof was still functioning. A girding beam at ground floor ceiling height was seen in the corridor on the north-east side next door (Fig. 9). This may have been part of this building.

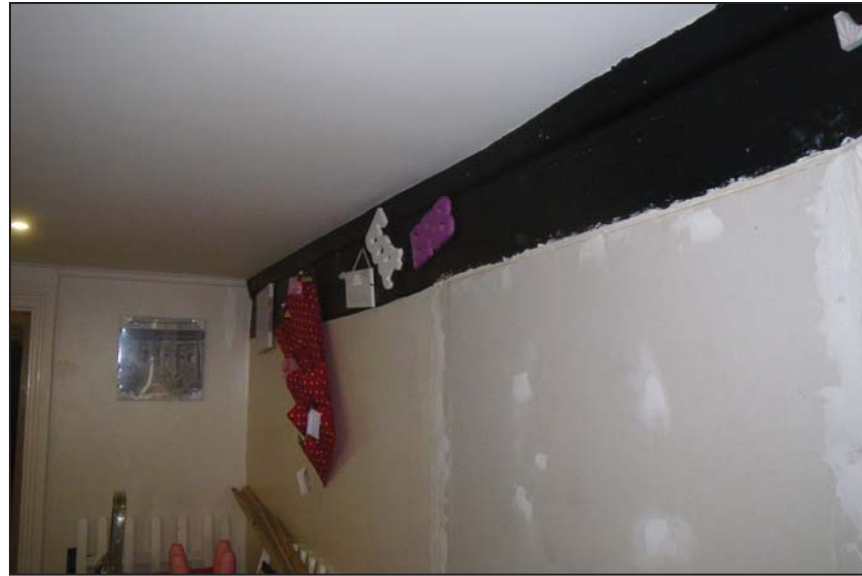
12 Inside the cafe entrance (Block 3a) looking to the south-east showing the beam at ceiling level in the party wall and blocked door below

- 3.33 Nothing of the structure below the roof was really visible except the external brickwork, with one exception. This was a large beam in the north-eastern, ground floor wall at ceiling level. This was rather substantial and square cut. Its most likely function would have been as a girding beam or bressummer in a timber framed building, suggesting that the present brick exterior is a replacement. It was seen in the front room of the café next door (Fig. 12).

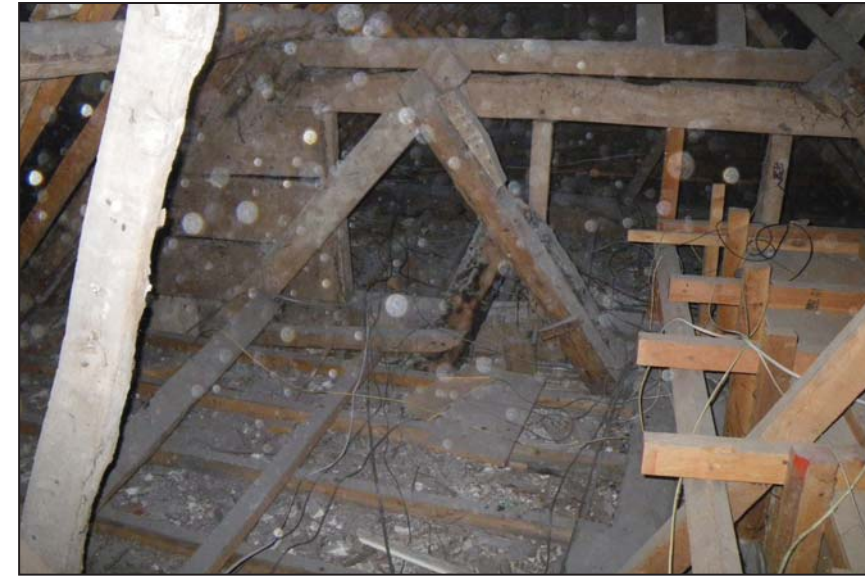
14 The roughly built extension of Phase 2, looking north-west. The north-west building's hipped gable end is evident immediately behind it

3.20 The trusses were both extended upwards and to the south-west, by the addition of a new principal rafter truss on the side of the old ones. The north-eastern rafter simply extended its Phase 1 counterpart upwards and the south-western rafter was consequently displaced south-westwards relative to its predecessor (Fig. 14). The timbers were sawn but secondarily adzed to shape and nailed together. The apex was a nailed lap joint and a sort of half collar or tie was nailed from the original south-east rafter to its replacement at ceiling level. The trusses were joined by staggered, through-mortised, butt purlins, secured by pegs. The lower inside arises were run-out chamfered. No common rafters survived but they had been also secured by pegs.

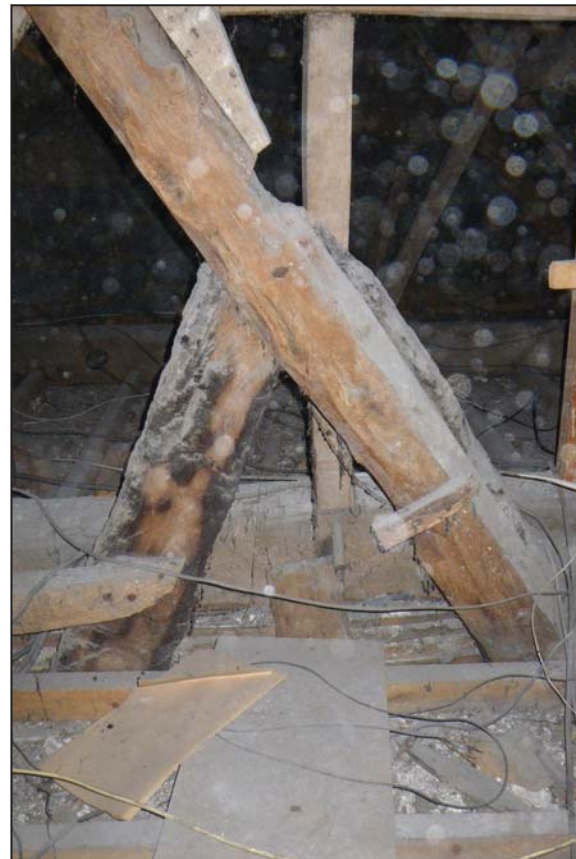
13 The charred phase 1 truss apex, looking north-west partly obscured by phase 2 timbers

3.19 The earliest phase was represented by a principal rafter truss, the lower part of the principal of which was noted on the first floor. This formed the gable of the south-east building. The apex of the truss only projected a short distance above the ceiling, indicating it was the roof of a single-storey building. It had been badly charred and the apex joint was damaged (Fig. 13). There was some indication of a mortise for a tenoned, butted, ridge piece, but this was also badly damaged. That there was a ridge piece, was indicated by the existence of a cut-out for it in a later timber. This was also indicated by a similar couple of rafters to the south-east. This was unburnt and the timbers were sawn. The pegged mortise and tenon had sprung. A vertical post had been knocked into the rafter as if to support it, but both had moved considerably out of position. No collar or tie-beam was visible and this would have been below ceiling level. Part of the principal rafter of the north-western truss was noted in the wall at first floor level ("a" on Fig. 11). A large timber linked these trusses at ceiling level, in the manner of a purlin. However, it was laid flat on the ceiling, passing under the principal at one end and outside it on the other. It seems to have been a re-used piece of timber roughly bracing the timbers in an *ad hoc* manner.

- 4.10 As the Phase 1 roof in the south-east end pre-dates this roof, it must be 17th-century in date or older. It is extremely steeply pitched and was probably originally thatched. Little more can be said until more of it is visible. The large stack, a 17th-century feature one would surmise, especially from the very thin bricks it is built with, seems to be attached to the outside of the Phase 1 roof truss and is enclosed by the Phase 2 work.

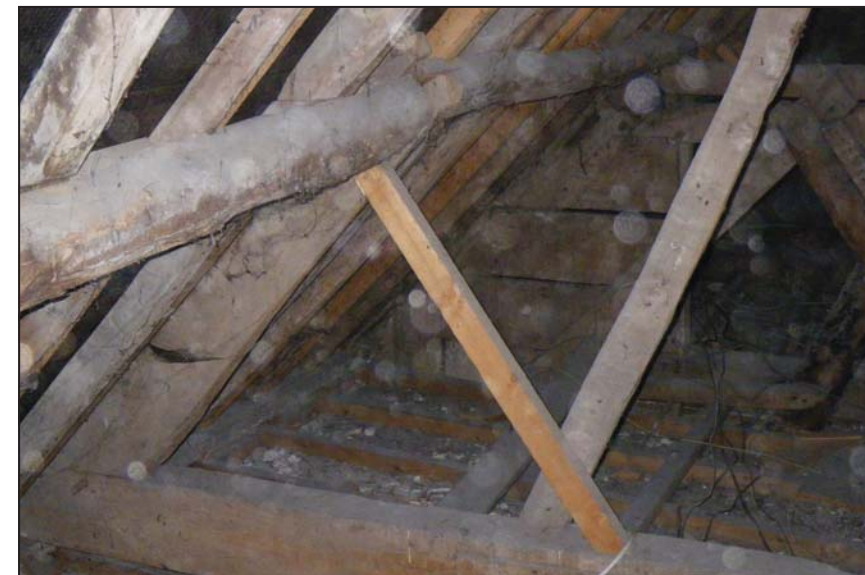
15 One of the phase 3 trusses, showing butt purlins and tie beam. Phases 1 and 2 visible at rear

- 3.23 This phase resulted in the provision of the roof of which the current south-western slope still exists. A completely new set of trusses and rafters was provided. These had various cut outs to allow them to pass over and around the earlier timbers where they were not removed. The timbers were sawn, with pegged mortise and tenon joints, and were of relatively large scantling, especially the tie beams. The purlins were mortised butt purlins but the principals have been sawn off above them or completely removed (Fig. 15). The north-western end of the purlin merely rested on the north-western building (described below) and there was no truss at this point. The trusses rested on a wall plate on the top of the present brick wall, which also enclosed the earlier wall posts, and also on the stack brickwork. This suggests that the roof is contemporary with the current visible external wall, unless it was underbuilt and originally of timber.

- 4.12 The Phase 3 roof is well-made of large scantling, hardwood timbers with well-executed pegged joints. The general impression, especially from the over-specified and neatly sawn tie beams is of 18th-century joinery, but in a traditional vein. The purlins are quite roughly cut, however, and there is a lot waney wood in the structure. This probably reflects the relatively low status of the building.

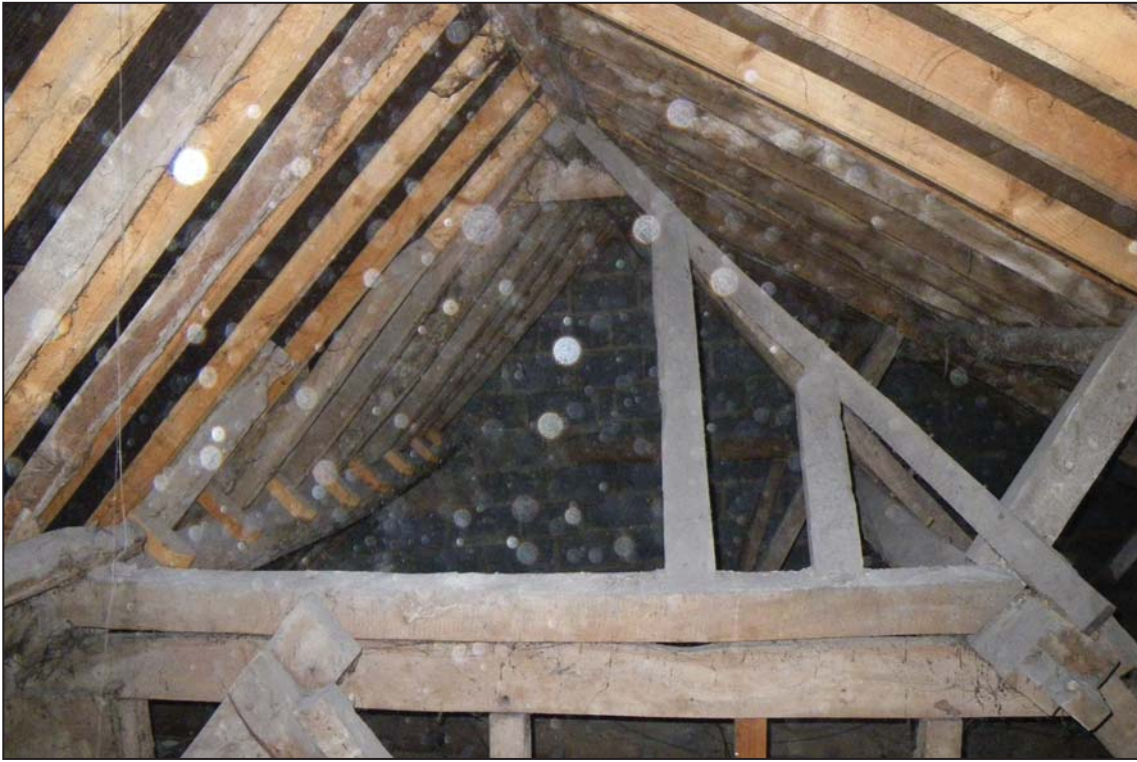
16 The hip of the roof of the north-west building, looking north-west

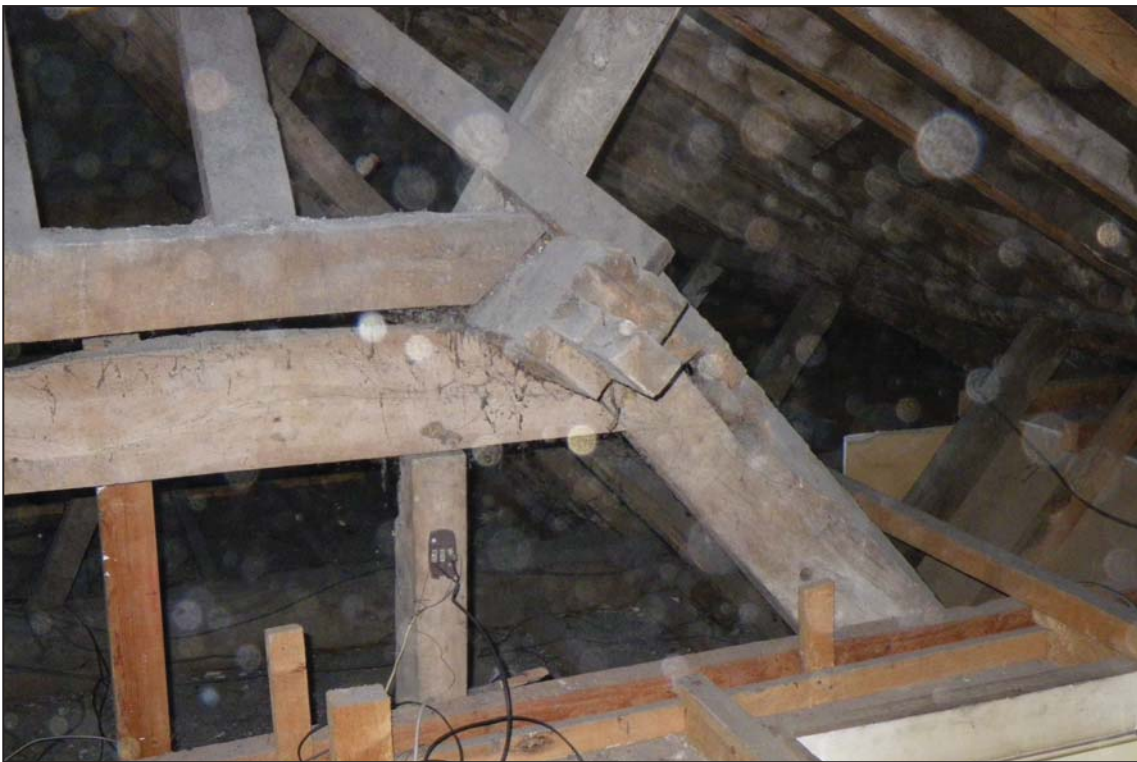
17 The face-halved bladed scarf joint on the end of the re-used and clasped purlin of the north-western building, looking north

- 3.28 The roof was of clasped-purlin collar-braced form (Fig. 17) with the principals mortised into the tie beams, which rested normally on the wall plate. All joints were pegged. The south-east gable end truss had three studs between the tie beam and collar. Broad, horizontal planks nailed in place on the south-west side of the studs were the remnant of a planked gable end wall. This was missing from the north-eastern side. The neat end of the planking indicates a central window here, divided by the central stud. The hip may be a later alteration. The rafters and the hip purlin or plate are not jointed and pegged but simply nailed in place.

- 3.30 The purlin on the north-east slope is re-used. It has nocks on one corner to take common rafters and redundant peg holes and mortises. This and the face-halved and bladed scarf at its south-eastern end (Fig. 17) indicate it was originally cut as a wall plate and re-used here. A simple pegged and through-splayed scarf shows where it was extended at the other end (and the extension removed in the truncation). The principals of the south-eastern truss are also possibly re-used as both have mortises for wind braces on both faces (with pegs and broken tenons in them). It is just possible that they are *in situ* and the wind braces have been removed, but this requires further and more detailed investigation of other timbers in the roof.

- 3.31 The common rafters mostly survive either entire or truncated on the north-eastern side, and the Phase 4 roof simply built above it from the same ridge (Fig. 17).

- 3.32 The current ceiling is carried on thin joists set in mortises in the tie beams and these timbers may be contemporary with the main roof structure (Fig. 17). The exact character of the joints could not be ascertained.
