Former Gasworks  
Bristol Road  
Gloucester  
Gloucestershire

Historic Building Recording

CA Project: 3393  
CA Report: 11074

Historic building recording was undertaken by Cotswold Archaeology for CgMs Consulting, of the buildings related to former use as a Gasworks, on an extensive site on the Bristol, Road, Gloucester. The gasworks was founded in 1875. Of this earliest foundation, only a few boundary walls and a partly demolished gate lodge survived above ground. The infilled brick pit for the eastern gasometer of 1875 was visible on the site visit. The complete but sunken and completely empty gasometer on the north, added in 1901 was also visible. The stanchions of the rising framework for this were removed in 2001 and the stumps are still *in situ*. A brick-built office on the south side of the entrance road looked as if it belonged to the first phase, but does not appear on mapping until 1936. The other buildings recorded all belonged to the experimental gas production plant established in the 1950s.

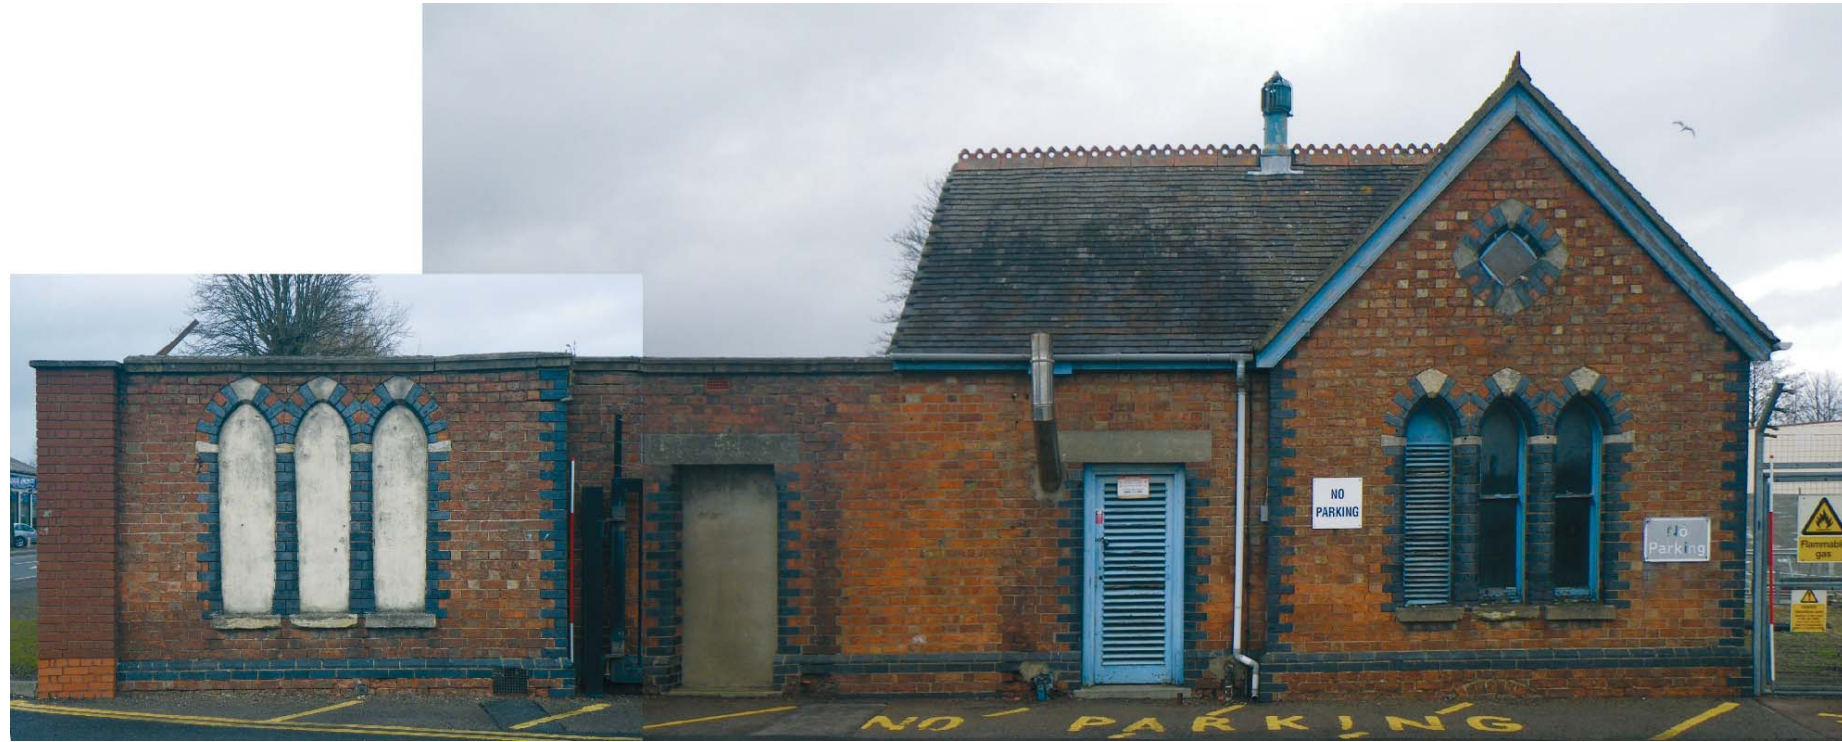
Fig. 8 The south elevation of the gate lodge BD1 (Scale 2m)

- 4.1 This small brick, single-storey building appears to have functioned as the gate lodge. It can be identified on the earliest OS maps to show the gasworks, dating to 1884. Another building shown on the maps up to at least the 1950s, facing this one on the south side of the access road, may have made a matching pair (Fig. 6). The western end has been partially demolished, leaving only the façade, but it can be reasonably interpreted as being originally a simple symmetrical composition of two gabled blocks flanking a central linking block (Fig. 8). Note that the ranging rod used in the illustrations in this report came from a faulty manufacturing batch and is white/red/red/white, rather than the conventional white/red/white/red.

- 4.2 The openings all appear to be original, although the two doors seem to have had arched tops replaced with concrete lintels. The central, blocked opening seems to have had the brick plinth rebuilt and this may have been a passage through the building.

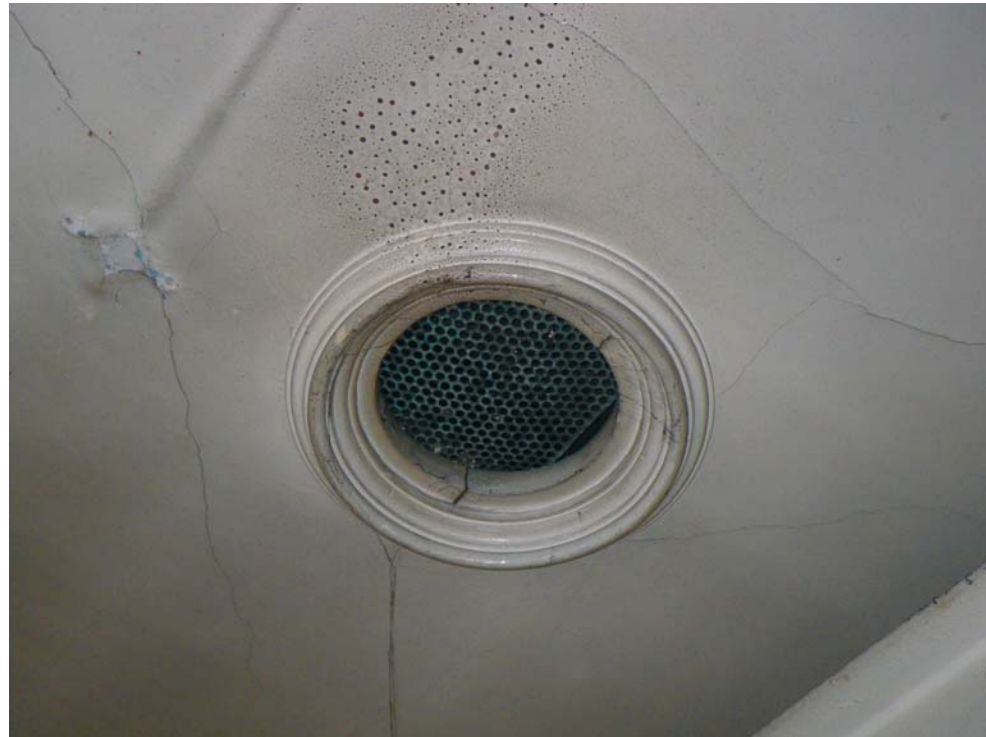
Fig. 9 The ceiling vent in the eastern room of BD1

- 4.3 The roof is tiles with decorative ridge tiles. The spinning ventilator may be original and seem to be connected to the central ceiling openings with moulded plaster frames that occupy the two rooms at this end (Figs 8 and 9).

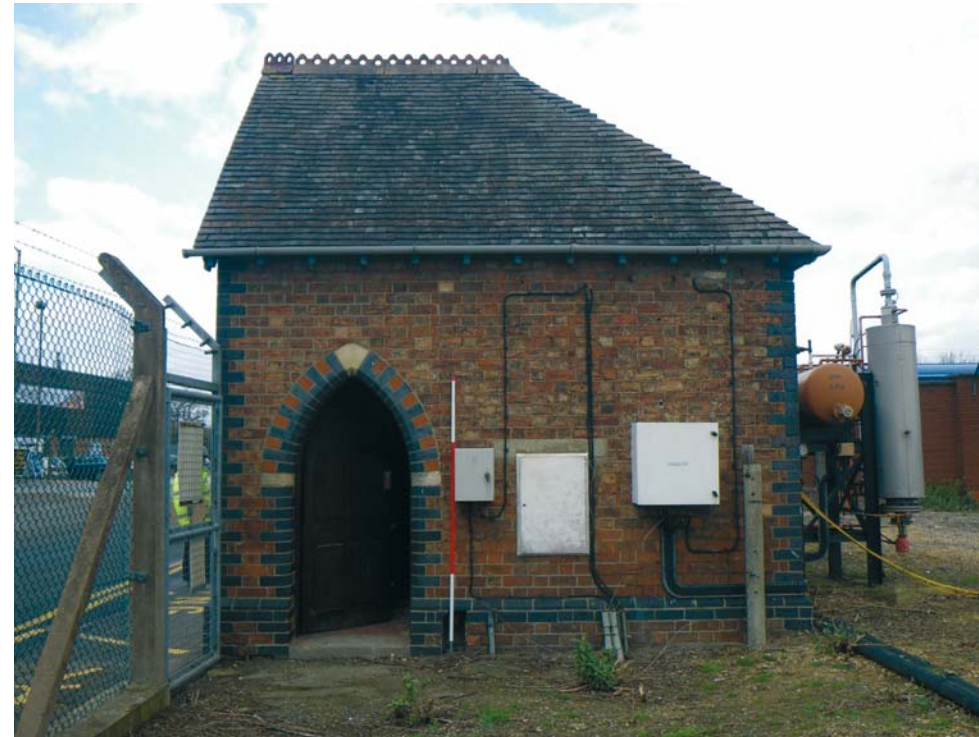
Fig. 10 The east elevation of BD1 (Scale 2m)

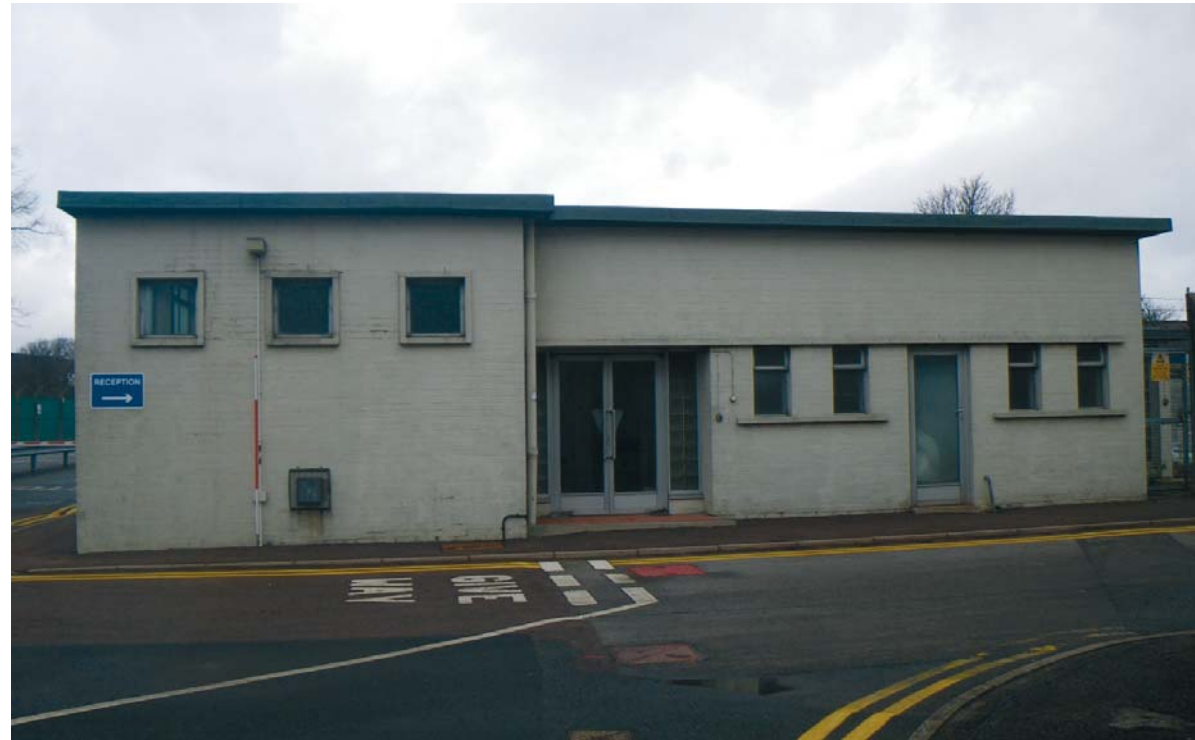
Fig. 12 The east elevation of BD2 (Scale 2m)

- 4.7 This is a building of "modern movement" design, flat-roofed, brick-built with simple concrete window frames and string courses (Figs 12, 13 and 14). The aluminium door- and window frames and the door furniture are typical of the 1950s in Britain. The glass-brick windows either side of the main entrance are slightly old-fashioned but not untypical of this sort of design at this time. The plan is a simple rectangle with a projecting porch at the north end. The interior was not accessible during our visit. This building is marked on the gas board plan of 1960 (Fig. 47) as the "Jones washroom". As it was next to the Jones plant (see below), it may well have been a welfare facility. It does not seem to have had any plant associated with it. This building is one of those erected as part of the thorough-going rebuilding resulting from the selection of the site as an experimental gas production site (VCH 1988, 262-269). As it was so simple and no internal access was possible, no ground plan was made.

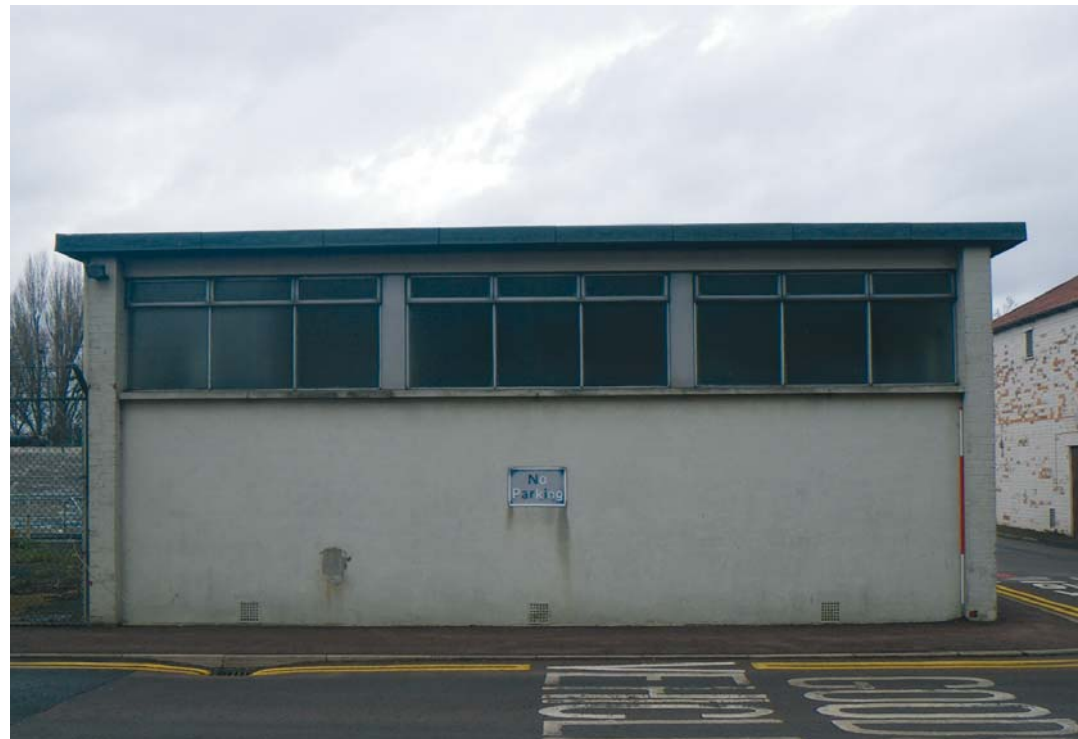
Fig. 13 The south elevation of BD2 (Scale 2m)

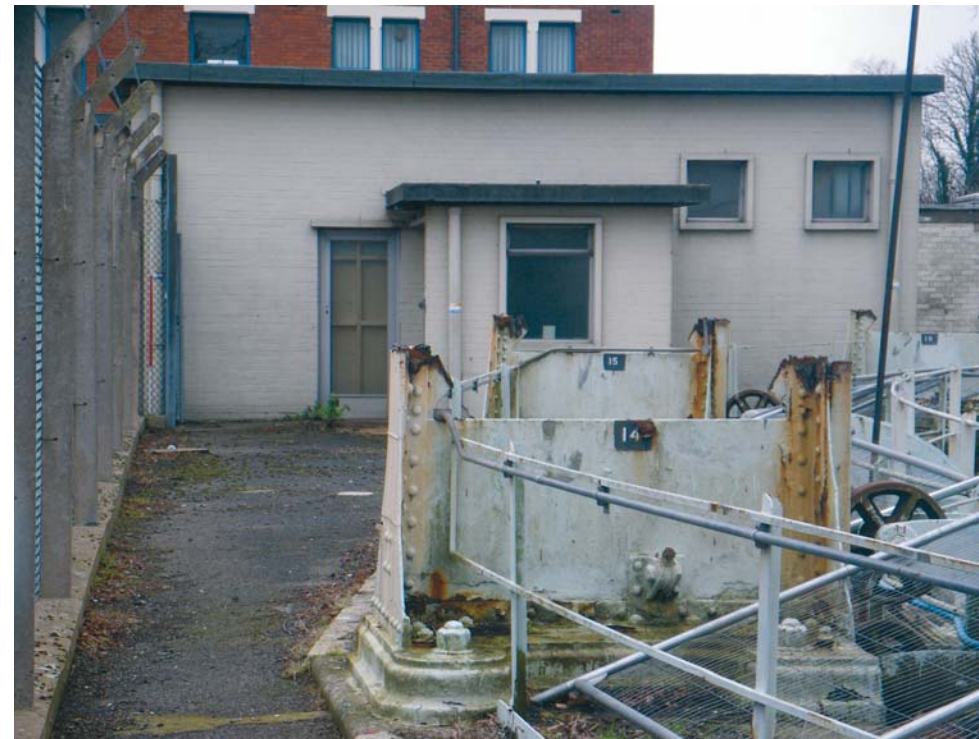
Fig. 14 The north elevation of BD2, with the 1901 gasometer stanchion stumps visible in foreground (Scale 2m)

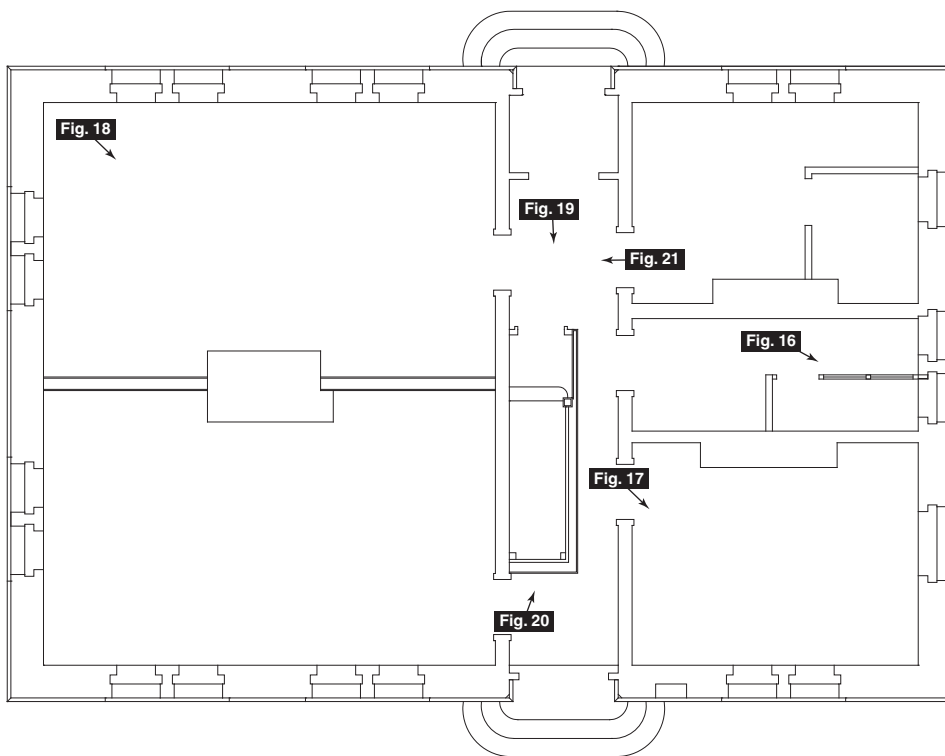
DRAWN BY	SCALE	PROJECT NO.	FIGURE NO.
LG	1:125@A4	3393	<b>15</b>

- 4.9 The plan was a simple, rectangular, double-pile, with rooms arranged either side of a front-to-back, off-centre, staircase hall (Fig. 15). The plan shows two large rooms on the west, and two smaller ones on the east separated by a WC and probable cloakroom, now just a WC and washroom. The WC still has its original glass-screened compartment, slightly altered for the provision of another closet (Fig. 16).

- 4.10 The main rooms were plain but well-lit, with large sash windows on two external sides (Figs 15 and 16). Fire surrounds had all been removed and the chimney breasts plastered over/dry-lined, but the grate recesses, where visible, were lined with olive-green tiles as were the hearths. This suggests that the large chimneys were actually fitted with gas fires, rather than coal ones, as the tiles were neither especially heat-resistant nor soot-marked.

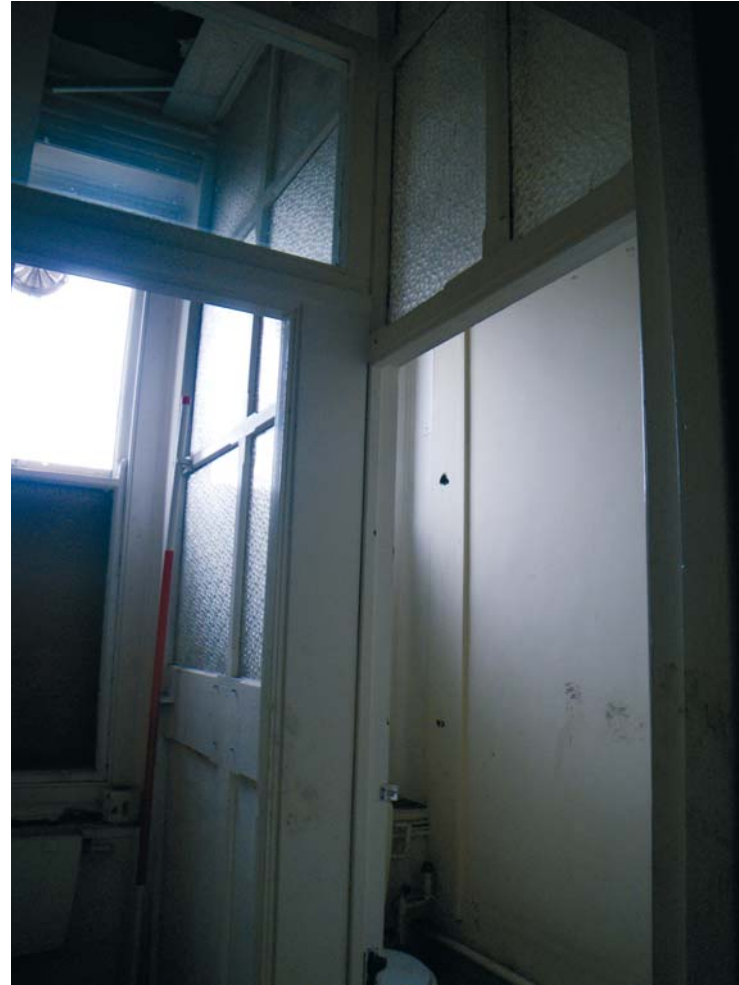
Fig. 16 The original WC screen in BD3, looking east  
(Scale in 0.5m divisions)

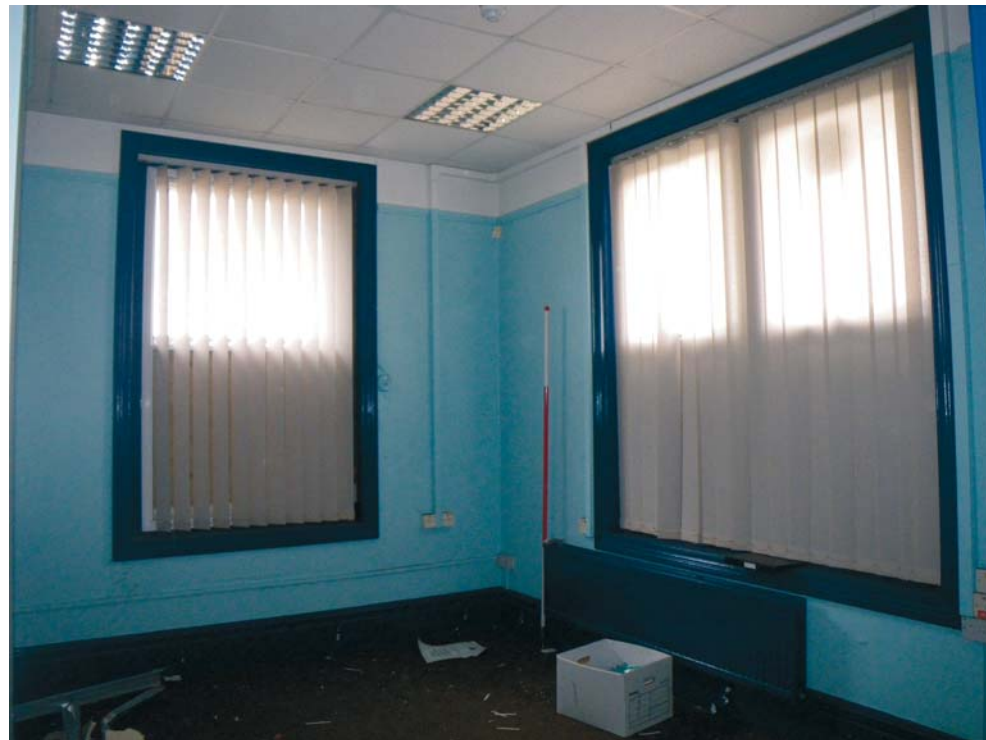
Fig. 17 The south-east ground-floor room in BD3 looking south-east, showing size of windows (and modern fittings) (Scale 2m)

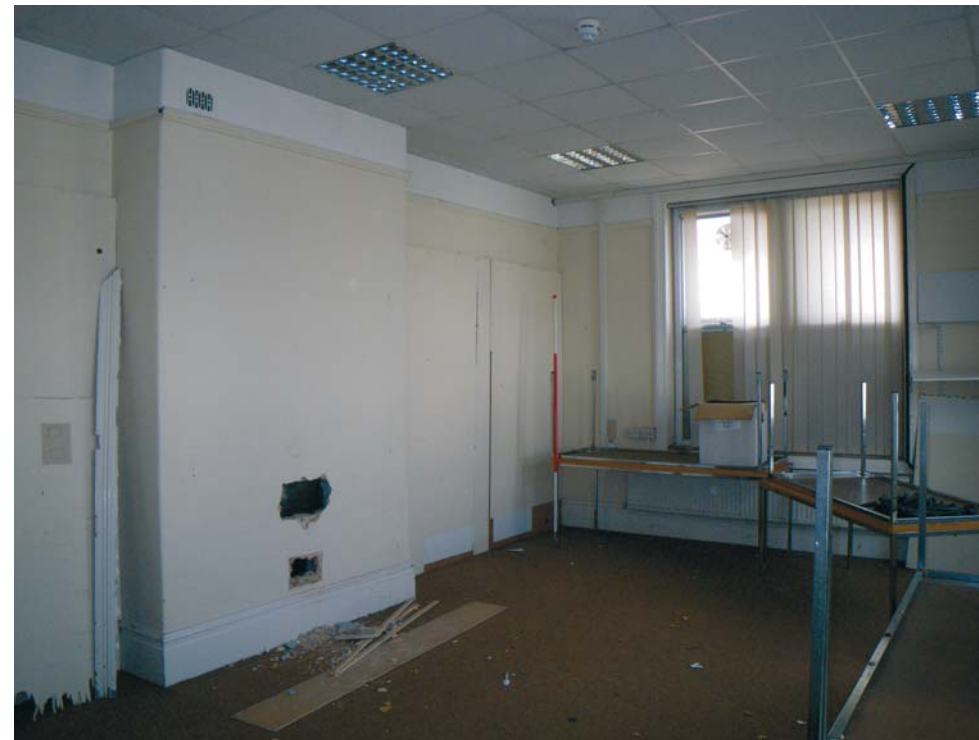
Fig. 18 The north-west room in BD3, looking south-west, showing false ceiling, blocked-in fireplaces and stud infill of the formerly-removed internal walls either side of the fireplace (Scale 2m)

- 4.11 The two larger rooms on the west had been knocked into one (leaving the chimney breasts in place, however) and then later subdivided with stud and plywood walls on the line of the original walls (Fig. 18).

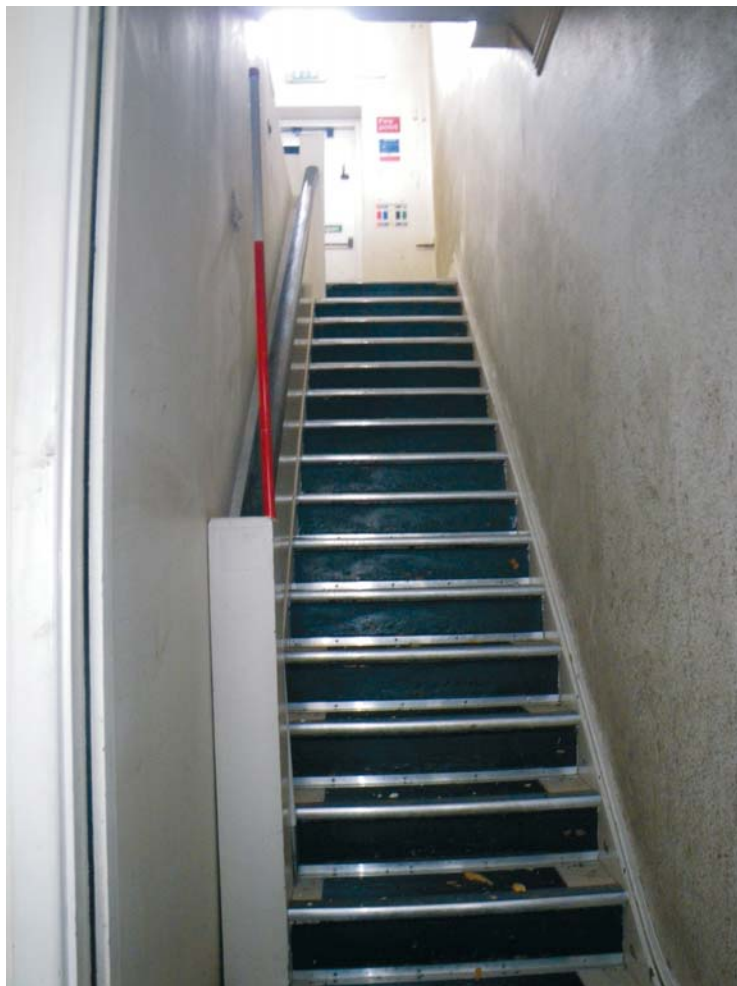
Fig. 19 The stair to the first floor in BD3, looking south. The inserted fire escape door on the first landing can be seen (cf Fig. 24) (Scale 2m)

- 4.12 The balusters on the stair were completely boarded in and the original, panelled, under-stair space was hidden behind a recent fire enclosure (Fig. 19 and 20).

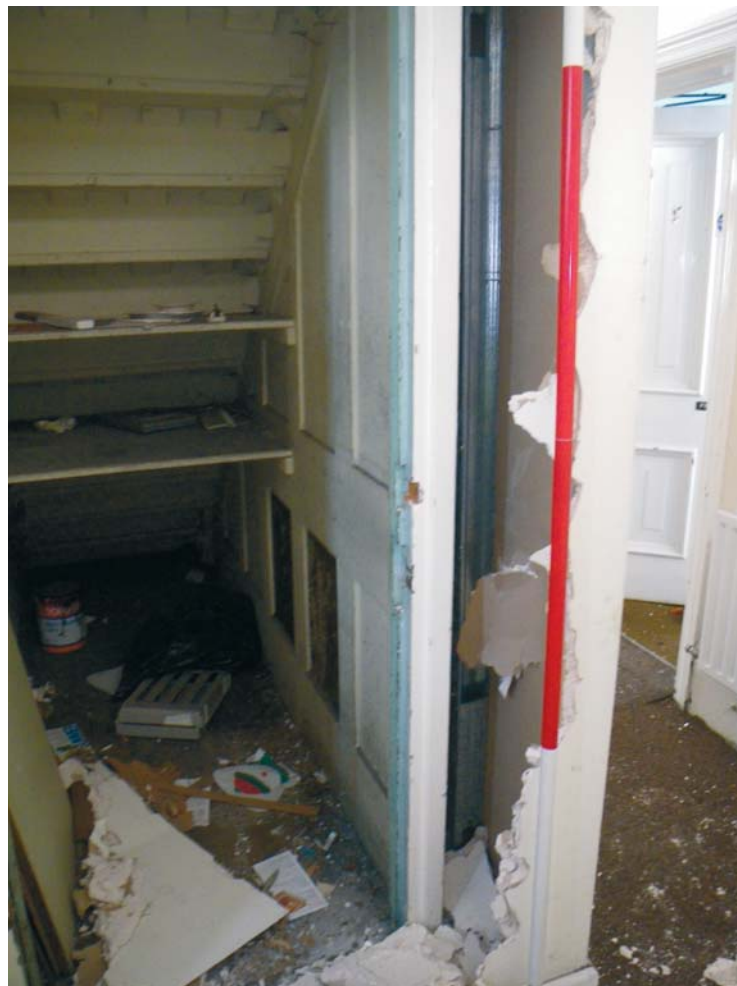
Fig. 20 The original under-stair cupboard and (rear of) panelling in BD3, with the remains of the recent fire enclosure, looking north-east (Scale in 0.5m divisions)

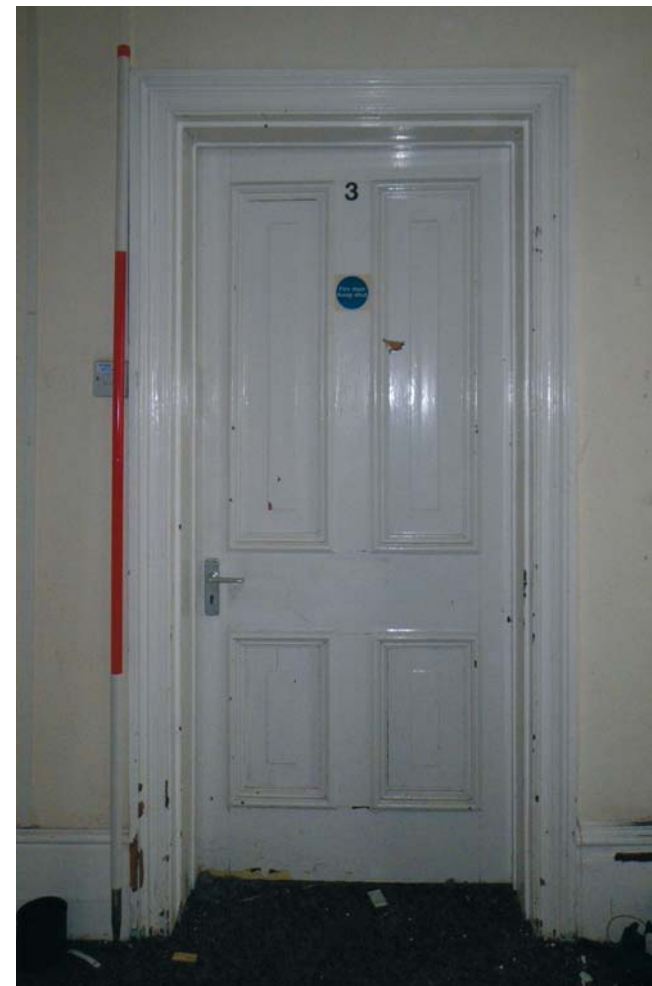
Fig. 21 A typical internal door and architrave on the ground floor of BD3 (Scale 2m)

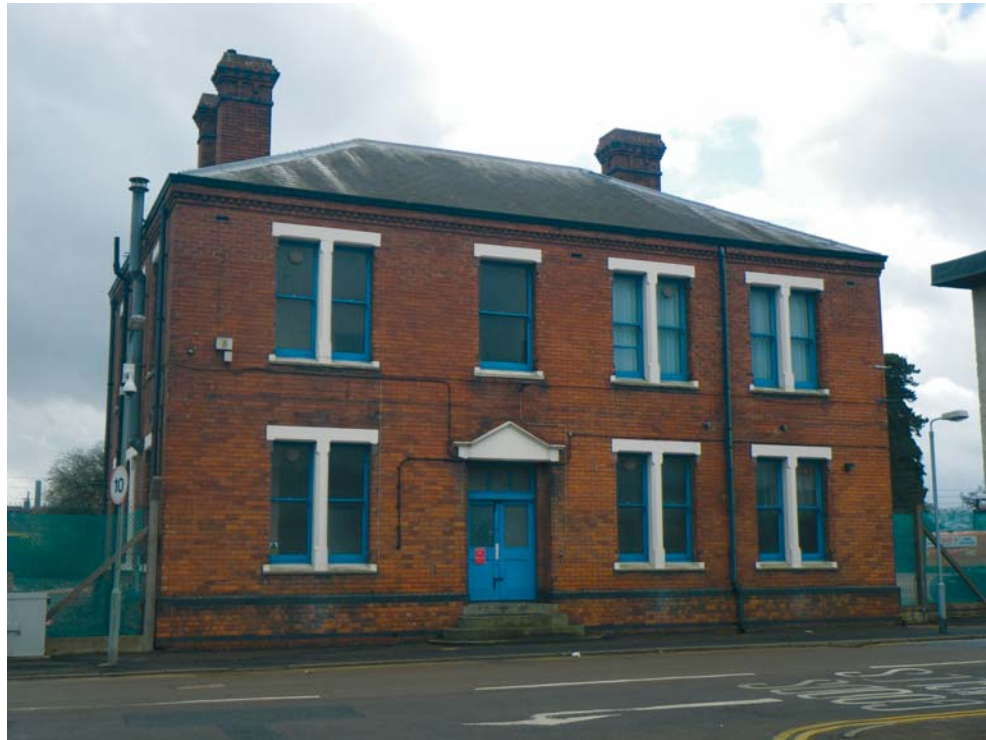
Fig. 22 The north elevation of BD3, looking south-west

- 4.13 The building was extremely solidly built. The brick walls were 23” (0.58m) thick. The external face was all in stretcher bond, suggesting that the walls had a cavity around 5” (0.13m) wide flanked by a single-brick skin externally and a double skin internally. No cavity was actually seen, as no relevant breaking out had occurred. The red engineering bricks (large at 3” x 4 $\frac{1}{8}$ ” x 8 $\frac{3}{4}$ ” to 9 $\frac{1}{4}$ ”) were set on a plinth topped with black, chamfered special bricks similar to those in BD1, but colourful trimming was sparsely employed elsewhere, in a line of black bricks near the foot of the wall and in the chimneys. (Fig 22).

eaves cornice was stepped and supported on angled bricks giving a corbelled effect. The stone work has been painted cream in recent times. The chimneys were quite elaborate with labels and string courses in black brick (Figs 22-26).

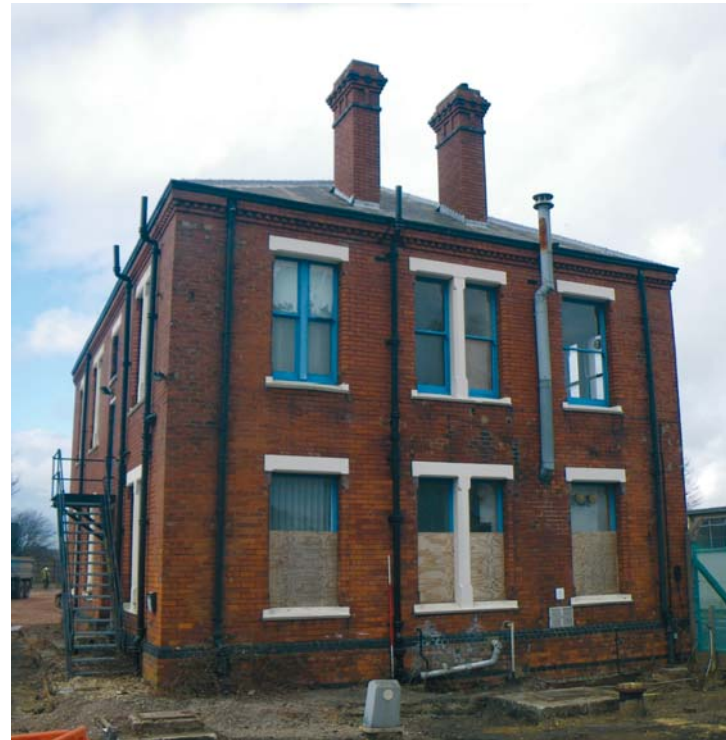
Fig. 23 The east elevation of BD3, the fenestration reflecting the smaller rooms and the WC on the ground floor (Scale 2m)

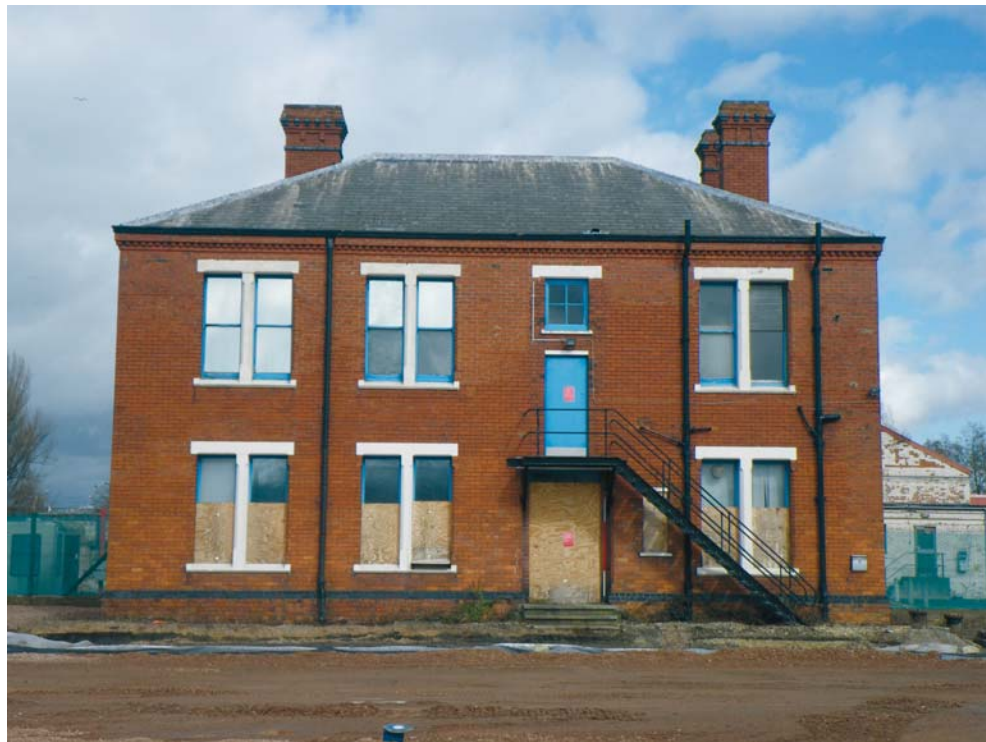
Fig. 24 The south elevation of BD3 showing the inserted fire escape door (and fire escape), converted window above it and the inserted window on the ground floor (Scale 2m)

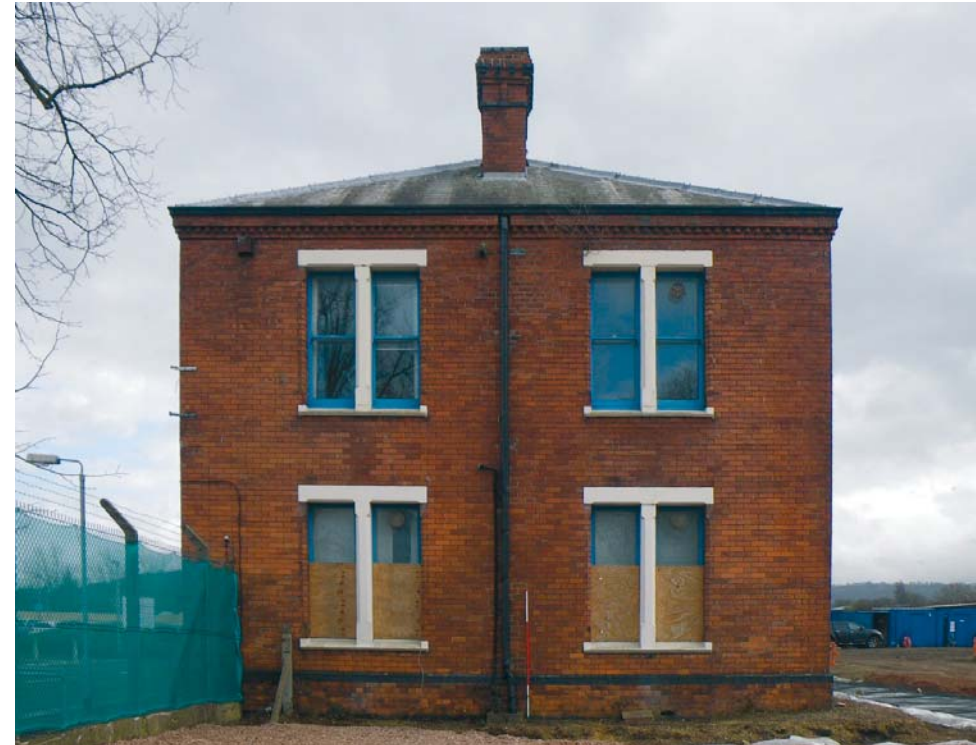
Fig. 25 The west elevation of BD3 (Scale 2m)

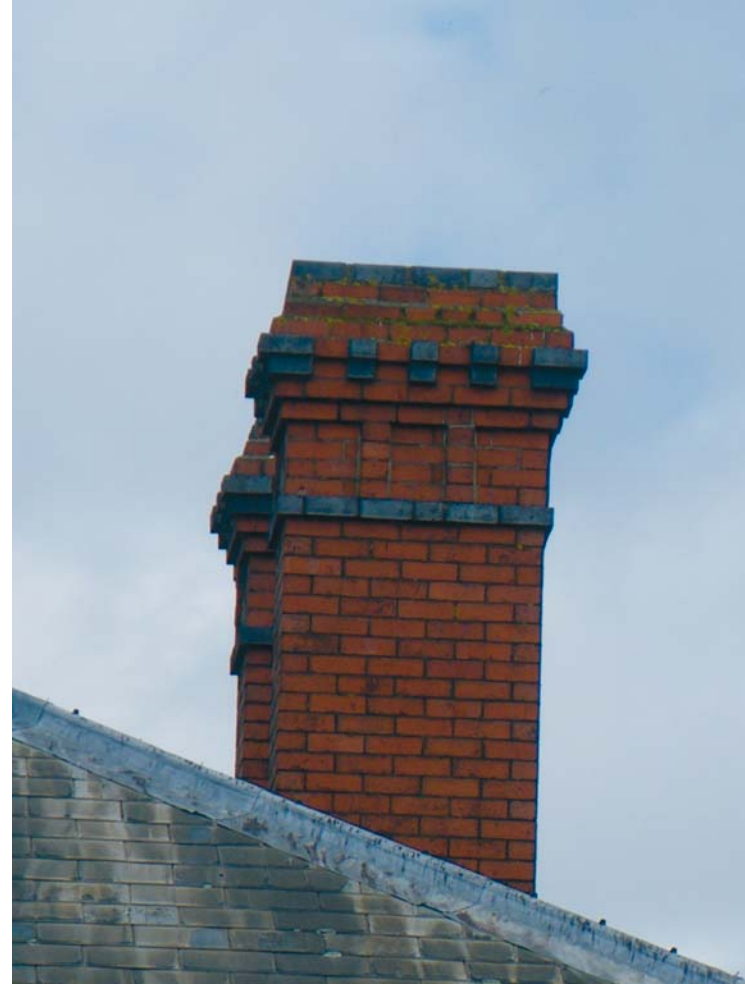
Fig. 26 One of the decoratively-treated chimneys on BD3

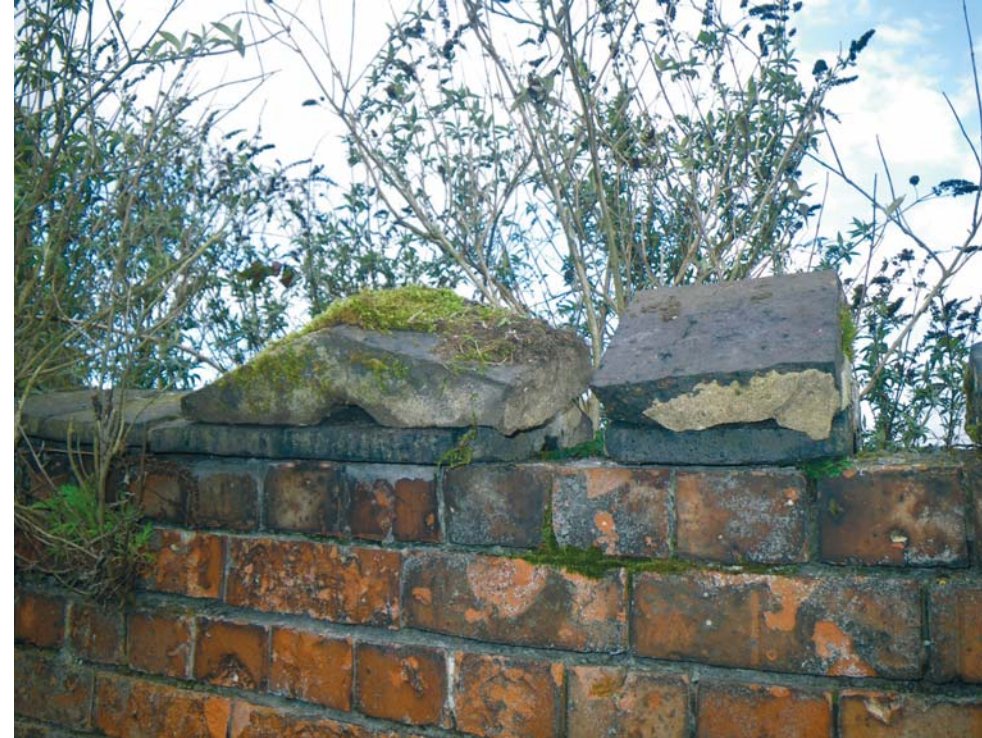
Fig. 27 The fired brick copings of most of the walls in BD4

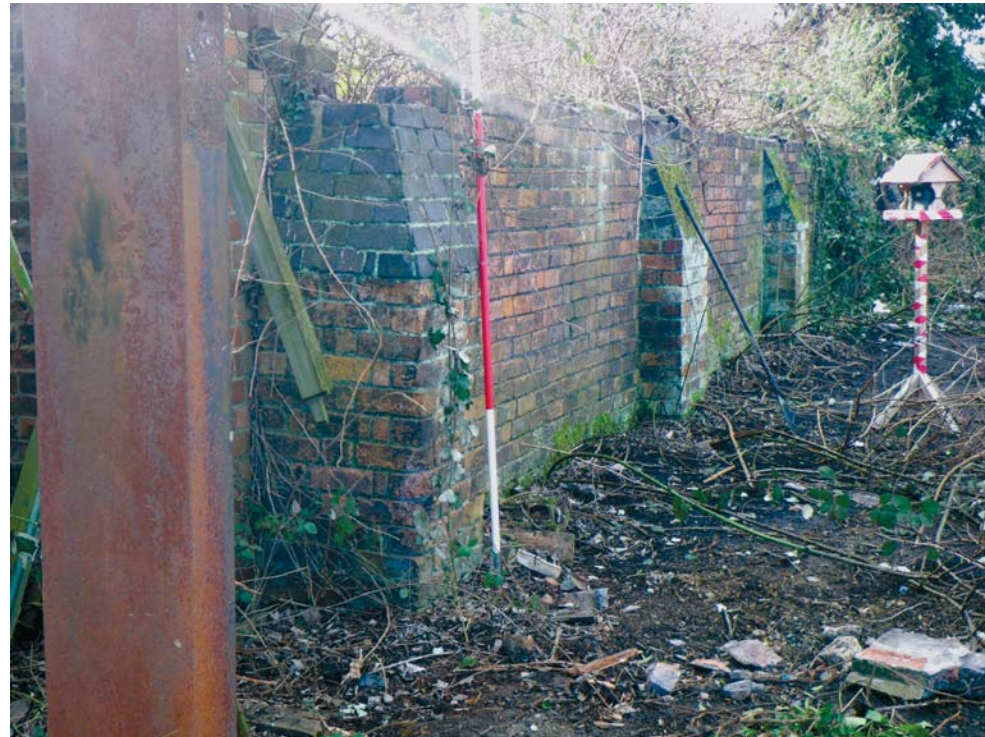
Fig. 28 The north wall and north-east corner of BD4.1 looking west, showing the buttresses (Scale 2m)

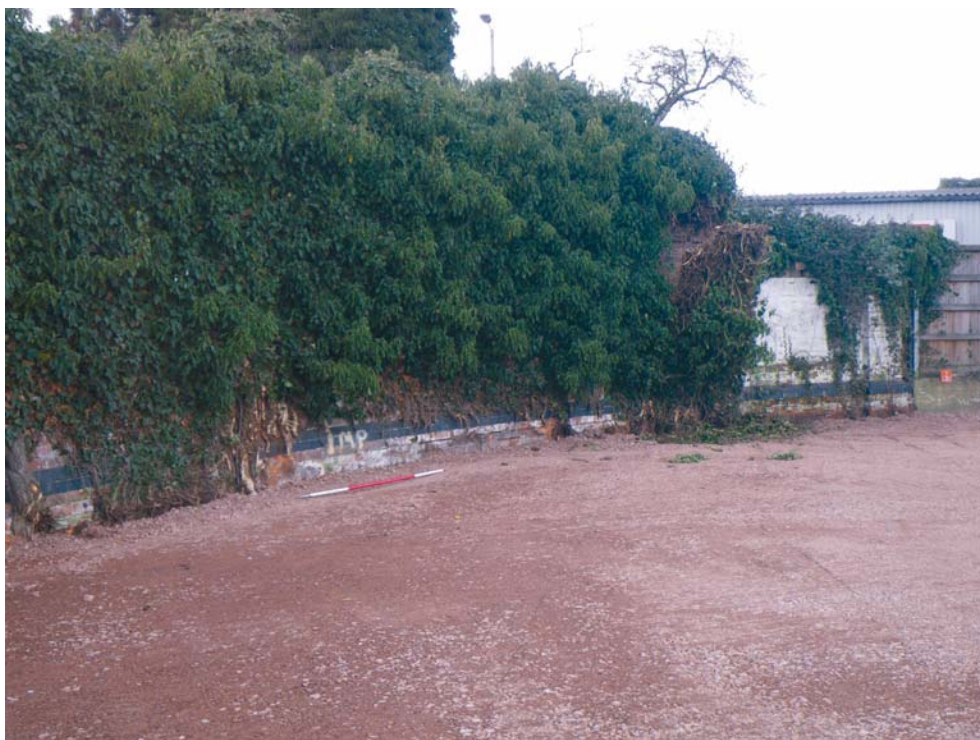
Fig. 30 The curved wall at the west end of the south part of the gasworks, looking west (Scale 2m)

- 4.17 The northern side of BD4.2 had no buttresses and was generally consistently around 2.2m high. It was otherwise similar to the walls in BD4.1 and to its own southern side. At its west end it joined a curved section of wall forming the south-west corner of the gasometer enclosure. This had a black-brick chamfered plinth like that in BD1 and BD3 (Fig. 30).

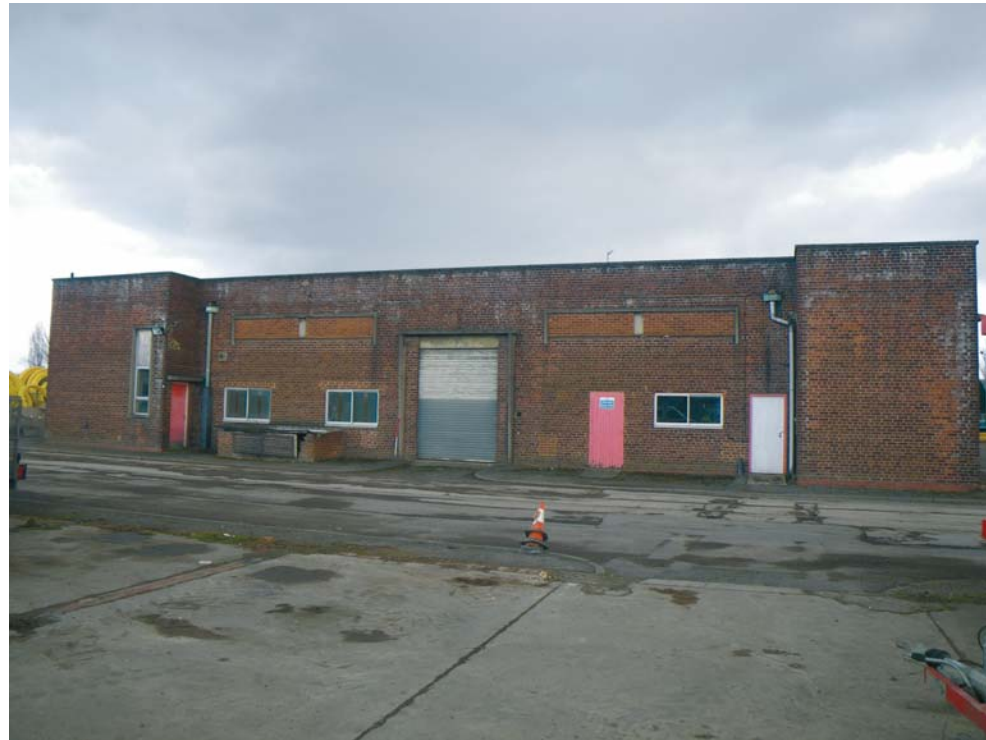
Fig. 32 The west elevation of BD5, looking north-east (Scale 2m)

- 4.22 The external treatment was rather old-fashioned with echoes of 1930s Art-Deco in the fluted panels between the blocked high level windows on the west façade (Fig. 32) and the combination of dark red brick and concrete detailing. Otherwise it was not untypical of 1950s industrial design in the wake of the Festival of Britain of 1951 with its projecting concrete canopies and window architraves. The large lateral windows and cladding, however, may be later alterations (Fig. 34).

- 4.23 The building had undergone various changes. All the ground floor doors and windows in the central recessed part of the west elevation were later insertions (Fig.

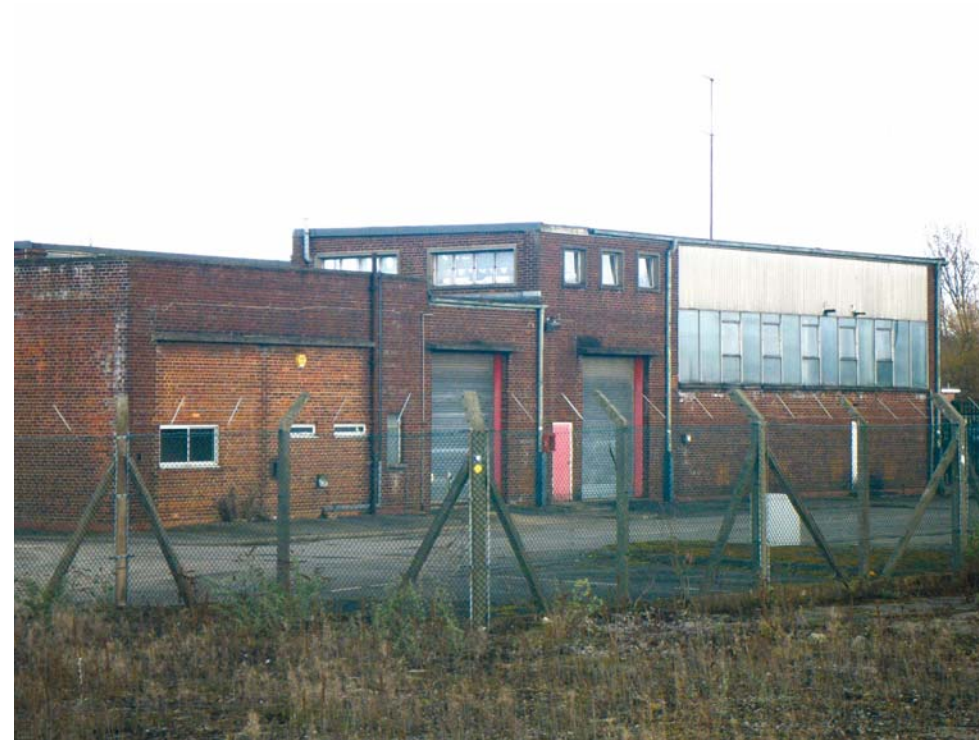
Fig. 33 The south elevation of BD5, looking north-east

- 32), and two large doors in the west end of the south elevation had been blocked up and the rooms they served turned into offices or stores (Fig. 33). The windows in the blocking were contemporary with it. Further east, the two small doors on this façade were also insertions. The large vehicle doors here are original to the fabric.

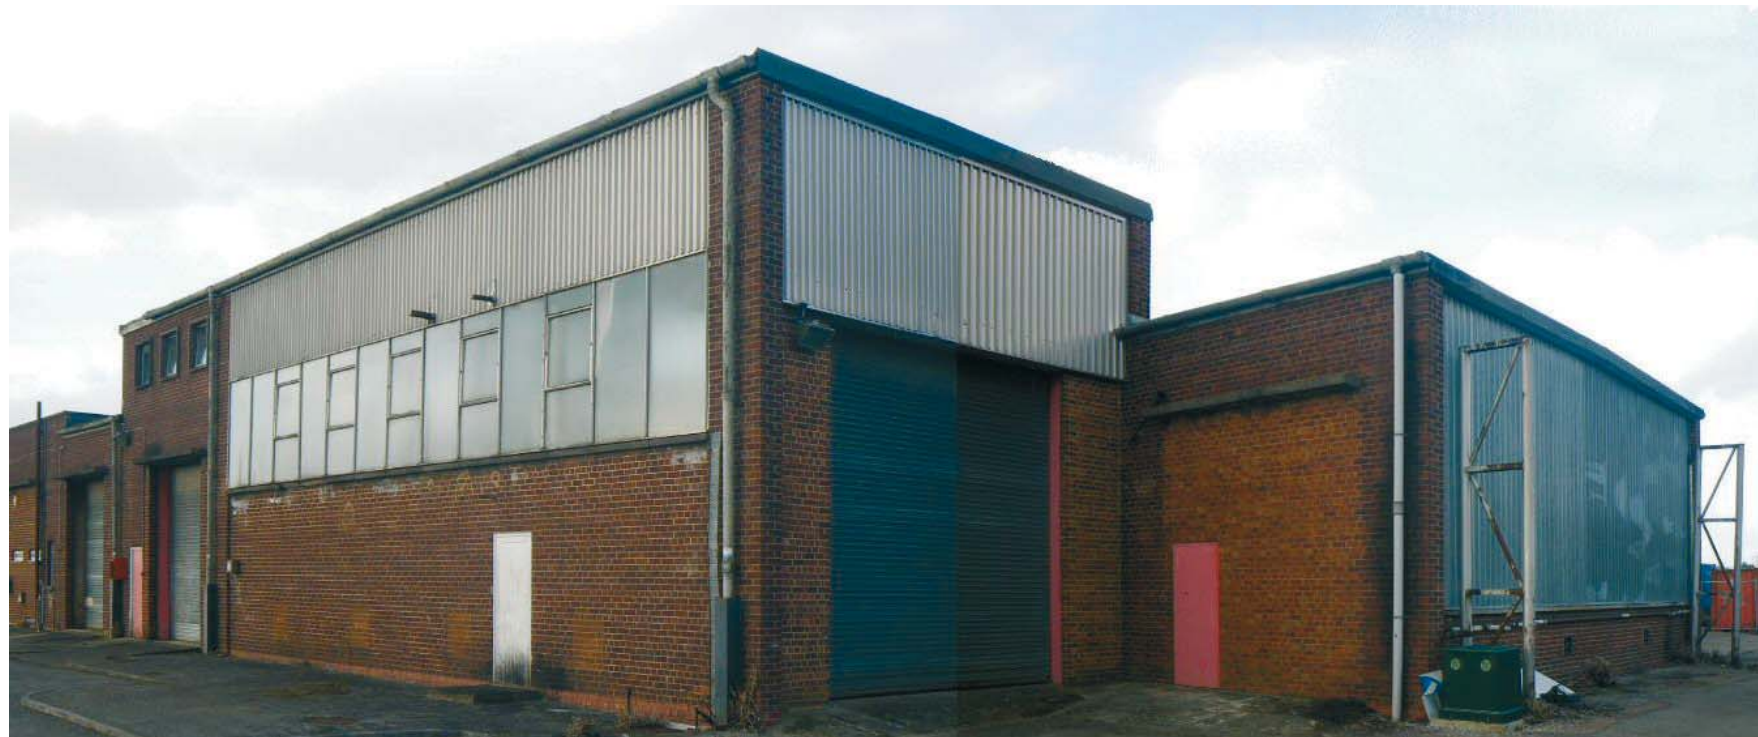
Fig. 34 The south and east elevations of BD5, looking north-west

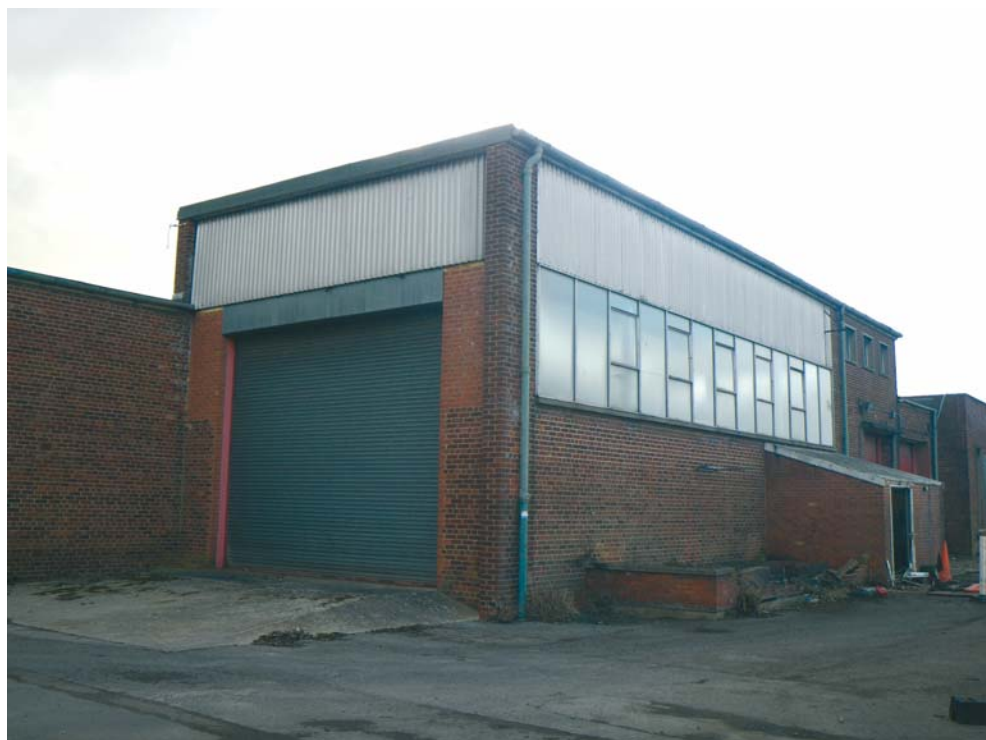
Fig. 35 The door in the north-east corner of BD5, looking south-west, showing evidence of former window

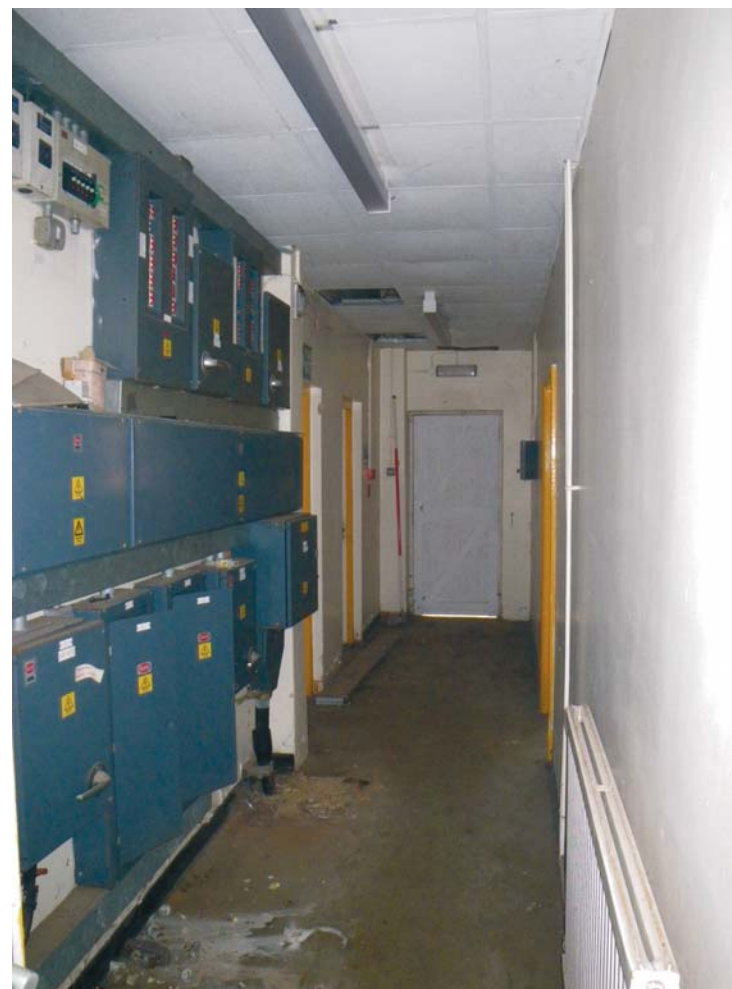
Fig. 36 The corridor in the south-west corner of BD5, looking west, showing the two original doors to the vehicle bays on the left, the inserted door, by the scale, and the added office wall on the right (Scale 2m)

- 4.26 Internally the building was very plain. There had been some alterations, some connected to those noted externally and some in addition. In the south-west corner the blocking of the two vehicle doors in the south face have allowed the spaces behind to be converted into three rooms. The western one is the original space behind the westernmost door; the other has been divided by a concrete block wall. This is the normal material for these later subdivisions. Two of the rooms seem to have been offices and the easternmost is now a WC and shower room, entered from the “transept”. The two other rooms are reached via a corridor, but while its southern wall is original (the back of the vehicle bays) this was created as a separate circulation space when the office to its north was added (in concrete block) and the door at its west end inserted (Fig. 31). This corridor was used for the siting of the most recent electrical breakers and other control circuitry (Fig. 36).
