Former Gasworks  
Bristol Road  
Gloucester  
Gloucestershire

Historic Building Recording

CA Project: 3393  
CA Report: 11074

Historic building recording was undertaken by Cotswold Archaeology for CgMs Consulting, of the buildings related to former use as a Gasworks, on an extensive site on the Bristol, Road, Gloucester. The gasworks was founded in 1875. Of this earliest foundation, only a few boundary walls and a partly demolished gate lodge survived above ground. The infilled brick pit for the eastern gasometer of 1875 was visible on the site visit. The complete but sunken and completely empty gasometer on the north, added in 1901 was also visible. The stanchions of the rising framework for this were removed in 2001 and the stumps are still *in situ*. A brick-built office on the south side of the entrance road looked as if it belonged to the first phase, but does not appear on mapping until 1936. The other buildings recorded all belonged to the experimental gas production plant established in the 1950s.

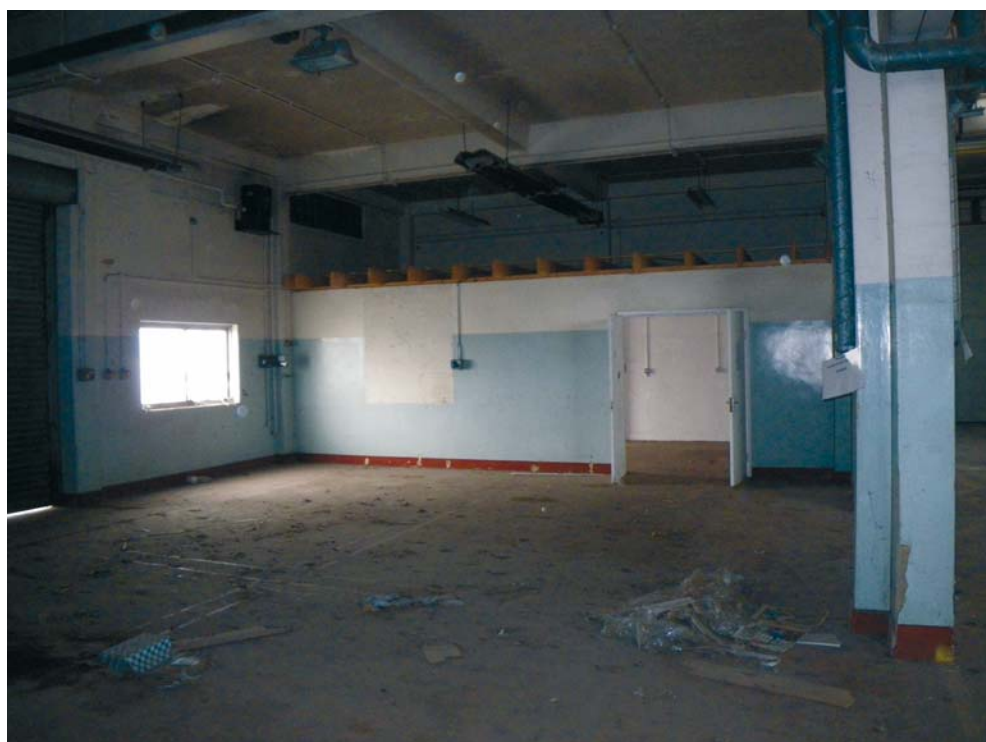
Fig. 37 The western central room of BD5 and the office inserted into the northern side of it, looking north-east

- 4.27 The added office was one of two inserted into the western central room, the other being in stud work (Fig. 37), which had been first one large space, open to the “transept”, via two doors (Fig. 38).

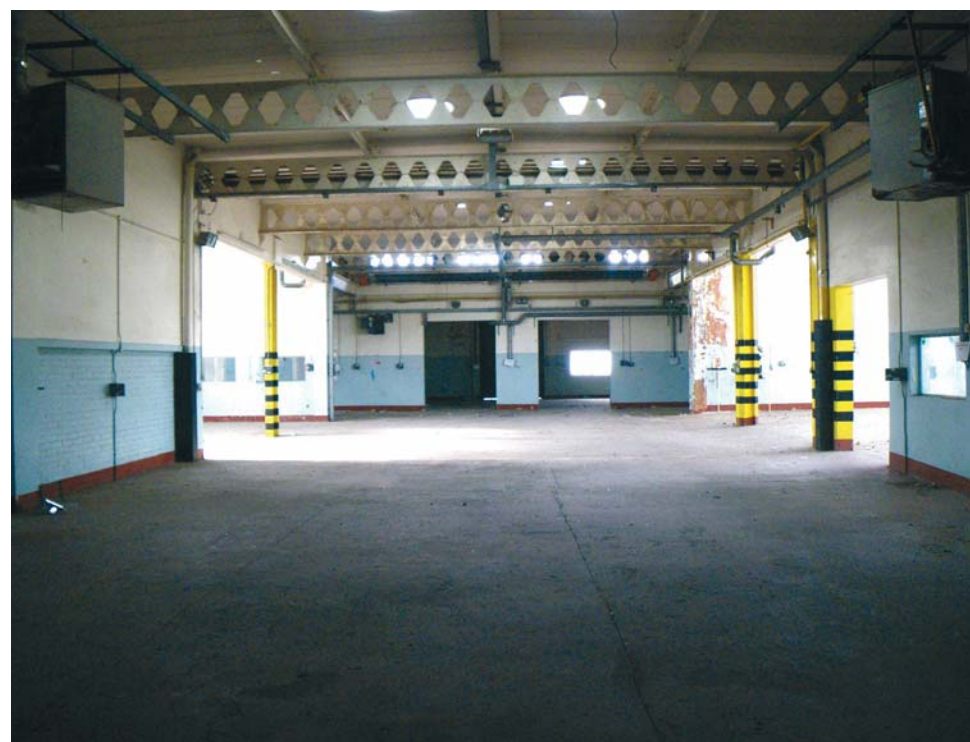
Fig. 38 A view westwards along the "nave" of BD5 to the two doors into the western room, or "chancel"

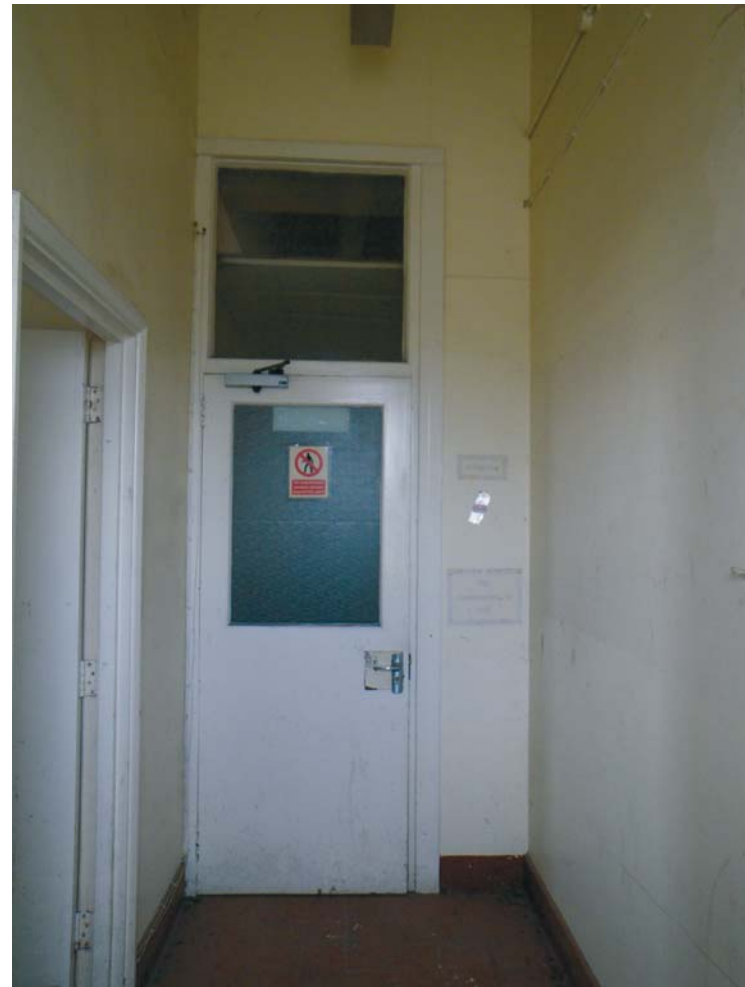
Fig. 39 The door from the (full height) entrance lobby in BD5 into the corridor in the north-western corner block, looking east. Note the false ceiling behind the transom light

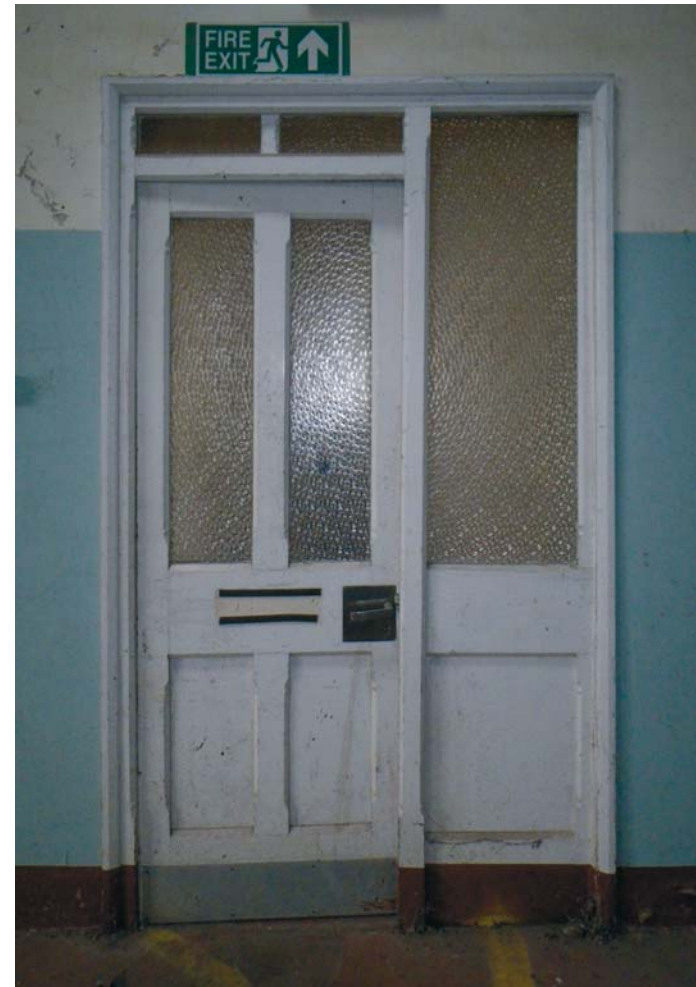
Fig. 40 The recycled door and partition at the east end of the corridor in the north-west corner block of BD5, seen from the "transept", looking west

- 4.29 An unusual note is struck by the door at the other end of this corridor, which has clearly been recycled from earlier buildings (Fig. 40) It is almost identical to an *ex situ* door seen in BD3. It is late 19th or early 20th century in date.

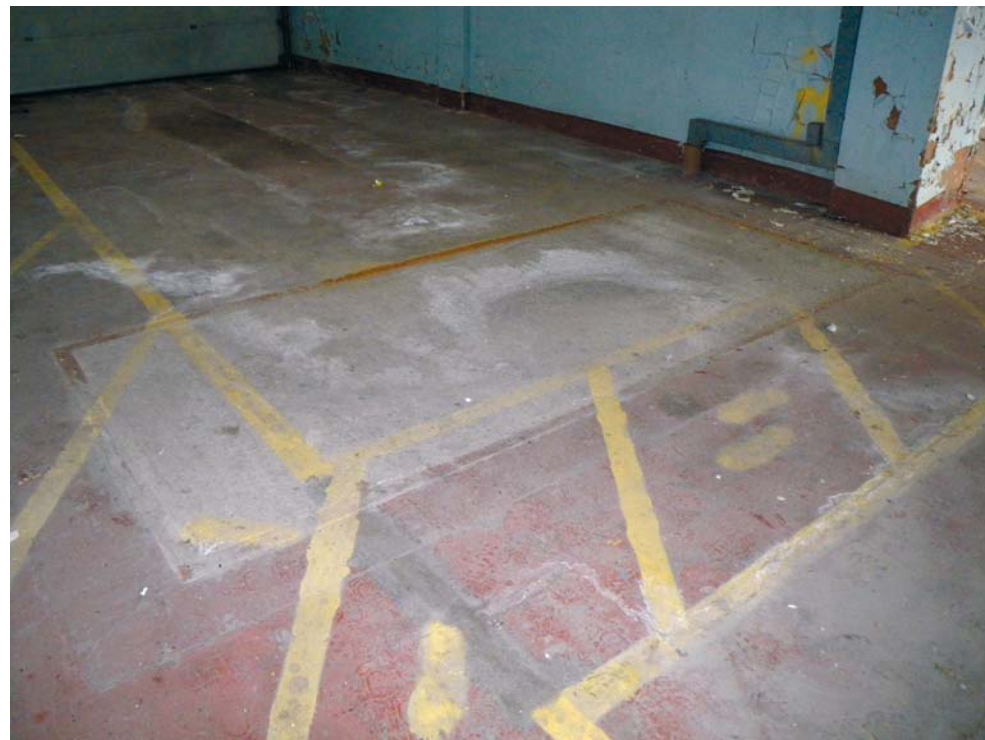
Fig. 41 The site of the rolling road in the north "transept" of BD5

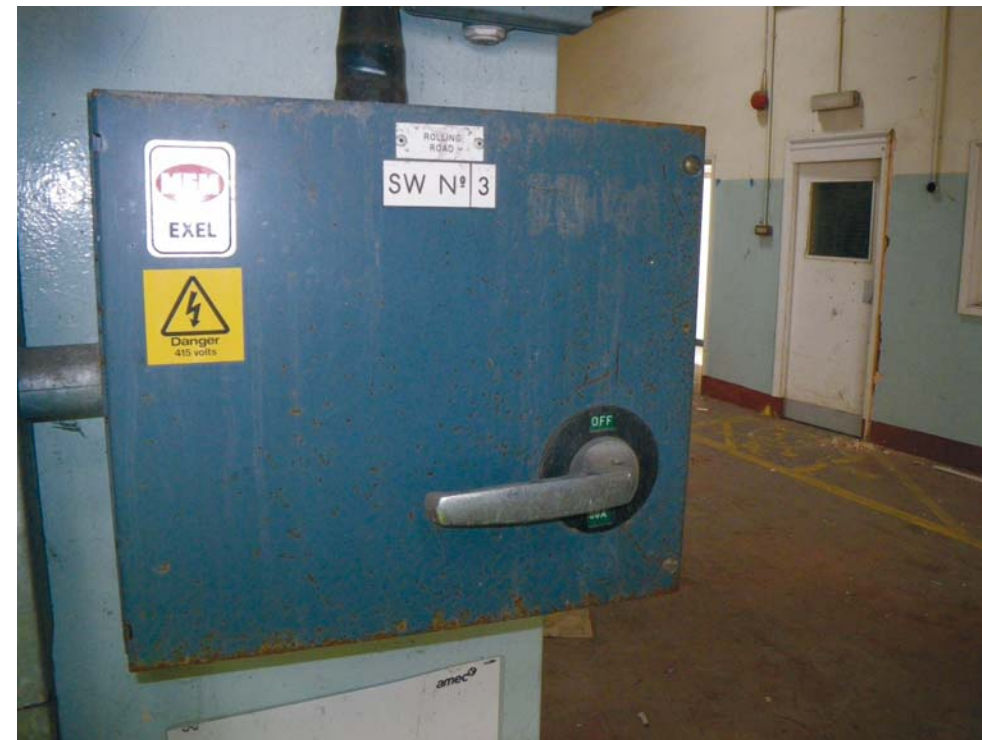
Fig. 42 The control box for the rolling road in BD5, on the wall nearby

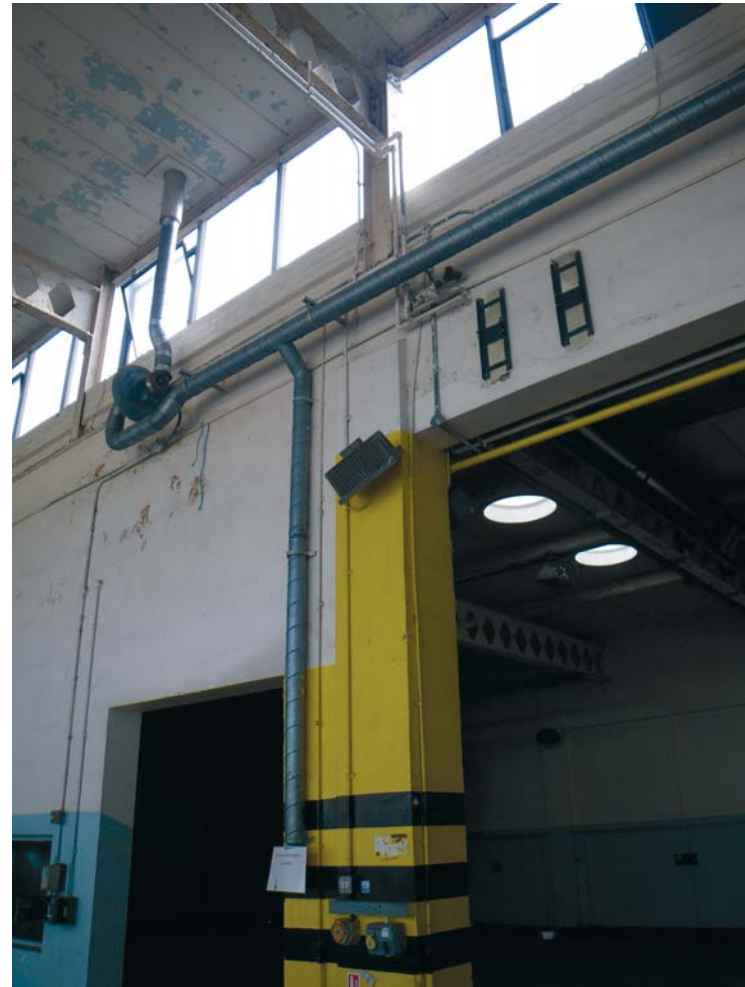
Fig. 43 The exhaust extraction system and one of the stations feeding into it in the north "aisle" of BD5

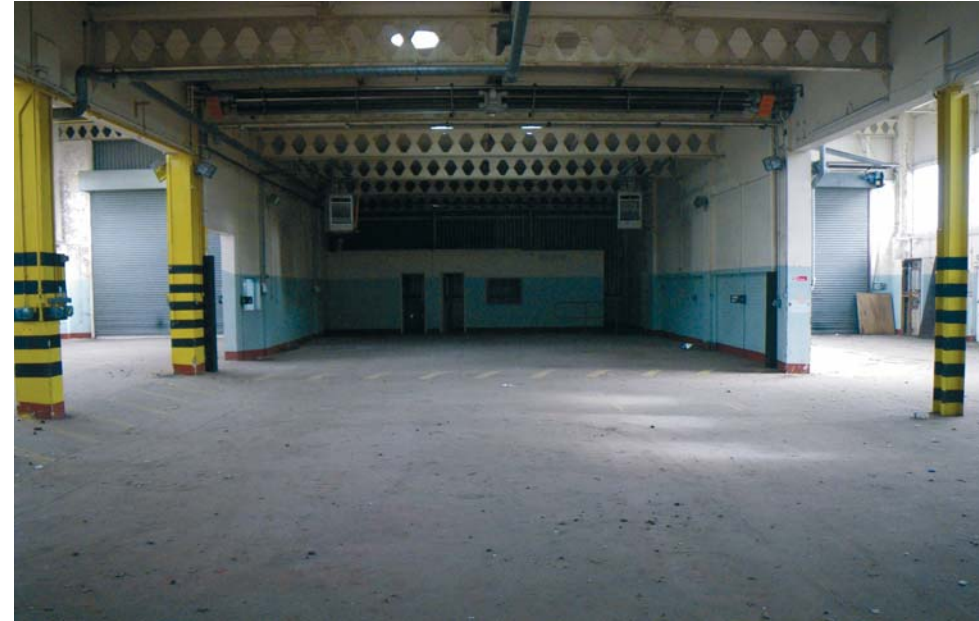
Fig. 44 The central "nave" of BD5, looking east, with offices at the far end and the heaters and ventilators slung from the ceiling

- 4.32 Heating and ventilation was most recently provided by many large gas radiators slung from the roof and wall tops, and what appear to be air conditioning units also slung from the roof (Fig. 44).

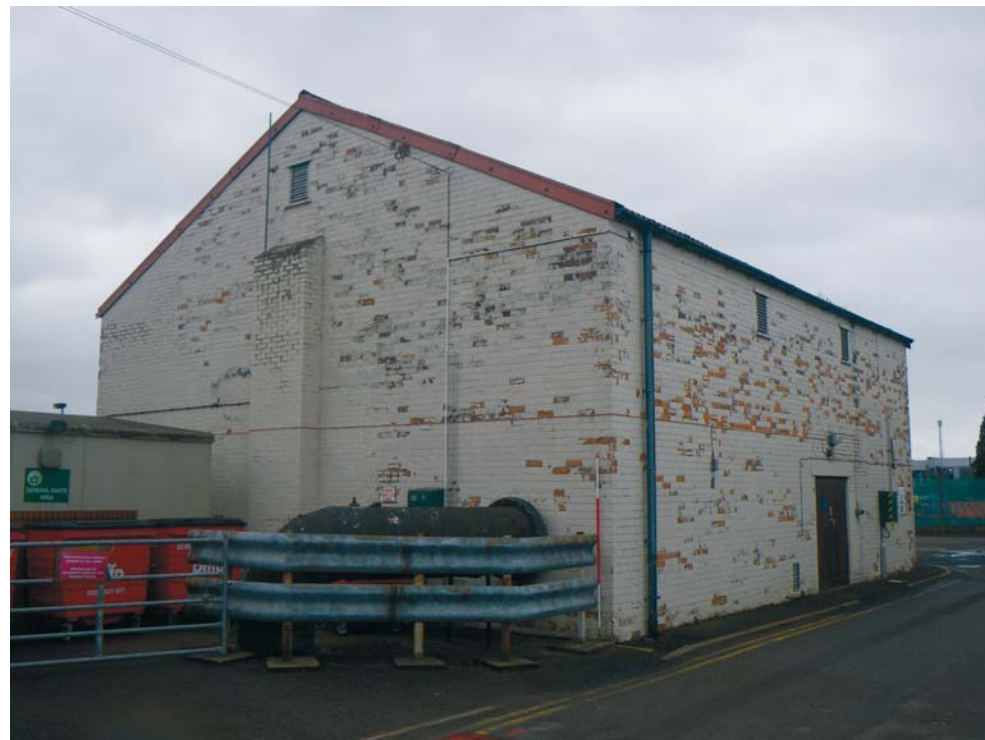
Fig. 45 BD6 looking south-east (Scale 2m)

- 4.33 This was very utilitarian brick shed whose purpose was to house the machinery that pumped gas from the retorts to the gasometers. It appears on maps after 1936 and by 1954. Its asbestos roof covering is very typical of the war years and just after, as are the concrete lintels and Crittall-style windows. It is built in rather soft bricks in stretcher bond, suggesting a cavity wall. The only change in the fabric was the reduction in size of the door in the western side.

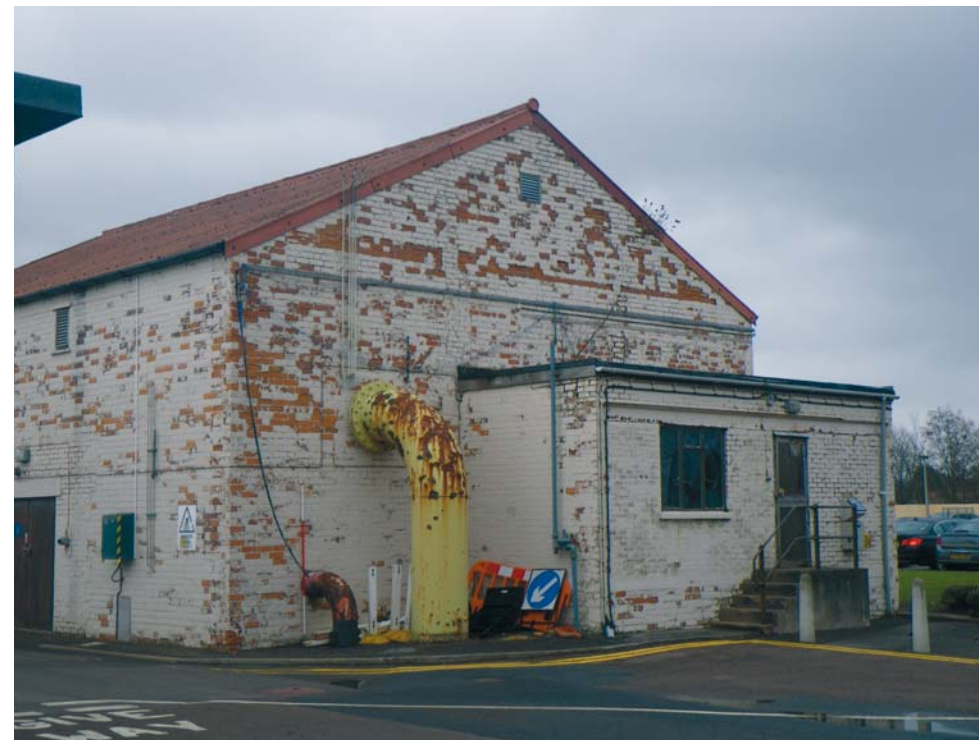
Fig. 46 BD6 looking north-east (Scale 2m)
