**Church House  
Lechlade  
Gloucestershire**

Archaeological Watching Brief

CA Project: 3429  
CA Report: 11159

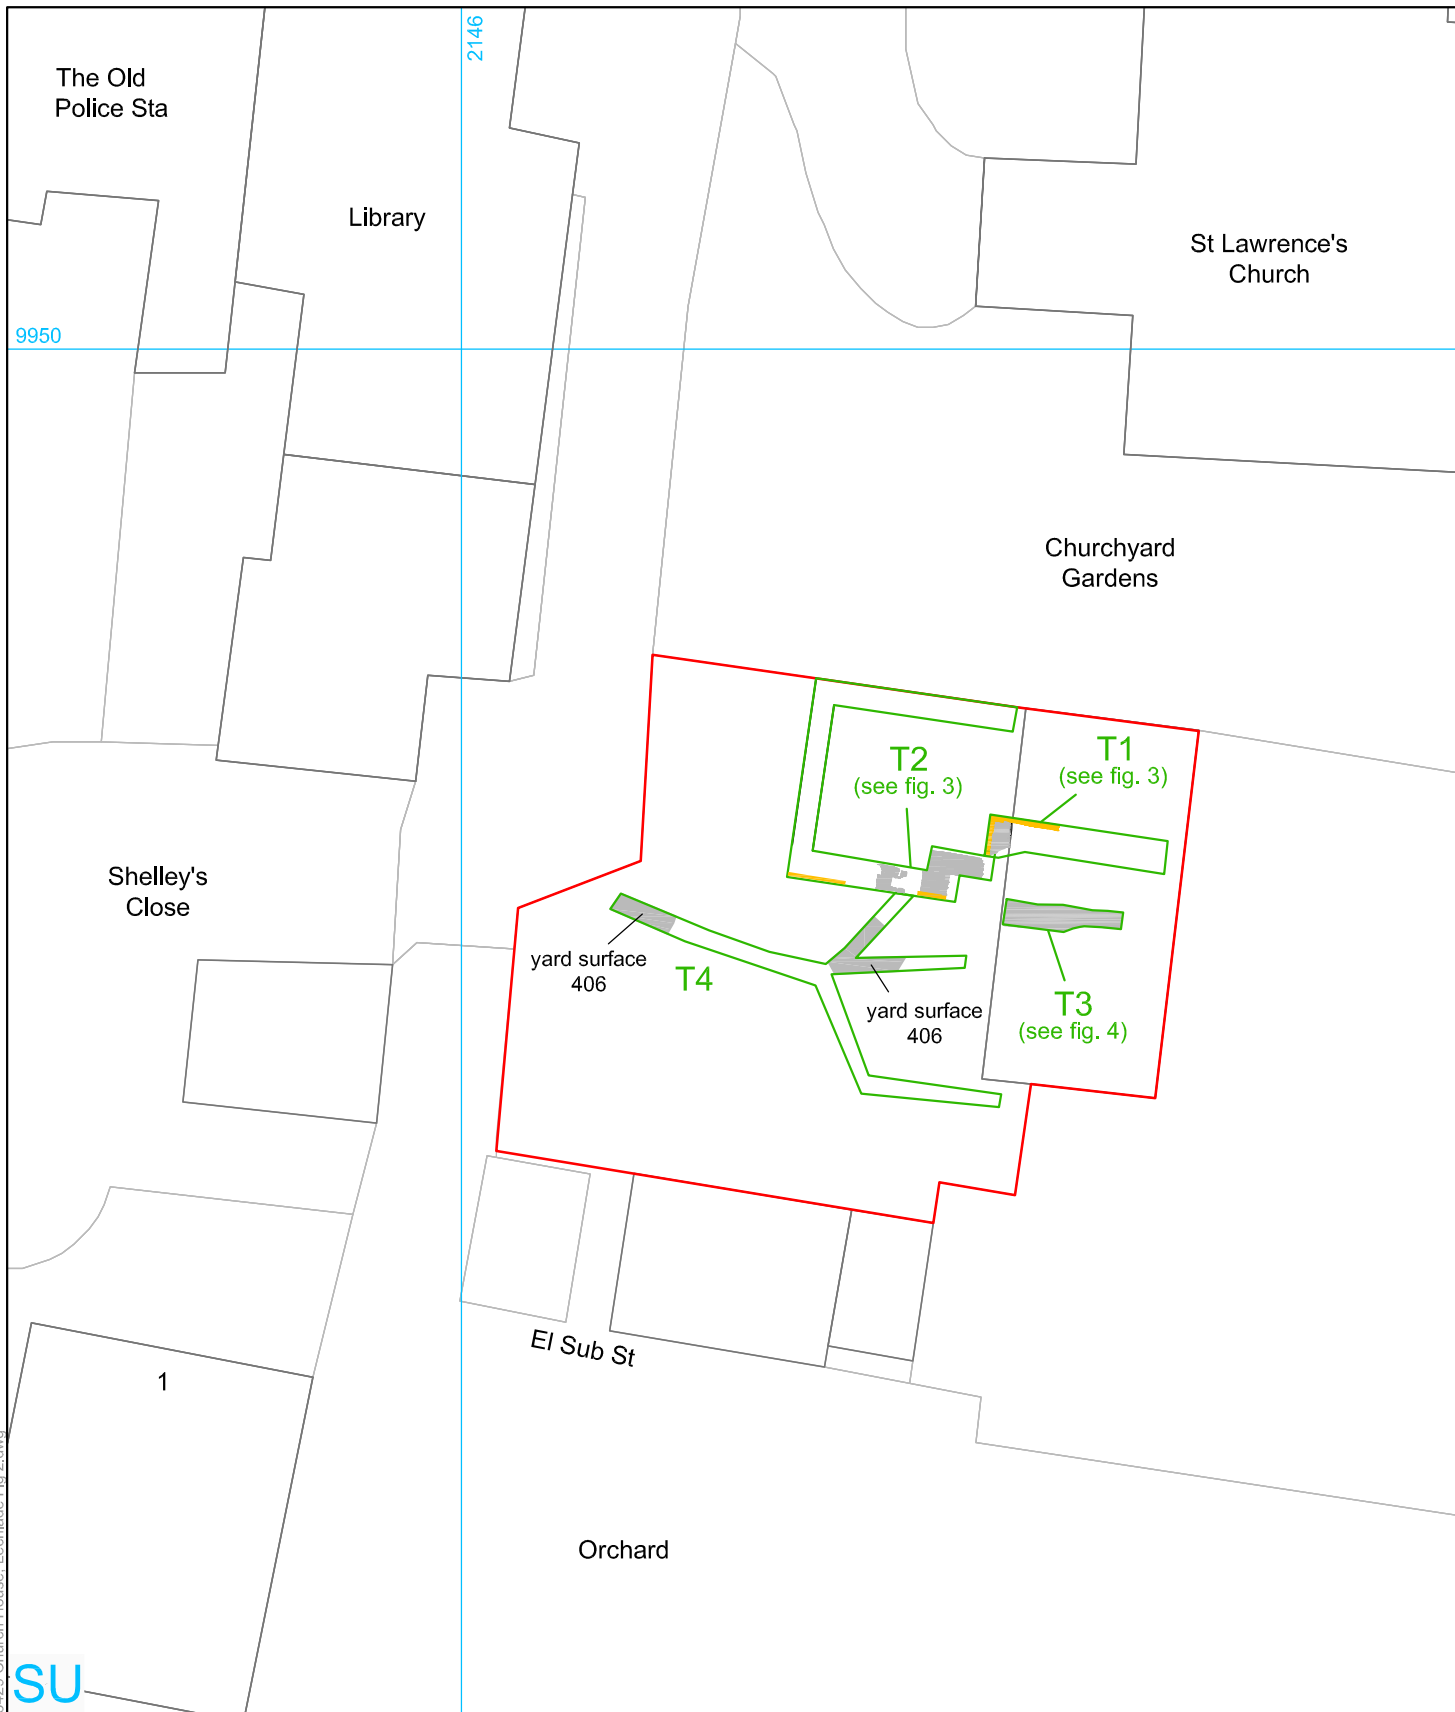
FIGURE TITLE  
**The site, showing location of groundworks and archaeological features**

- 1.5 The fieldwork followed the methodology set out within the WSI (CA 2011). An archaeologist was present during intrusive groundworks comprising the excavation of new footings and service trenches (Fig. 2, T1-T4).
- 1.6 Where archaeological deposits were encountered written, graphic and photographic records were compiled in accordance with CA Technical Manual 1: *Fieldwork Recording Manual* (2007).
- 1.7 The archive and artefacts from the evaluation are currently held by CA at their offices in Kemble. Subject to the agreement of the legal landowner the artefacts will be deposited with Corinium Museum, along with the site archive. A summary of information from this project, set out within Appendix C, will be entered onto the OASIS online database of archaeological projects in Britain.

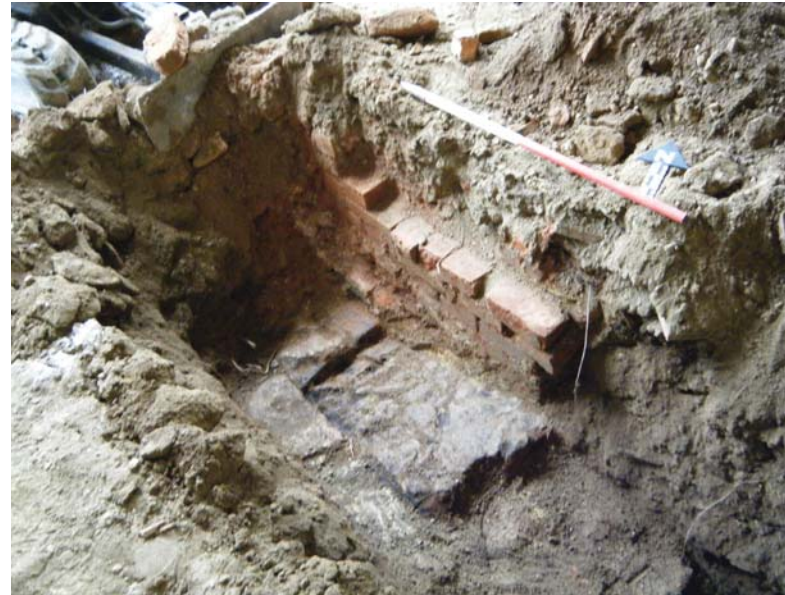
View of Trench 1 showing wall 103 looking north-west (scale 1m)

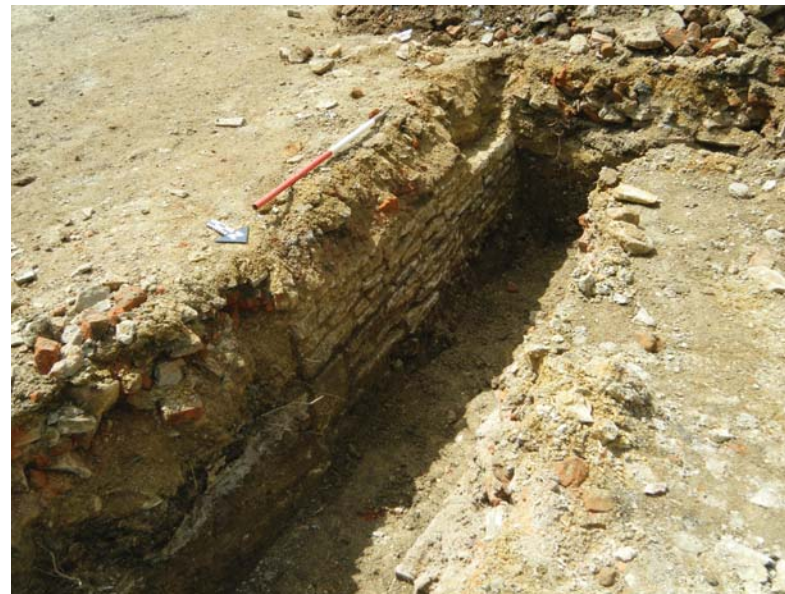
View of Trench 2 showing wall 206 looking south-west (1m scale)

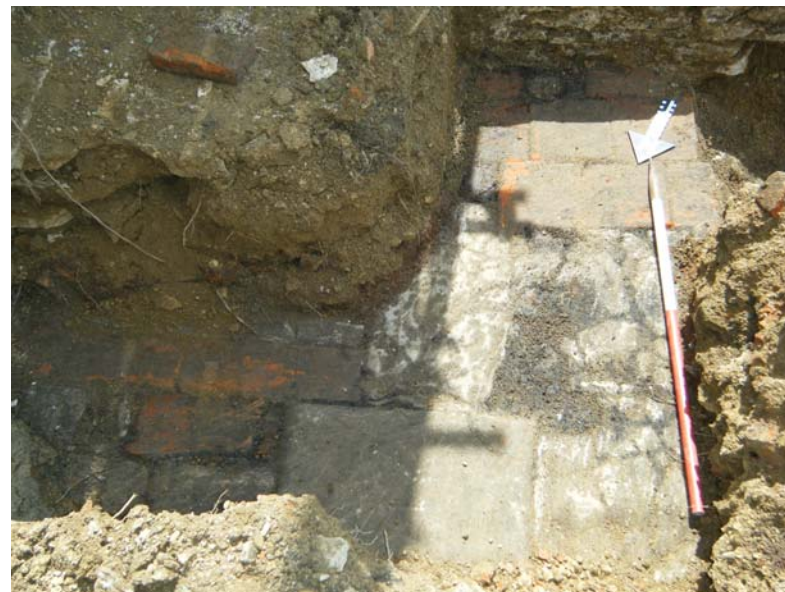
View of floor surface 209 (1m scale)

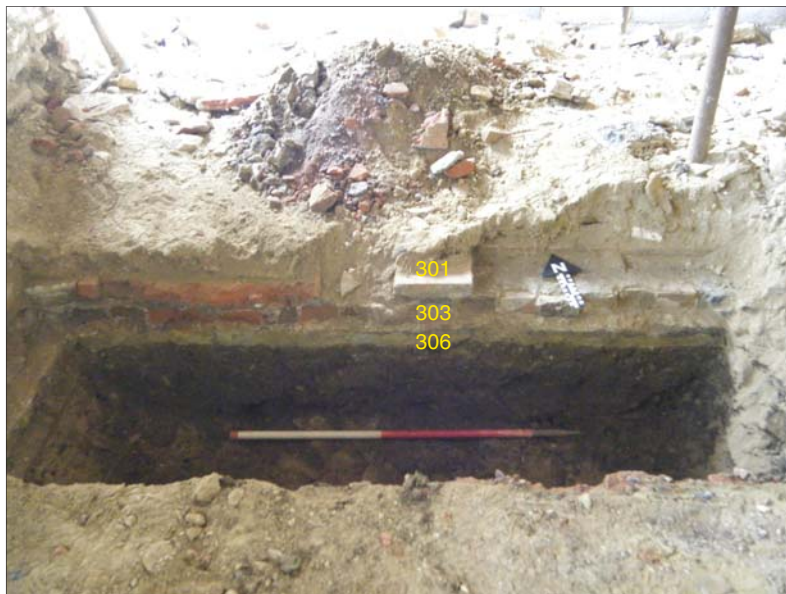
View of Trench 3, showing tile floor 301 brick floor surface 303 and clay layer 306, looking north (scale 1m)

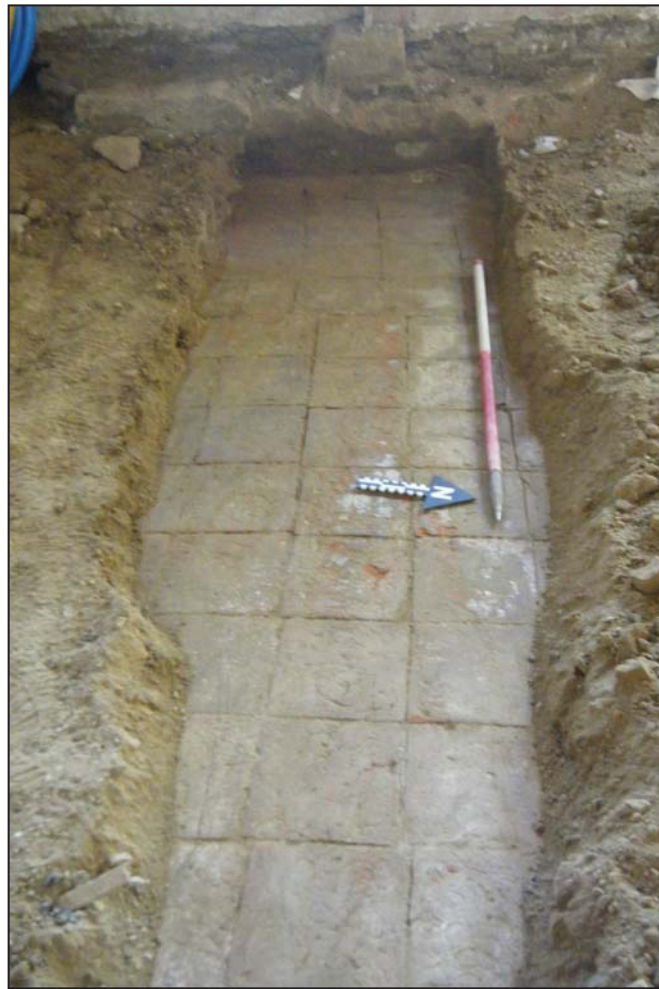
- 5 Tile floor surface 301 in Trench 3 looking west (scale 1m)
- 6 Yard surface 406 in Trench 4 looking west (scale 1m)
- 7 Surface of 'kiln tile'. The mortar is from later re-use of the tile (scale 0.25m)
- 8 Underside of ' kiln tile' (scale 0.25m)

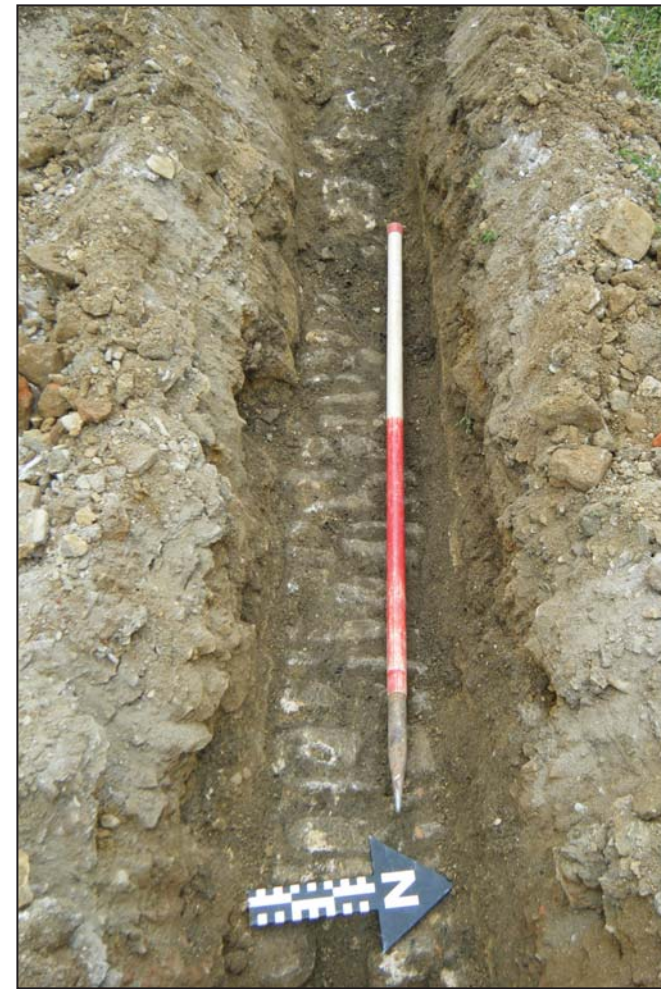
6

- 2.4 Dark brown sandy silt make-up 403 and mid orangey brown sandy grit make-up 404 were identified were identified at the base of trench 4 approximately 0.75m bpgl. They were overlain by mid yellowish brown silty sand make-up 402. In three areas of the trench on-edge limestone blocks were observed to form a rough cobbled surface. This surface was covered by dark grey sandy silt 405. All areas were sealed by brick rich hardcore deposit 400, similar to that recorded in trench 2.

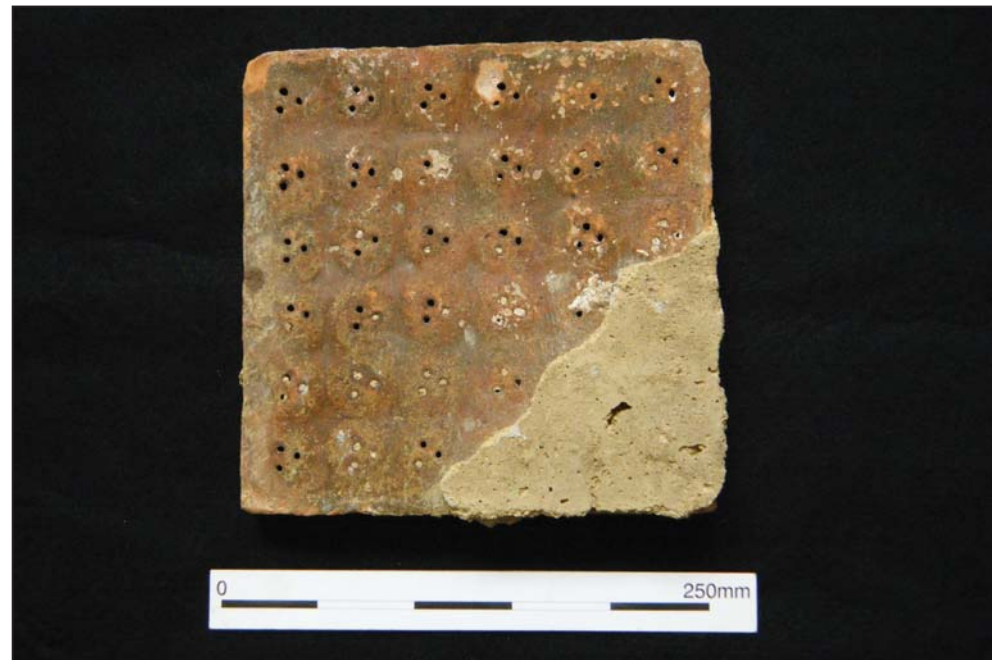
7

Notable are two samples of perforated kiln tiles, retrieved from layer 100 within trench 1. One is a complete floor tile, measuring 23.5cm by 23.5cm and 3cm thick, with 36 conical keys cut into the base. These tiles were made in a frame as in the manufacture of bricks, roof and floor tiles. They were originally clear lead-glazed and used as an important building component of the malthouse, as a floor for kilning the green malt which was heated on the drying floor to arrest the germination. Below this perforated floor there was a heat chamber. This type of kiln tile was mainly in use from the 18th century until the last quarter of the 19th century when wire kiln drying floors were becoming more commonly used (Patrick 2004, 19–22).
