Land at Bourton-On-The Water Gloucestershire

Archaeological Evaluation

CA Project: 3441 CA Report: 11186

Project Name:	Land at Bourton-On-The-Water, Gloucestershire
Location:	Bourton-On-The-Water, Gloucestershire
NGR:	SP 165 214
Туре:	Measured Earthwork Survey and Trial Trenching Evaluation
Date:	29-30 June and 25-29 July 2011
Location of Archive:	Corinium Museum Cirencester
Site Code:	BTW11

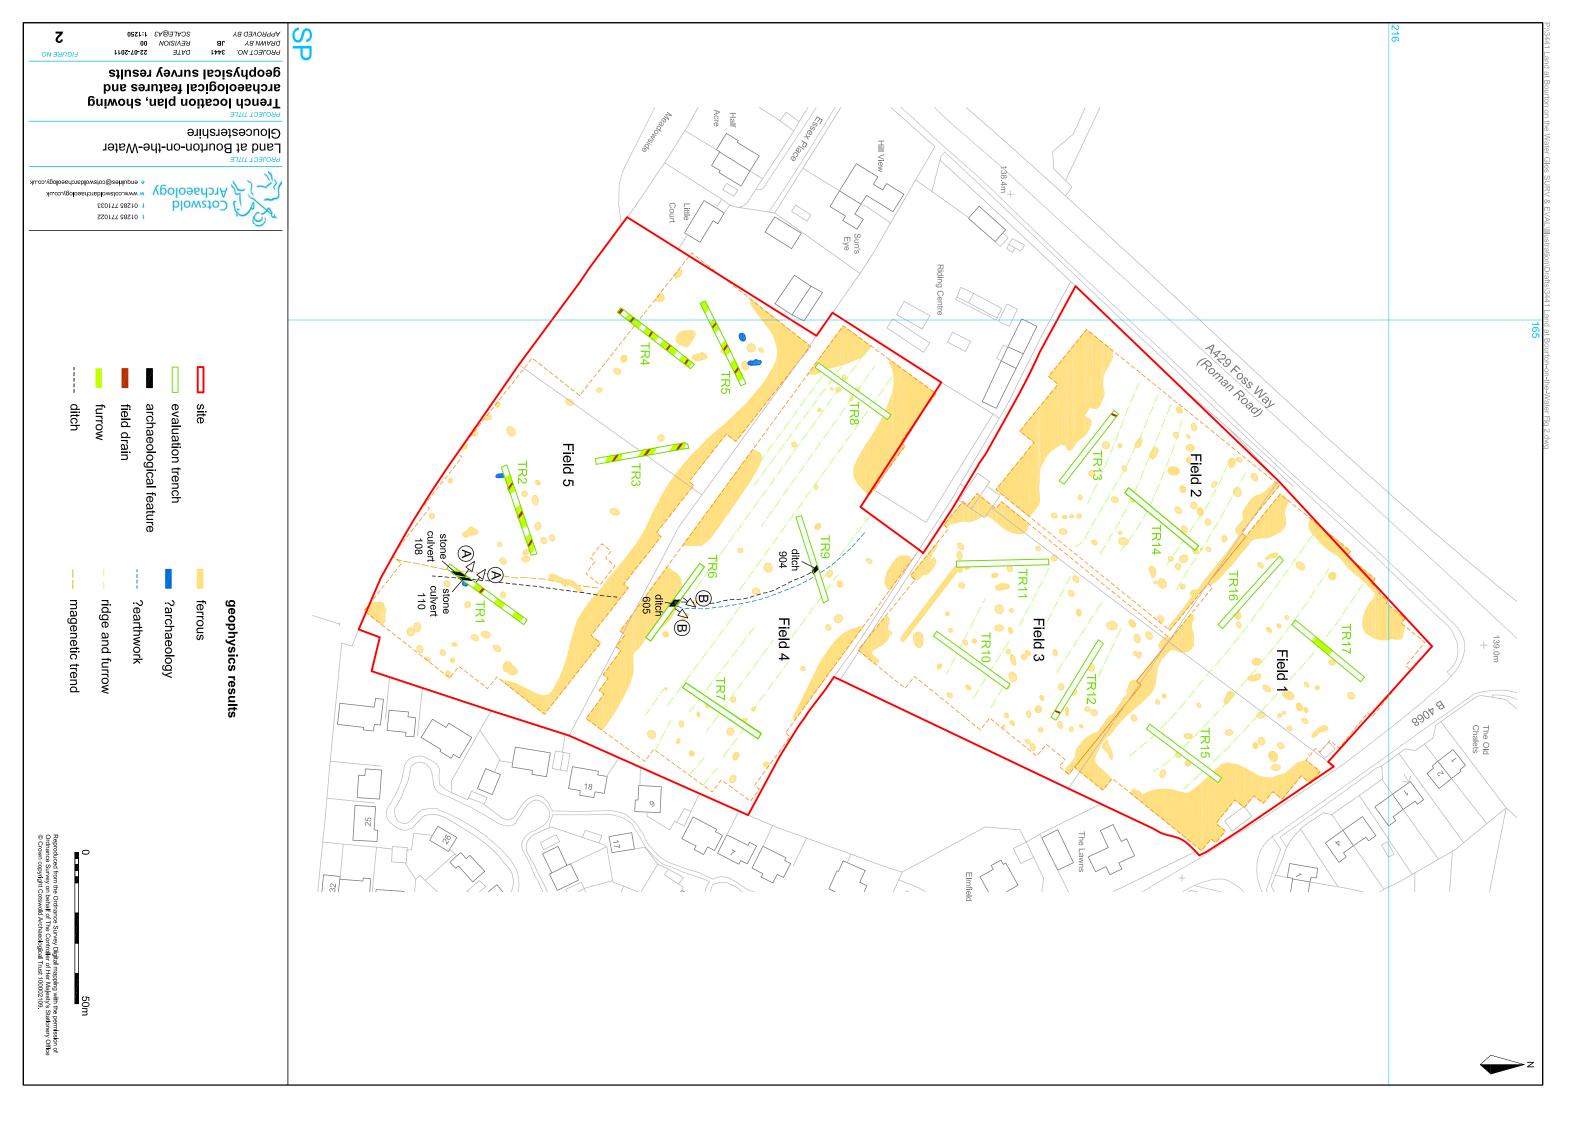
2.3 In total eight trenches (10-17) were excavated in fields 1-3. With the exception of the established north-west to south-east aligned ridge and furrow the only other archaeological features identified in these fields consisted of two post-medieval or modern ceramic land drains (1203 and 1303), both orientated north-east to south-west, and therefore cutting across the ridge and furrow in trenches 12 and 13 respectively.

2.4 A curvilinear ditch, broadly orientated north-west to south-east and which visibly truncated the ridge and furrow earthworks, was encountered in trenches 6 and 9. It measured 1.05 to 1.39m in width and survived to a maximum depth of 0.4m bpgl. In trench 9, ditch 903 contained a single fill, 904, from which no artefacts were retrieved. Two fills, 603 and 604, were revealed in the excavated section through the same ditch, 605 in trench 6. Post medieval pottery, and a residual medieval pottery sherd were recovered from secondary fill 603.

- 2.5 In four of the excavated trenches (trenches 2-5) a simple north-west to south-east aligned stone drain was revealed within, or at the base of, each of the furrows (Fig 6). Each of these drains measured approximately 0.4m in width and survived 0.35m to 0.6m bpgl. The construction cuts of the stone drains were only revealed in plan once redeposited furrow fill had been removed.

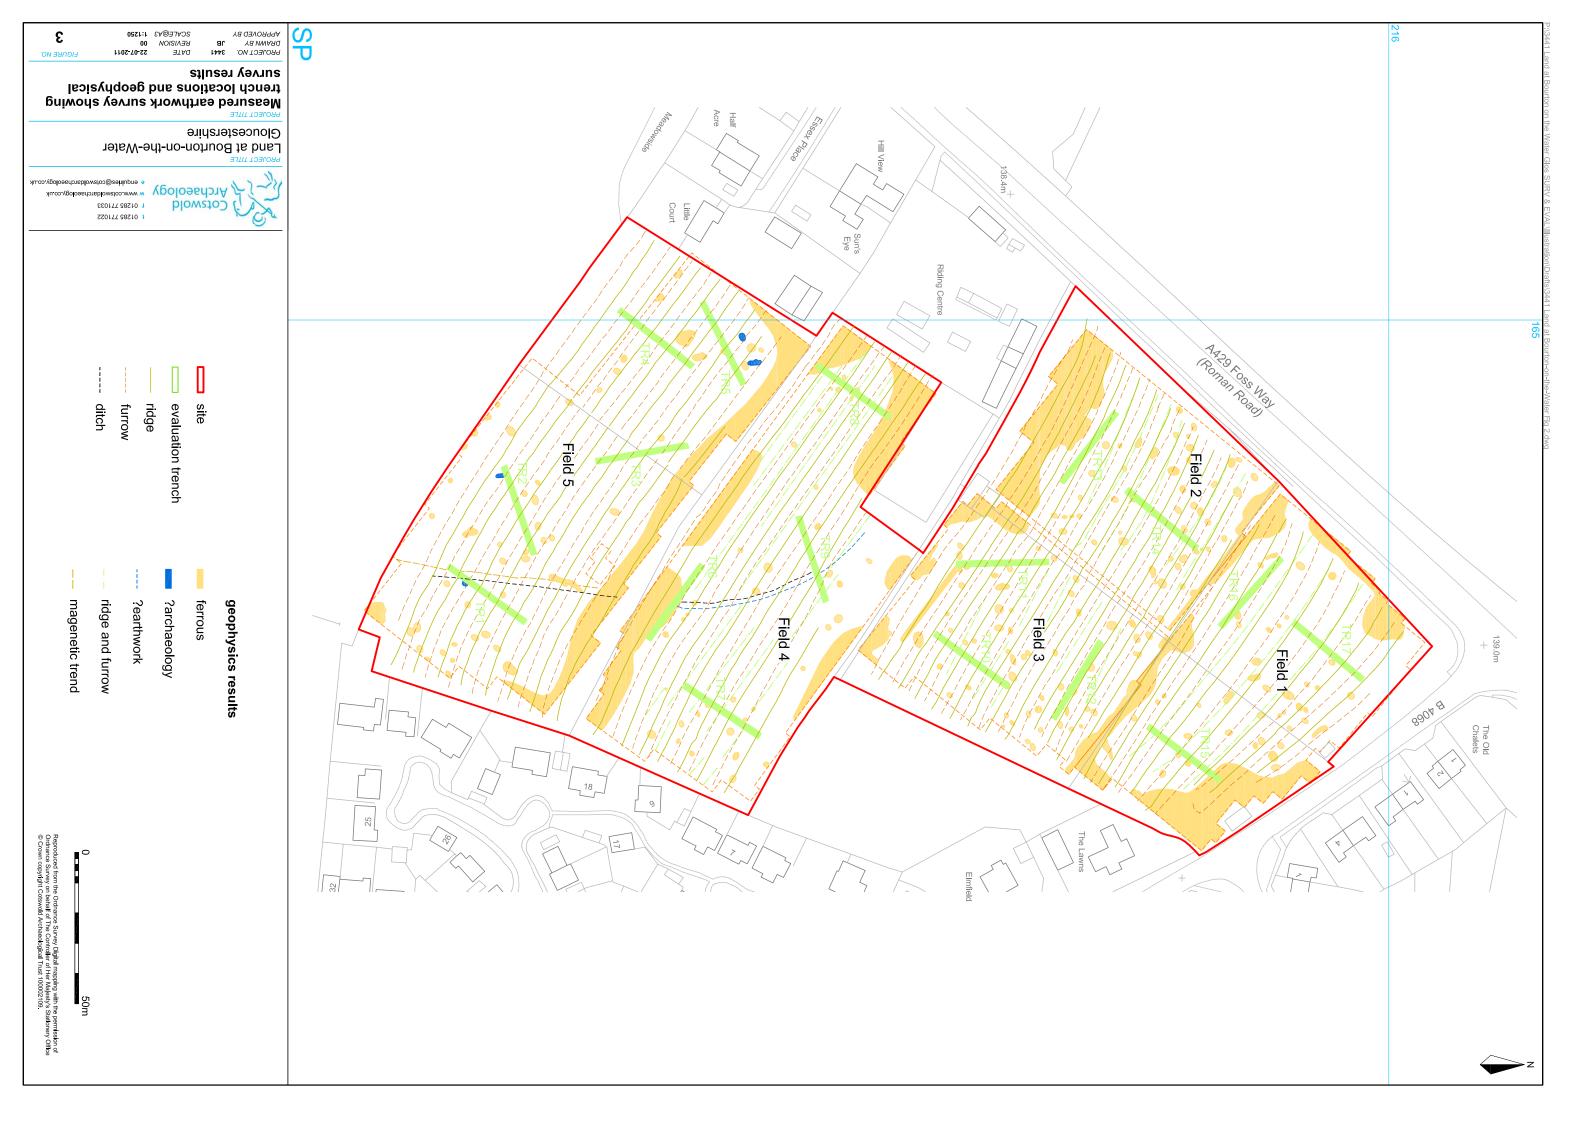
2.1 The measured survey produced a series of four illustration figures showing the ridge and furrow earthworks in both plan and cross section form. A total of 20 ridge and furrow pairs were recorded running north-west to south-east along with a gully which ran north-south through the site. The spacing of the ridges varied in width from a minimum measurement of approximately 6.5m to a maximum of approximately 10.5m, with an average depth from the top of the ridge to the base of the furrow in the region of 0.2m. The earthworks at both the northernmost and southernmost extents of the site were more pronounced than those recorded in the central areas, possibly due to protection from erosion provided by the large hedgerows.

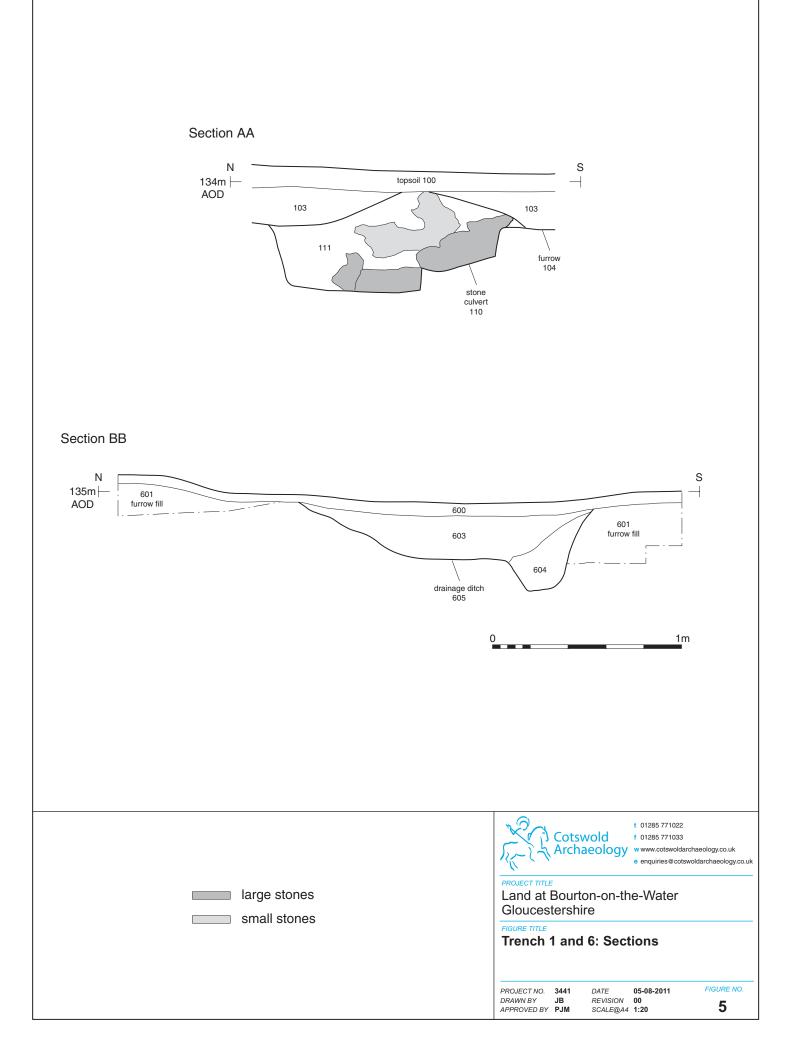
- 2.6 In trench 1 a variation to this drainage pattern was revealed. Two parallel stone culverts, 108 and 110, broadly aligned north-south and corresponding with a linear geophysical anomaly, were revealed cutting across the ridge and furrow at the south-western end of the trench. The southernmost of these culverts, 108, contained 19th-century pottery within the backfill of its construction cut. One of the simpler stone drains fed into this culvert. Aligned parallel with culvert 108 was similarly constructed, but undated culvert 110. Both culverts clearly cut across the ridge and furrow.

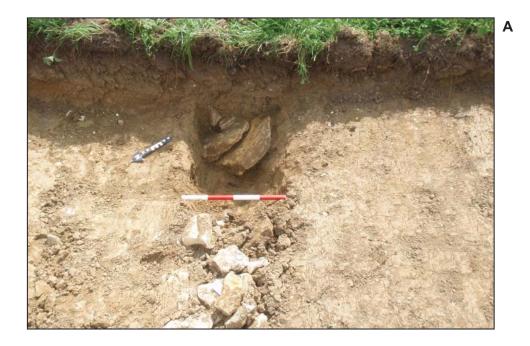
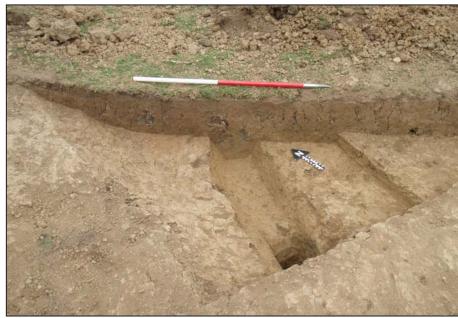
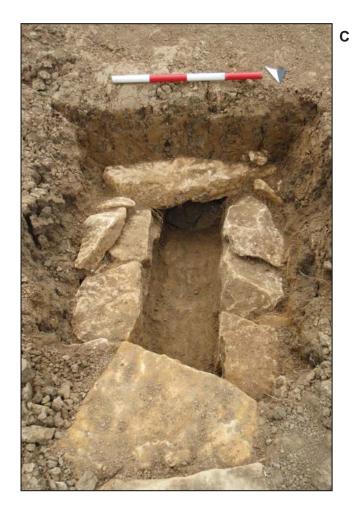
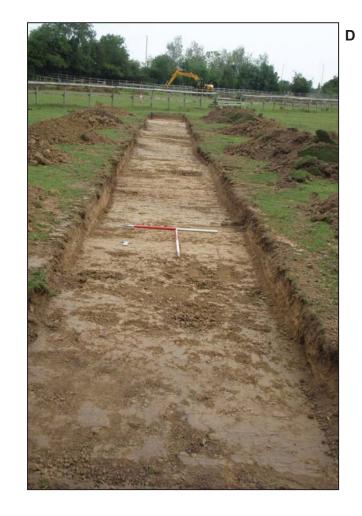
- 2.7 In the north-eastern part of trench 1, a simple stone drain, 114, orientated north-west to south-east and comparable to the stone drains excavated in trenches 2-5, was revealed. A single residual worked flint flake was recovered from fill 115 within this drain.
