**Cherington Park  
Cherington  
Gloucestershire**

Archaeological Watching Brief

CA Project: 3433  
CA Report: 11206

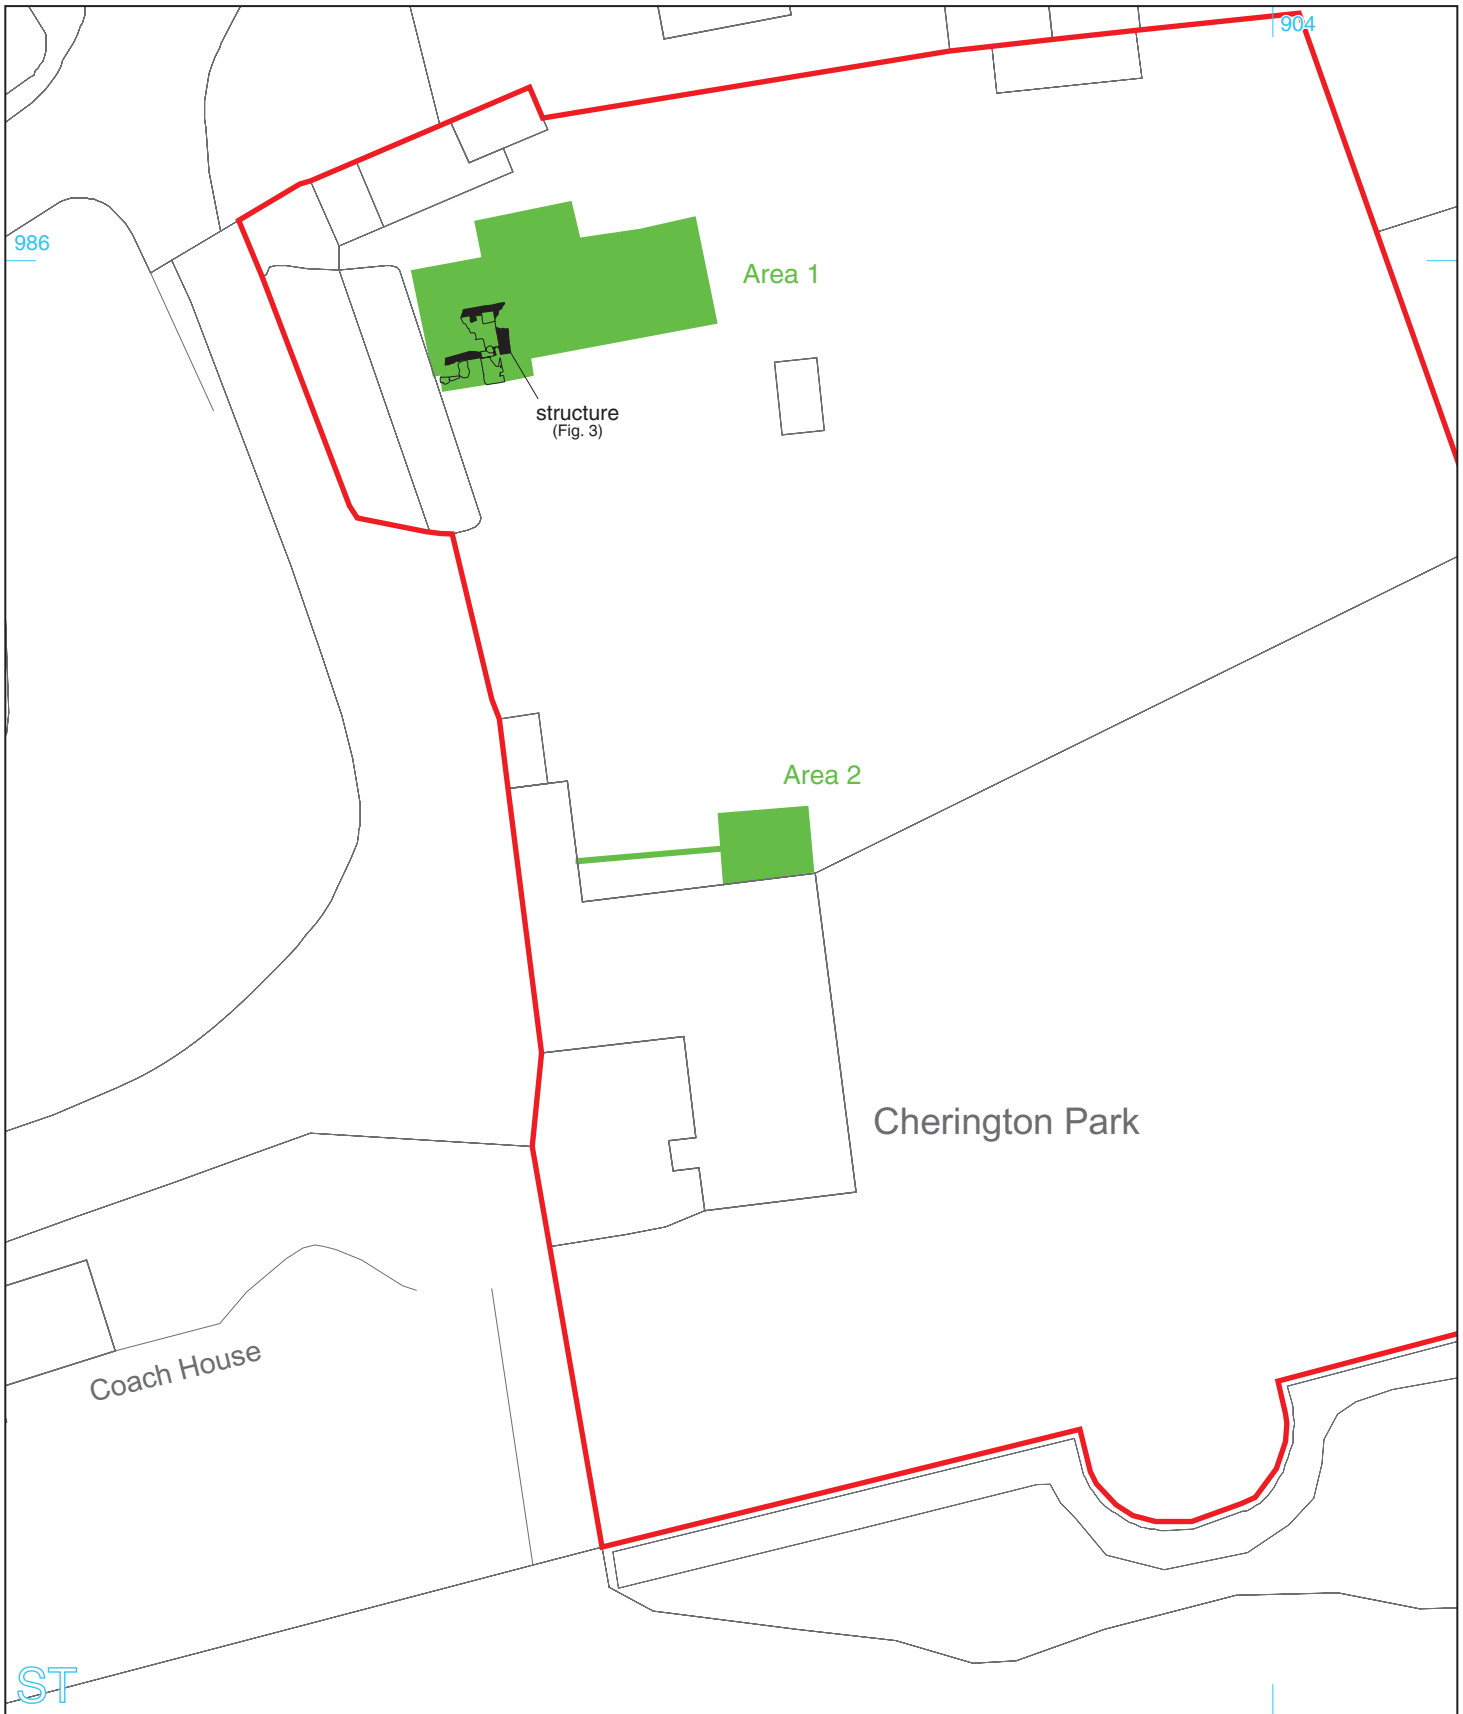
**The site, showing location of  
groundworks**

- 1.7 The fieldwork followed the methodology set out within the WSI (CA 2011). An archaeologist was present during intrusive groundworks comprising the reduction in ground level and the excavation of footings trenches for the construction of a new garage block and the removal of cellars along the northern frontage of Cherington Park house for the construction of an extension and stone walled courtyard (Fig. 2).

- 2.1 Groundworks were undertaken as part of the development in two discrete areas. Area 1 refers to the excavations associated with the construction of the new garage block to the east of the entrance to the property and adjacent to the northern boundary wall. Area 2 refers to the groundworks associated with the construction of the extension along the northern side of the existing structure of Cherington Park.

- 2.10 The ground works within Area 2 involved the removal of a cellar believed to be constructed as part of the 19th century service wing (CA 2011), and the excavation of a footings trench extending approximately 8m to the west of this cellar for the construction of an external wall for the planned extension. This trench ran parallel with the northern frontage of the existing structure (Fig. 2).

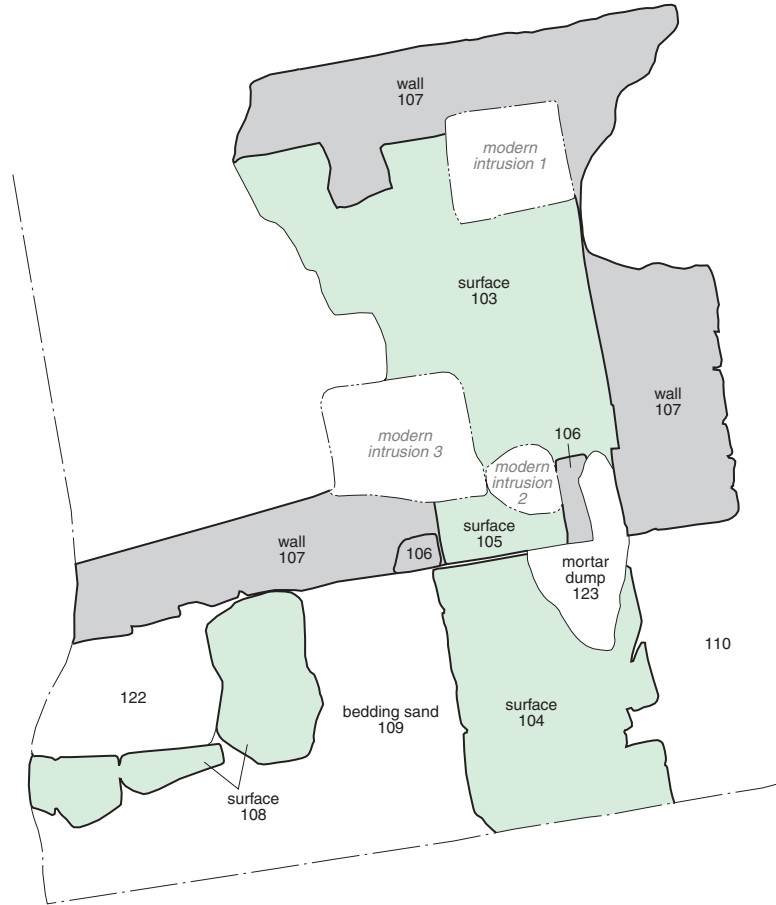
Plan of the structure

- 2.4 Three sides of a small rectangular structure 107 were observed in the western part of the area (Fig. 3). Two large limestone blocks formed a door jamb creating an entrance to the structure along its southern side. These blocks were set deeply into the buried topsoil and subsoil layers and were butted on either side by a roughly coursed, Cotswold limestone walls. These walls formed three external sides of the structure, the western most wall was not seen to survive. The wall running north-

west/south-east and the northernmost wall of the structure were built onto a levelling deposit of dark brown sandy silt with frequent limestone fragments whilst the southernmost wall was constructed directly onto a clean layer of yellow bedding sand. Other structural features were also laid onto this sand suggesting they were contemporary with the construction with the walls. These features included a large limestone paving slab (surface 105) set between the stones of the door jamb and a limestone paved pathway (surface 104) leading to the entrance of the structure from the south-east. Along the external southern edge of the structure and also lain onto the layer of bedding sand a further area of paving (surface 108) was observed. This area consisted of an L-shaped arrangement of large limestone paving slabs with the short arm of the L butting the external side of the wall of the building, and the long arm of the L running parallel to this north-east south west aligned wall. The internal space created by this paving was filled by roughly stepped layers of unfinished limestone (122) sloping gradually downwards to the south-east.

- 2.5 The internal space of the structure was paved with large limestone slabs (surface 103). Three intrusions had been punched through this floor, two in the entrance way and the third in the north-eastern corner of the building. This hole (intrusion 1) was square in shape and 0.49m in depth and was backfilled by loose dark brown, back and yellow sand and sandy silt with frequent inclusions of modern demolition rubble. A small roughly circular intrusion (intrusion 2) observed in the doorway of the structure cut through both the internal paved floor and the limestone door step and similarly to the square intrusion in the north-eastern corner, was backfilled by modern demolition rubble in a matrix of brown sandy silt. The third intrusion adjacent to the circular hole in the doorway was rectangular in shape and measured 0.90m by 0.86m. A large iron plate, possibly part of a machine base was inserted into the void created in the floor. Limestone blocks and a single brick had been used to pack the space around this plate.

- 2.6 A large spread of limestone demolition rubble in a dark grey brown silty clay matrix (110) was observed lying along the eastern side of the structure and overlying the paved external pathway. This dump extended approximately 5m to the east of the structure. Furthermore two dumps of mortar which appeared to post-date the demolition of the structure were observed overlaying the walls and door jamb.

- 3.1 The structure in Area 1 probably represents a small garden outbuilding which may be contemporary with the construction of the 19th century service wing (CA 2011). It is certainly visible on the 1884-6 OS mapping. The pathway at the entrance to this

building appears to lead from the area where the service wing is known to have stood. It appears the function of the building may have changed during its lifespan as is evidenced by the presence of the three intrusions into the floor which possibly represent the introduction of machinery to the structure; the surviving iron plate may have acted as a machine base. The obstructive positioning of two of these fittings suggest they were a later addition to the structure rather than having been planned at the time of construction. It is likely this building was demolished in 1965 in the same phase as the demolition of the service wing as it doesn't appear in the 1978 OS mapping. The spread of demolition rubble along the eastern side of the structure is probably representative of this event. Further truncation in the modern era may be responsible for the total loss of the western side of the building.
