Gloscat Main Site and
Media Studies Building
Brunswick Road
Gloucester
Historic Building Recording

CA Project: 3645
CA Report: 12005

March 2012

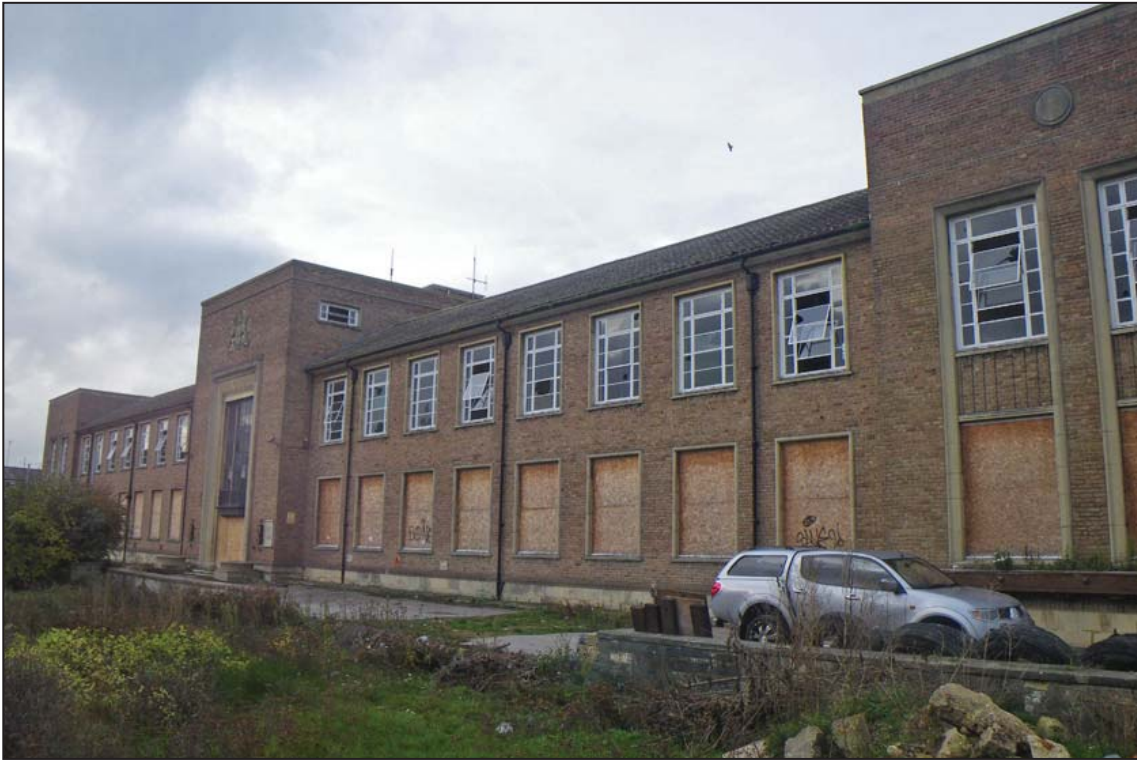
3 General view of the building from the north-east (east elevation) in January 2012

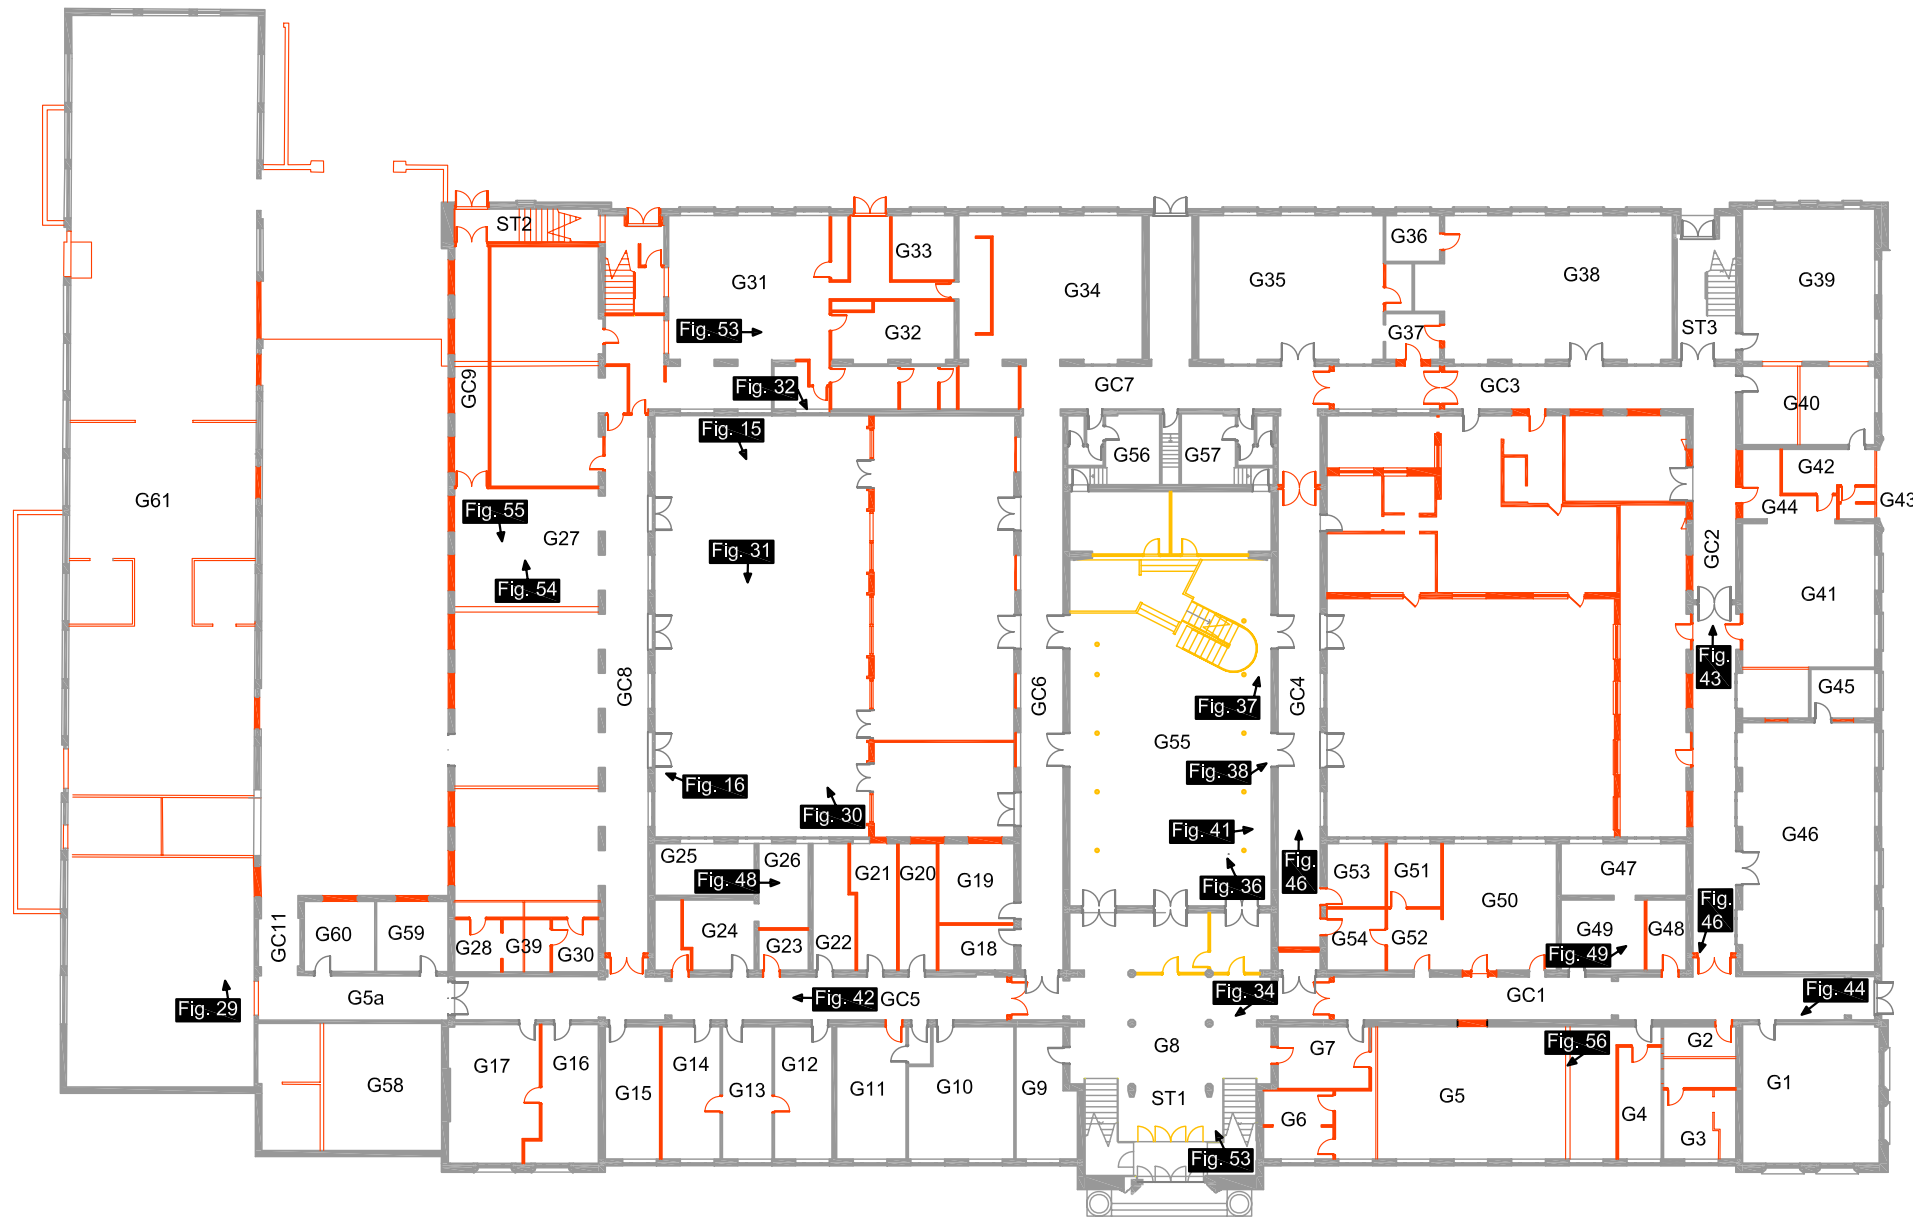
6

- 1938-40 fabric
- 1938-40 fabric removed c.1970-73
- Fabric inserted c. 1970-73
- Fabric inserted c. 1997
- Fig. 49 direction of photograph

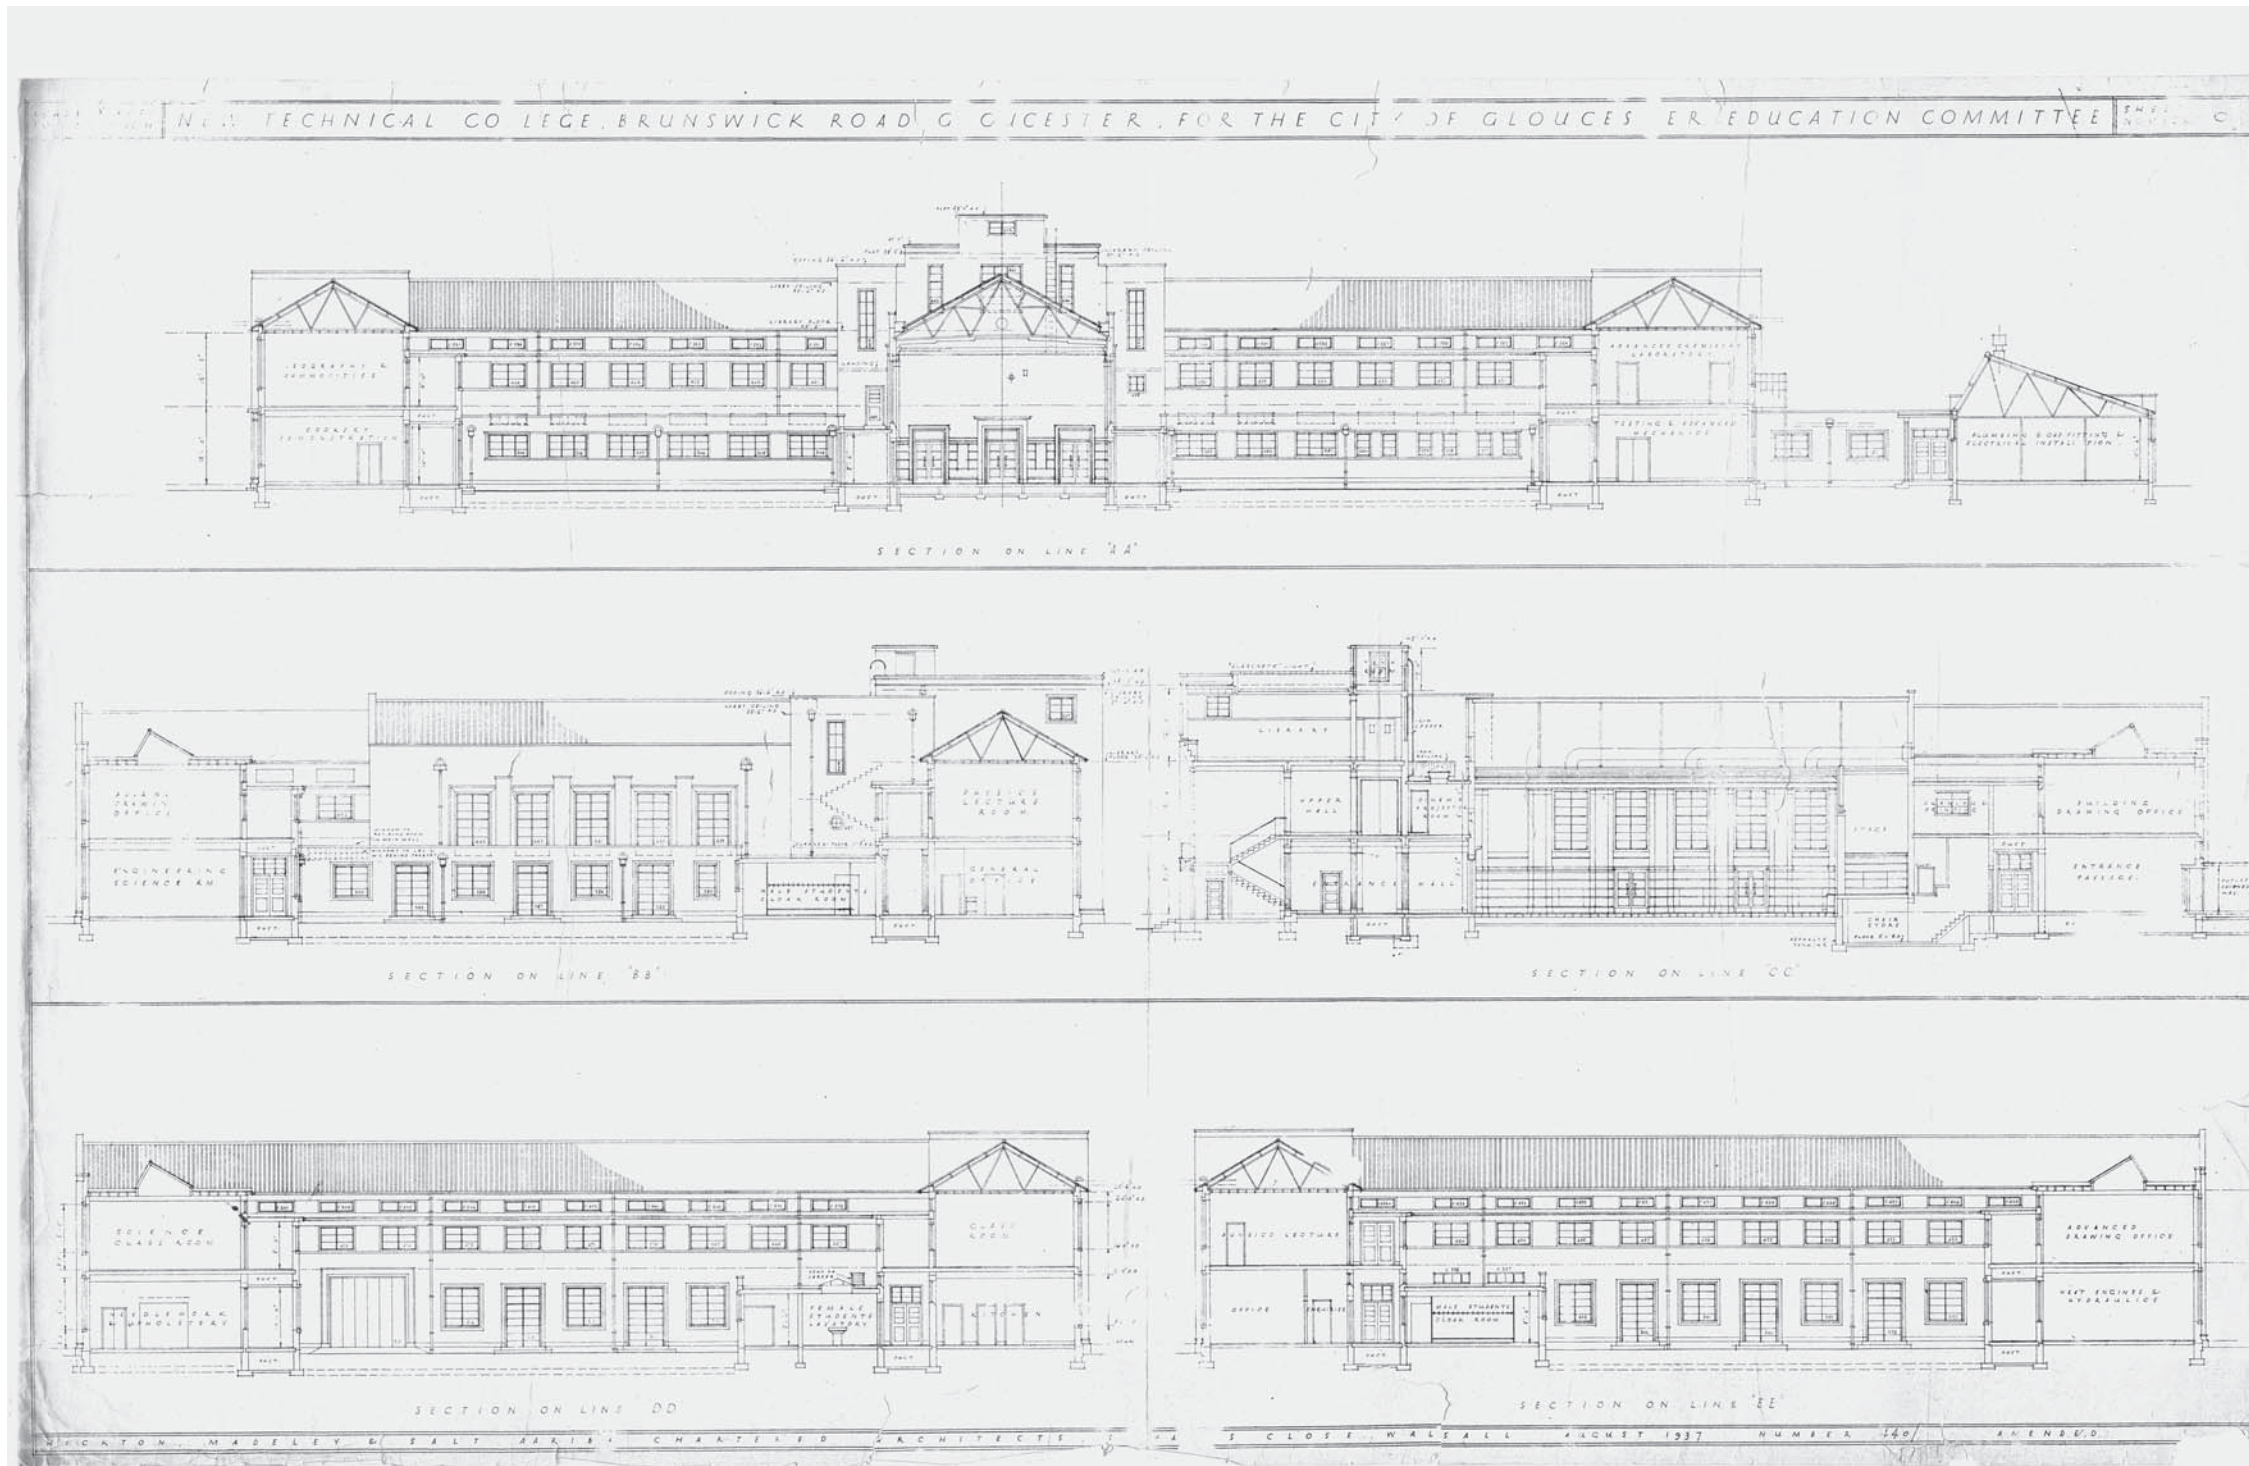
FIGURE TITLE
**Cross-sections and internal elevations
 as designed in 1937 (and as built) (1)**

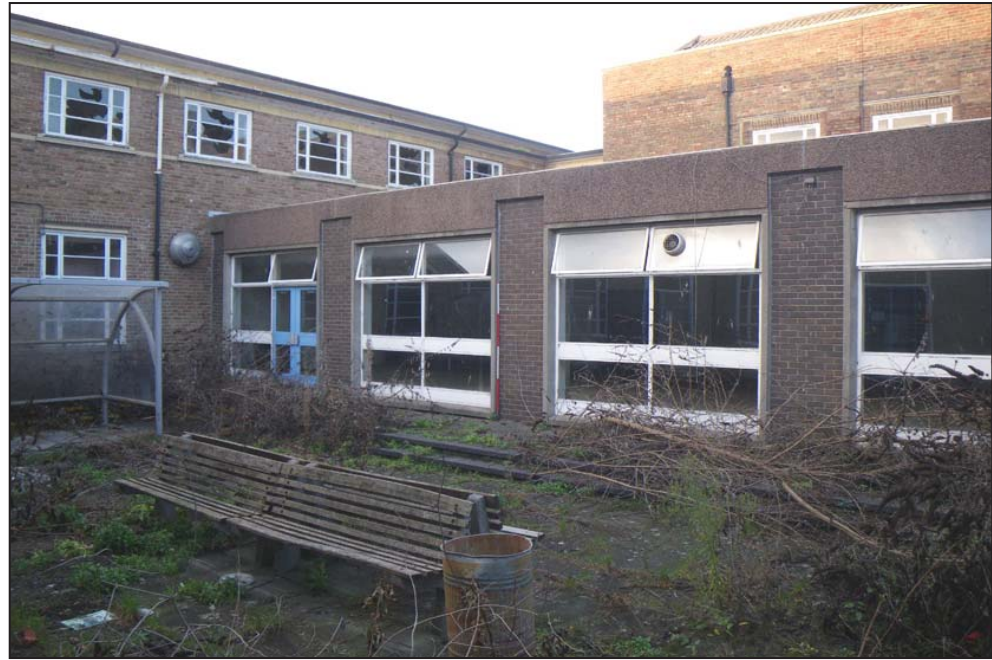
- 15 The 1970s addition in the southern quadrangle looking north-west (scale 2m)
- 16 The standard bolection moulded bricks, here in the southern quadrangle
- 17 The central entrance bay or pavilion on the east elevation
- 18 One of the two "column drum" bases flanking the main entrance (scale 2m)

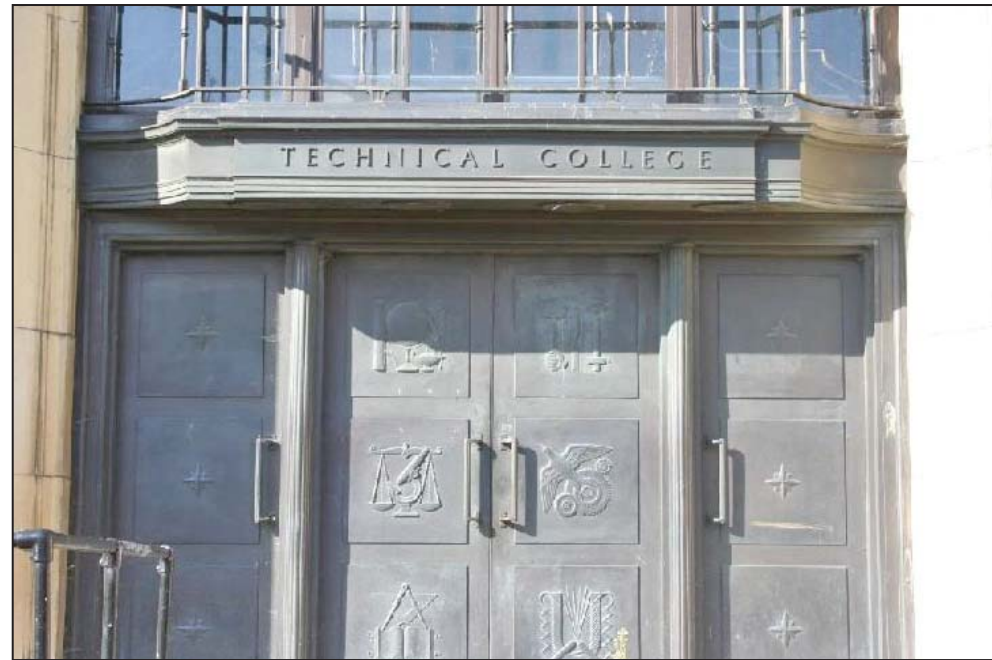
- 19 The bronze main entrance doors and the entablature over (from the derelict places website)
- 20 The north-east corner pavilion, looking south-west showing the “stone” panelling and brick ribbing
- 21 The typical pantograph hingeing of the external windows in the building
- 22 The link building between the main building and the workshops

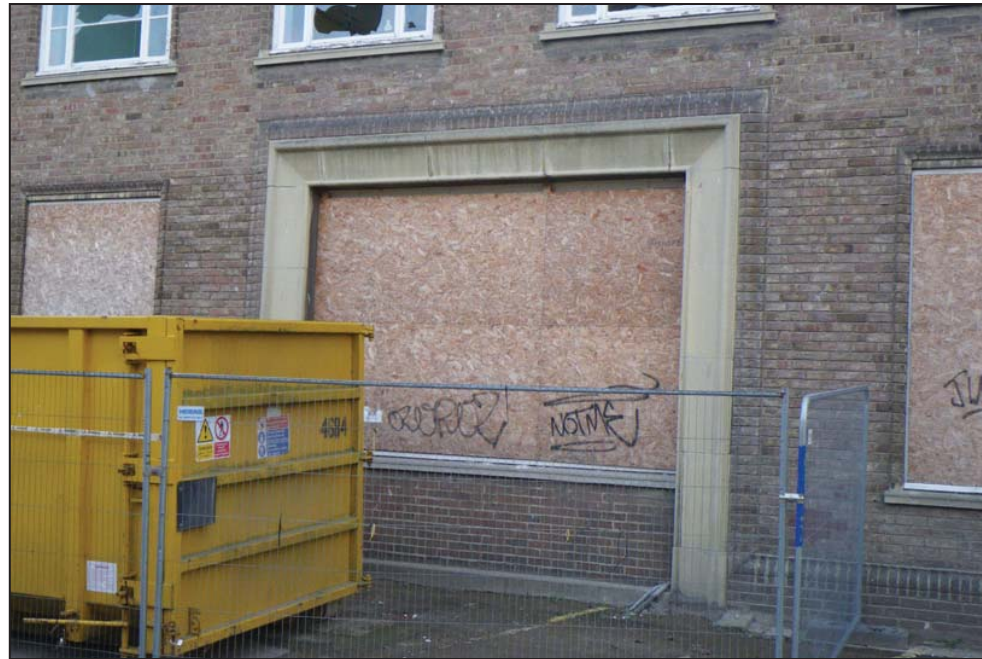
- 23 The reeded door jambs and lintel in the north elevation
- 24 The blocked loading door in the north elevation
- 25 One of the staircase bays in the west elevation
- 26 The north elevation showing the lengthened window in the east end, probably done when the room became the food technology kitchen

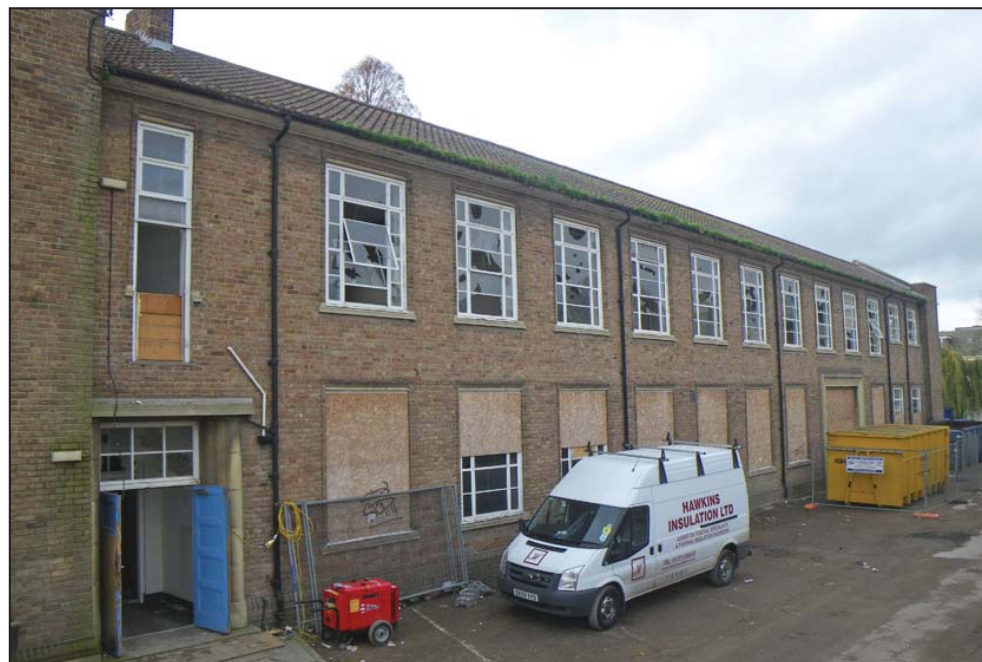
26

- 4.10 The plinth of these elevations was of moulded brick and the ground floor windows were framed with brick mouldings (Fig. 26). The staircase bays in the west elevation (ST3 and the original position of ST2) were distinguished by long windows with brick-ribbed aprons framed in the larger moulded brick profile and the monumental doorways beneath (Fig. 25). The central door on the west elevation was badly damaged by the construction of the bridge to the tower block in 1973, but it was possible to see that it had been treated in a similar fashion as a central motif, even though there was no stair here or indeed anything other than a drawing office window at first floor level.

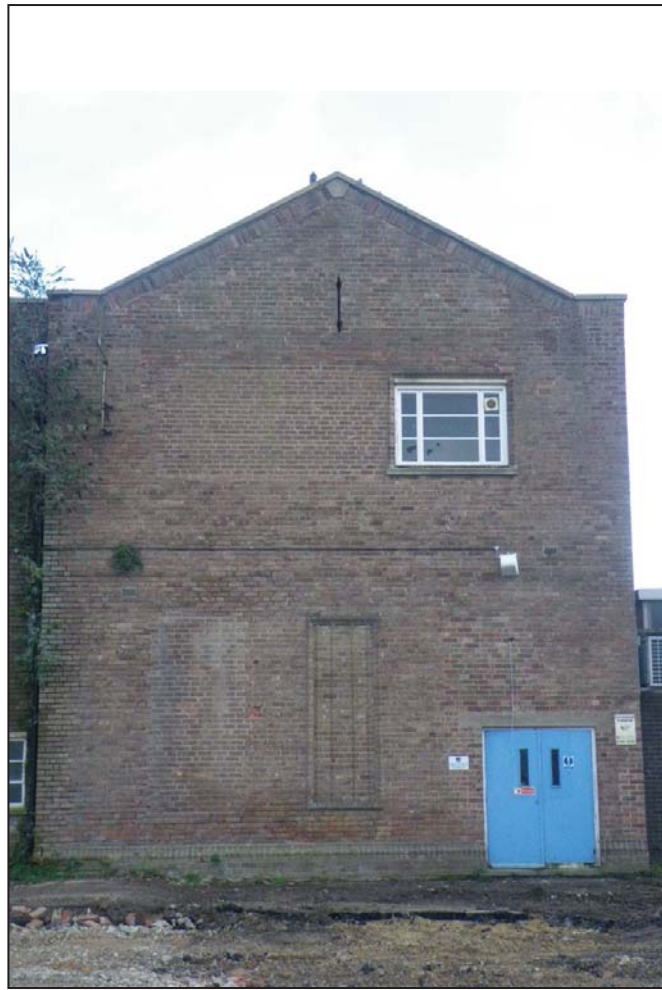
- 27 The southern pavilion of the west elevation, showing the changes following from the realignment of ST2
- 28 The south elevation, oblique view over the 1970s infill range
- 29 The interior of the workshop block, looking west (scale 2m)
- 30 The southern quadrangle looking south-west (scale 2m)

- 4.39 The alterations to the staircase ST2 were necessary before this arrangement could be installed, and these also date from the 1970s (Figs 7 and 13). These changes involved the removal of the lower flight of the original stairs and their replacement by a flight at right angles rising from a new external door and corridor in the south-west corner of the block. The enlarged underfloor space was then made part of the kitchen, the new walls here being in breeze-block.

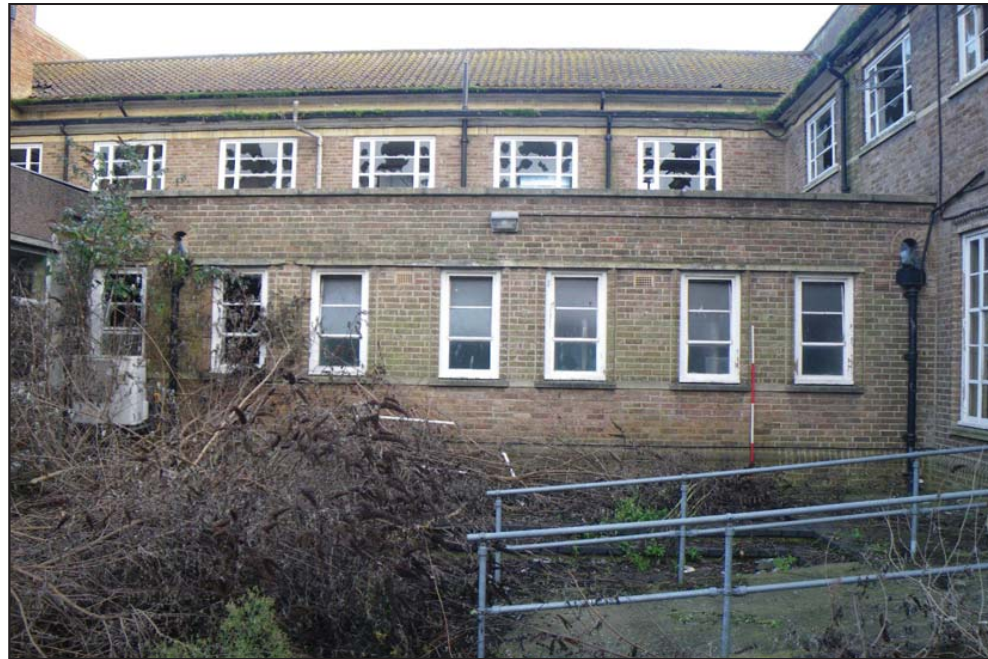
31 The southern quadrangle looking east, the small windows of the men's WC block (scale 2m)

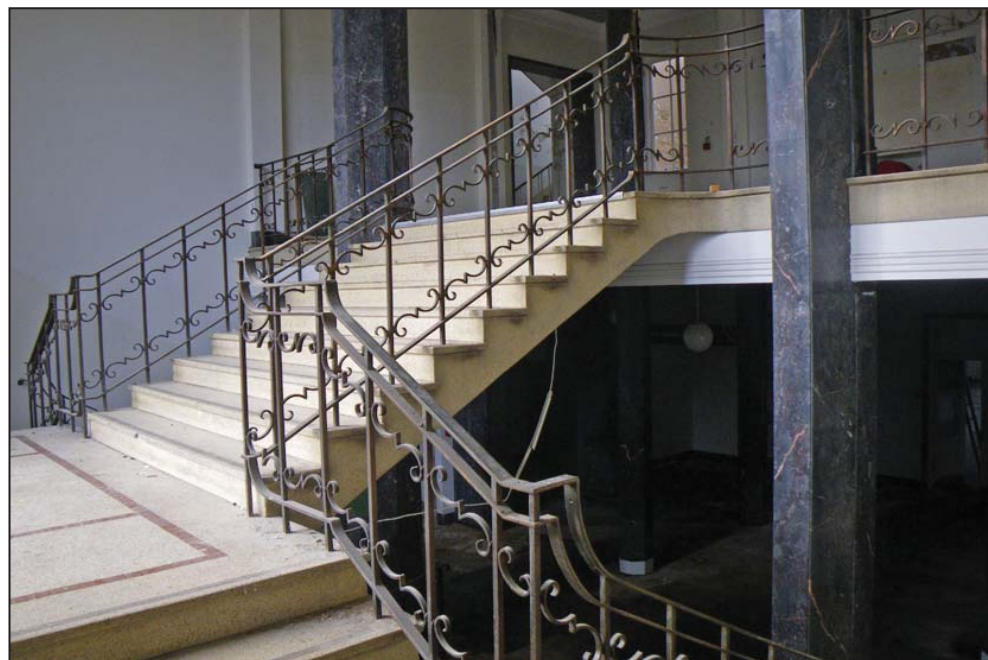
33 The staircase ST1, looking south-west

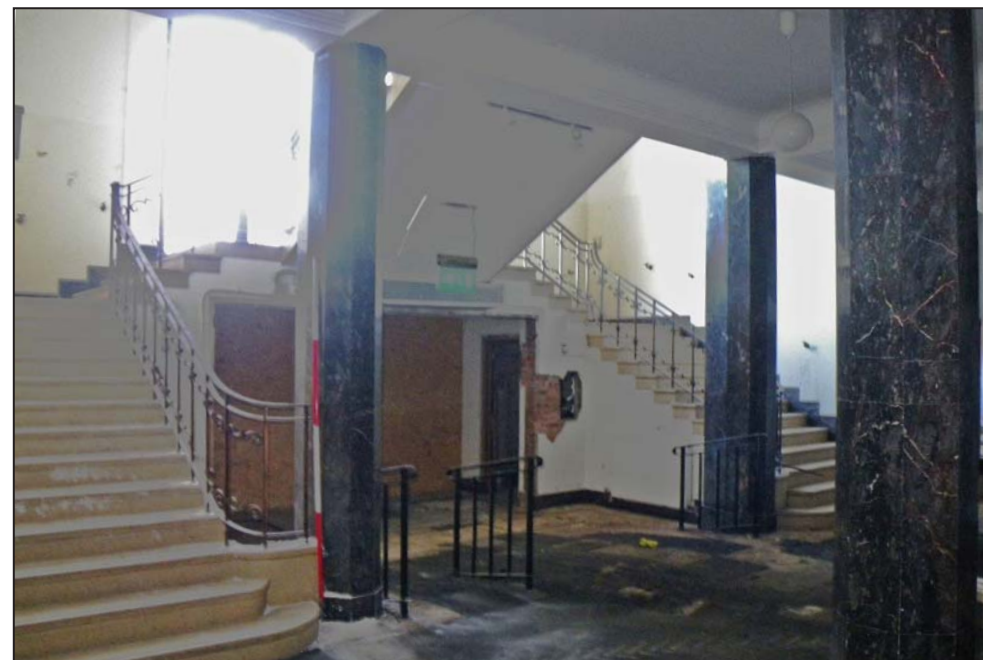
34 Entrance hall G8, looking south-east

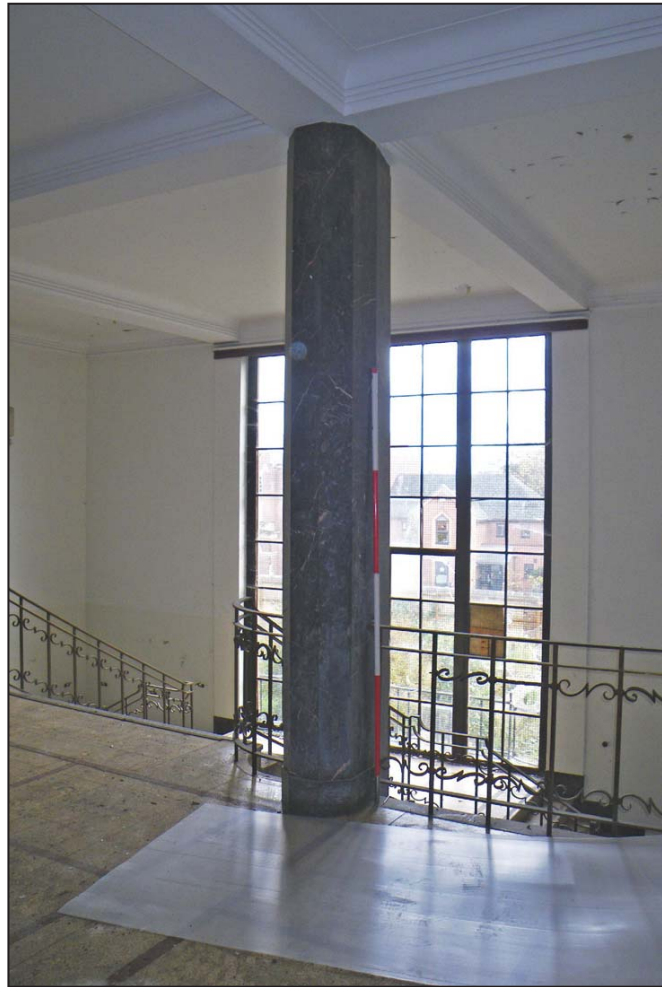
- 35 The upper landing of ST1 F47, looking north-east
- 36 The inserted steel floor in the hall, G55, looking south-west
- 37 The lower part of the proscenium arch, dado mouldings and other details in the hall, G55
- 38 One of the side doorways in the hall G55, cf Fig [19]

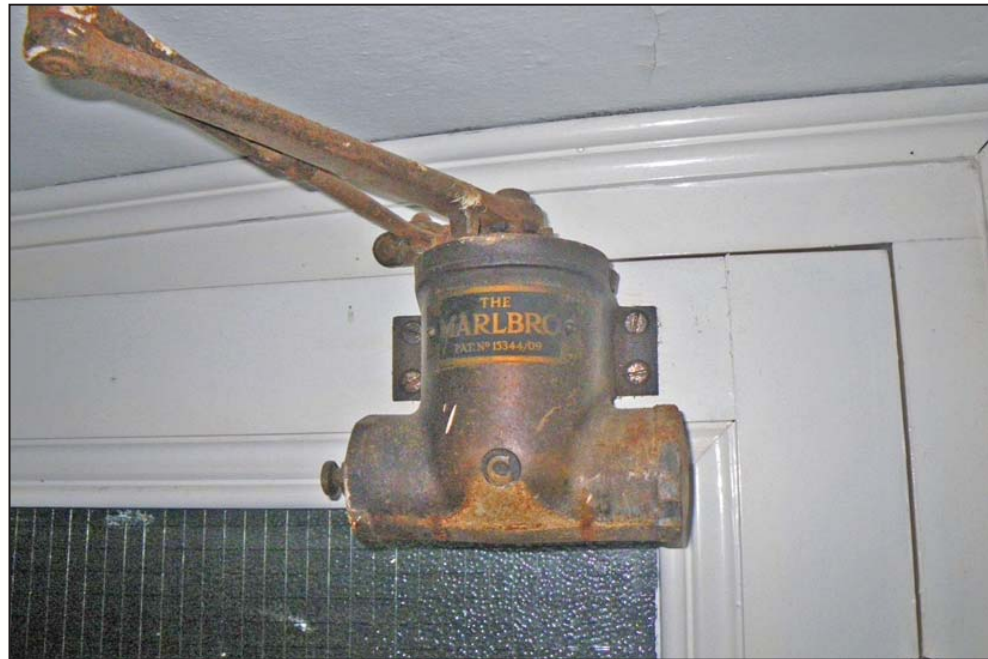
39 A door closer “The Marlbro” on a hall side door. The patent no. indicates a post-1949 date

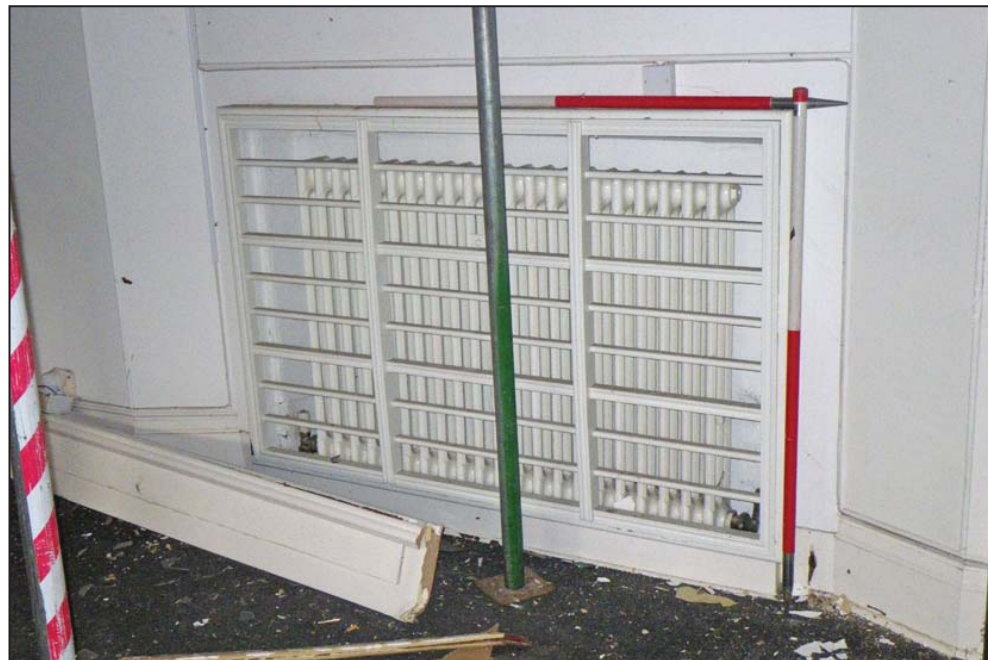
41 One of the wooden radiator covers in the hall, G55 (scales 1m)

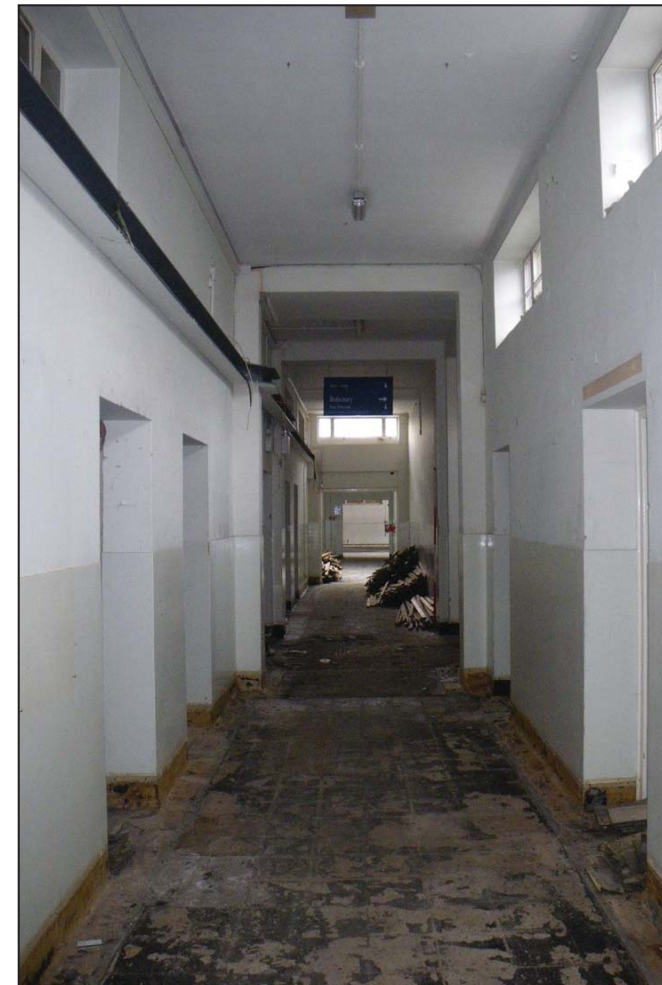
42 View south along corridor GC5. GC5a is beyond the doorway below the end window. Note the terrazzo skirting and the painted dado zone

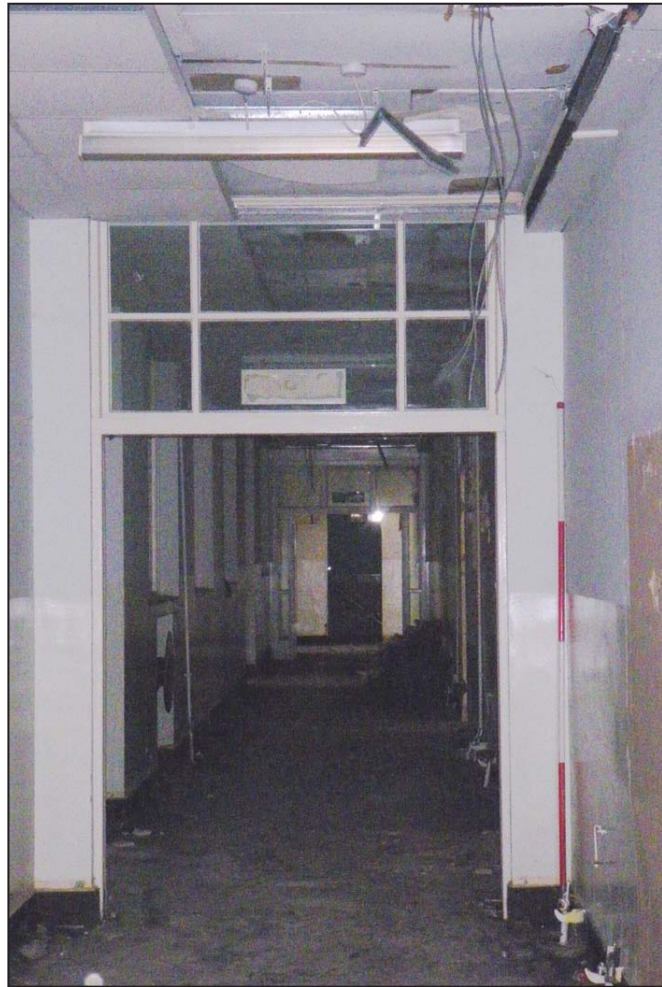
43 Early dividing screen/doorway in corridor GC2. Scale 2m. The skirting has been covered with glued lino tiles. Note original fibreboard ceiling over later suspended one

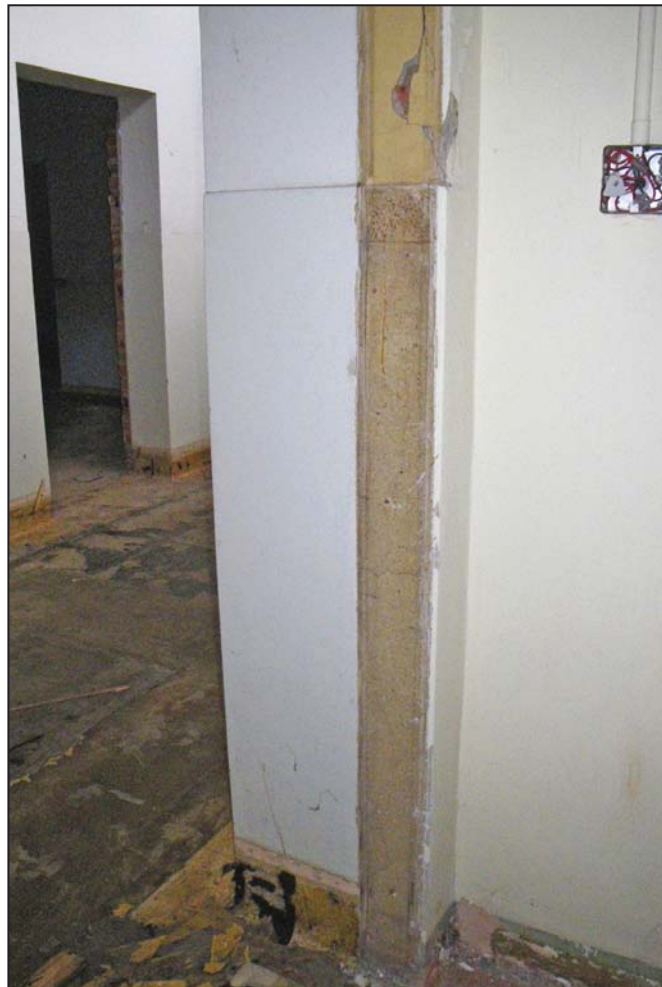
45 The original polished plaster dado finish in GC2, having survived behind a later door frame. Note painted-over dado zone still standing proud of the wall face

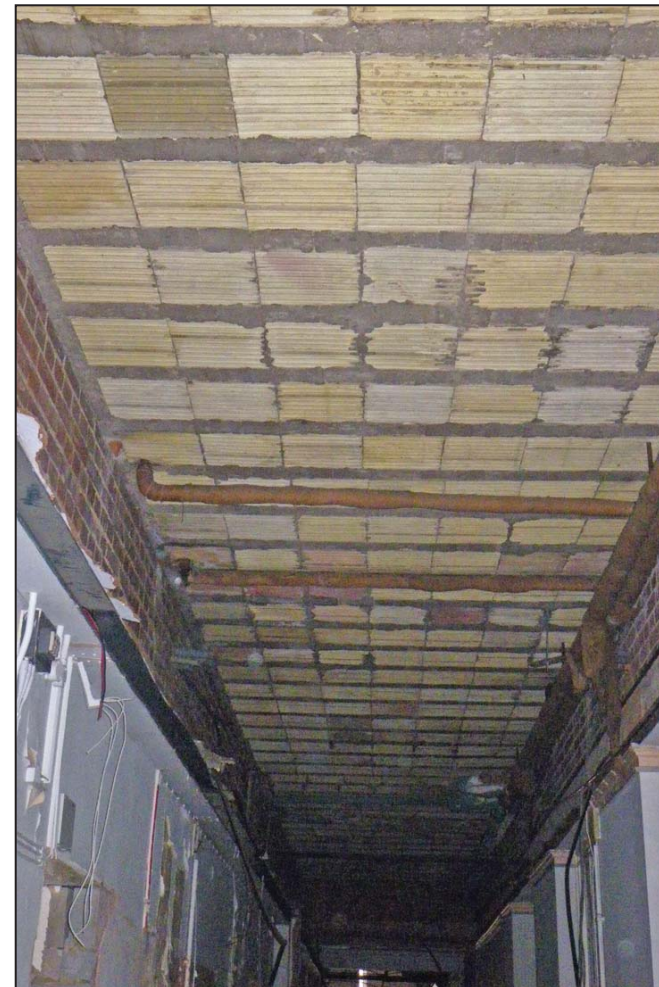
- 4.31 The ceilings of these corridors were usually hidden by modern suspended ceilings but where this was missing the older ceiling could be seen to be fibreboard panelling concealing a services duct, above which the pot (thin, hollow brick) underside of the concrete floors above could be seen (Fig. 46). These pots were also used in non-load-bearing partitions in the 1930s build. These were 12" x 8¾" x 2¾" (305mm x 223mm x 70mm) with three 1½" (38mm) square cavities running along the length and provided rigid but lightweight walls. They indicated 1938-40 partitions, especially upstairs.

46 The pot/concrete ceiling of GC4, looking west. The services duct occupied the zone where the brick is exposed

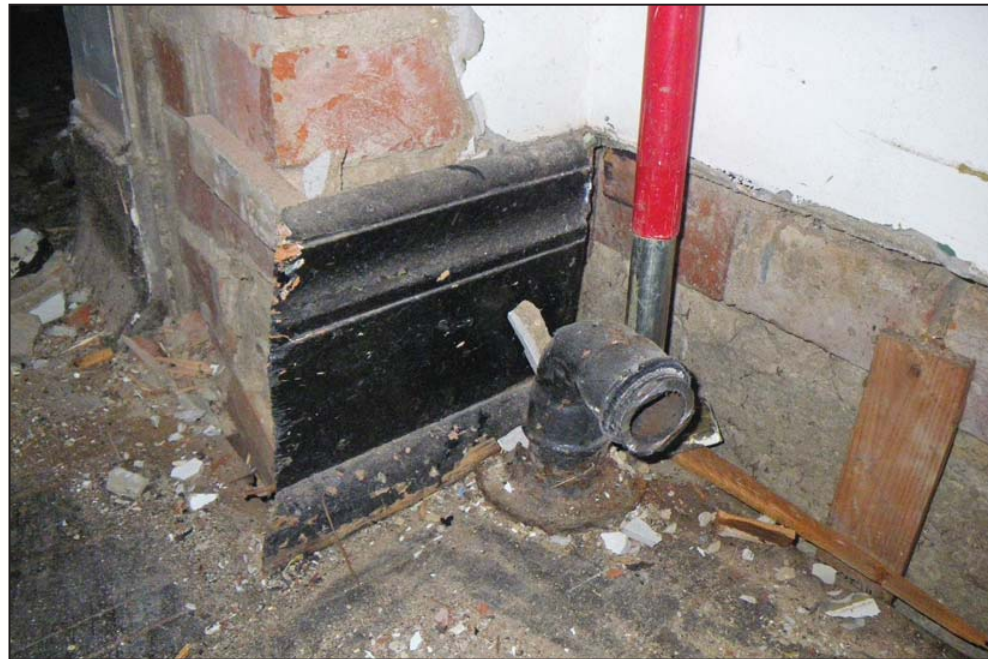
47 Example of 1938-40 wooden skirting: fragment of fitting surviving in F1

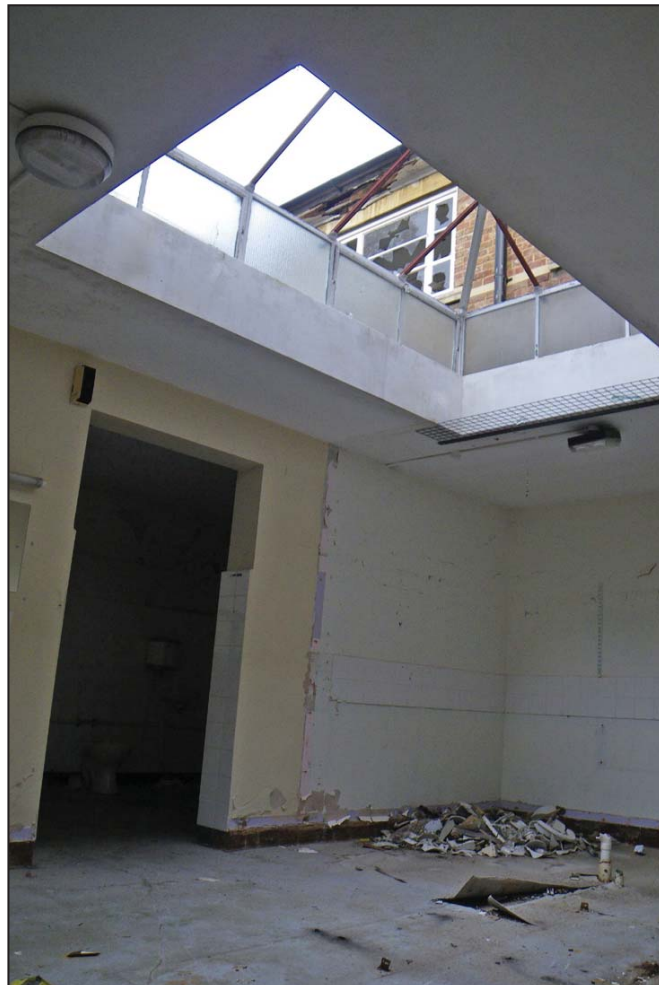
49 Skylight over the female students' lavatories (G48/G49), looking north-west

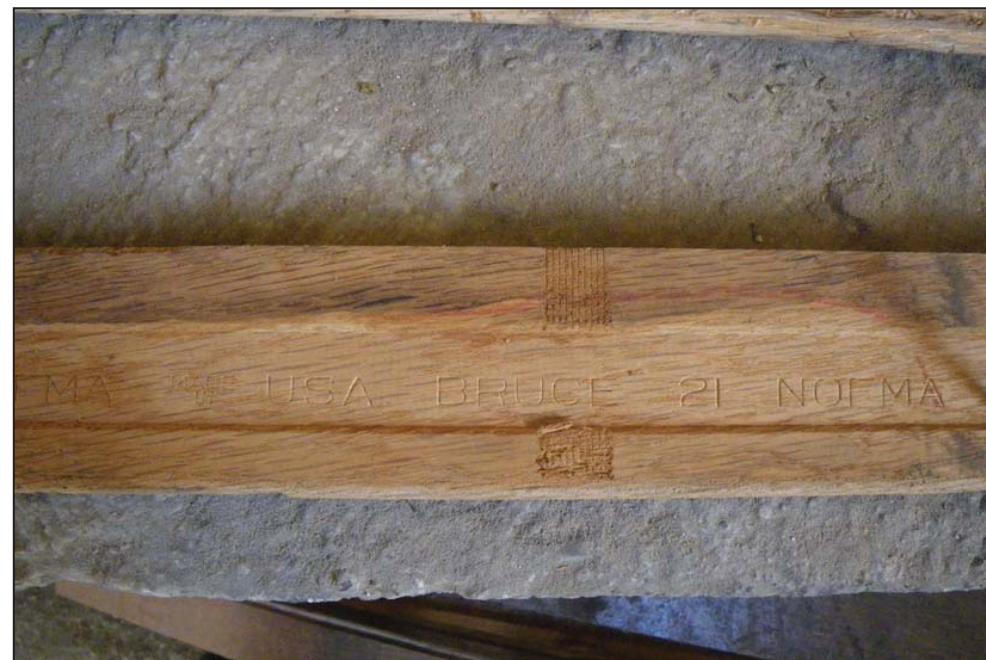
- 4.33 The floors were almost all of thin oak planks which, when lifted, proved to have been supplied by the E. L. Bruce Company of Nashville, Tennessee. The wood was stamped on the back "Made in USA Bruce NOFMA" and a business reply coupon was found under the floorboards (Figs 50 and 51). NOFMA, now NOfMa/NWA, was the acronym for the National Oak Flooring Manufacturers Association, now the

50 The stamped underside of the floorboards used throughout the building

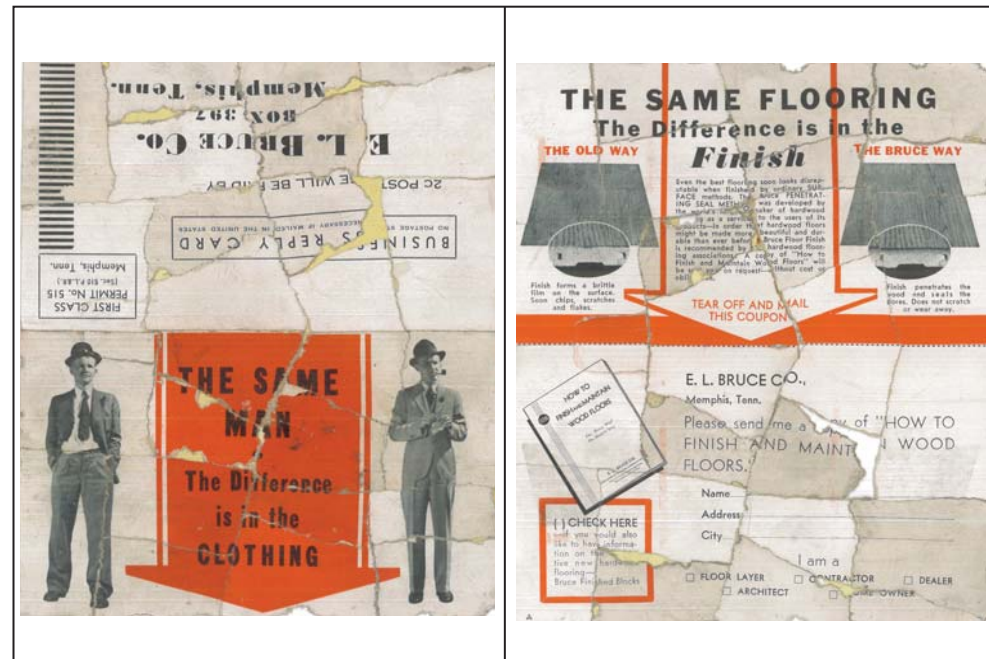
- 51 The business reply coupon found under the floors in the library
- 52 Staircase ST3 looking east from the halfway landing (scale 2m)
- 53 The kitchen in G31 etc looking towards the door into G32 etc (scale 2m)
- 54 The serving area at the west end of the refectory G27 looking west (scale 2m)

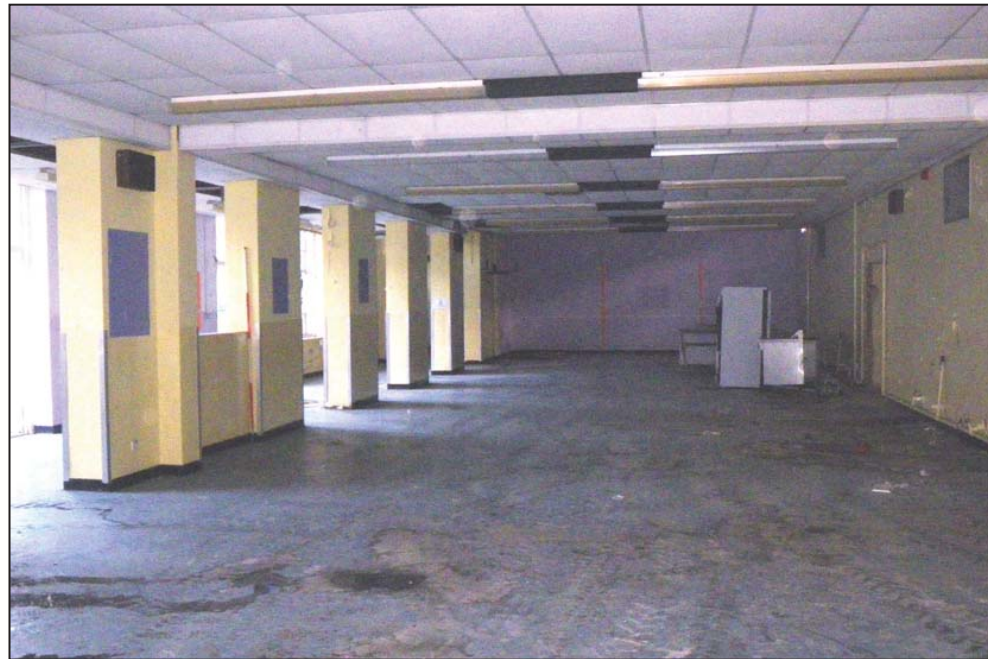
- 55 The refectory G27, looking east s(scale 2m)
- 56 The cookery classroom (G5) after removal of early and late subdivisions, looking south (scale 2m)
- 57 A surviving early, probably original, paint finish in FC1
- 58 First floor corridor FC6 looking east. Paint traces on near corner, fibreboard ceiling and thin ceiling cornice, all dating from the first build. Scale 2m

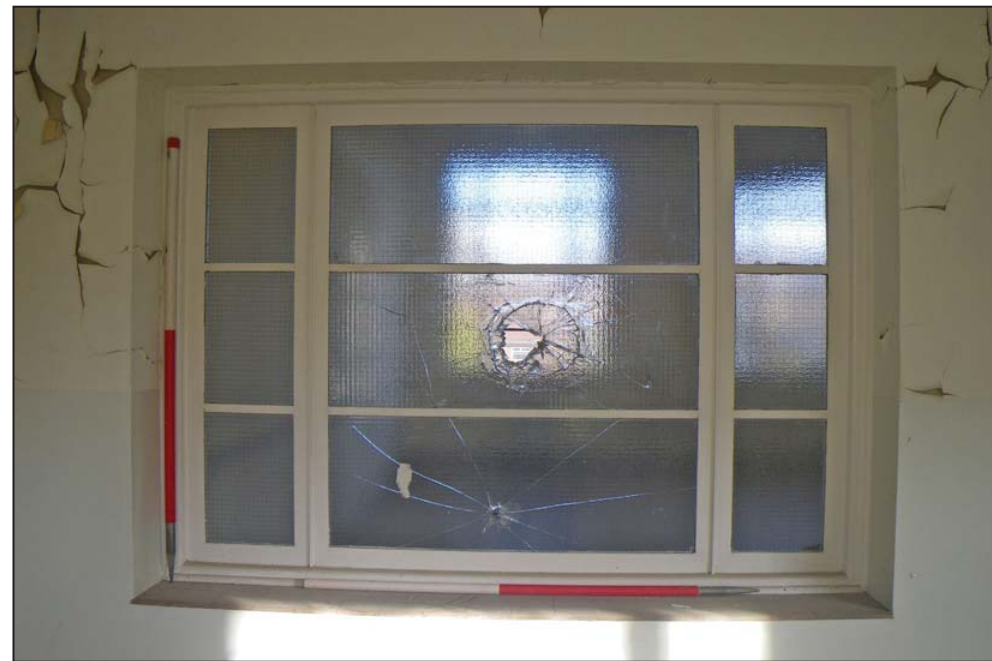
59a

- 59 A typical external and internal window from the first floor of the main building (scales 1m)
- 60 Stud and plasterboard walls in F29, built on the carpeted floor, to S. Scale 2m
- 61 Staircase ST4 looking east from the intermediate landing (scale 2m)

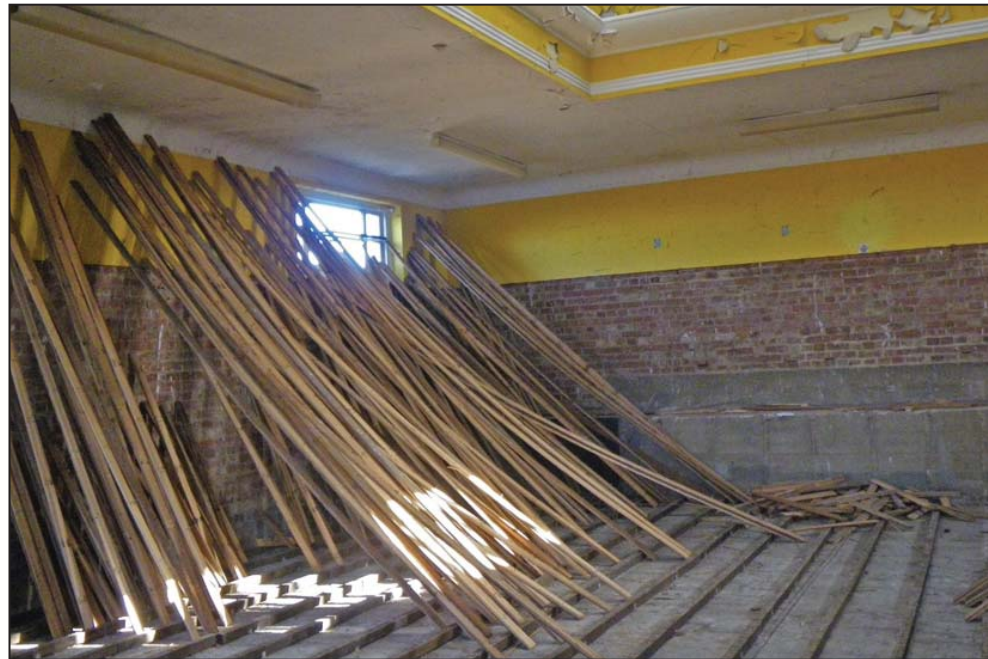
- 62 The library during stripping out
- 63 One of the stanchions in the library
- 64 Detail of the glass block skylight over the library
- 65 The western or entrance front of the Media Studies Building from Brunswick Road
