Gloscat Main Site and
Media Studies Building
Brunswick Road
Gloucester
Historic Building Recording

CA Project: 3645
CA Report: 12005

March 2012

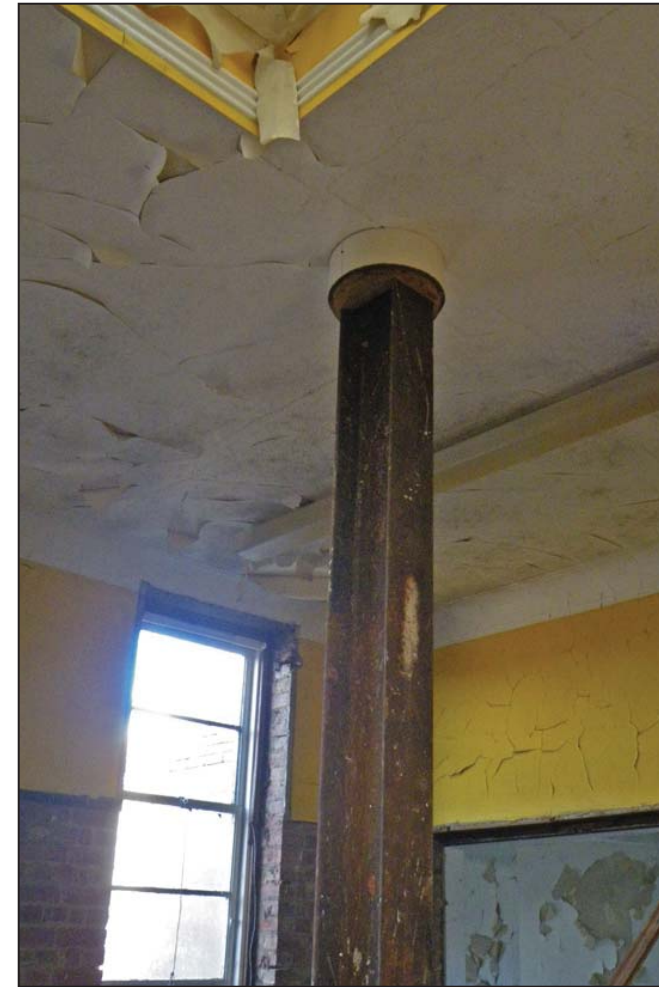
- 62 The library during stripping out
- 63 One of the stanchions in the library
- 64 Detail of the glass block skylight over the library
- 65 The western or entrance front of the Media Studies Building from Brunswick Road

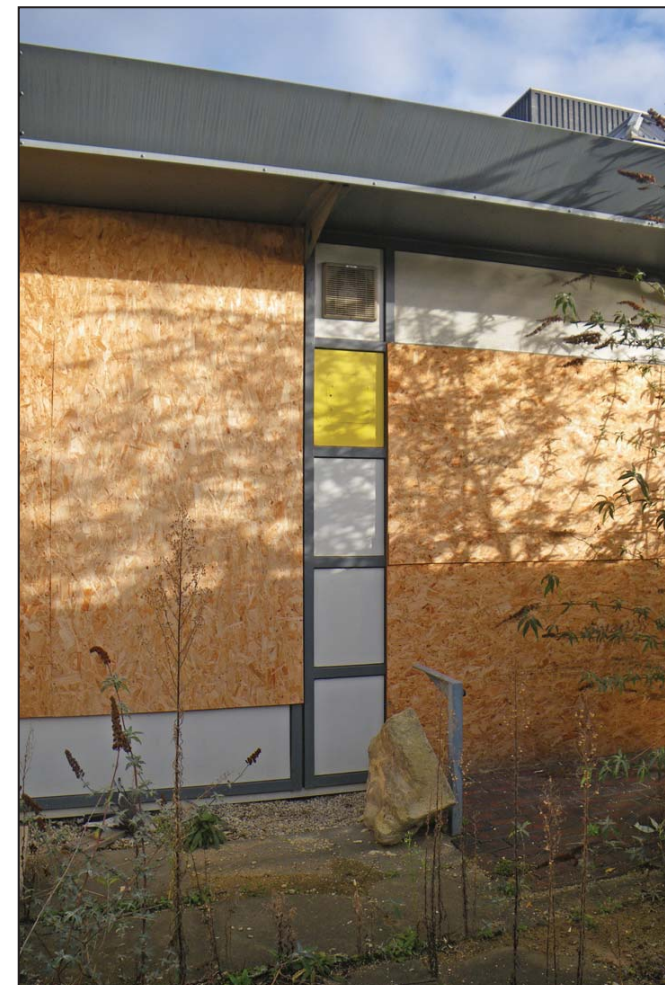
- 4.72 There is probably a *De Stijl* influence discernible in the somewhat randomly placed coloured rectangular panelling, and, as noted in the refurbishment works in the annexe to the tower block (CA 2011b) and also visible in the inserted floor in G55 (Fig. 36), a general influence of the “ocean liner look” derived from the International Style of the 20s and 30s. Unfortunately the building was heavily boarded-up on our visit, making adequate photography of the building impossible. It is not known who designed the building, but the structural studies were carried out by the Rowntree Partnership, Structural Consulting Engineers of Gloucester.

- 70 The east elevation of Block 1
- 71 The north elevation of Block 1, looking south-west
- 72 The pyramidal roofs over Block 3, looking north-east
The lift tower in the background was added in this phase
- 73 Coloured panelling in the walls of Block 3

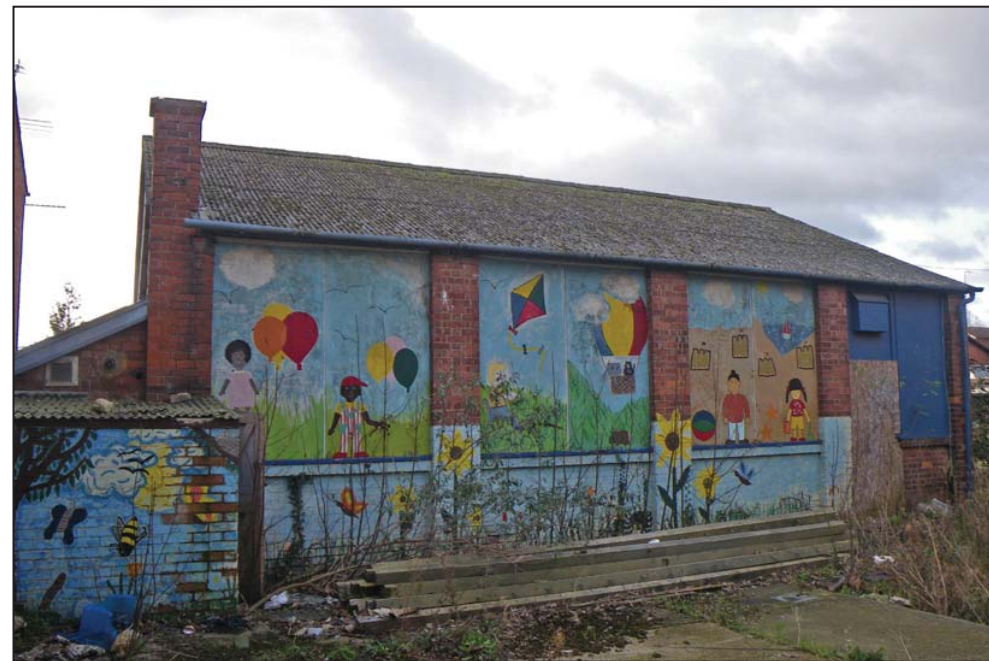
74 The north elevation of the Cromwell Street building

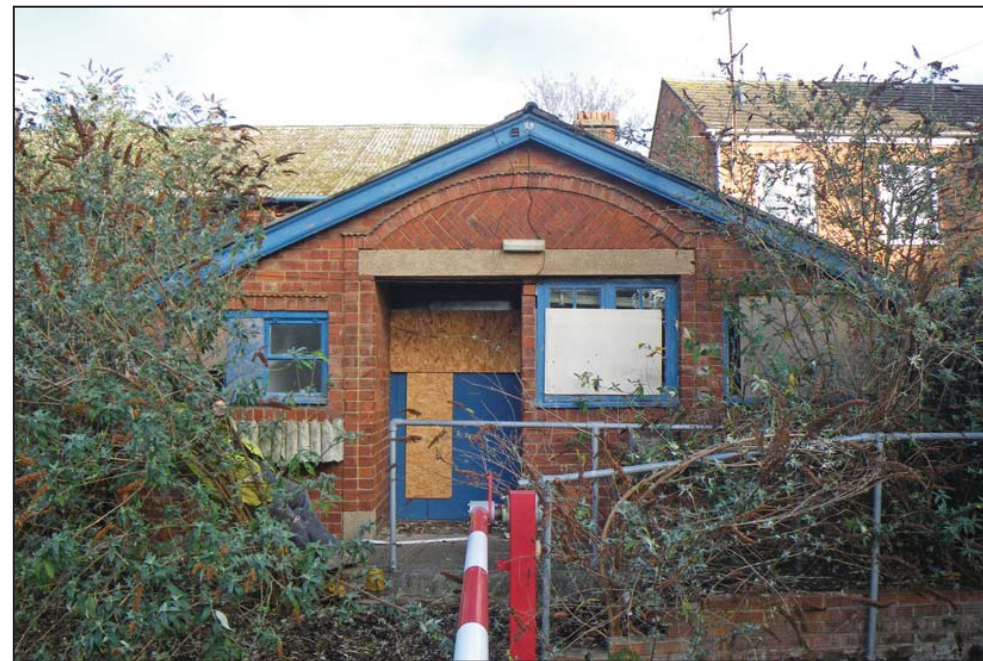
75 The south elevation of the porch of the Cromwell Street building
