**The Malthouse
Lechlade
Gloucestershire**

Archaeological Watching Brief

CA Project: 3658
CA Report: 11327

March 2012

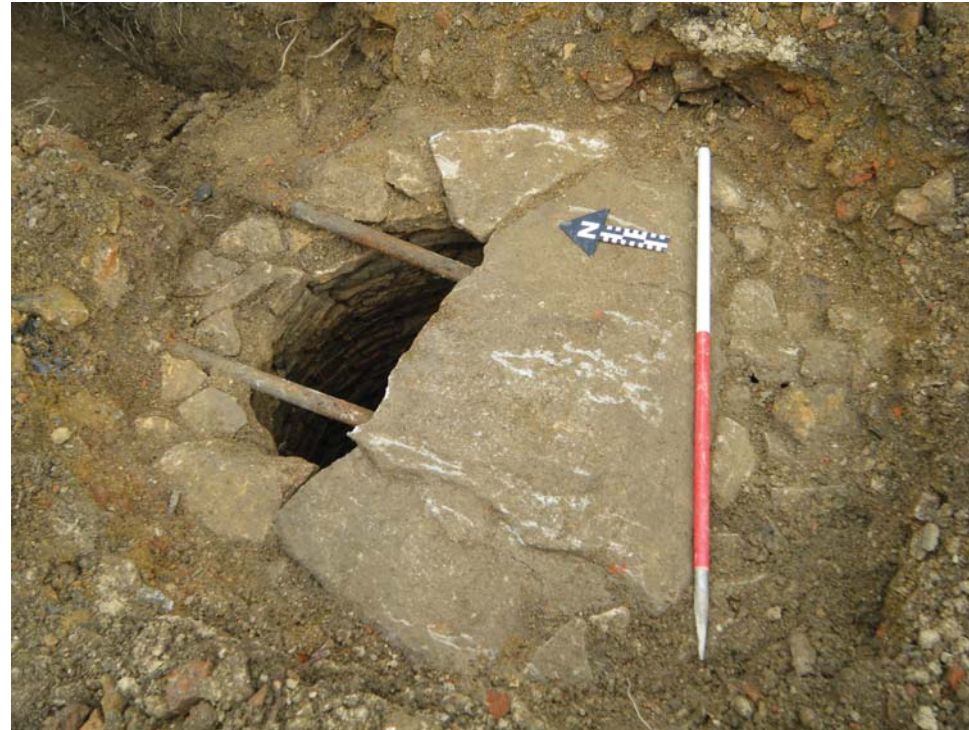
Trench 1, well 109, looking east (scale 1m)

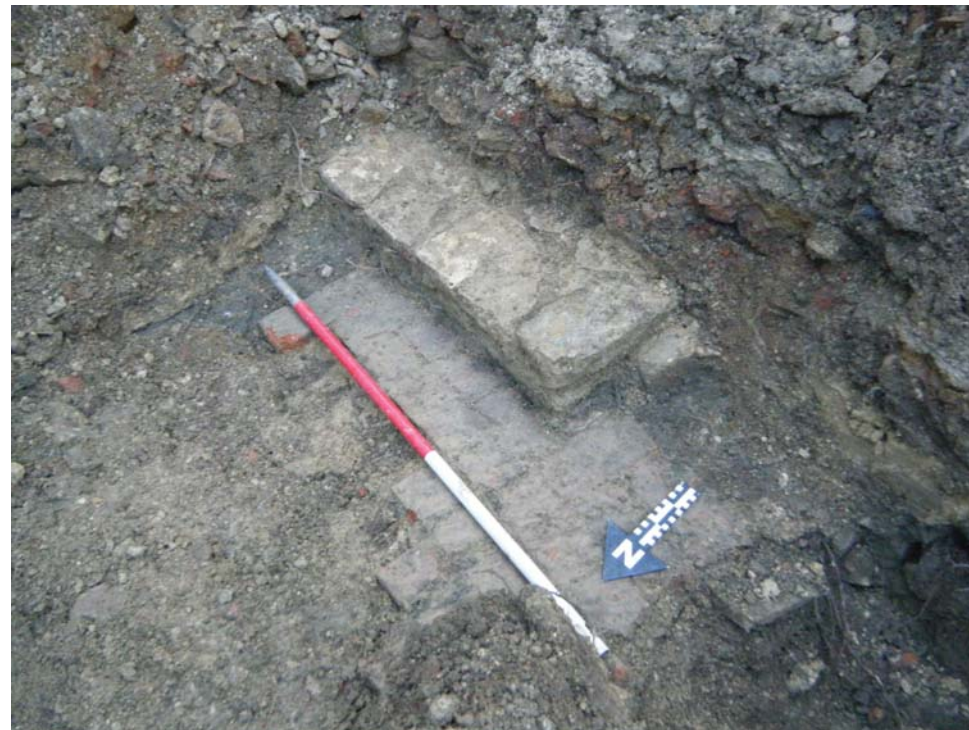
- 2.2 In the southern section of the trench east-west aligned Cotswold stone wall 110 was revealed above deposit 112. This was a continuation of a wall identified in the earlier watching brief. It extended the length of the trench from the earlier extension to the east and appeared to continue beneath the extant property boundary wall to the west. There was a gap in the wall in the middle section of the trench which is presumed to be a doorway. The wall was abutted to approximately half its height by mid brownish grey gritty silt 115. This was sealed by red brick surface 113 which survived only around the doorway of wall 110. The brick surface did not extend through the doorway and here the bricks and the wall were butted by dark grey clayey silt 116. The surface and wall were sealed by a thick layer of light yellowish brown fine silty sand 111. This deposit appeared truncated on its northern edge, probably by the construction of well 109. The well was approximately 1.7m in diameter and was constructed of Cotswold stone and red brick. The well was butted by sandy silt 107 and sealed by rubble layer 108 which contained bottles of late 19th to early 20th-century date. In the north-east corner of the trench deposit 107 was also covered by mid brown silty sand 103. This was covered by charcoal rich silt 102, which was only present in the north-east corner of the trench. This was covered by mid yellowish brown gritty silt 101. All deposits were sealed either by brick and rubble deposit 117 in the southern half of the trench or by topsoil 100 in the northern part of the trench.

Trench 1, wall 110 and surface 113, looking south-east (scale 1m)
