Allen House Ashley Down Bristol

Historic Building Investigation and Impact Assessment

CA Project: 3476 CA Report: 11150

January 2012

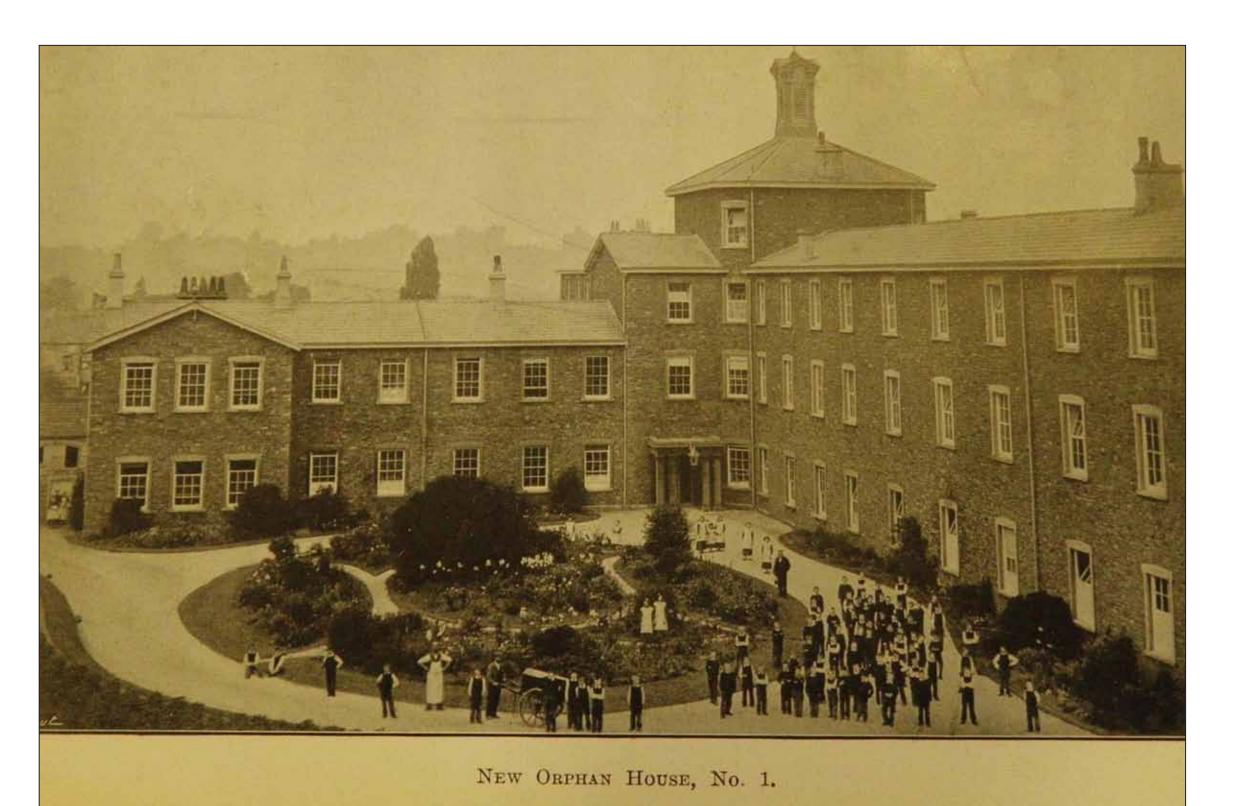
FIGURE NO. 13

South-facing historic photograph of Allen House entrance and formal gardens, looking north. c.1850s.
Photograph depicts original lantern chimneys, farm buildings and portico with lamp over

- 7.1 The details of the proposed scheme can be found in the Design and Access Statement; and the plans and elevation by AWW (drawing numbers 210A, 211A, 212A, 213A, 300A, 301A, 302A & 303A).
- In summary, it is proposed to refurbish the existing building for conversion into apartments and houses. Wings C, D and E will be removed and replaced with likefor-like new built wings. The remainder of the building will be refurbished and will retain the surviving exterior fabric where possible, including restoring original (but since lost) elements such as the lantern and weather vane. Further new build is proposed to recreate the original three enclosed playgrounds (replacing the covered sheds, Washrooms and Water Closets removed in the 1950's) and the garden at the entrance to building (Fig. 13).

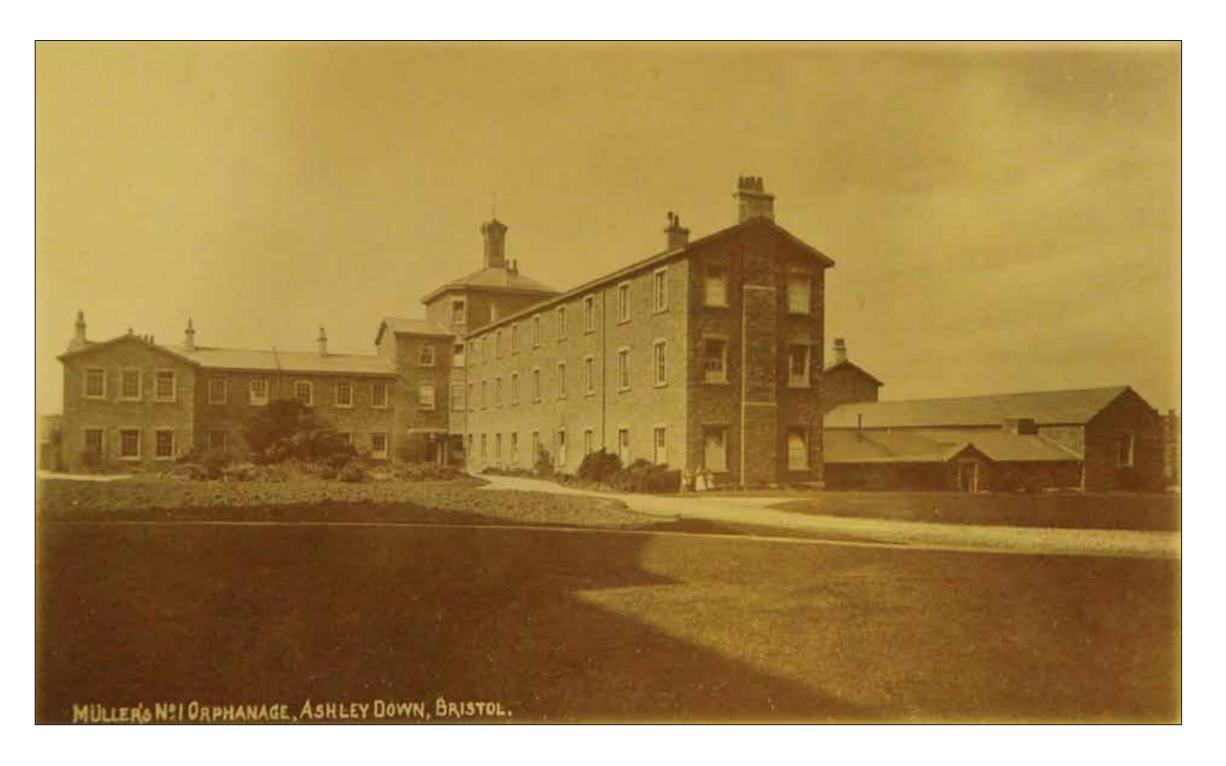
SCALE@A3
 N/A
 FIGURE NO. 14

Historic photograph of Allen House entrance and north-east wing, looking north. Photograph depicts original lantern, chimneys, roof and the north-east covered shed between Wings D and E

the centre of the cross plan, forming the centrepiece from which Wings B, E, F and G project. It has a flat roof with post-1950s concrete and metal railing additions forming a parapet. This has replaced the original roof which had a central lantern, shown on Fig. 14. The ground floor was original intended as a 'disbursement room'.

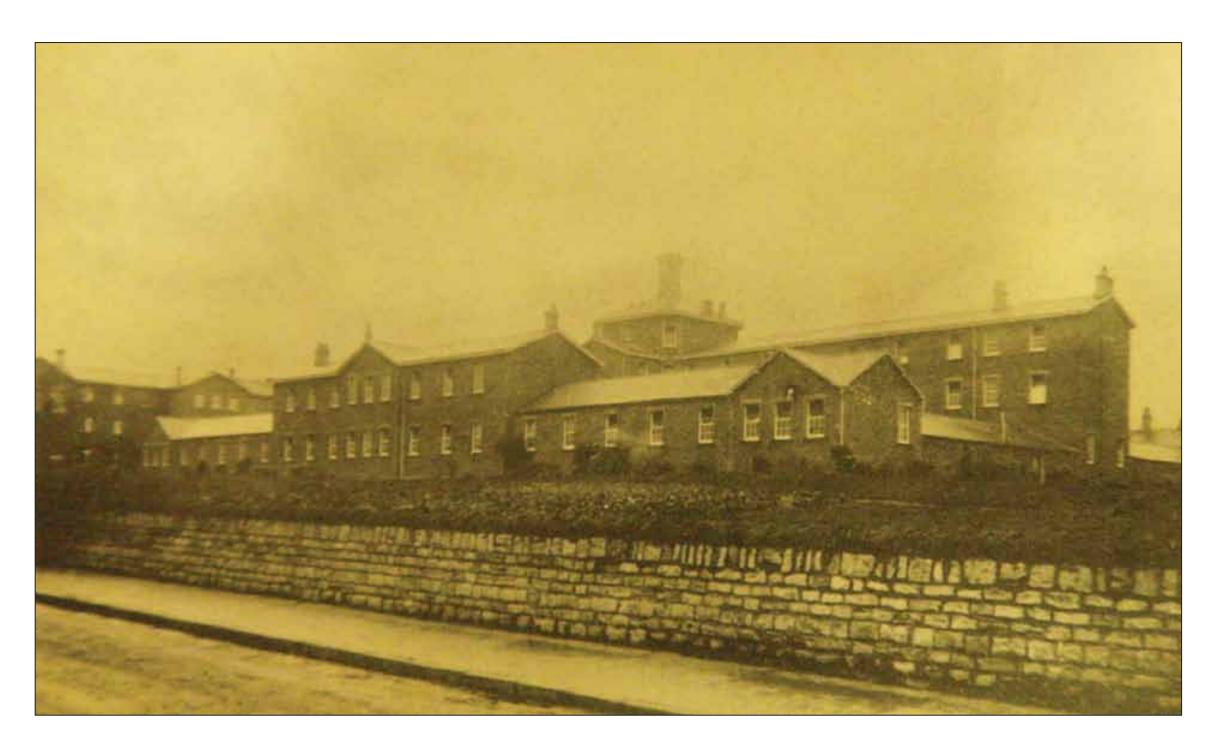
FIGURE NO. 15

Historic photograph of Allen House north-east elevation, looking south. Photograph depicts two-storey chapel on north-east elevation, single storey gabled pavilions on north and south ends, and two northerly coverd sheds See fig. 7 for elevation 4 and fig. 20 for photograph of elevation 4 (may 2011)

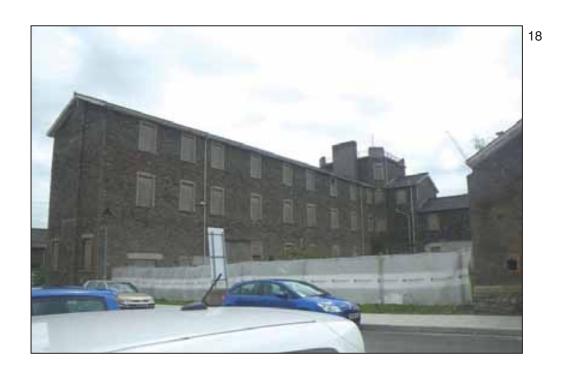
- 18 Wing B and Former Infants Playground, looking east
- 19 Wing C and Former Girls Playground, looking south-east
- 20 Wing C, north-east elevation looking south showing former chapel and side wings
- 21 Wing D, north-east elevation, south end looking west (scale 2m)

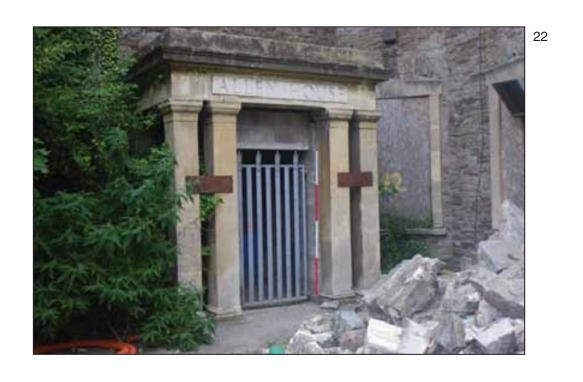
- 22 Entrance to Allen House, looking north (scale 2m). See fig 13 for original entrance
- 23 Wing B, north end of east elevation looking south. Scarring evidence of former covered shed with holes for timber purlins
- 24 Wing C, north end, west elevation looking north-east. Evidence of large timber beam, partially concealed behind later render (scale 2m)
- 25 Wing A, facing north, showing inserted steel roof (scale 2m)

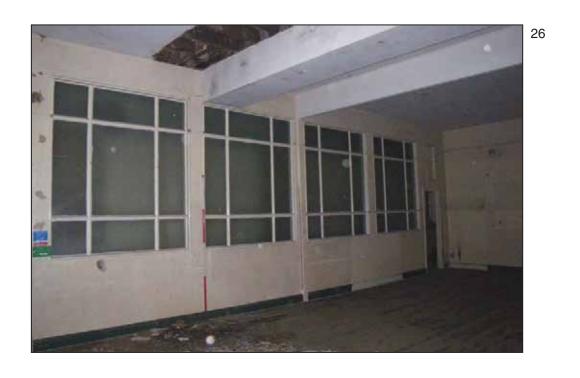
- 26 Wing G, first floor, looking north Showing a typical example of post-war inserted partition walls (scale 2m)
- 27 Wing F, main staircase leading to third floor, looking north-west. Showing original staircase and newel posts with post-war infill
- Wing B, first floor looking north.
 Showing boxed-in RSJ's supporting older beams
- 29 Wing H (central tower), third floor, looking north-east. Showing two beams supporting the lantern

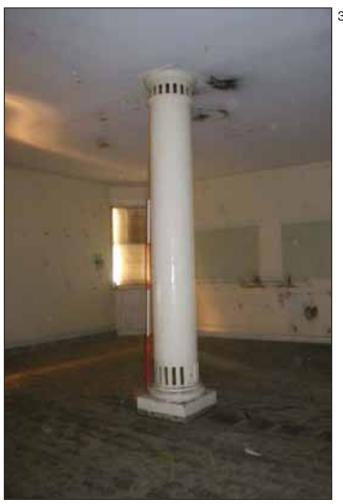
- 30 Wing H (central tower) first floor looking east. Showing detail of cast iron heating flue (scale 2m)
- 31 Wing H (central tower) ground floor looking north. Showing cast iron heating flue and boxed-in platform (scale 2m)
- 32 Historic photograph of 'Disbursement Room' (Wing H) ground floor, looking north. Showing cast iron heating flue with staff around central table, c.late 19th century
