**St Katherine and St Peter's Church  
Winterbourne Bassett  
Wiltshire**

**Archaeological Watching Brief**

CA Project: 3813  
CA Report: 12157

August 2012

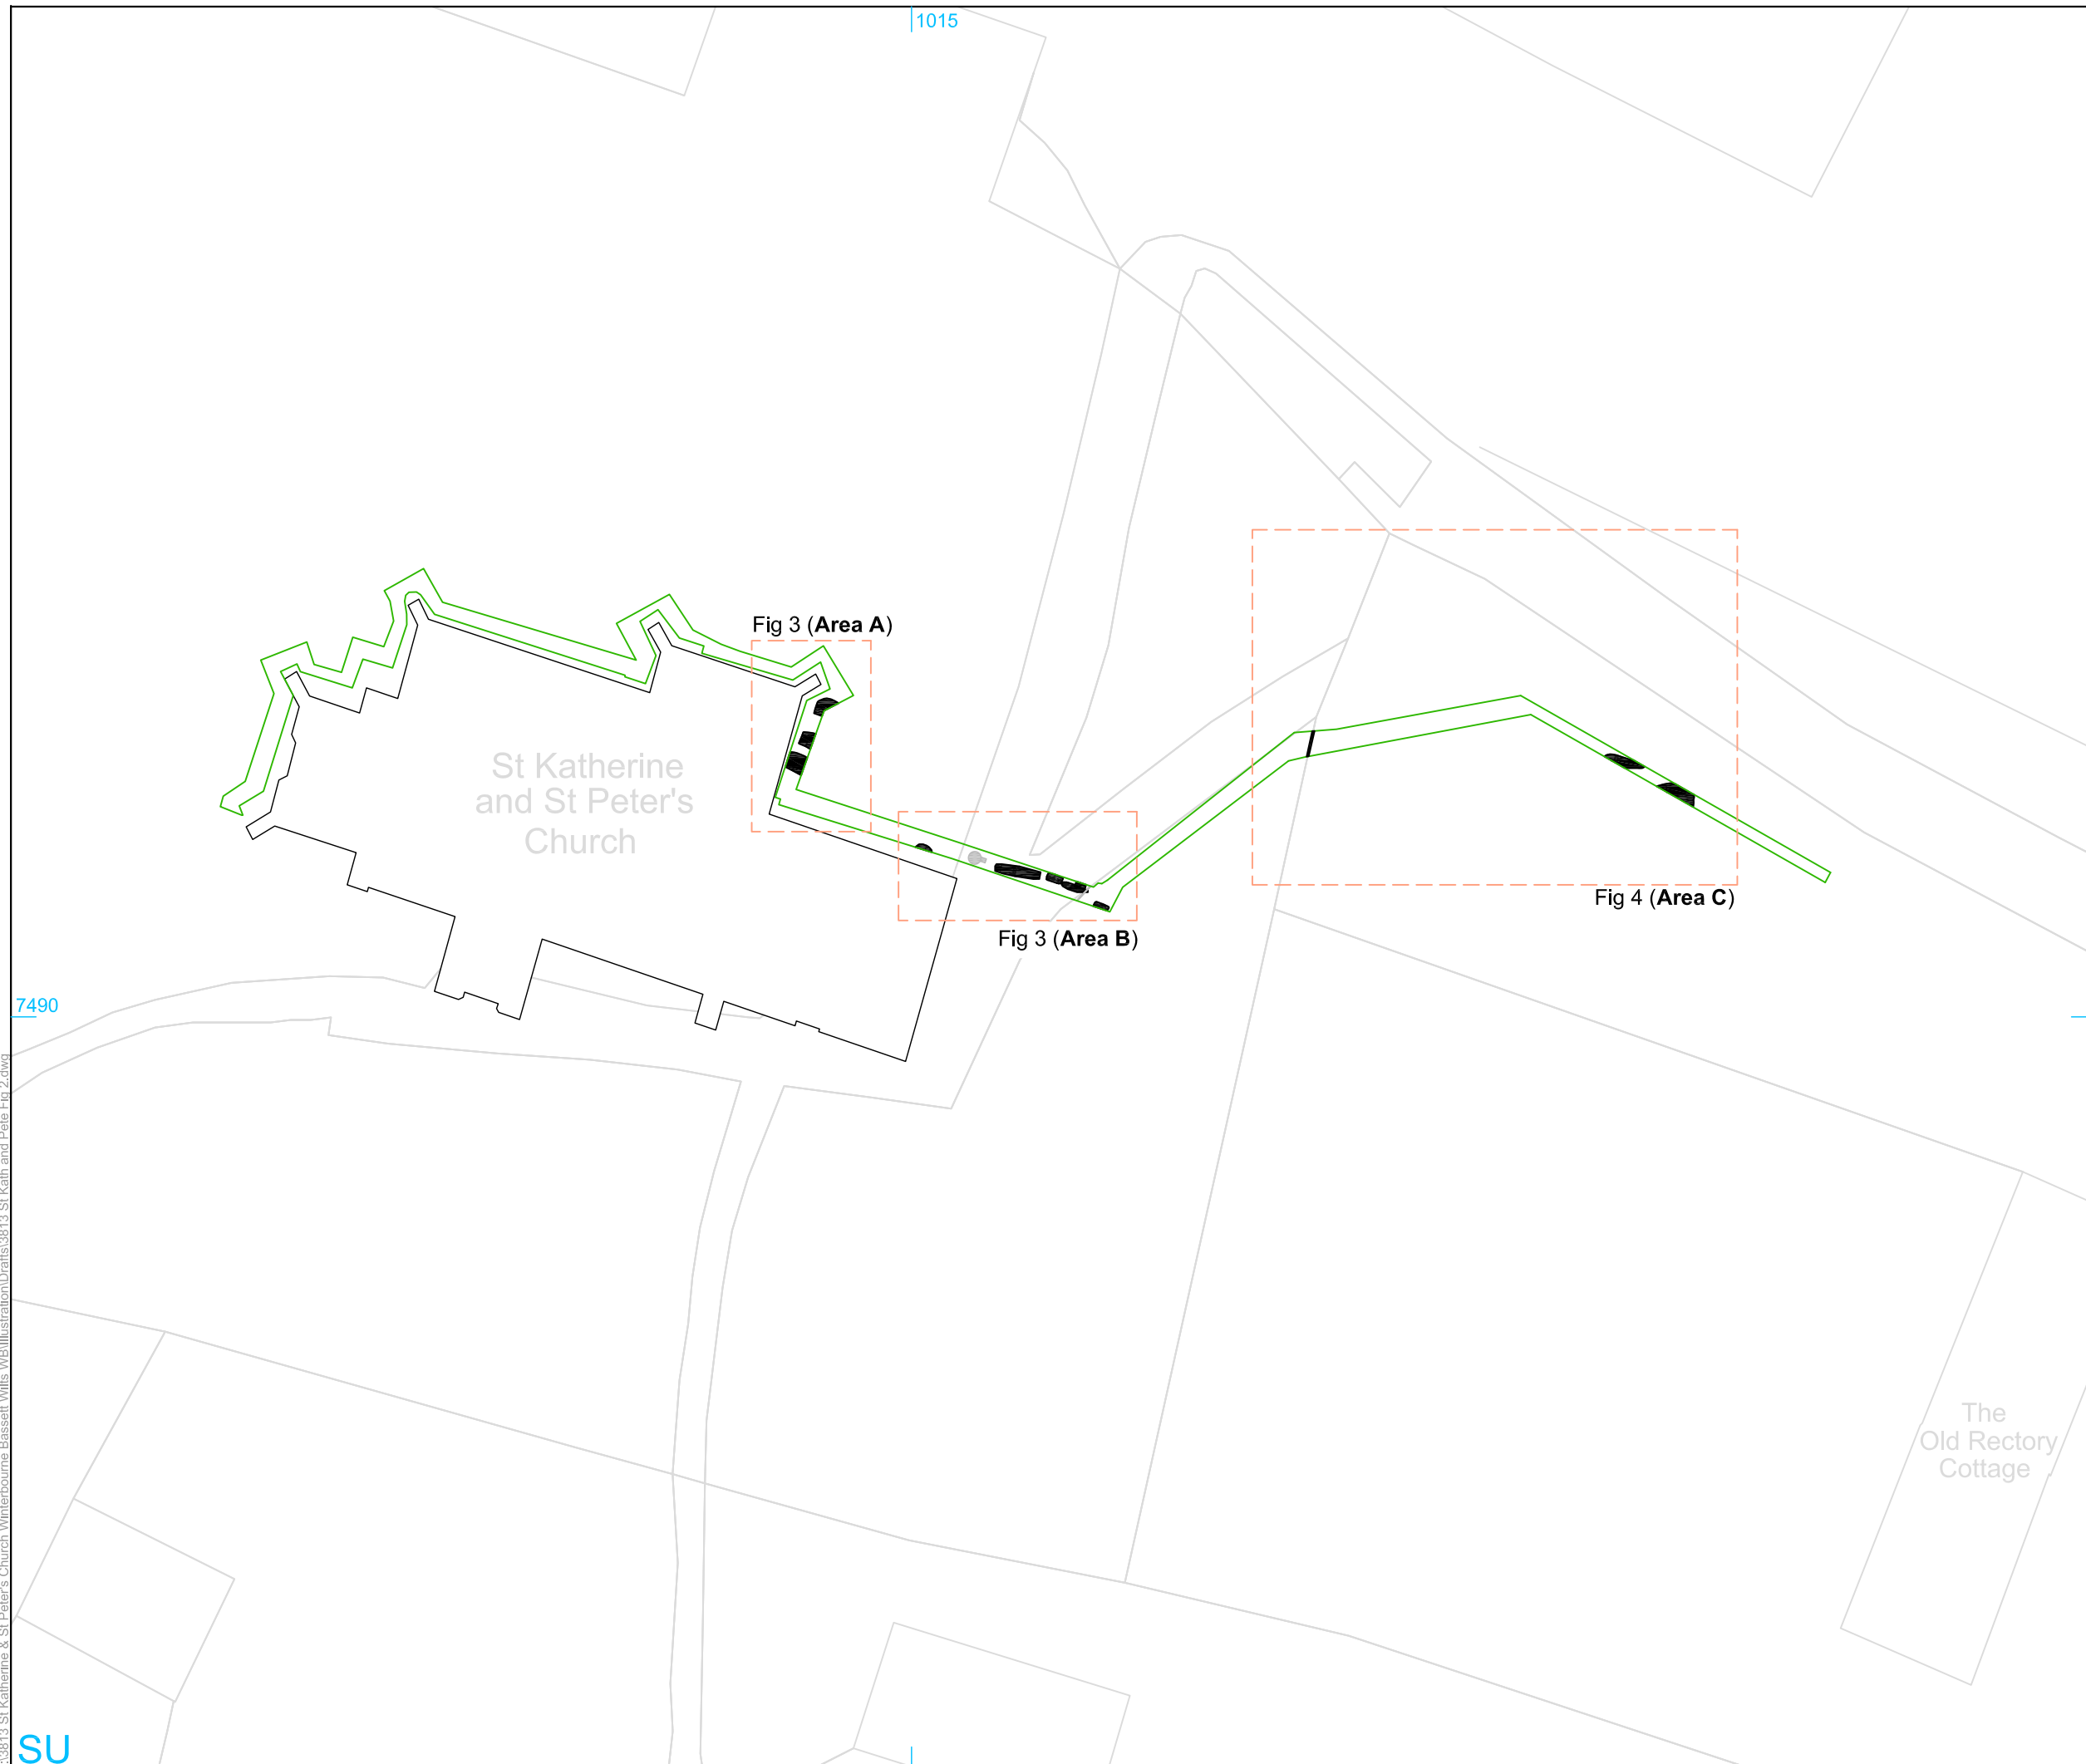
FIGURE TITLE  
**Trench location plan, showing  
archaeological features and Areas  
A to C**

- 1.4 St Katherine and St Peter's Church is located in the centre of the village of Winterbourne Bassett (Fig. 1) and the site itself comprised of the church and churchyard as well as land to the east of the churchyard. The excavations consisted of a single trench, measuring approximately 110m in length, which passed adjacent to the western and northern walls of the church, then alongside the gravel access path and under the churchyard wall. At this point the trench ran directly down towards an existing ditch.

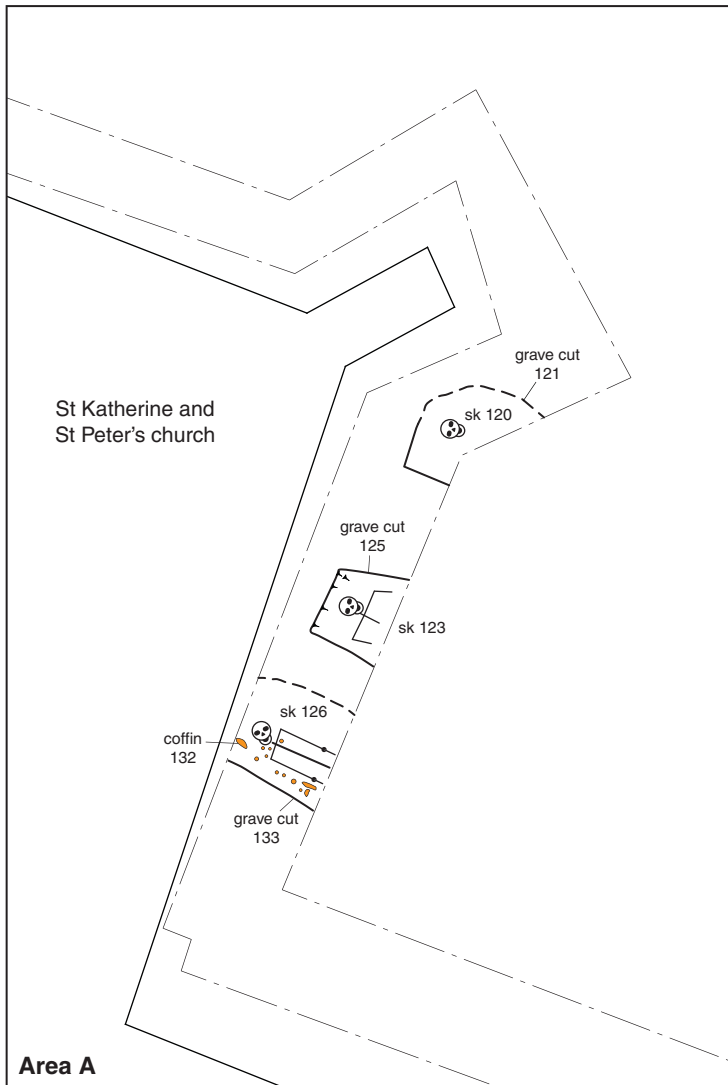
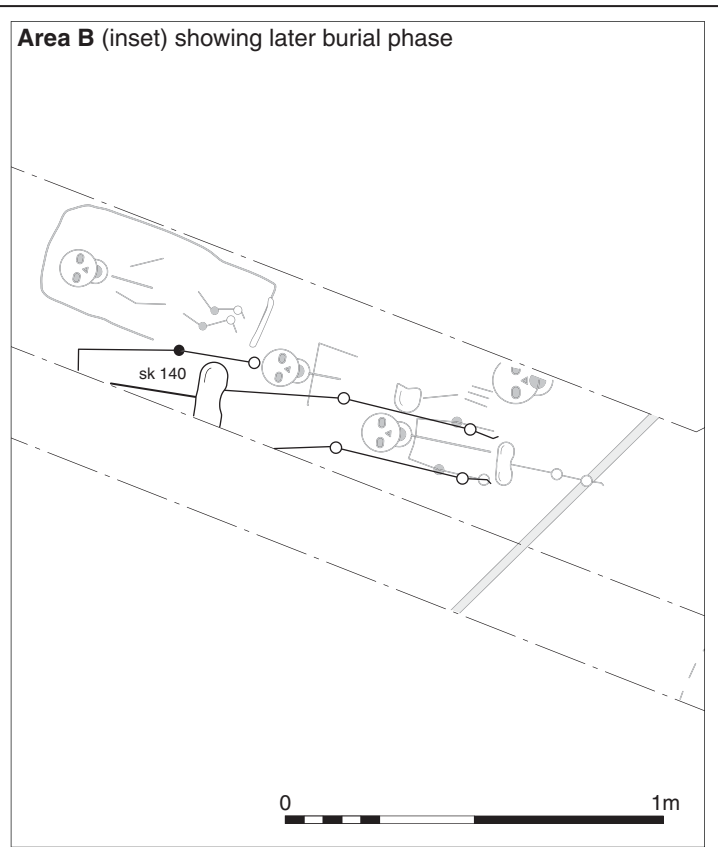
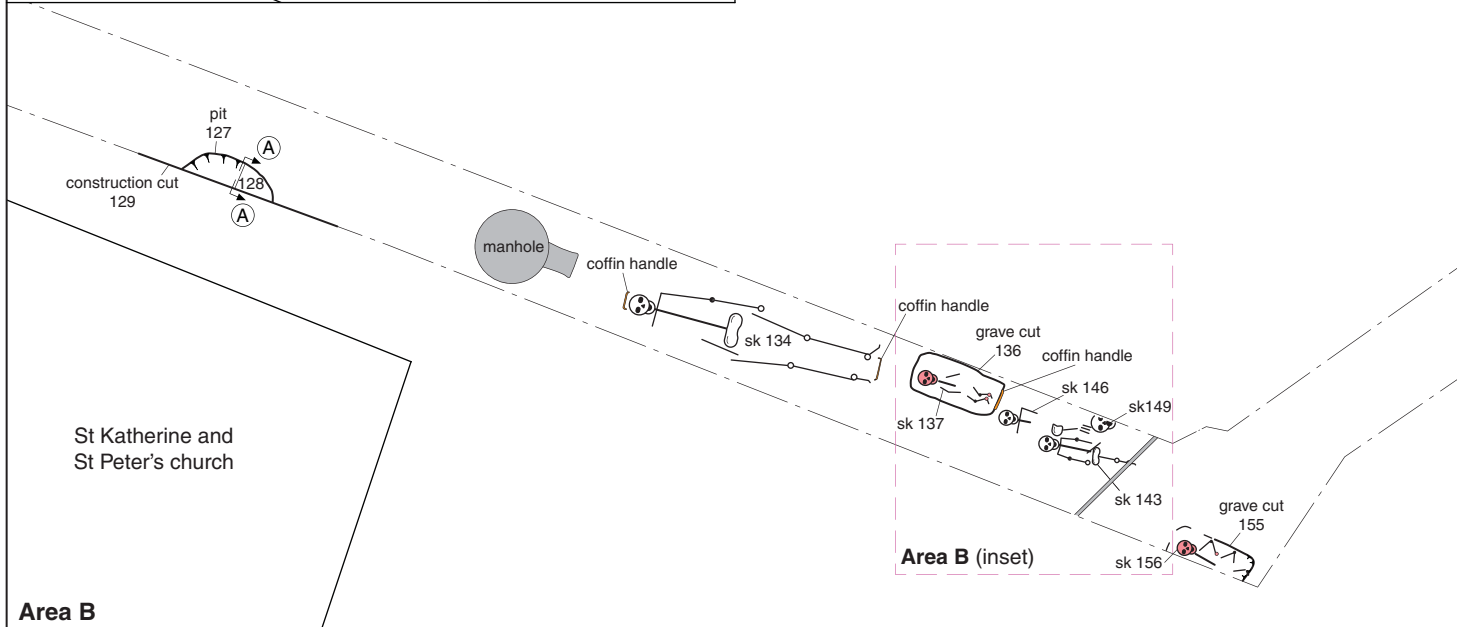
**Trench 1; plans of Areas A and B**

- 2.6 In Area A, to the east of the vestry wall, three skeletons (120, 123 and 126) were discovered within reworked grey brown clay silt graveyard soil 119. In grave cut 121

skeleton 120 comprised the skull and left shoulder of a probable adult. The grave cut and traces of coffin 122 rested at a depth of c. 0.6m bpgl. In grave cut 125 skeleton 123 comprised the skull and upper torso and arms of a probable adult male, although the right ribs and right humerus were not present. The coffin, 124, was represented by a number of iron nails and this, along with the cut, was identified at c. 0.75m bpgl. Grave cut 133 contained skeleton 126 (Fig. 5), another probable adult male was identified within coffin 132 which was represented by a number of iron nails and a possible leather cover decorated with a number of copper alloy studs. The skeleton comprised the skull, torso and upper arms, with the grave cut and coffin identified at c. 0.5m bpgl.

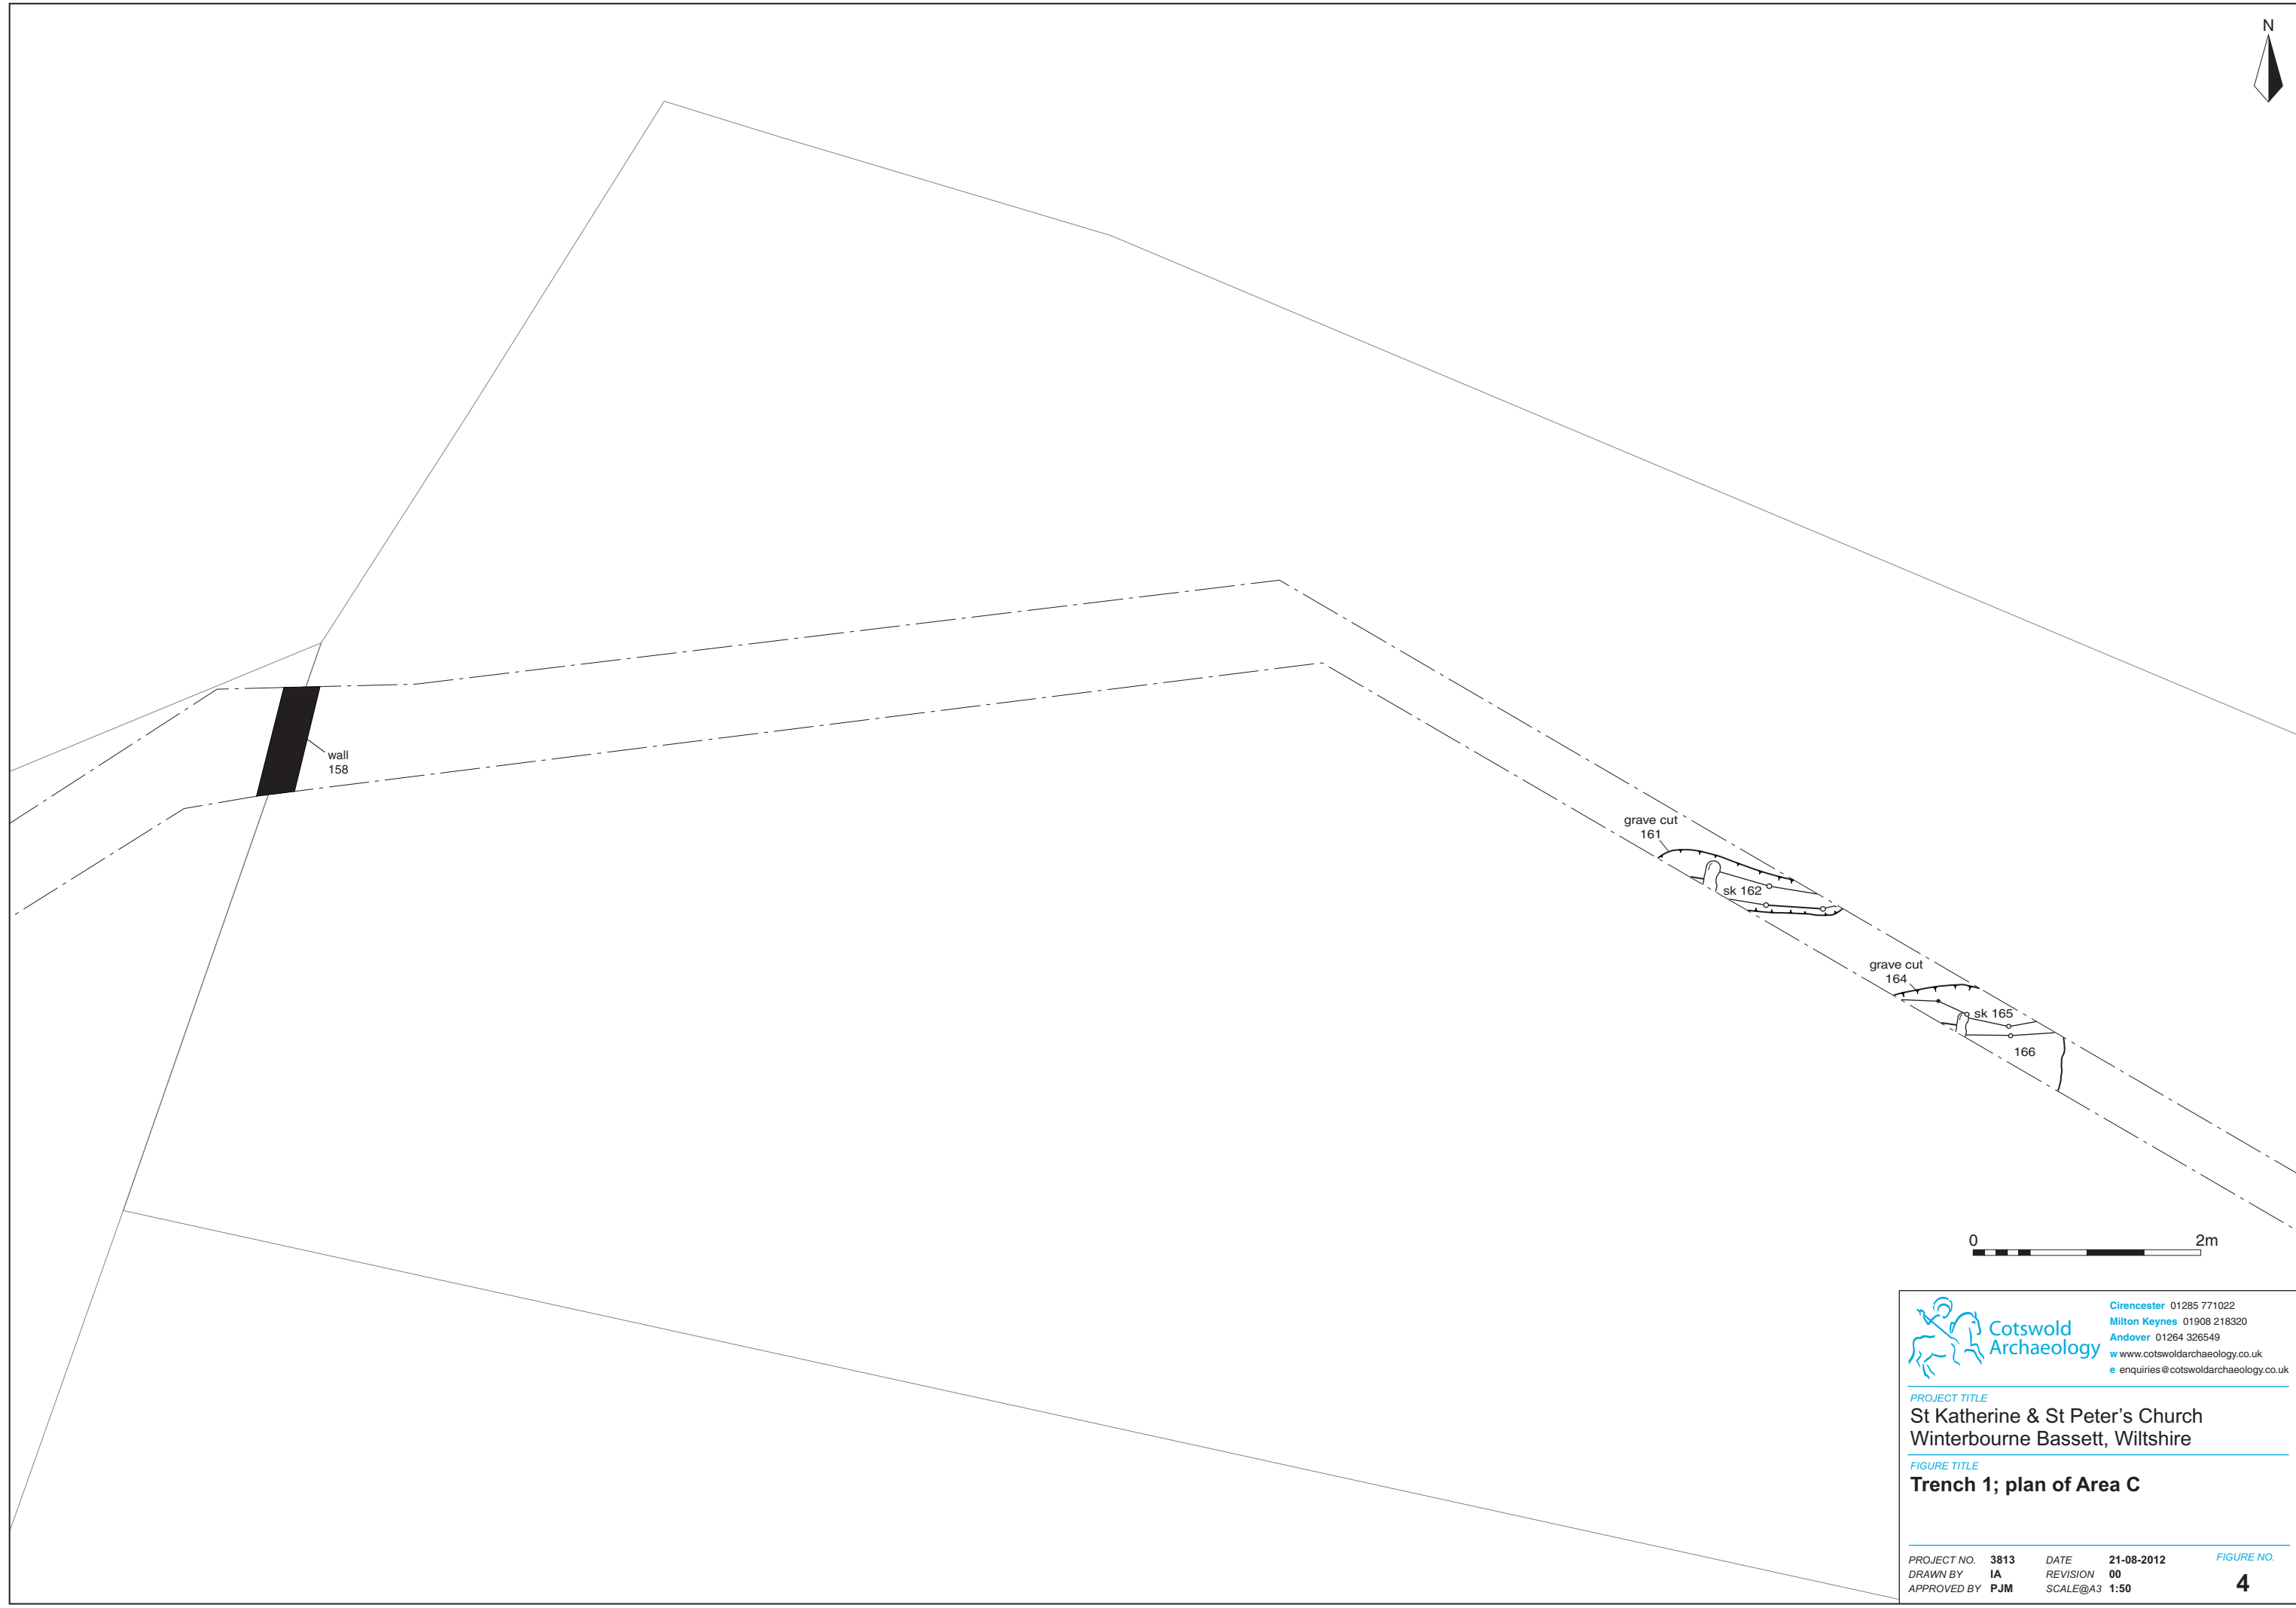
FIGURE TITLE  
**Trench 1; plan of Area C**

- 2.13 Natural geological substrate 167 was identified at a depth of c. 0.5m bpgl and was cut by two graves, 161 and 164.
- 2.14 Grave cut 161 contained the skeletal remains of a probable adult male, 162 (Fig. 8). This burial comprised the left side of the torso and pelvis along with both legs and both feet, although no left arm was present. This grave was filled by a dark brown sandy-clay deposit 163 containing numerous fragments of chalk.

- 2.15 Grave cut 164 contained possible adult female 165. The burial comprised the lower left torso, left arm and hand, pelvis and upper legs and the burial was filled by a similar deposit 166 to that in grave cut 161.

- 2.16 The fills of both grave cuts were overlain by subsoil 168 (0.25m thick) and topsoil 169 (0.15m thick). These topsoil and subsoil deposits (and subsoil 154 and topsoil 101 to the west) were truncated by construction cut 160 which was c. 0.5m in depth and 1m in width and contained the footing of churchyard wall 158. The wall consisted of closely mortar-bonded and regularly coursed red bricks with a capping

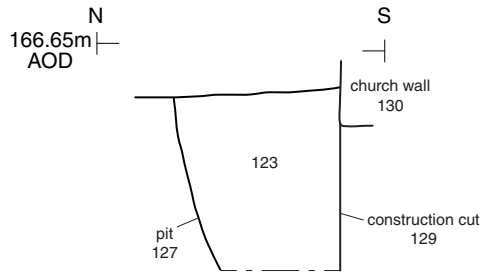
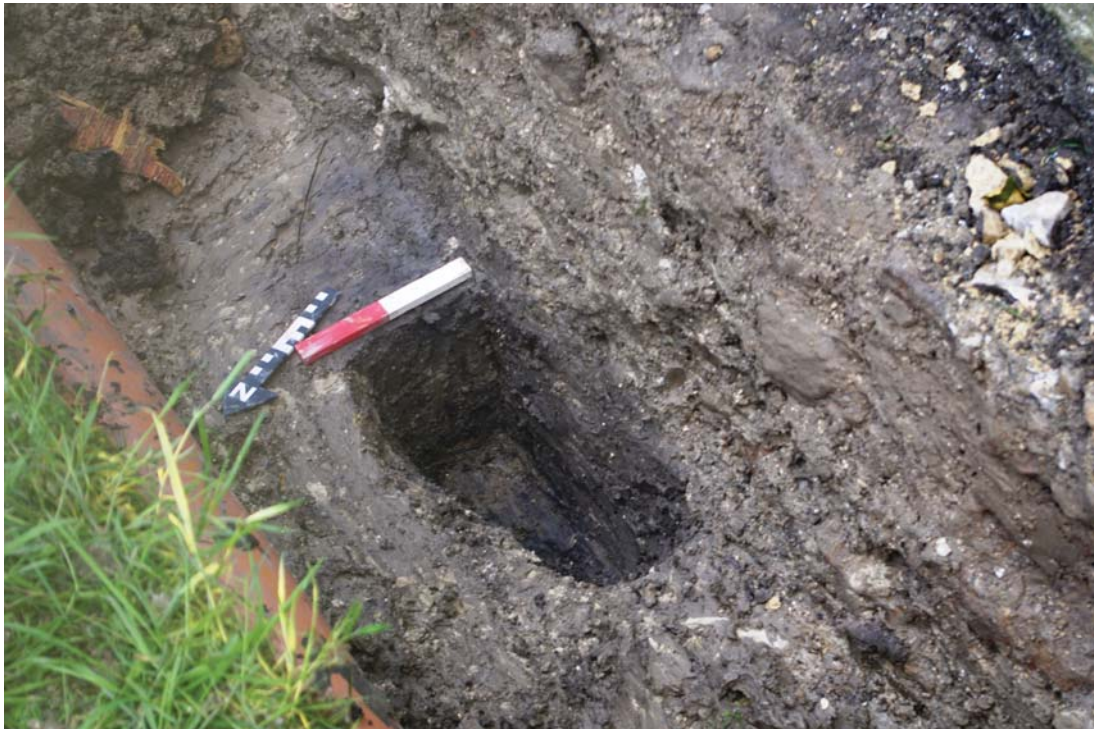
**Pit 127; section and photograph**

- 2.7 Immediately to the north-east of the north chancel wall deposit 131 was cut by a small steep-sided sub-circular pit 127 (Fig. 4), c. 0.5m below present ground level (bpgl). This pit contained fragments of 11th or 12th-century pottery within the dark grey brown silty clay fill 128. The fill was truncated by the cut, 129, for the church wall foundations 130 which, along with the tower wall 100, were subsequently abutted by the various graveyard soils and other deposits outlined above.

Pit 127, looking south (scale 0.2m)

- 3.2 Firstly, the oldest feature discovered during the watching brief was the small medieval pit 127, located under the north wall of the chancel in Area B. The fragments of 11th or 12th-century pottery taken from the fill of this pit suggest that it pre-dates the construction of the chancel in the mid-13th century and is likely to be a refuse pit possibly relating to an earlier phase of church building on the site.

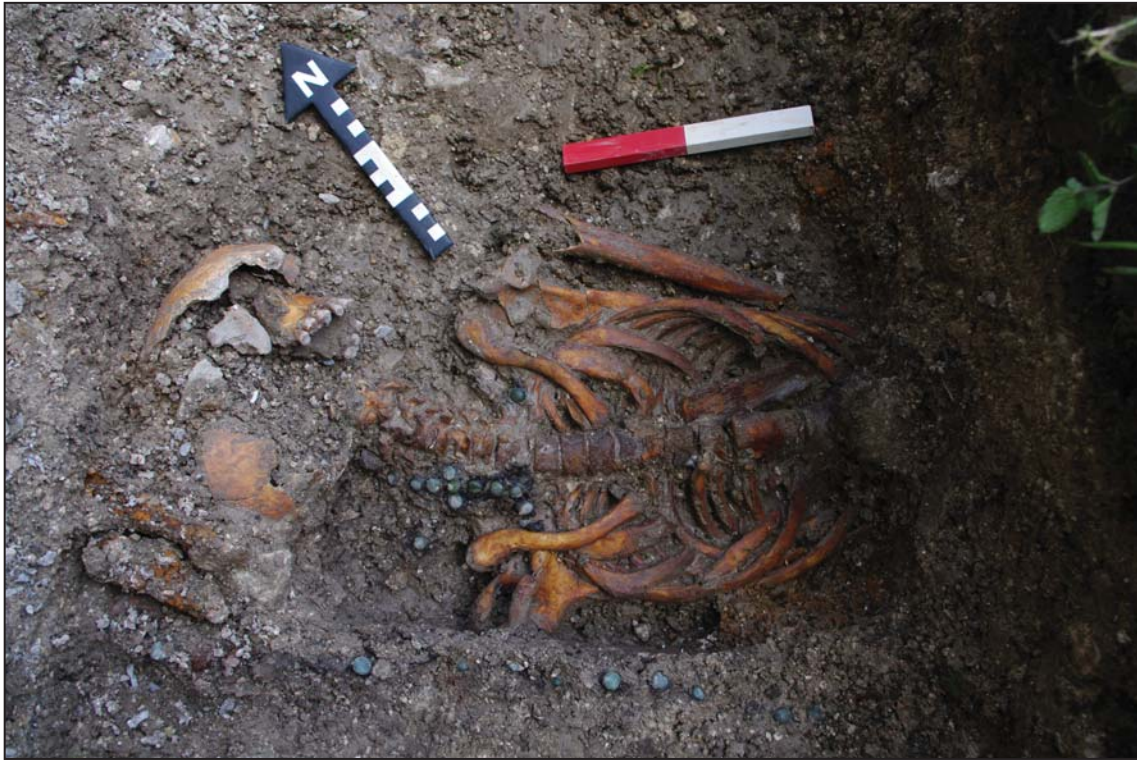
6

6. Photograph; sk 126 and detail of copper alloy studding (scale 0.2m)

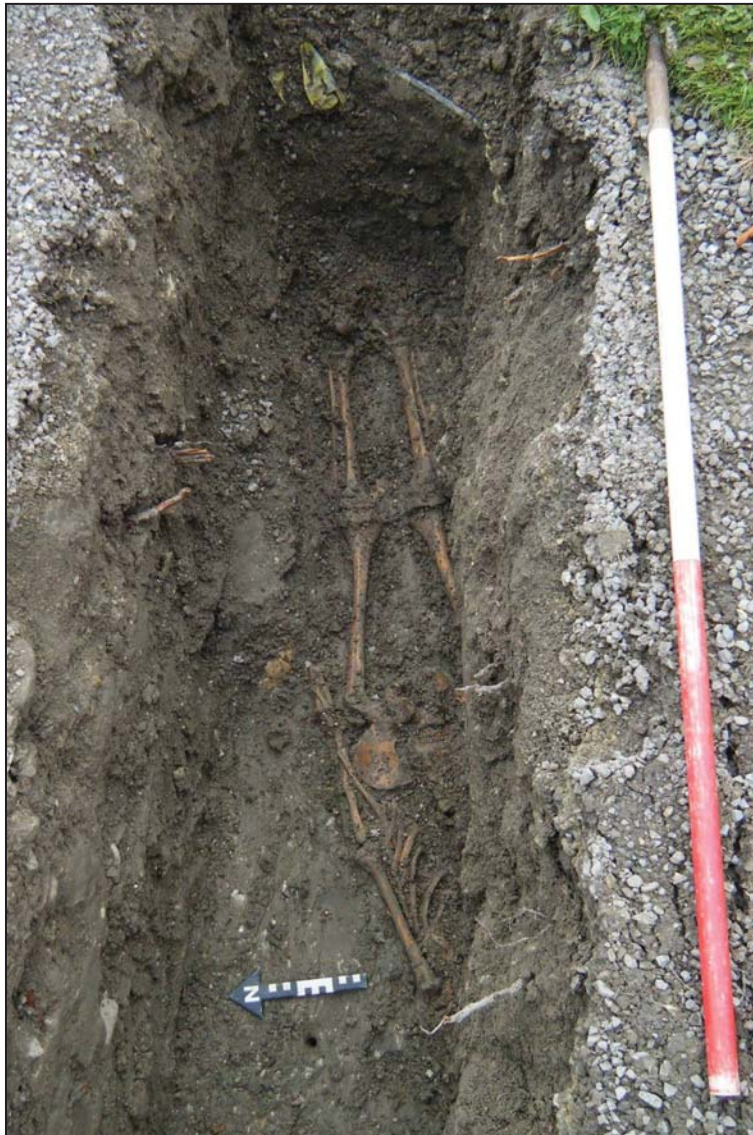
8

- 2.10 Above these burials, at a depth of c. 0.7m bpgl, lay skeleton 140, a probable young adult (Fig. 7). This burial was represented by the majority of the entire skeleton but the skull and right arm extended beyond the southern edge of the trench. The grave cut 139 was only visible as a trace in section.

**8. Photograph; sk 140, looking east (scale 1m)**

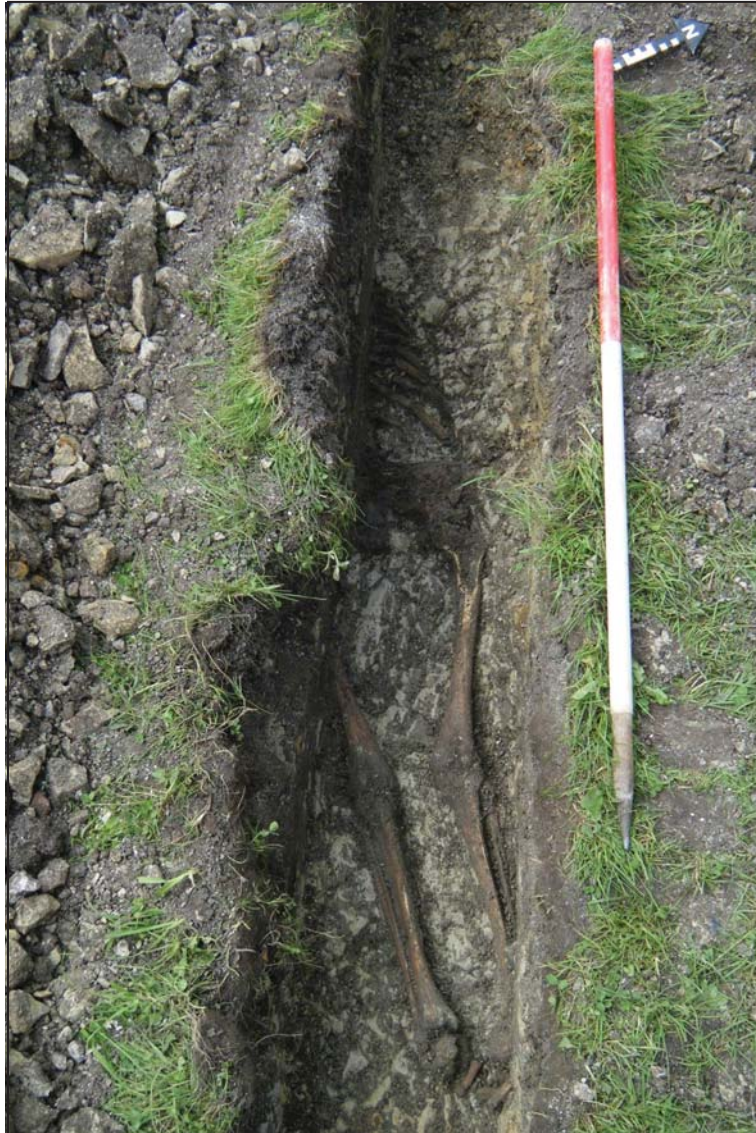
9

**9. Photograph; sk 162, looking west (scale 1m)**

- 3.5 The two burials discovered outside of the churchyard, in Area C, are harder to place chronologically, with two main possibilities. Firstly, with the current boundary erected in the mid-18th century, these burials could represent an earlier extent of the churchyard and thus could date from the 1750s or earlier. Secondly, these burials could represent 'non-conformist' graves, perhaps of criminals, suicides or the very poor who would not have been permitted or could not afford to be buried within the churchyard itself. The shallow character of these graves and the likely shrouded nature of both inhumations supports the second possibility, although without further analysis of the area a definite conclusion is difficult to draw.
