**St Andrew's Church
Blunsdon St Andrew
Swindon**

Archaeological Watching Brief

CA Project: 4057
CA Report: 12359

November 2012

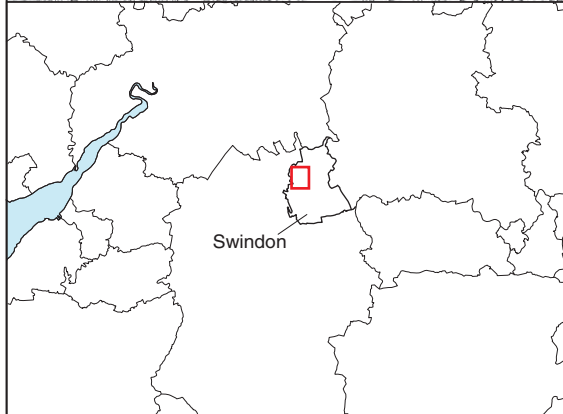
FIGURE TITLE
 The site showing the location of groundworks

- 1.6 The fieldwork followed the methodology set out within the WSI (CA 2012). An archaeologist was present during all intrusive groundworks within the churchyard comprising the excavation of a 0.3m wide trench prior to the installation of a service water pipe (Fig. 2).
- 1.7 Written, graphic and photographic records were compiled in accordance with CA Technical Manual 1: *Fieldwork Recording Manual* (2007).
- 1.8 The archive from the evaluation is currently held by CA at their offices in Kemble and will be deposited with Swindon Museum. A summary of information from this project, set out within Appendix B, will be entered onto the OASIS online database of archaeological projects in Britain.

modern disturbance
104

water pipe trench
-

- 2.1 The natural geological substrate 106, consisting of light yellow clay and limestone, was revealed at an average depth of 0.45m below present ground level. This was overlain by a subsoil, 105, averaging 0.27m in thickness and containing occasional disarticulated human bone, which was in turn sealed by 0.18m of topsoil, 100. To the east, the trench partially ran through the church footpath and revealed that the footpath consists of 0.1m of gravel surface sealing 0.15m of compacted made ground, which slightly truncated the subsoil. At the southern end of the trench an area of modern disturbance 104 was identified, probably associated with the installation of a ceramic drainage pipe. Due to its modern date no artefactual material has been retained; disarticulated human bone was immediately reinterred on site, in accordance with provisions made within the WSI.

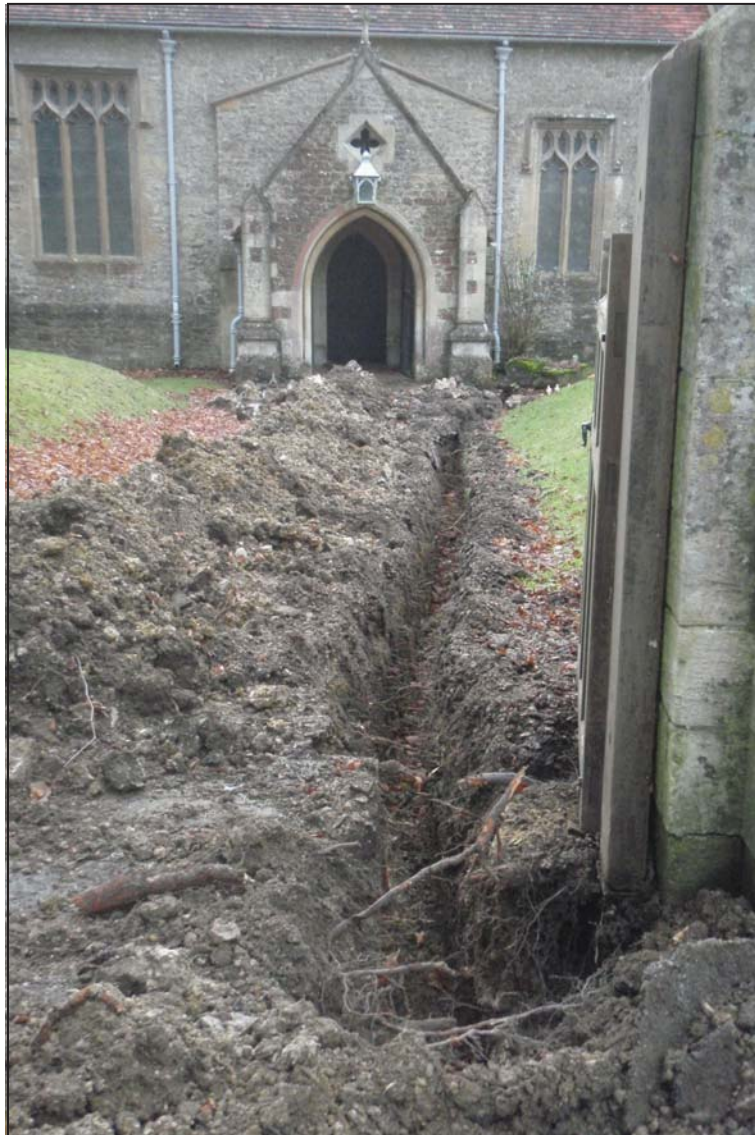
3 View of the excavated trench, looking south
