India House
227 Barton Street
Gloucester
Gloucestershire

Historic Building Recording

CA Project: 4070
CA Report: 12382

December 2012

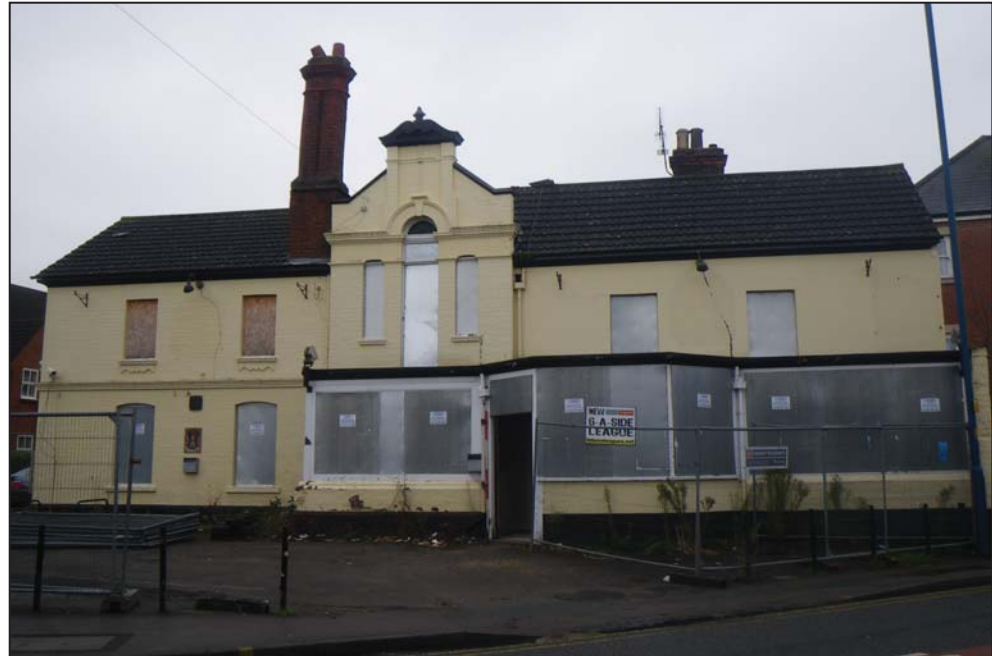
- 3 The west facing elevation. Scale 2m
- 4 The north gable end of the main range. Scale 2m
- 5 The south end of the west elevation. Scale 2m
- 6 The south gable end elevation. Scale 2m

- 4.4 India House is a brick building two storeys high, with a relatively shallow-pitched roof ending in a plain unverged gable at the south. The bricks in the northern part are machine-made but not obviously pressed and are 8³/₄" x 4" x 3" (222.3mm x 102mm x 76.2mm). They are laid in English bond. The roof covering is modern concrete tiles. The northern gable is also unverged but has a moulded brick or terracotta cornice under the eaves, returning at each end to form an open, pediment-like feature (Fig. 4). The eaves on the west elevation have similar cornicings which seem to be of similar material but are heavily painted (Fig. 3).

- 4.5 They are interrupted by a gabled central feature or frontispiece (Figs 3 and 7). This is the most elaborately treated part of the elevation. The ground floor is masked by the bay window extension (of uncertain date, but probably 1920s or 30s, see below), but the first floor has a triumphal arch motif of a central, arched doorway flanked by two windows which have the shallowest of arched heads. None of the openings have any mouldings on the jambs. The architrave of an implied entablature is just cut by these side windows and the central door rises through the blank frieze and the heavily moulded brick cornice which acts as the impost for the central arch (Fig. 7).

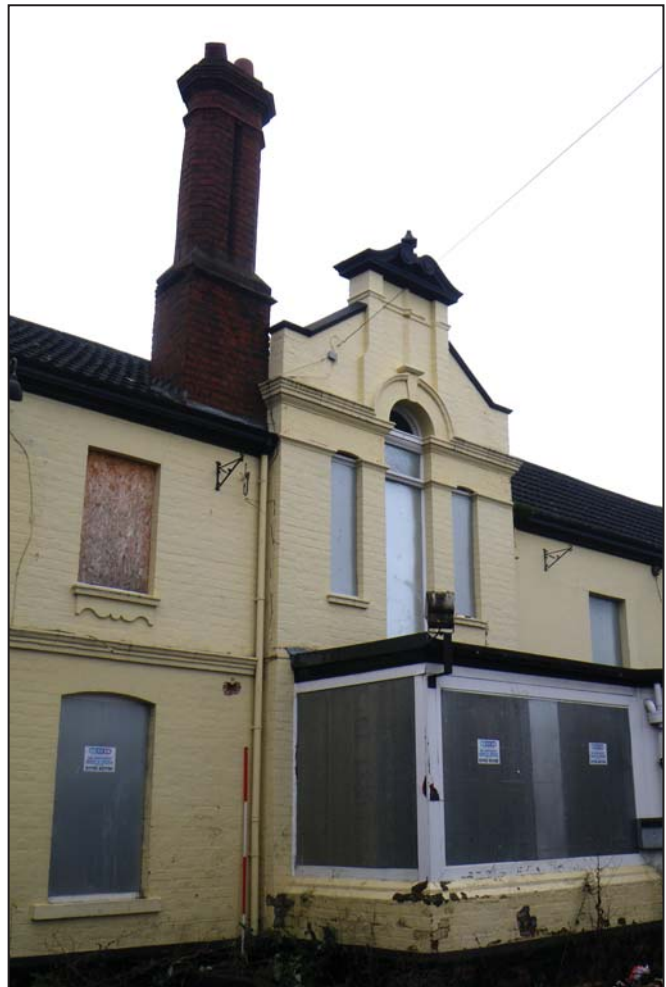
- 7 The central feature or frontispiece, on the west elevation, looking south-east. Scale 2m
- 8 The northern end of the western elevation. Scale 2m
- 9 The junction of the central bay window with the west elevation frontispiece, looking south-east. Scale 2m
- 10 The street elevation of the skittle alley, looking south-east

- 4.7 Competing for attention with the frontispiece is a Tudor-style chimney (Fig. 7). Two notionally octagonal stacks rise out of a rectangular brick base on the front plane of the west façade (but die into each other so that they are not full octagons in plan) and support a shared, elongated octagon cornice in elaborately moulded brick. The transition from the base to the double octagon is made by a shaped monolithic stone base (or perhaps it is more likely that it is cast in a patent artificial stone or terracotta).

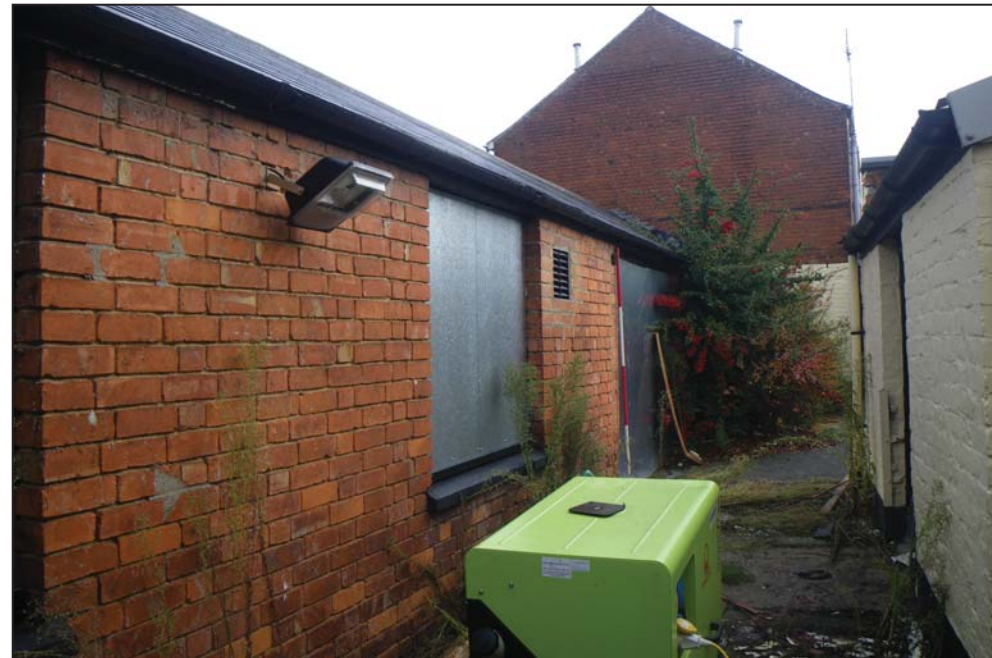
- 11 The south, yard, elevation of the skittle alley, looking east
- 12 The skittle alley chimney, looking south-south-east
- 13 The east side of the north end of the west or main range, looking west

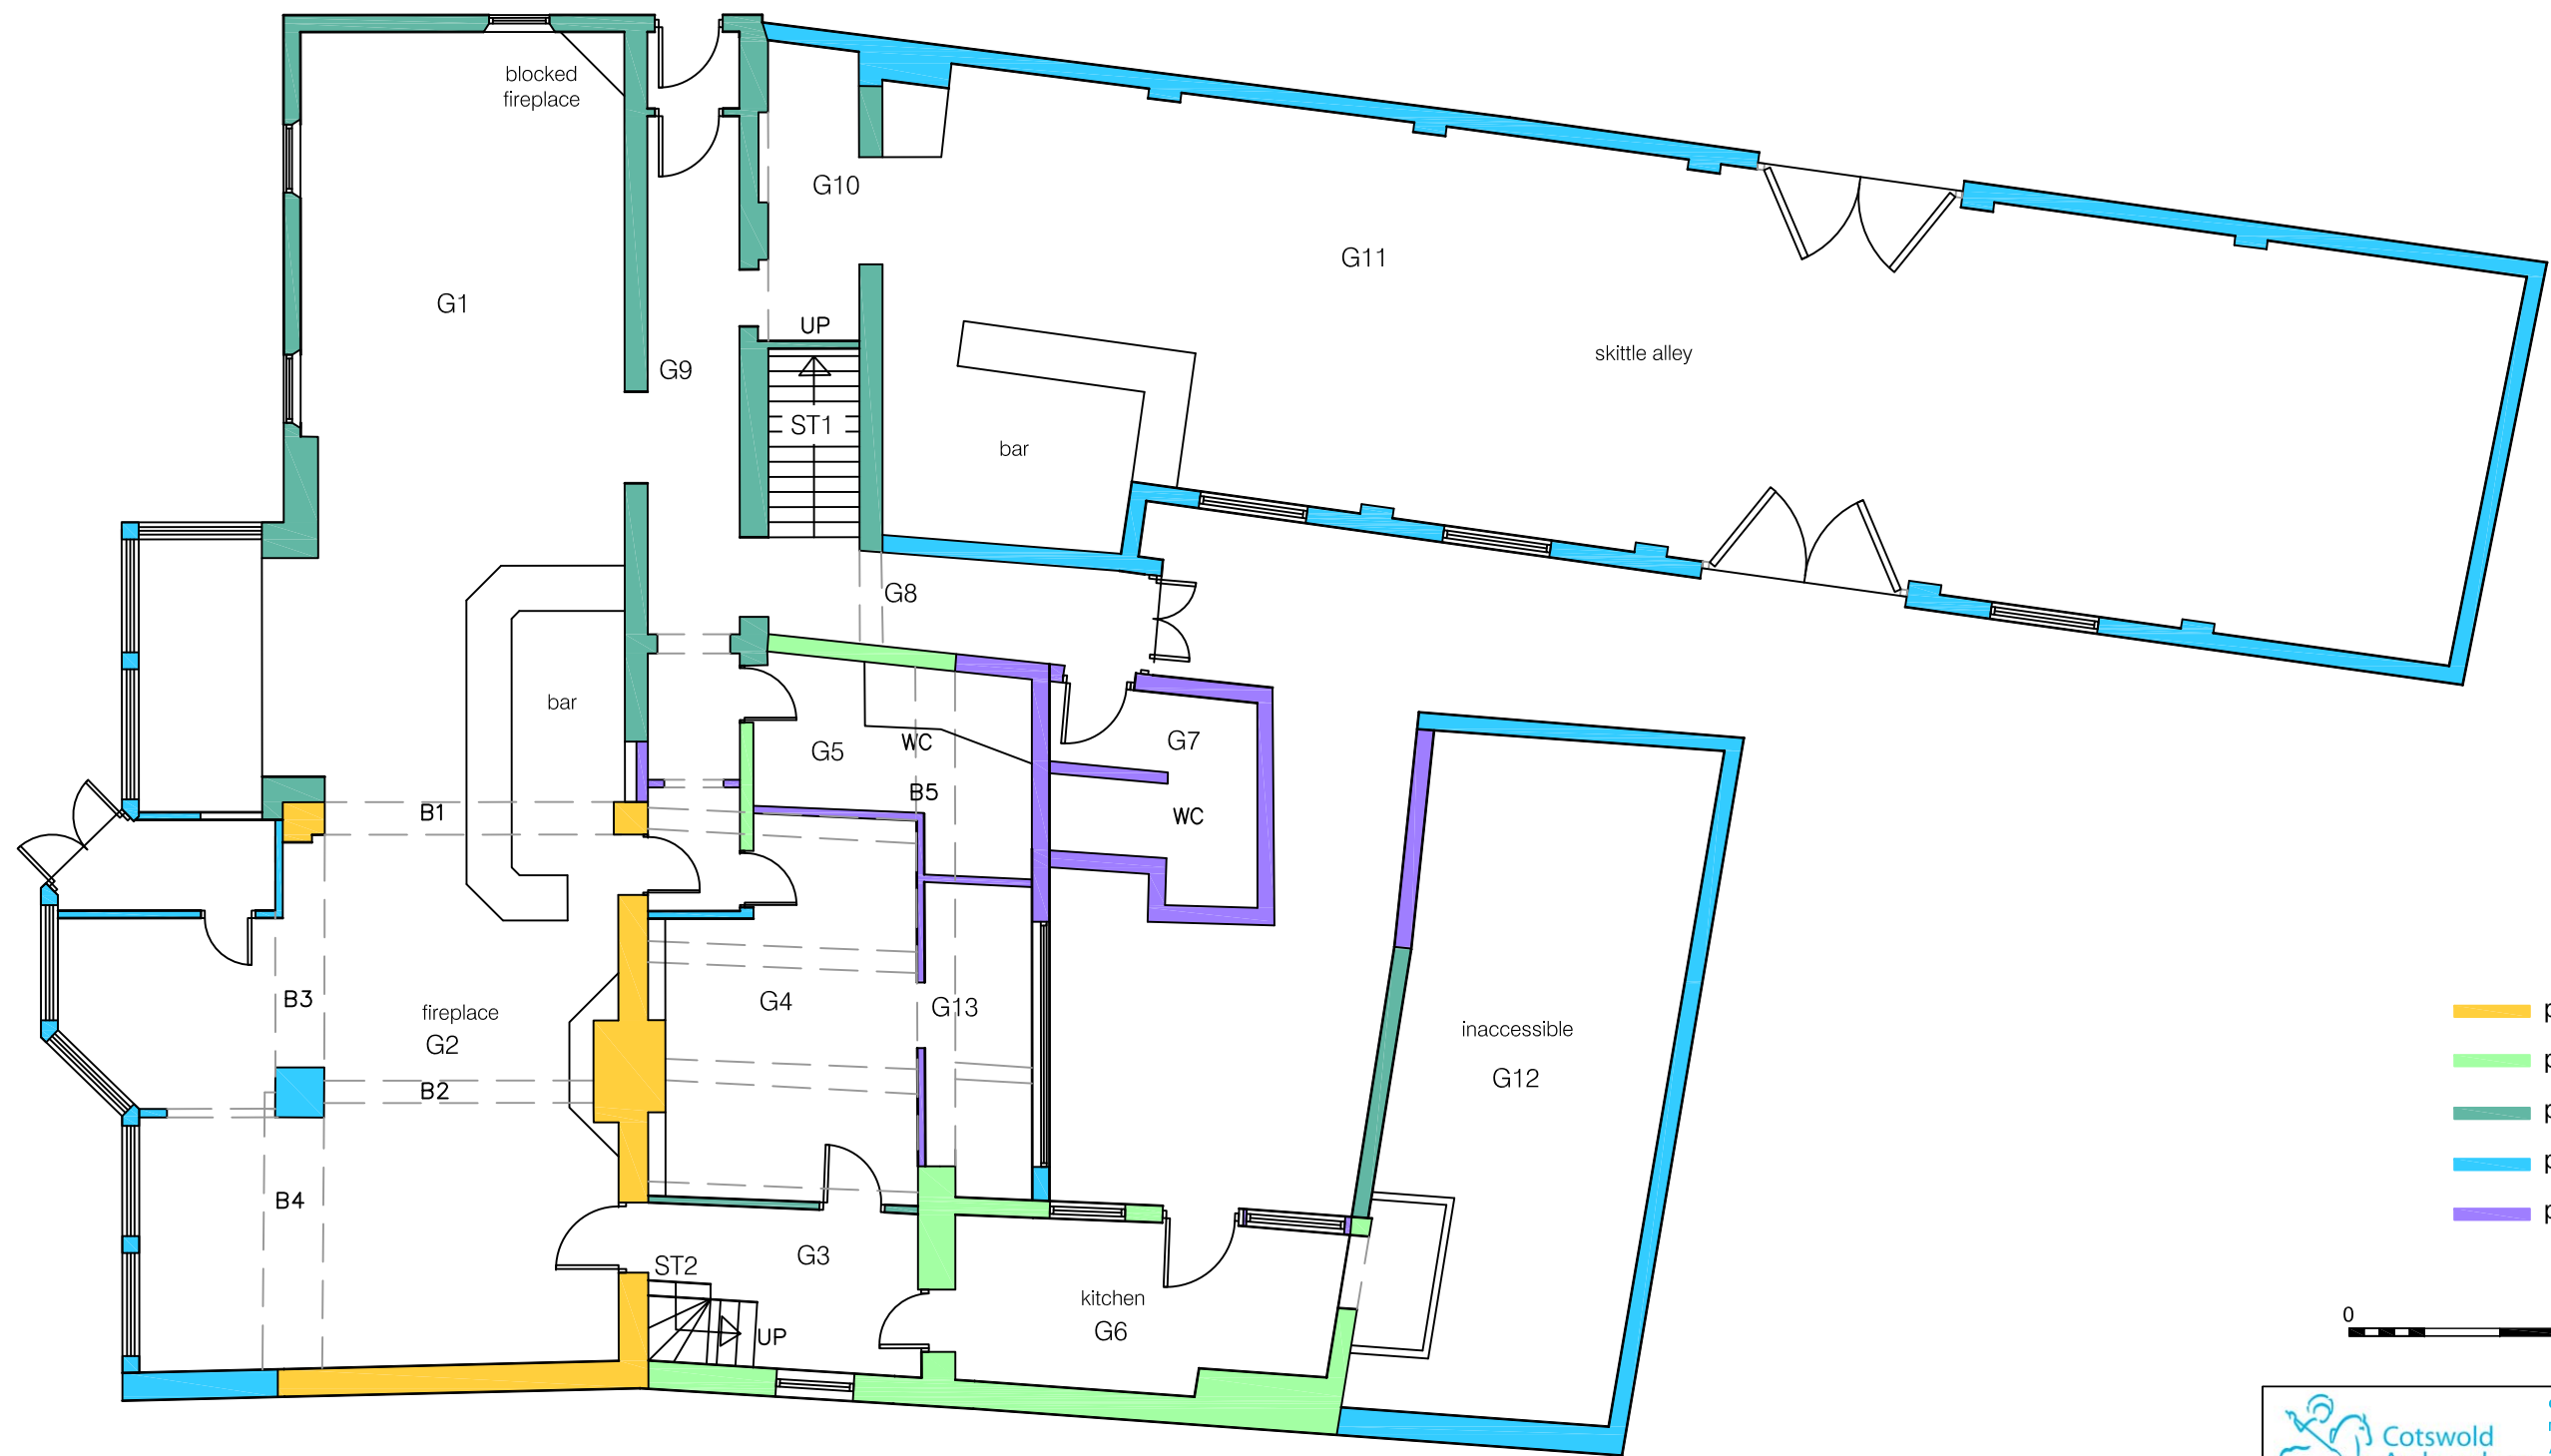
PROJECT NO. 4070	DATE 19-12-2012	FIGURE NO. 14
DRAWN BY IA	REVISION 00	
APPROVED BY PJM	SCALE@A3 1:100

PROJECT TITLE
 India House, 227 Barton Road
 Gloucester, Gloucestershire
FIGURE TITLE
 Phased ground-floor plan of India House

- 4.25 The downstairs bar area (Figs 21, 22 and Fig. 14, G1 and G2) has no features earlier than the mid 20th century other than some door frames and the window frames in G1. These share a moulding that can be considered typical of the building of the northern range between 1884 and 1902, our type A. This is a broad flat fillet flanked by two quadrants on the outer element of the architrave, then on the window or door side with two simple rebates, the second filled with a roll. This type A profile occurs on all the windows in the northern end of the west range and on doors in rooms G1, G9, G10 (entrance from G9) and F1.

- 4.27 The ceiling shows substantial beams where walls have been removed (Figs 14, 21). B1 marks the position of the party wall between the southern and northern properties and this is also where the ceiling level drops. This drop reflects that seen in the window levels noted in para. 4.8. Beam B2 shows where a wall has been removed which formerly divided two rooms here (as is still the case upstairs). B3 and B4 indicate the position of the ground-floor front wall of the southern property, removed for the insertion of the bay windows.

- 4.29 Below beam B2 is a fireplace with angled sides (Fig. 14). What is visible is modern but it certainly encloses an older fireplace. The angles suggests two corner fireplaces heating the rooms either side of B2. There is reason to suggest, however, that even this was not the original layout. This will be returned to later.

- 4.34 G3, G4, G5 and G6 are all part of the L-shaped addition to G2 (Fig. 14). The doorway from G2 is type B and probably belongs to this phase. G5 has been extended by the sequential addition of G13 and G7 in the early to mid 20th century, but the type A architrave of the door from G9 to G5 shows it was modified in the late

- 4.36 In the corner of G3 is a dog-leg semi-winder stair (ST2) rising to F3 (Figs 14 and 27). The stair is typical of earlier 19th century design in style and shape, being contained in a planked enclosure, otherwise not separated from G3 or F3, and very steep. The door at its base leading from G3 into G2 is modern.

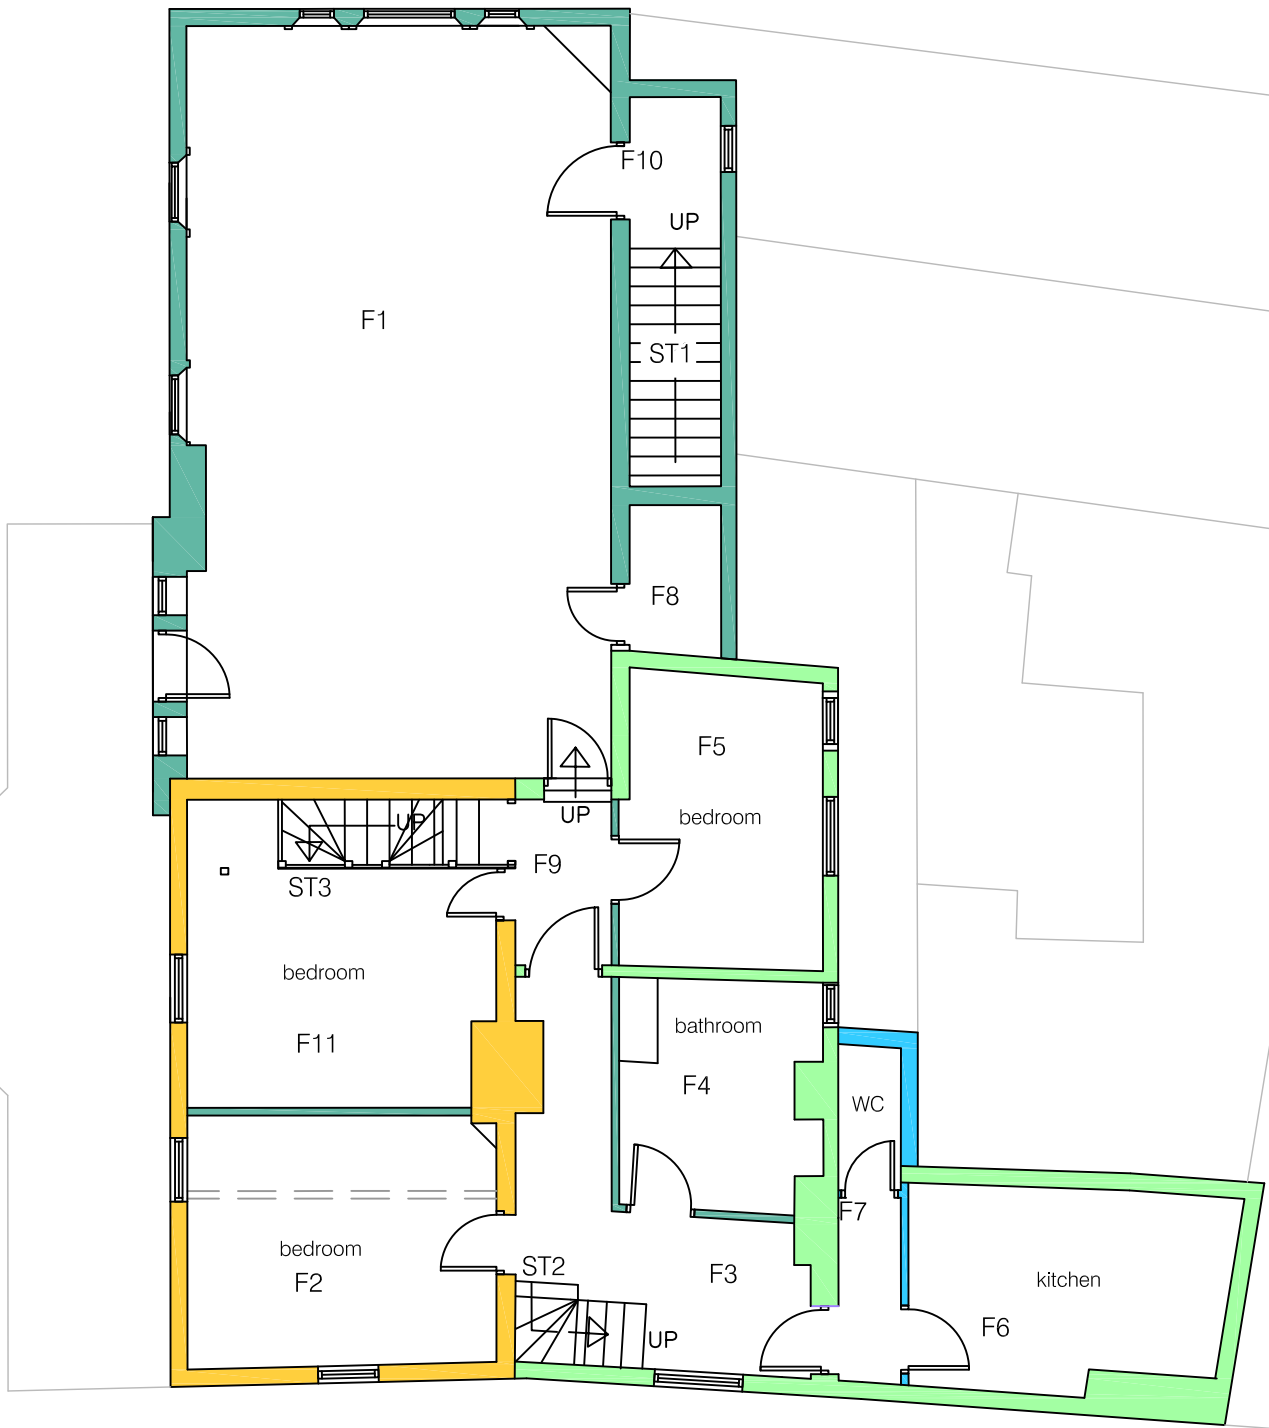
PROJECT NO.	4070	DATE	19-12-2012	FIGURE NO.
DRAWN BY	IA	REVISION	00	15
APPROVED BY	PJM	SCALE@A4	1:100

PROJECT TITLE
 India House, 227 Barton Road
 Gloucester, Gloucestershire
FIGURE TITLE
 Phased first-floor plan of India House

- 4.39 ST1 rises in its own brick enclosure to the landing G10 (Figs 14, 15 and 18). From here the door leads into the large room that occupies all of the rest of the first floor in the northern end of the western range, F1. This was always a large function or meeting hall, latterly used as a boxing gym. It is largely in its original, plain condition.
- 4.40 The room rises up into its open ceiling, revealing the roof timbers and tensioning iron work (Fig. 28). The principals of the two trusses are kept from spreading by a series of triangulated iron rods which can be tightened by a turnbuckle in the centre of the tie rod. Trenched purlins support the common rafters which are planked over to support the roof. All is stained dark reddish brown.

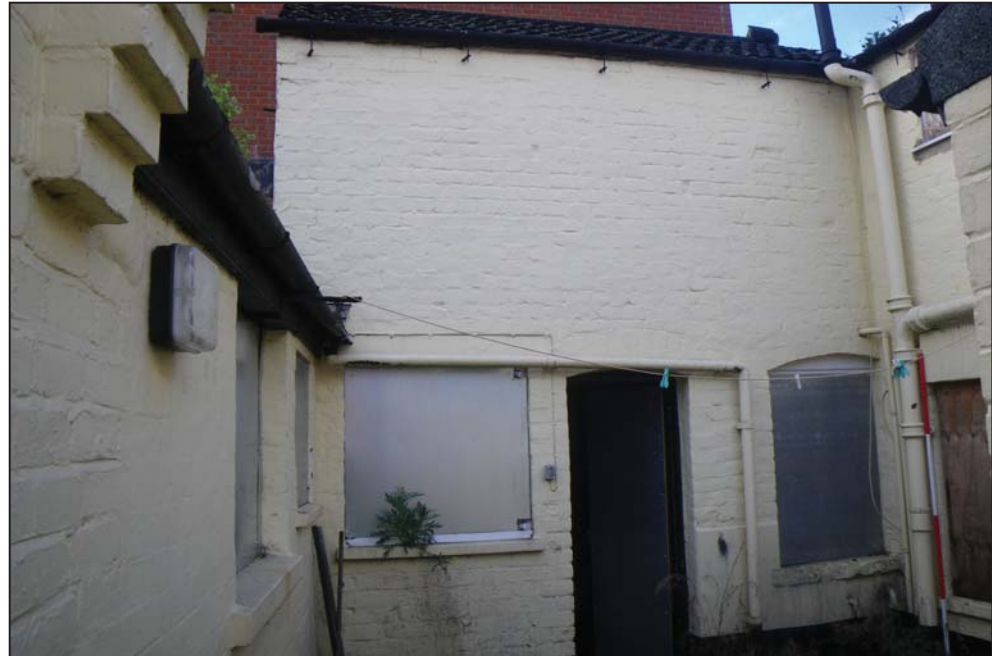
- 17 The rear of the L-shaped rear range, looking south-west (rooms G6 and F6). Scale 2m
- 18 The north/south section of the L-shaped rear range (room G5), looking south-west
- 19 The added angle room, (F7) and G13, with the large window, running under it, looking south west. Scale 2m
- 20 The south face of G12 showing the junction/rebuild at the north (left) side. Scale 2m

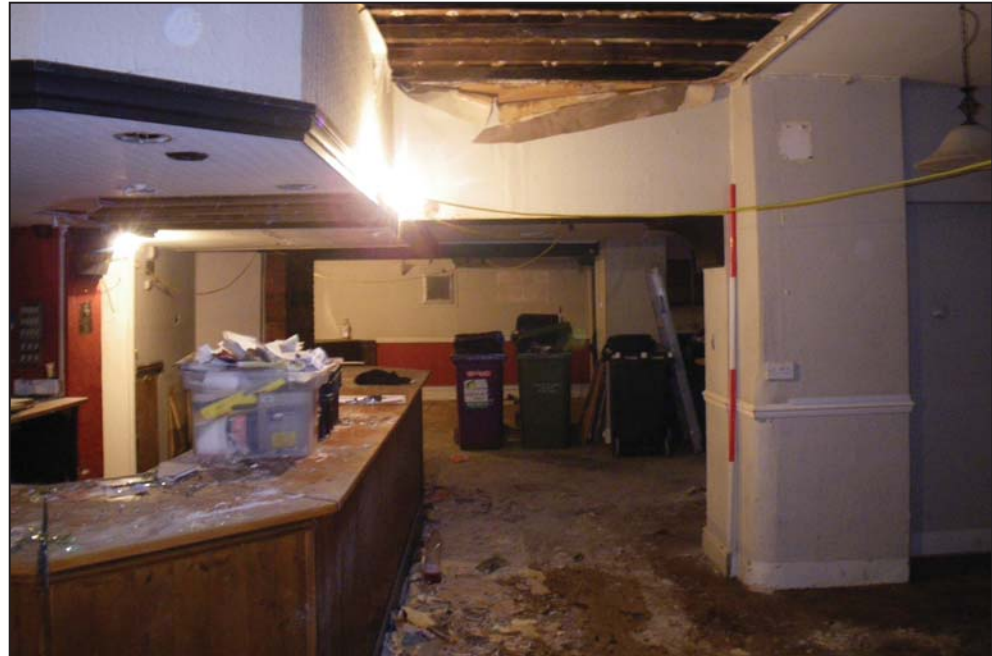
- 21 The bar, ground floor, looking south from G1 into G2. Scale 2m
- 22 The bar, ground floor, looking north into G1. Scale 2m
- 23 The northern bay window, off G1, looking west. Scale 2m

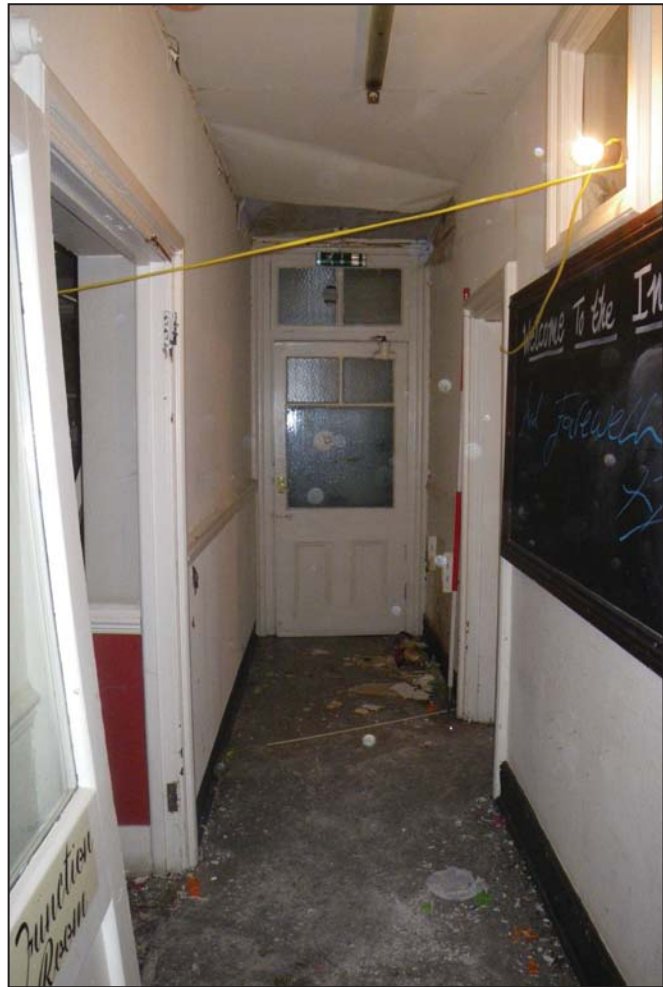
- 24 The northern end of G9, looking north. Scale 2m
- 25 The skittle alley, looking east. Scale 2m
- 26 Room G5 looking north. Scales 1m

- 4.30 Passing through double doors (the leaves being 20th century) in G1 leads to corridor G9 (Figs 14 and 24). Most of the detailing here is of the late Victorian build, including a length of dado rail at the north end, unlike the rest of the building's later rails. From it a door leads into G10 the lobby for the skittle alley, G11. G10 must be part of the Victorian phase as it is the understair area of ST1, but a door way has been cut through from this area when the skittle alley was added. It is unlikely that the sheds (stables?) which preceded the skittle alley were reached other than from the rear yard. The tongue-and-groove panelling is continuous with that in G11 and is post-1923.

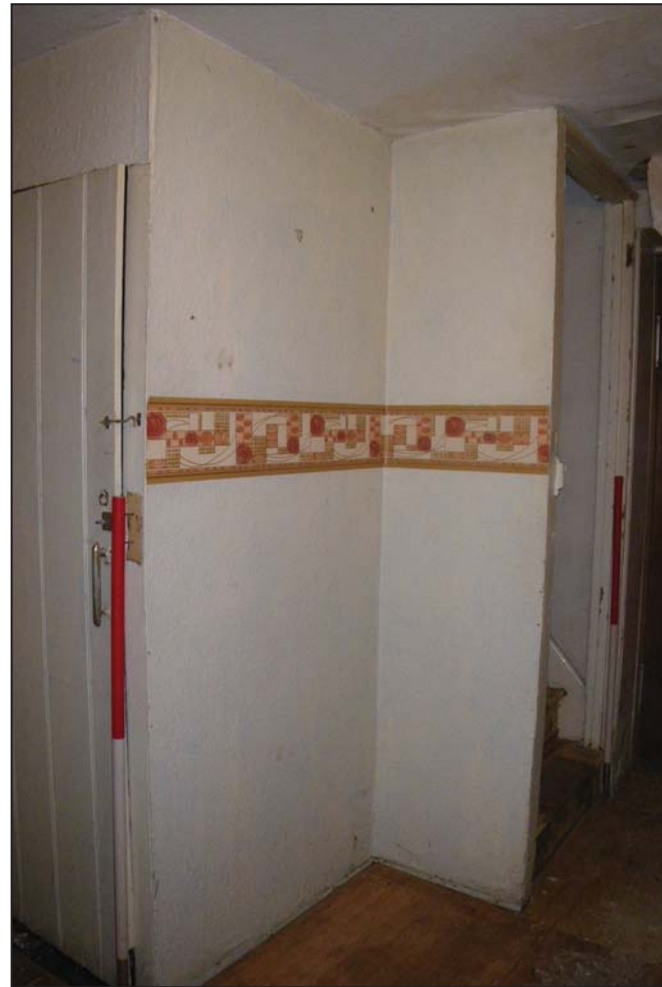
27 The winder stair ST2 and its enclosure in G3, looking south-west. Scale 2m

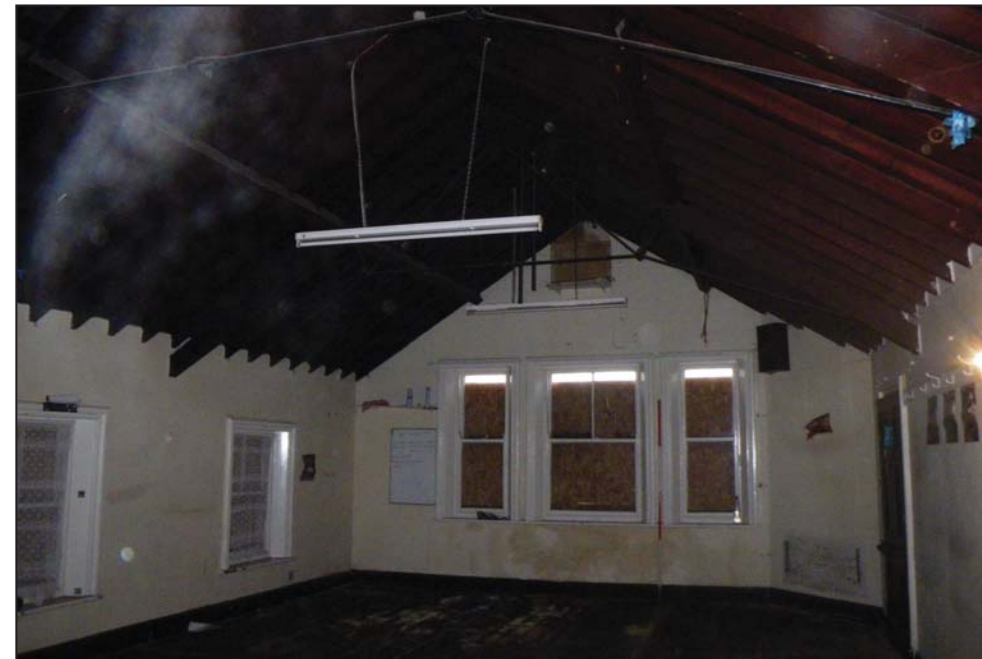
28 Room F1, looking north. Scale 2m

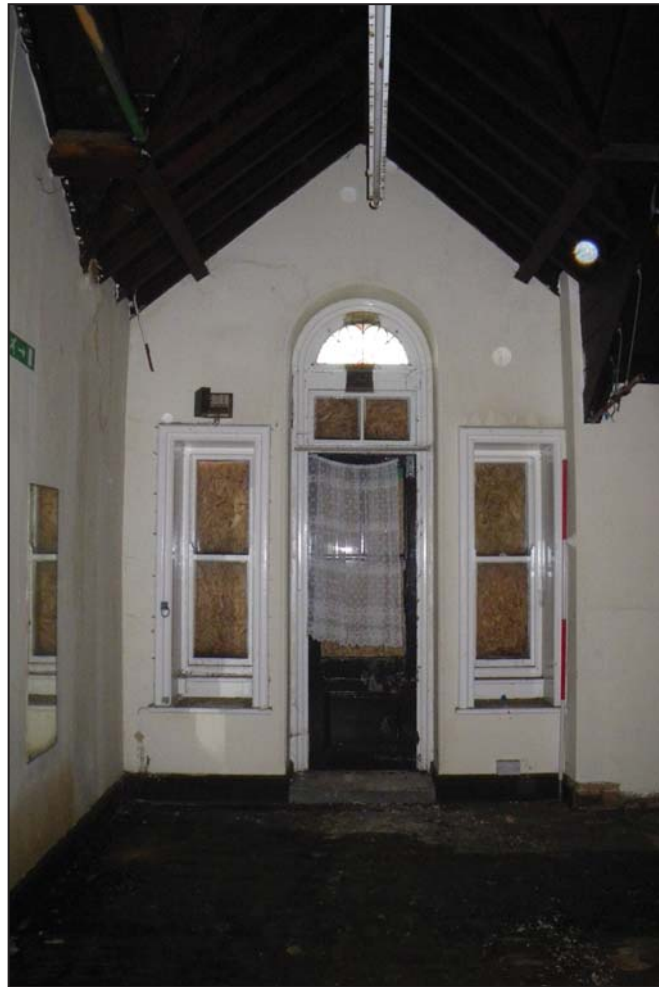
29 Room F1, looking west towards the door and windows in the central feature. Scale 2m

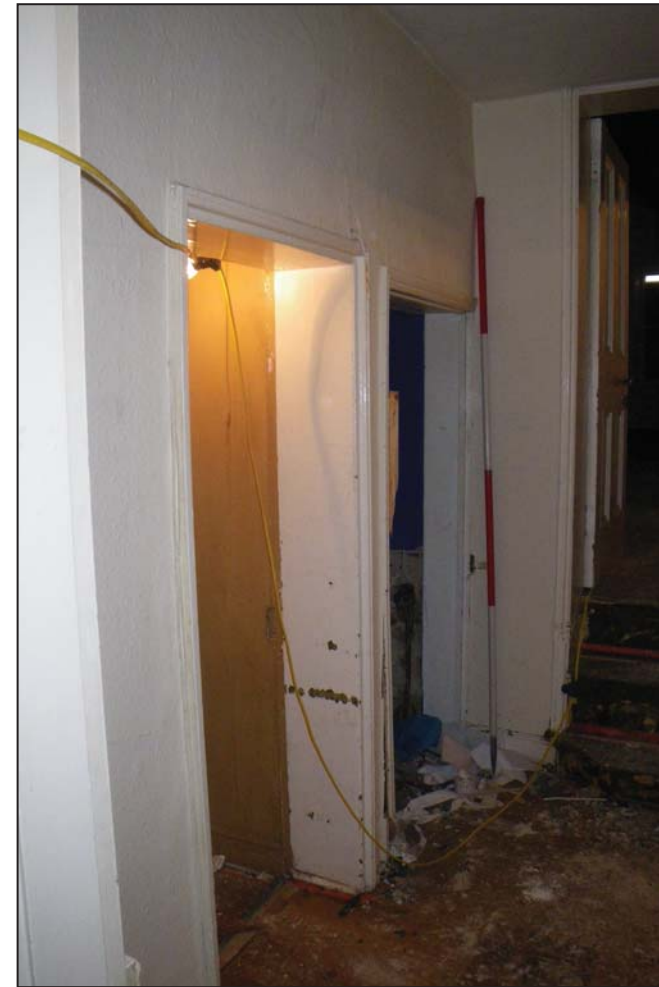
30 The north end of F9 with the doors to F11 and ST3 on the left and the steps to F1 on the right. Scale 2m

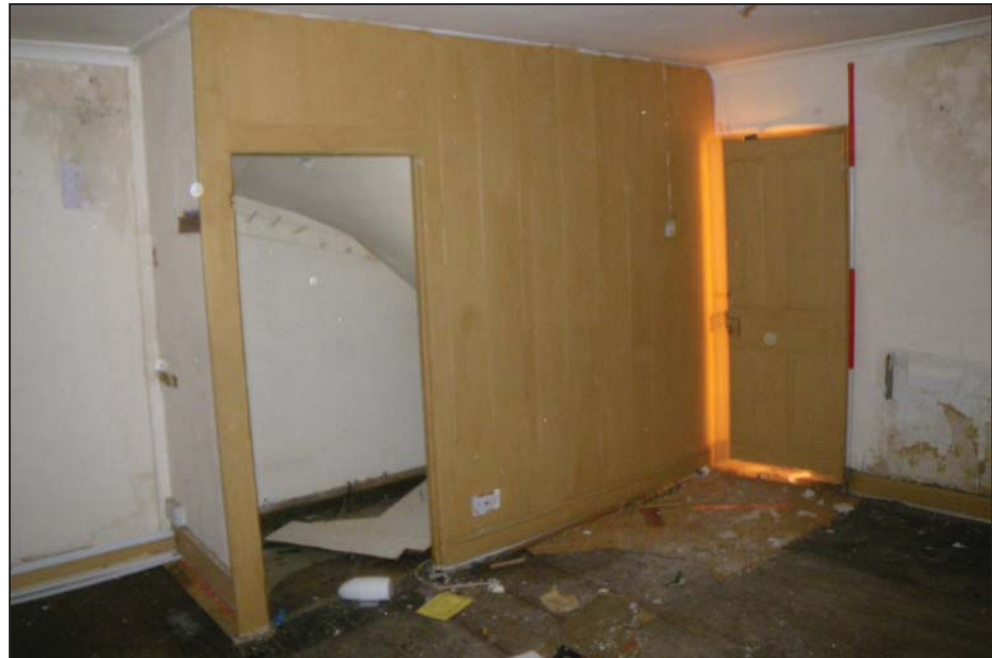
31 The stair enclosure for ST3 in F11, looking north-east. Scale 2m

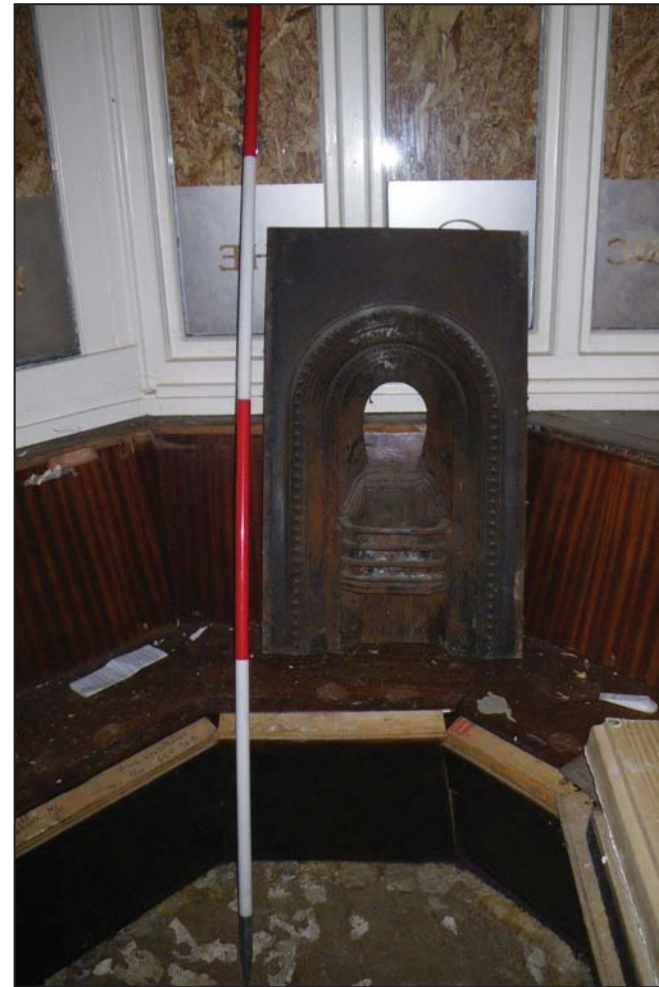
32 The ex-situ cast-iron grate, thought to be from F11. Scale 2m
