**Church Close
Dartmouth
Devon**

Archaeological Watching Brief

CA Project: 4221
CA Report: 13166

May 2013

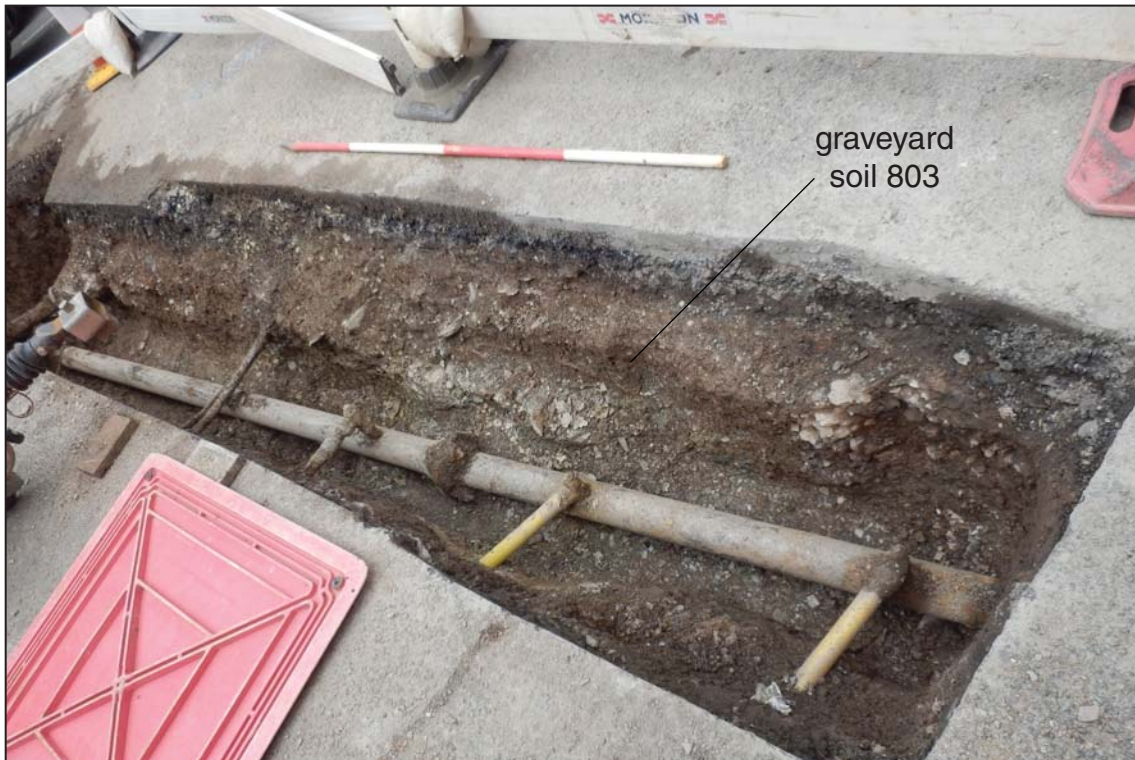
3 Trench 8, looking north-west, showing graveyard soil 803 (scale 2m)

- 2.5 The natural geological substrate (805) consisting of shale bedrock, was revealed at depths of between 0.3m and 0.55m bpgl. This was overlain by deposit 803, which comprised shale fragments in a clay matrix, up to 0.4m thick. Parts of six inhumation burials (804) were identified within the cleaned section of this deposit, which were identified within the section exposed by the re-excavated pipe trench 807 (see Fig. 3). Despite hand-cleaning no grave cuts were identified, although they must have existed.
- 2.6 The burials remained unexcavated as they were not impacted upon by the current works. No further artefactual or ecofactual material was identified and no human

bone was recovered from the excavated backfill. The exposed remains of each burial are detailed below:

Burial 1: Left humerus, scapula and mandible

Burial 2: Tibula and possible fibula

Burial 3: Left humerus, radius, ulna, metacarpals and scapula

Burial 4: Vertebrae, ribs and skull

Burial 5: Humerus and ulna

Burial 6: Decayed cervical vertebrae
