# 205a Banbury Road Stratford-upon-Avon Warwickshire

Archaeological Evaluation

> CA Project: 4211 CA Report: 13096

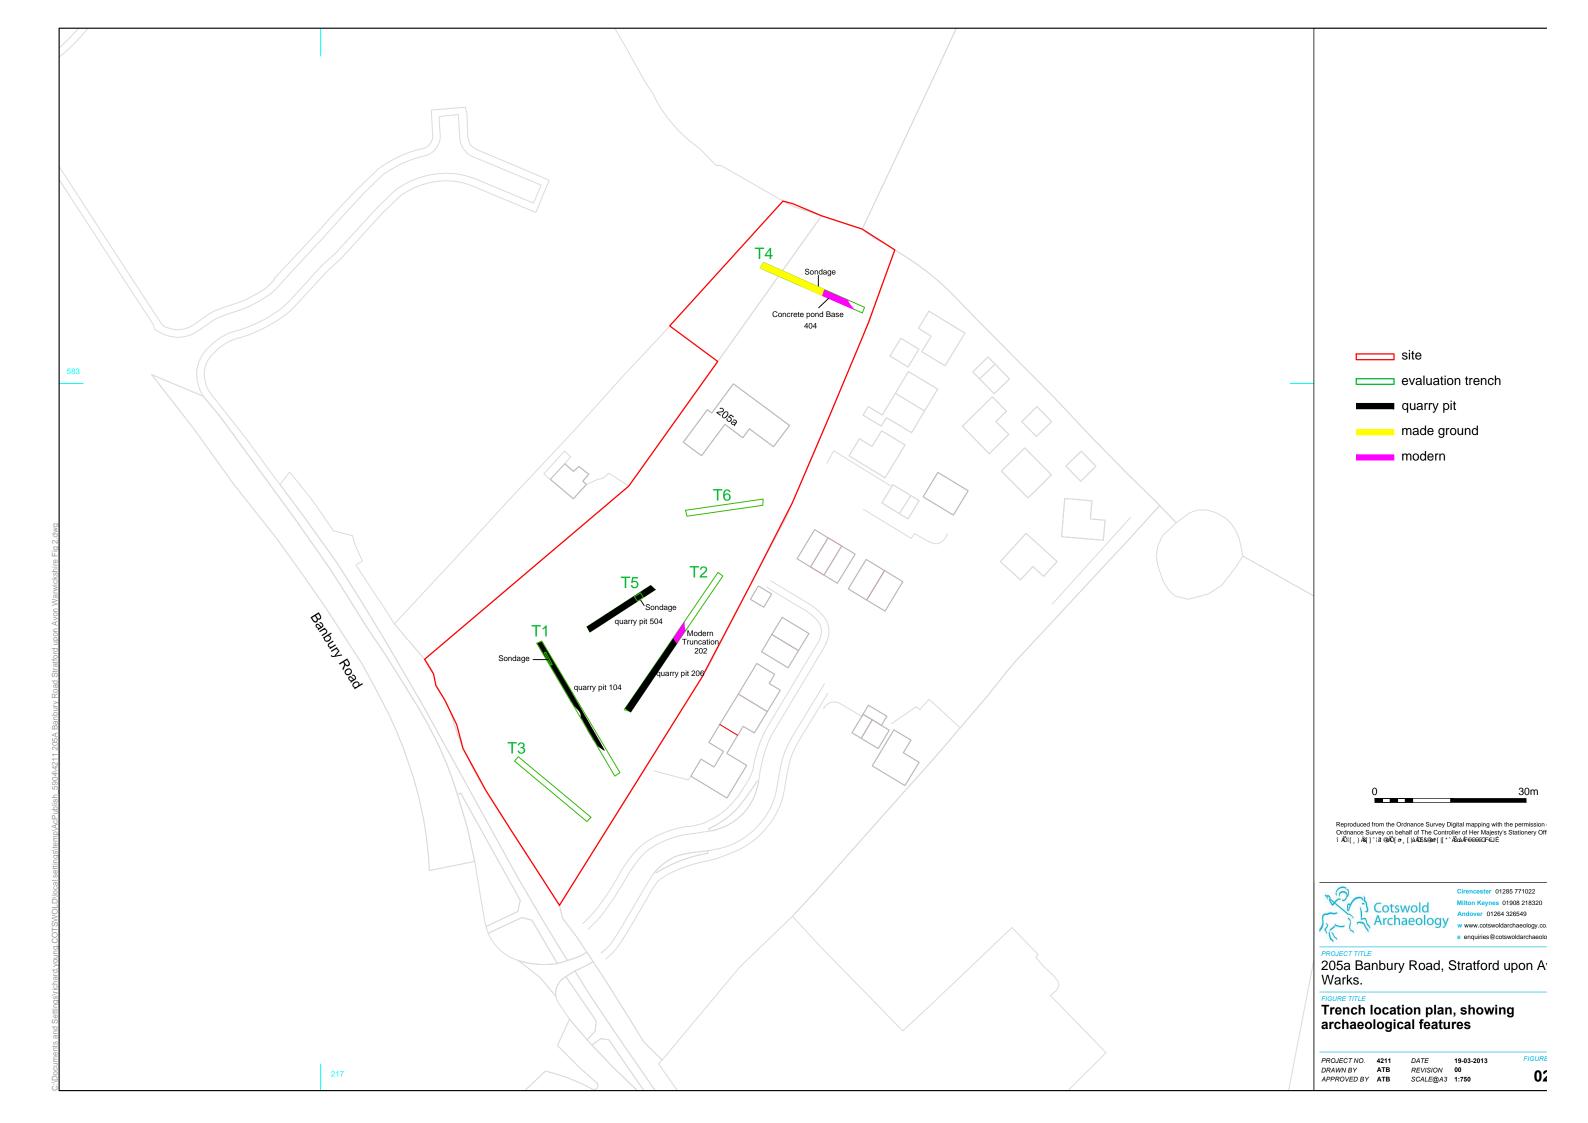
- 1.8 The fieldwork comprised the excavation of six trenches in the locations shown on the attached plan (Fig. 2). The trenches varied in length to between 20 and 45m. All trenches were 1.8m in width. The number and distribution of the trenches was amended on site from the layout agreed in the WSI in the avoidance of buried services and the root protection area of trees which are to be retained under the proposed development plan. The revised trench layout was approved by Caroline Rann. Trenches were set out on OS National Grid (NGR) co-ordinates using Leica GPS and surveyed in accordance with CA Technical Manual 4 *Survey Manual* (2012).

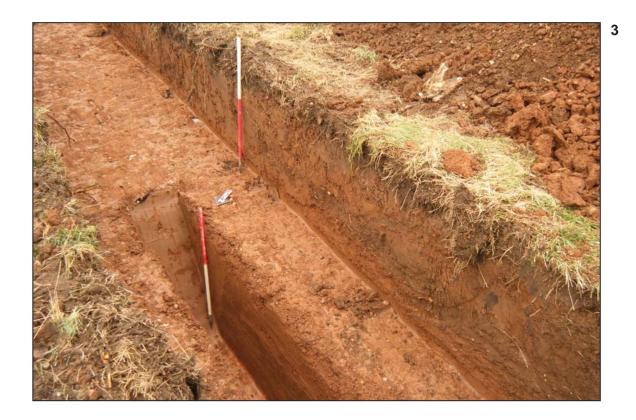
2.3 Natural substrate 101 and 201 was observed at the south-eastern end of Trench 1 at a depth of 0.21m below present ground level (bpgl) and at the north-eastern end of Trench 2 at 0.11m bpgl. The natural was cut by a very large irregularly shaped pit 105/206. The edge of the pit was only seen in plan in Trench 1. The pit contained dumped deposits all containing quantities of modern building materials and debris including brick, fragments of ceramic land drain, concrete, bottle glass and metal work which were not retained. Three fills 102, 103, and 104 were observed in the pit in Trench 1, whilst two 204 and 205 were observed in the pit in Trench 2. The northeastern edge of the pit was not observed in Trench 2 as it appeared to have been truncated by a more recent modern intrusion comprising an irregular linear feature 202 filled with crushed modern building materials 203. Modern dumped deposits exceeding 1.2m in depth and presumed to be fills of the same large pit, were observed across the whole of Trench 5. A sondage at the north-eastern end of this trench found the base of the pit lay at 1.65m in this location. The uppermost fill 500 of the pit in Trench 5 comprised dumped imported topsoil exceeding 1.2m in depth and was not discernibly different to the topsoil 100/200 observed sealing the pit in Trenches 1 and 2.

3 Trench 1, showing quarry pit 104 (scales 1m)	Cotswold Archaeology www.cotswoldarchaeology.co.uk e enquiries@cotswoldarchaeology.co.uk
	PROJECT TITLE 205a Banbury Road, Stratford-Upon-Avon, Warwickshire
	FIGURE TITLE Photograph
	PROJECT NO. 4211 DATE 27-03-2013 FIGURE NO. DRAWN BY DJB REVISION 00 APPROVED BY PJM SCALE@A4 N/A 3

- 3.2 OS mapping dating from 1834 label a loosely defined area immediately to the east of the site as an 'old quarry' (probably for the extraction of clay) and it is reasonable to assume the quarry workings may have extended into the site and that the large pit identified in Trenches 1, 2 and 5 represents this clay extraction in the early modern era. More recent OS maps (from 1938) demarcate the southern corner of the site around Trenches 1, 2 and 5, possibly indicating the presence of a hollow or depression in this area. A further quarry pit or pits were identified approximately 100m to the north-west of Trenches 1, 2 and 5 by an archaeological evaluation in 2011 on the adjoining eastern property (CA 2011).

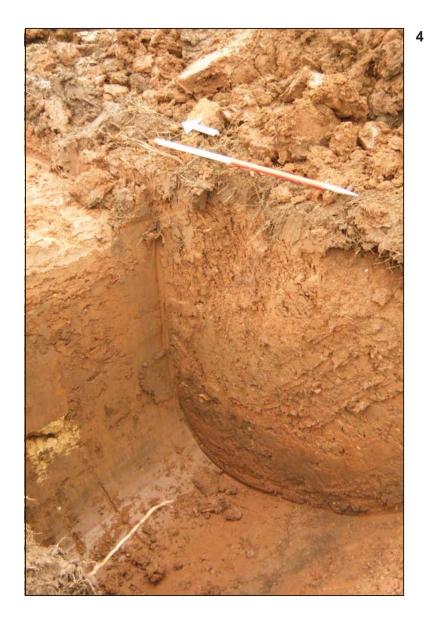
4 Trench 2, showing quarry pit 206 (Scale 1m)	Cotswold Archaeology www.cotswoldarchaeology.co.uk e enquiries@cotswoldarchaeology.co.uk
	205a Banbury Road, Stratford-Upon-Avon, Warwickshire
	FIGURE TITLE Photograph
	PROJECT NO. 4211 DATE 27-03-2013 FIGURE NO. DRAWN BY DJB REVISION 00 APPROVED BY PUM SCALE @A4 N/A 4

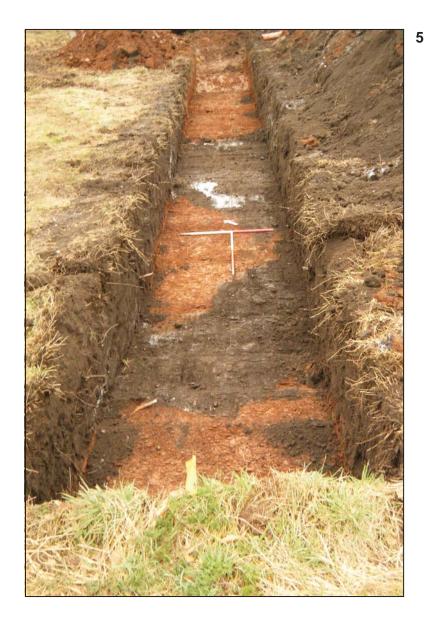
5 Trench 5, showing quarry pit 504 (Scales 1m)	Cotswold Archaeology e enquiries@cotswoldarchaeology.co.uk
	PROJECT TITLE 205a Banbury Road, Stratford-Upon-Avon, Warwickshire
	FIGURE TITLE Photograph
	PROJECT NO. 4211 DATE 27-03-2013 FIGURE NO. DRAWN BY DJB REVISION 00 5 APPROVED BY PJM SCALE®A4 N/A 5

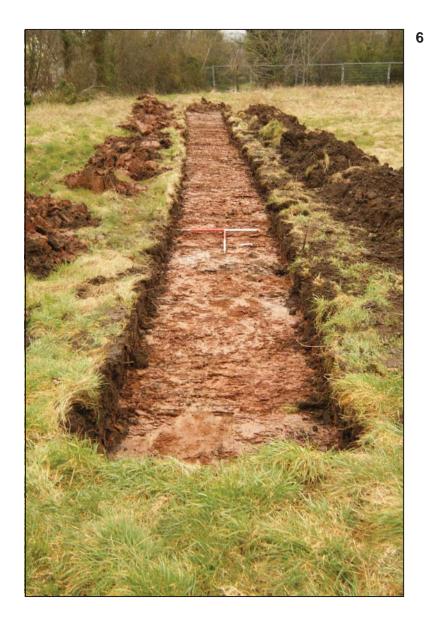
2.4 Natural substrate 406 was observed at the eastern end of Trench 4 at a depth of 0.56m bpgl and at a depth of 4.15m bpgl in a sondage dug in the central part of the trench. It was overlain by a series of layers of dumped re-deposited natural clay (401 and 403) and dark grey clay (402) which collectively accounted for a depth of made-ground in excess of 3.55m over most of the trench. These layers were cut by the construction cut 404 for a brick lined pond with a concrete slab base. This garden feature was filled with brick and concrete rubble 407. The whole trench was sealed by a further layer of made ground 400 comprising modern building debris in a dark grey clay matrix. This deposit directly overlay the natural substrate at the eastern end of the trench.

6 Trench 4, showing terrace 406 (Scales 1m)	Cirencester 01285 771022 Milton Keynes 01908 218320 Andover 01264 326549 w www.cotswoldarchaeology.co.uk e enquiries@cotswoldarchaeology.co.uk
	PROJECT TITLE 205a Banbury Road, Stratford-Upon-Avon, Warwickshire
	FIGURE TITLE Photograph
	PROJECT NO. 4211 DATE 27-03-2013 FIGURE NO. DRAWN BY DJB REVISION 00 6

- 3.1 Despite the archaeological potential of the development site no archaeological features were identified by the evaluation. It is apparent that the whole of the site has been subject to landscaping and quarrying in the modern era. It appears that the northern part of the property (the area around Trench 4) has been terraced to significantly raise the garden above the height of the surrounding fields and neighbouring properties. The brick-lined concrete slab observed corresponds to the location of a garden pond identifiable in modern aerial photographs.

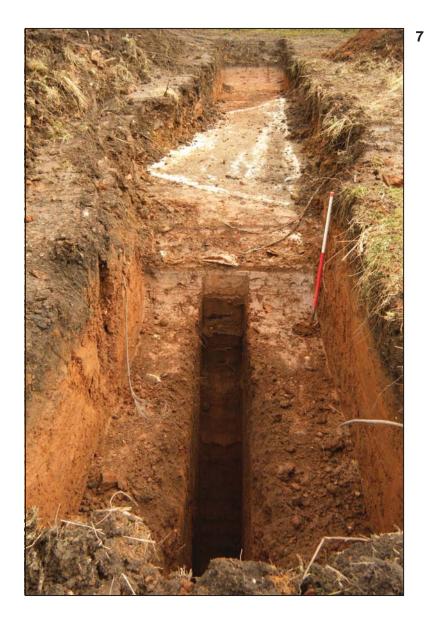
7 Trench 4, showing pond base 404 (Scale 1m)	Cirencester 01285 771022 Milton Keynes 01908 218320 Andover 01264 326549 www.cotswoldarchaeology.co.uk e enquiries@cotswoldarchaeology.co.uk
	PROJECT TITLE 205a Banbury Road, Stratford-Upon-Avon, Warwickshire
	FIGURE TITLE Photograph
	PROJECT NO. 4211 DATE 27-03-2013 FIGURE NO. DRAWN BY DJB REVISION 00 APPROVED BY PJM SCALE@A4 N/A 7
