# Land off Tyndall's Park Road Bristol

## Archaeological Watching Brief

CA Project: 4090  
CA Report: 13438  
Bristol City HER Event no.: 25178

August 2013

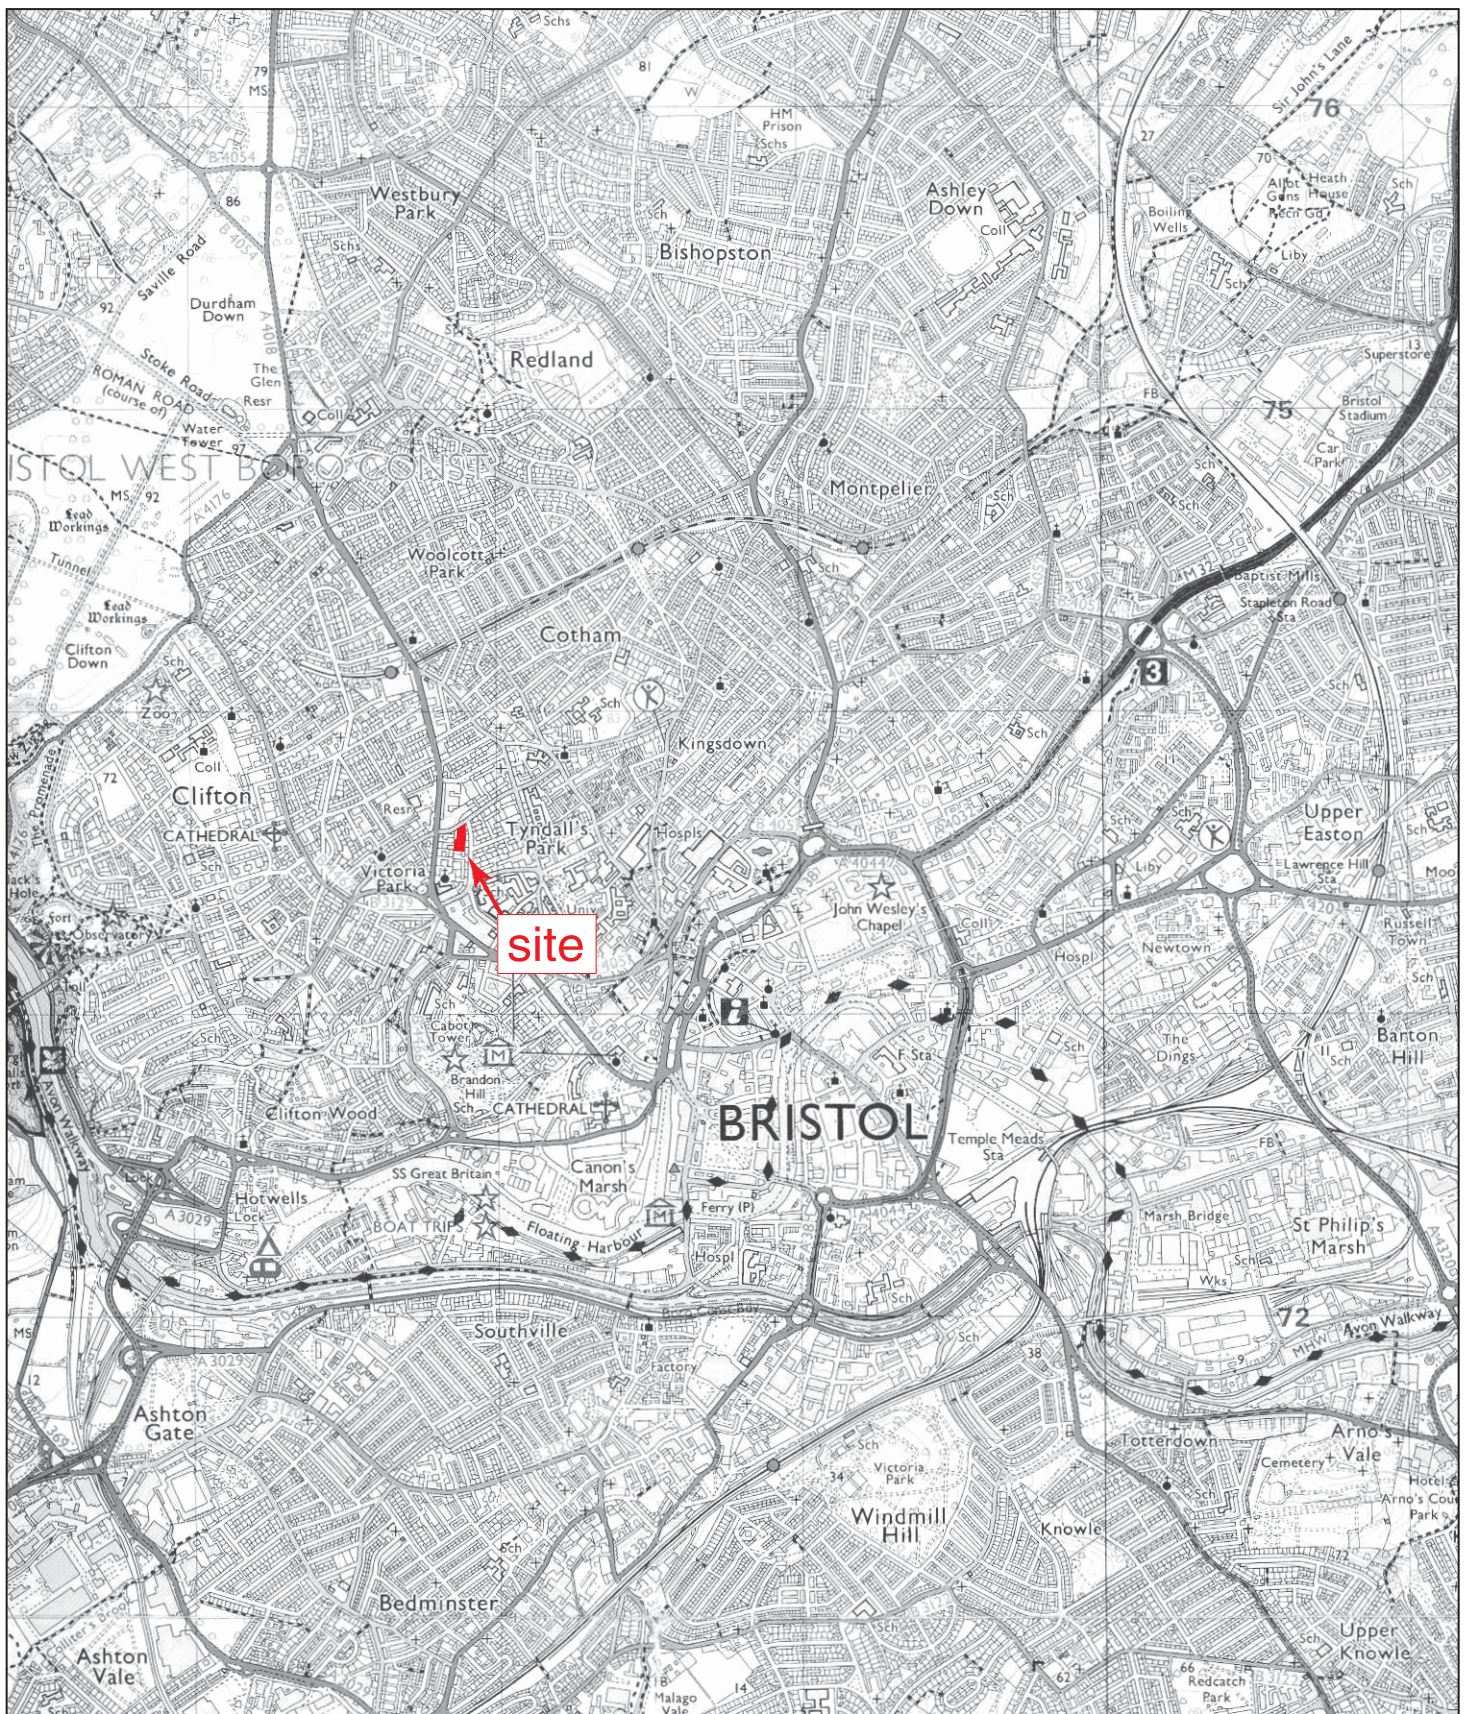
**FIGURE TITLE**  
 The site, showing location of  
 observed groundworks, archaeological  
 features and historic boundaries

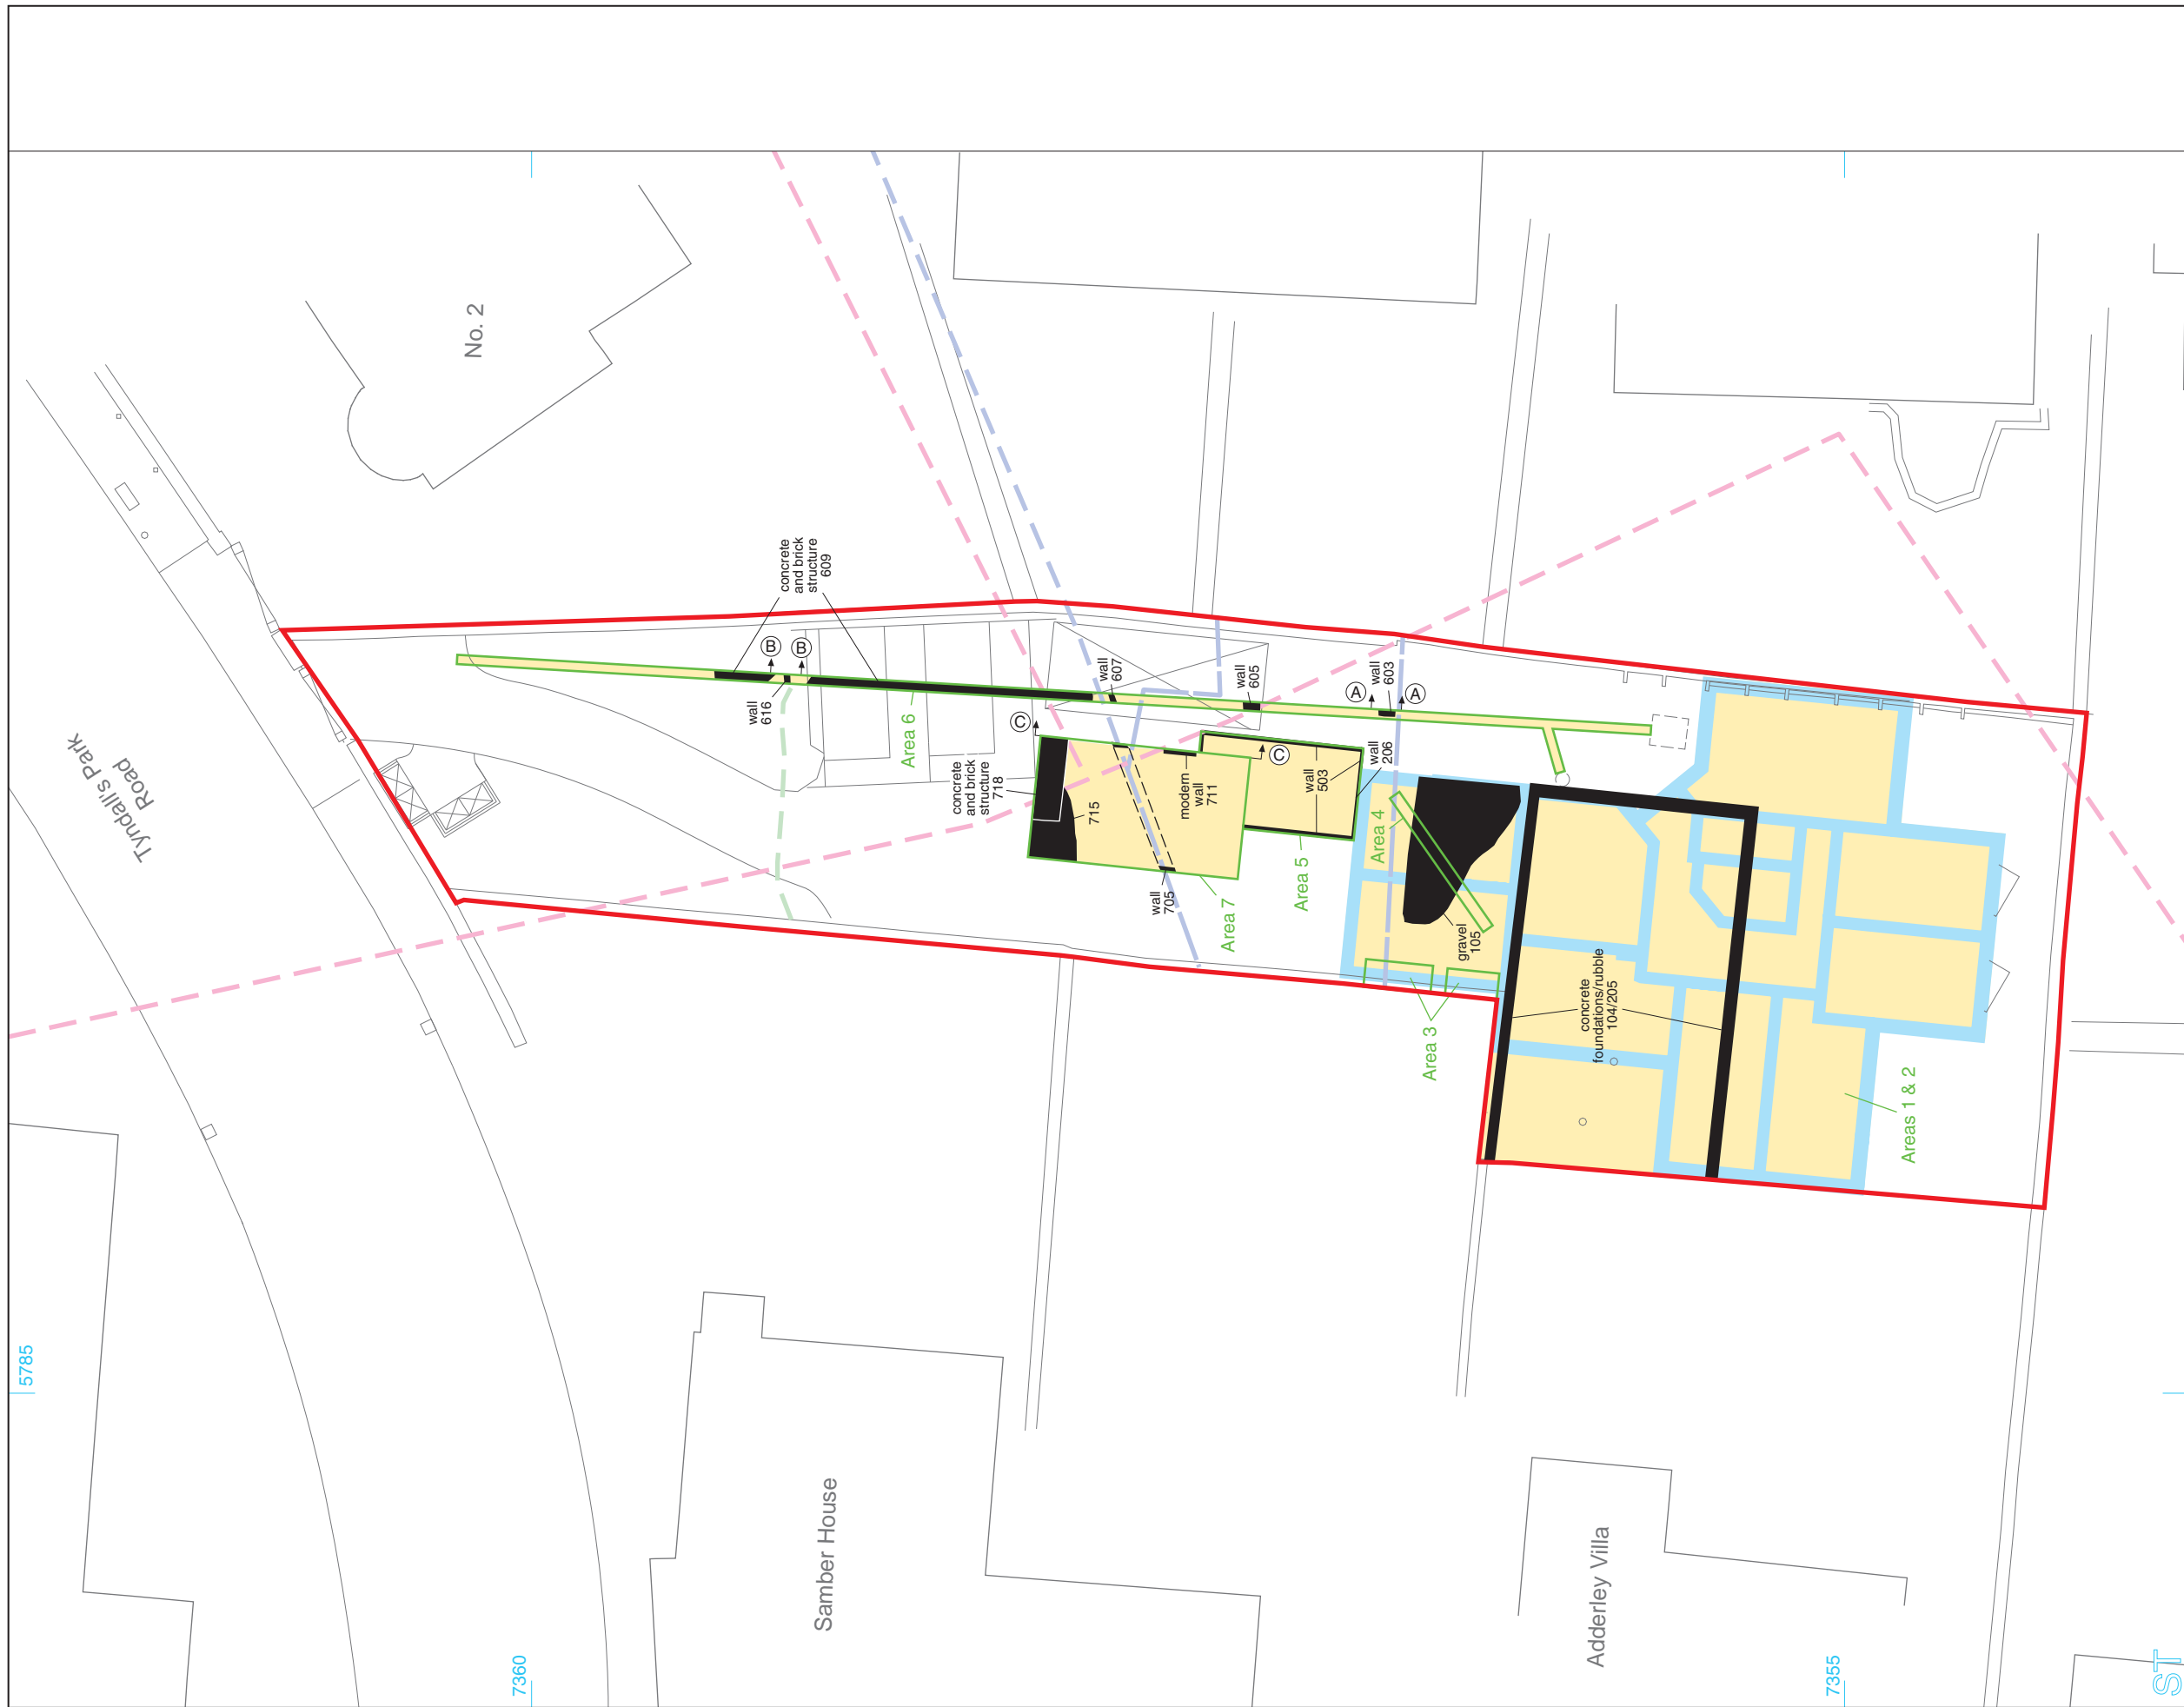
1.9 The fieldwork followed the methodology set out within the WSI (CA 2013). An archaeologist was present during intrusive groundworks comprising ground level reduction (Area 1), the excavation of building foundations (Area 2), the underpinning of an existing party wall (Area 3), service trenches (Areas 4 and 6), the excavation of a rubble filled cellar (Area 5) and the excavation of a soakaway (Area 7) (Fig. 2).

- 2.5 A layer of re-deposited natural clay 601, the same deposit as that seen in Areas 2, 3 and 5 (201/301/501), was observed in the southern part of Area 6, overlying the natural substrate. This deposit was cut by three further stone wall foundations, 603, 605 and 607 (Fig. 3, section AA). All comprised roughly coursed undressed stone walls bonded with dark grey ashy mortar set into construction cuts 604, 606 and 608 respectively. The walls broadly align with walls depicted on Ashmead's map of 1874 (Fig. 2).

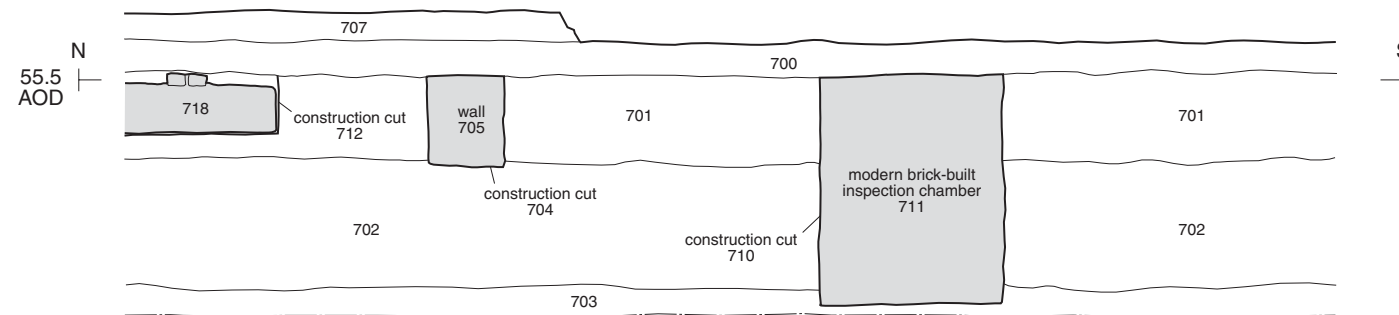
Section CC

- 2.7 Several structural features were observed cutting re-deposited clay layer 701 in Area 7 (see Fig. 3, section CC). Wall 705 was aligned north-east/south-west and appears to be a continuation of wall 607 identified in Area 6. In the western part of the area it revetted the re-deposited clay layer on its southern side but was abutted by a layer of buried topsoil 706 on its northern face (n.i.). In the eastern part of the area it was fully set into construction cut 704.

- 3.1 The watching brief identified a number of structural features dating to the modern period. Whilst no remains pre-dating the modern era were identified, wall 607/705 corresponds to a boundary first depicted on Ashmead's 1828 map demarcating the boundary between the parishes of Westbury-on-Trym and St Michaels. The wall may therefore represent the 'fossilisation' of this parish boundary as a property boundary. In 1828 the site was in agricultural use but by the time of Ashmead's 1874 map the residential development of Whiteladies Road and Elmdale Road had taken place. The parish boundary is depicted as a wall in this period forming a northern property boundary for a building, formed of three blocks, on the very western edge of a large plot fronting Elmdale Road. Walls 603 and 605 broadly align with this structure and are likely to be foundations associated with it. It is also likely that the cellar recorded in Areas 2, 5 and 7 is also associated with this building. The boundary wall remains depicted on Ordnance Survey maps until 1949 but is absent by 1956 when the whole site was incorporated as the property of Adderley Villa,
