**Site 3, Camera Recognition  
Bridgwater  
Somerset**

**Archaeological Watching Brief**

**NNB Generation Company Ltd**

CA Project:4212  
CA Report: 13085

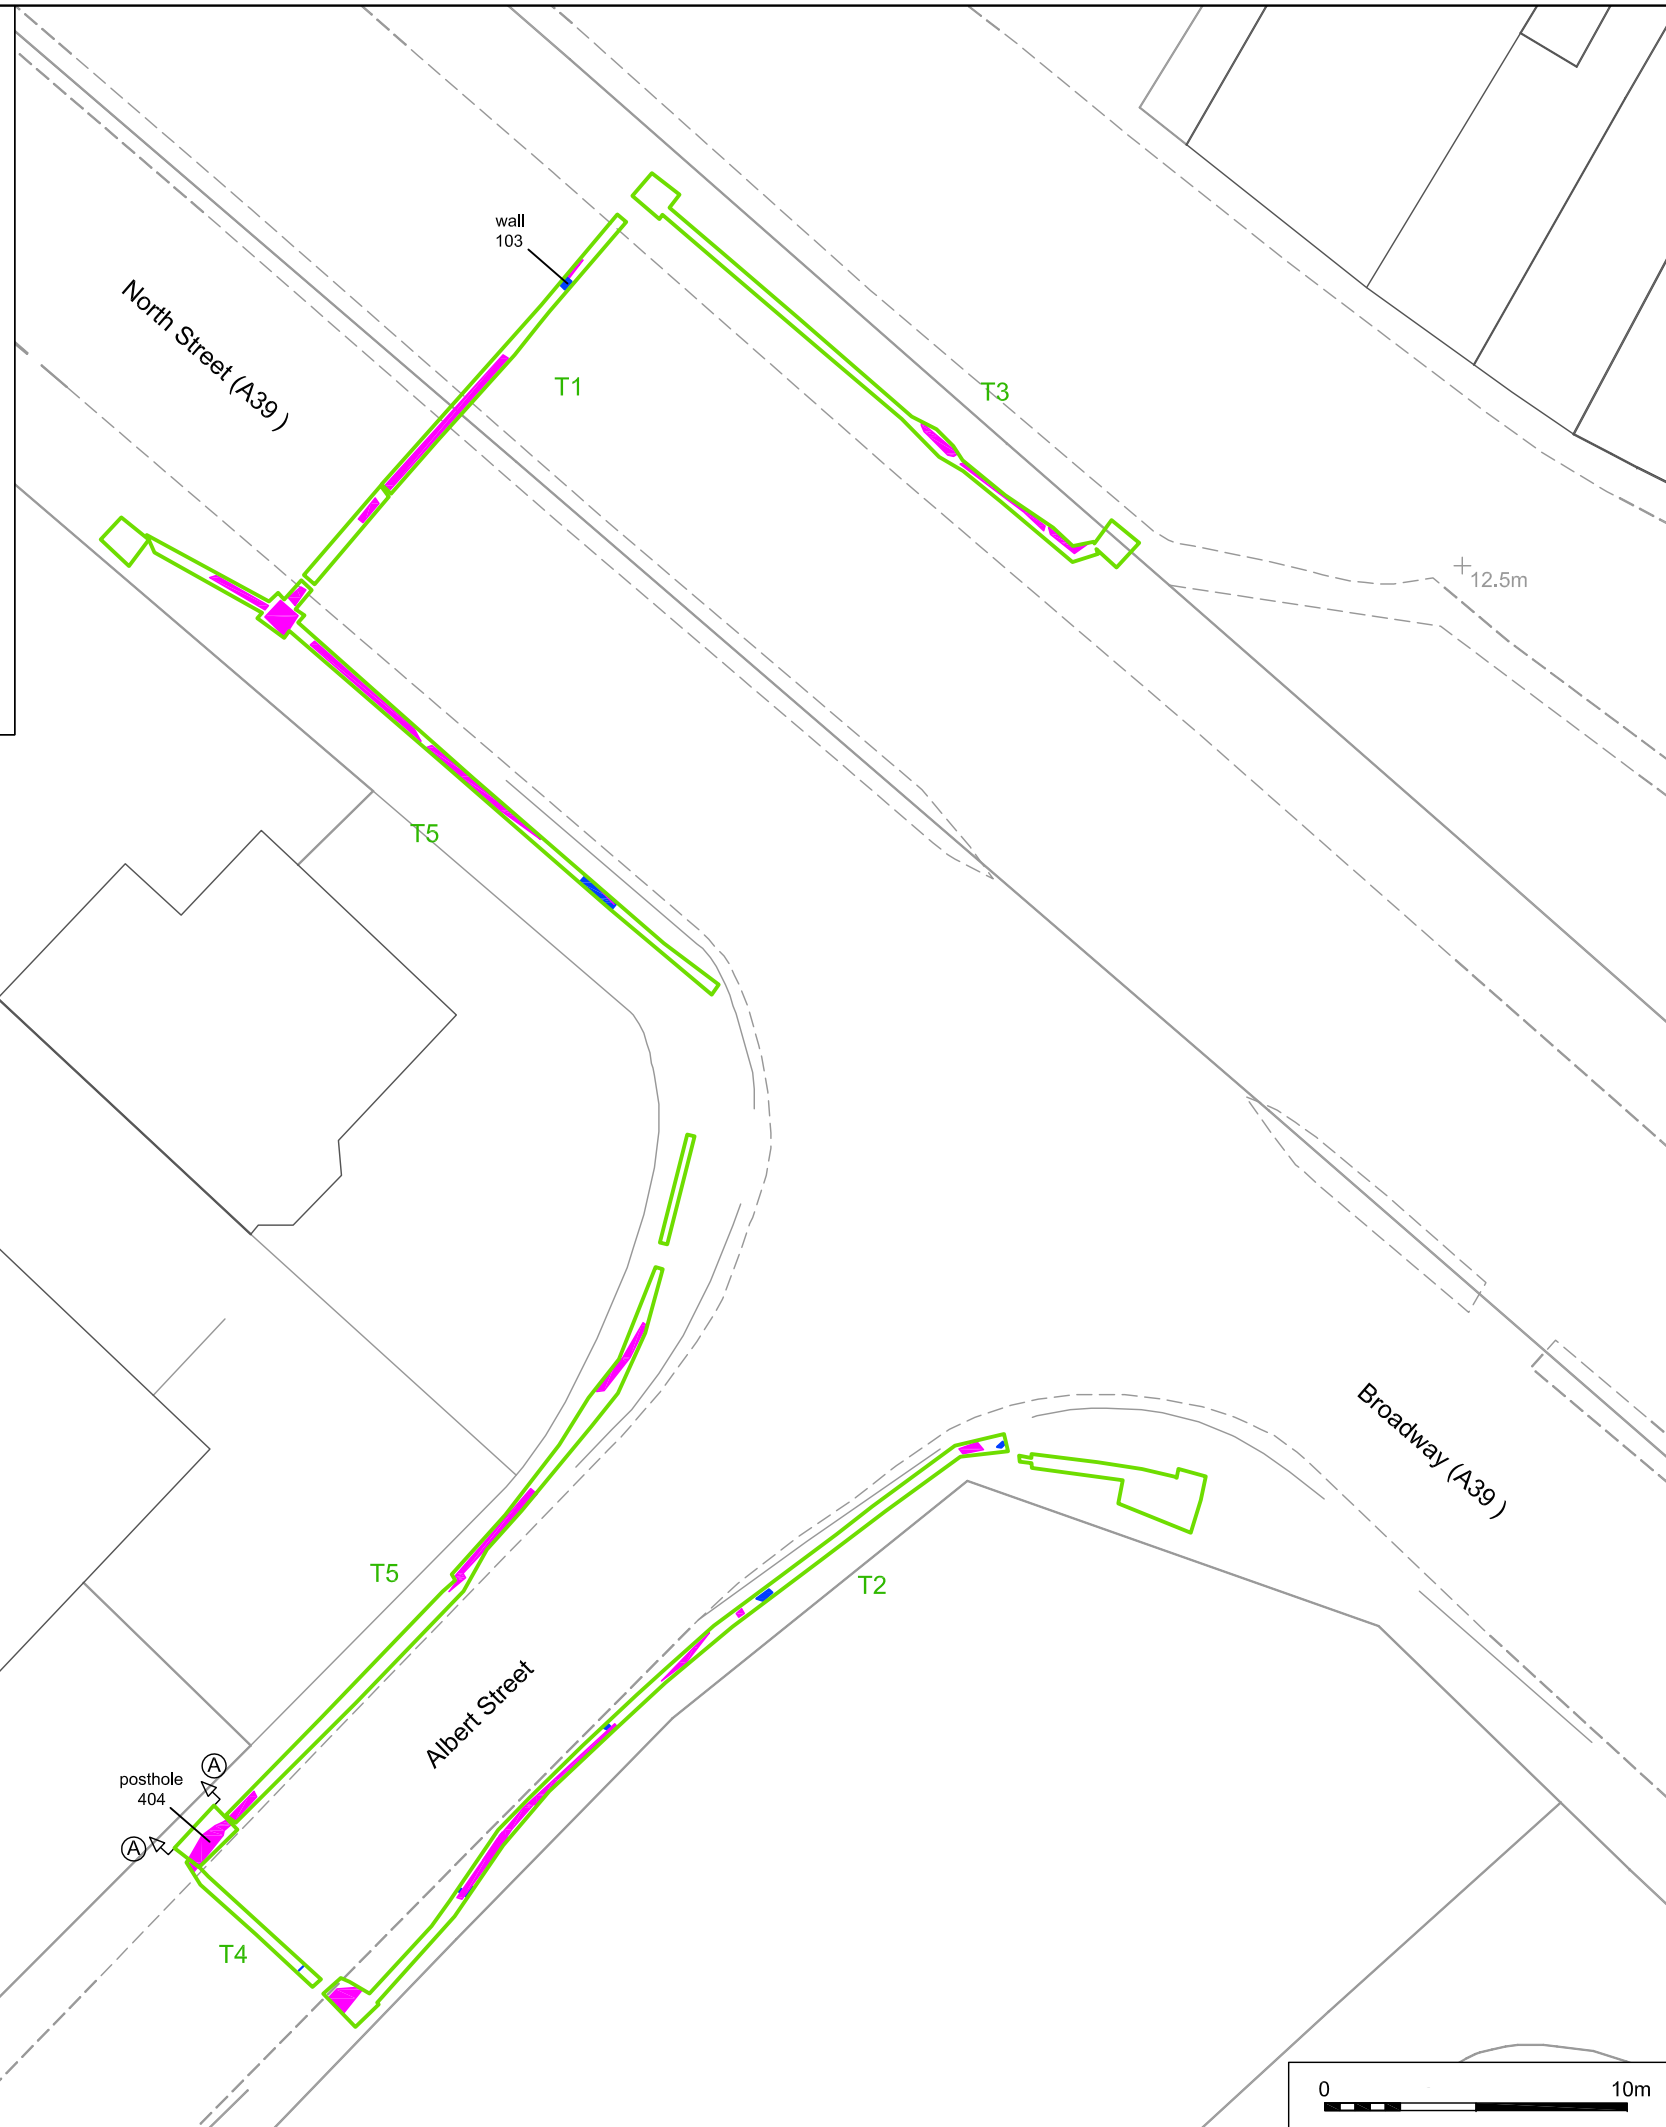
| PROJECT NO. 4212 | DATE 18-03-2013 | FIGURE NO. 2 |

- 2.3 Two courses of a red brick wall 103, aligned north-west/south-east were visible in the base of Trench 1. It was approximately 0.3m in width. It was associated with a ceramic, un-glazed, drainage pipe 105 aligned north-east/south-west emerging from the eastern side of wall 103. Both were cut into the top of dark brown silt clay, 107, that contained 19th-century pottery. Wall 103 and drain 105 had been heavily disturbed by the construction of the modern Broadway and were overlain by type 1 gravel.

**FIGURE TITLE**  
 Observed groundworks, showing  
 archaeological and modern features
