Winchcombe Abbey Winchcombe Gloucestershire

Archaeological Evaluation

CA Project: 4815 CA Report: 13495

April 2014

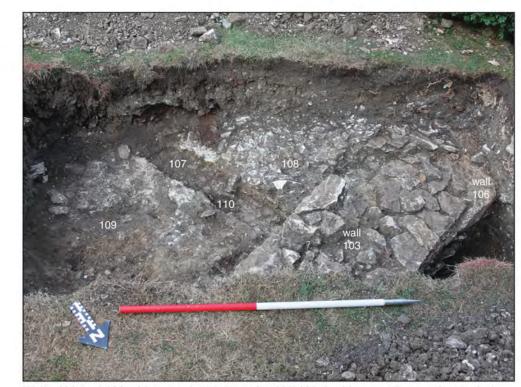
Walls 103 and 106 with associated deposits 107-109, looking south-west (scale 1m)

- Deposit 107 was subsequently overlain by a gravel and mortar deposit 109 and in turn by a fragmentary limestone deposit 108, both possibly representing floor foundation or floor deposits associated with wall footing 106. A shallow construction cut 105 through deposit 109 was associated with a widening of wall footing 106, as footing 103, to 0.7m in width. A single sherd of fourteenth to sixteenth-century AD pottery was recovered from between the uppermost courses of footing 103. A sand-clay backfill 104, containing three fragments of possible medieval window glass, lay within construction cut 105.

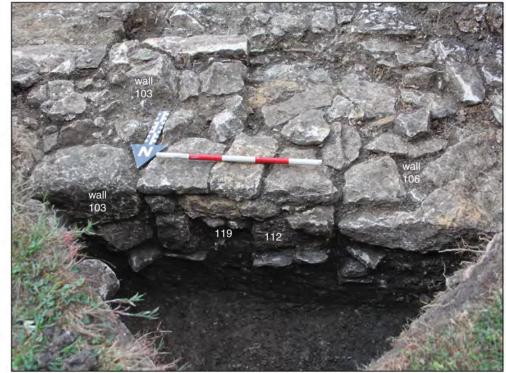
Walls 103 and 106 with a possible culvert structure 112, looking south (scale 0.5m)

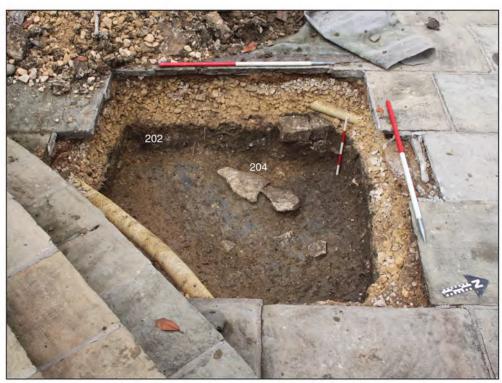
Soil horizon 202 and pit 204, looking north-west (scales 1m & 0.5m)

2.6 The natural geological substrate 203, comprised of gravel and clay, was encountered at the limit of excavation at 0.65m bpgl. It was overlain by a silt-clay soil horizon 202, containing one sherd of 11th to 13th-century AD pottery and four animal bone fragments, which was cut by a shallow pit 204, only partially exposed, with a clay-silt fill 205 which contained seven sherds of 19th-century pottery together with a clay pipe stem fragment, three pieces of glass, two iron nails and six animal bone fragments, and partially-exposed NE/SW-aligned dressed limestone blocks 206 suggesting a former wall footing. Overlying modern gravels 201 supported slab surface 200 of an extant patio.

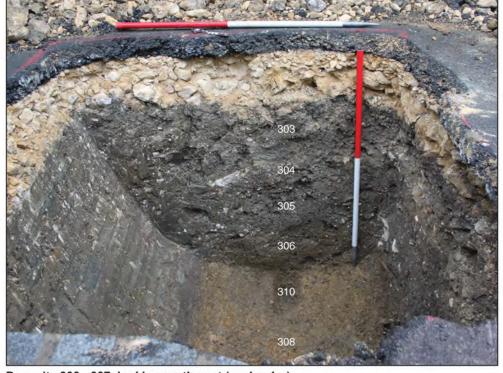
Deposits 300 - 307, looking north-east (scales 1m)

posthole could be discerned within an overlying, undated, clay soil 306, which was overlain by a series of sand-clay and sand-silt dump deposits 305, containing one sherd of late 18th to 19th-century AD pottery, 304 and 303. An overlying modern deposit 301 of fragmentary limestone supported the extant tarmacadam driveway surface 300.

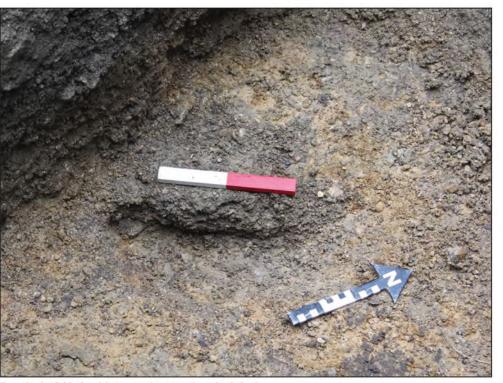
Posthole 310, looking north-west (scale 0.2m)

2.7 The natural geological substrate 307, consisting of compact gravels, was encountered at the limit of excavation at 1.2m bpgl. It was cut by two shallow circular postholes 308 and 310, with undated fills 309 and 311 respectively. No cut for either

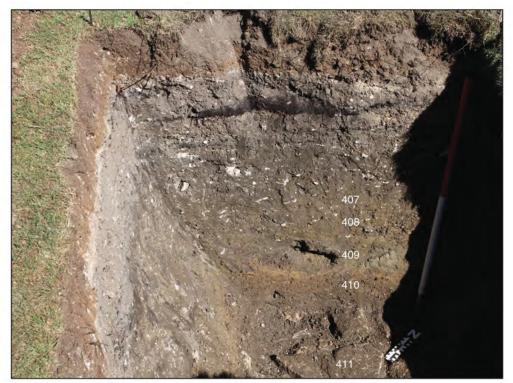
Deposits 400 - 411, looking north-west (scale 1m)

2.8 An undated horizontal spread of tightly-packed fragmentary limestone and clay 411 was encountered at the limit of excavation, at 1.35m bpgl. It was overlain by undated dump deposits 410, 409 and 408. Deposit 408 was covered by a stony gritty-clay 407, possibly a former soil horizon, which was in turn overlain by a series of dump deposits or external surfaces comprising a thin spread of black cinder 406, a sand-clay deposit 405, a black cinder spread 404, a sand-clay soil 403 and a mortar and fragmentary limestone spread 402. An overlying sand-clay soil horizon 401 was covered by topsoil 400.

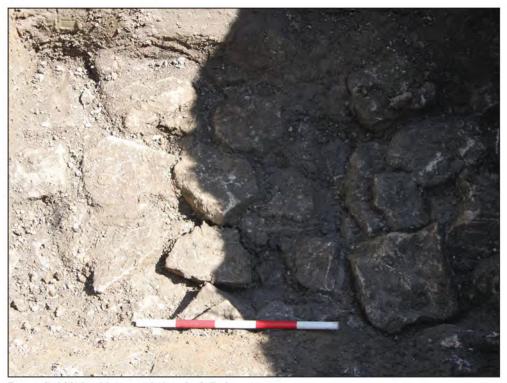
Deposit 411, looking north (scale 0.5m)

3.6 A small number of undated features were also recorded, comprising two postholes within Trench 3, stone spread 411 noted at depth in Trench 4 which may represent further structural remains associated with abbey buildings, a cut feature partially exposed in Trench 8, an east/west-aligned ditch in Trench 10 and cut features 1307 and 1314 in Trench 13.

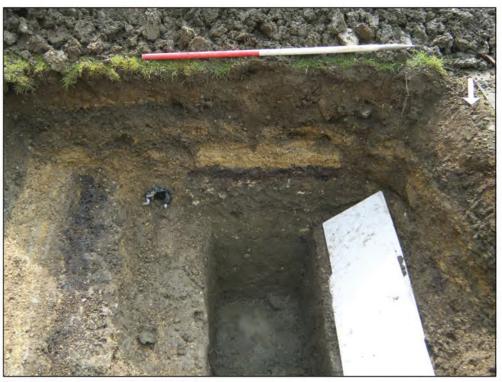
Trench 5, looking south (scale 1m)

2.9 The surface of a possible alluvial deposit, 517, was encountered at 1.26m bpgl and this deposit continued to the limit of excavation at 1.56m bpgl. It was overlain by 0.22m of made ground deposit 516, which contained pottery with a broad date range of 12th to 17th century, a clay pipe stem broadly dateable to the late 16th to late 19th centuries, two medieval/post-medieval brick fragments and quantities of animal bone. The clay pipe stem suggests a date no earlier than the late 16th century for this deposit, which was overlain by a further 0.18m made ground deposit, 515, which contained a sherd of Malvernian glazed ware pottery, which also had a broad range of production from the 14th to the early 17th centuries, limestone rubble and animal bone. Deposit 515 was covered by undated clay soils 508 and 509, measuring 0.23m in thickness, which were overlain by black cinder and clay layer 507. This was covered by a sand and gravel make-up layer 503 which supported hard, compact, smooth sandy mortar surface 502. The surface was subsequently cut by two north/south-aligned service trenches 504 and 510 containing pipes 506, 511, 512 and 513 and backfill deposits 505 and 514 respectively. An overlying garden soil 501 was sealed by topsoil 500.

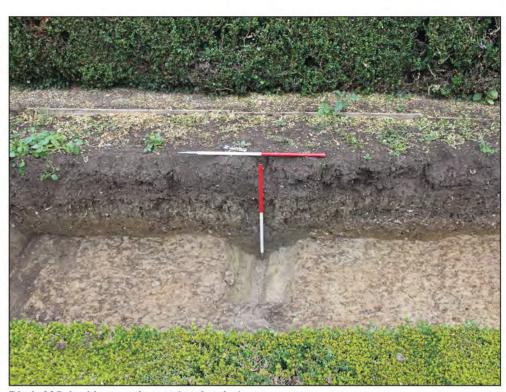
Ditch 605, looking north-east (scales 1m)

2.10 The natural geological substrate 604, comprised of gravel and clay, was encountered at the limit of excavation at 0.65m bpgl. It was overlain by sand-clay soil horizons 603, containing one sherd of Romano-British pottery, 602 and 601, the latter cut by a northeast/southwest-aligned ditch 605 with steeply-sloping edges and a flat base. Ditch 605 contained a sand-clay fill 606, from which one sherd of Romano-British pottery and three animal bone fragments were recovered, sealed by modern cultivation soil 600.

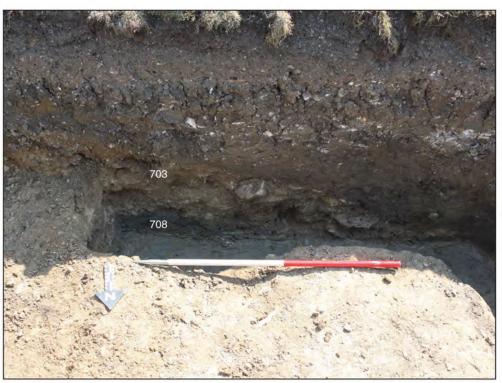
Possible demolition material 703, looking south (scale 1m)

- 2.12 Alluvial deposit 708 was overlain by a layer of mortar and fragmentary limestone 703 which yielded a sherd of 17th to 18th-century pottery, three post-medieval plaster fragments, four fragments of post-medieval brick, a piece of post-medieval glass, a piece of fired clay and eight iron fragments. The nature of deposit 703 suggests that it may represent demolition debris from a former stone building. It was cut by an east/west-aligned ditch 705 with a V-shaped profile and gently-sloping sides and a concave base. It contained a primary silt-clay fill 709 which produced one sherd of 14th to 16th-century AD pottery and a residual fragment of Romano-British box flue. Secondary silt-clay ditch fill 704 and tertiary fill 706 (n.i) were undated but uppermost ditch fill 707 contained one sherd of 14th to 16th-century AD pottery, one residual Roman roof tile fragment, three animal bone fragments and one shell fragment. Ditch fill 707 was overlain by a silt-clay garden soil 701 and by topsoil 700.

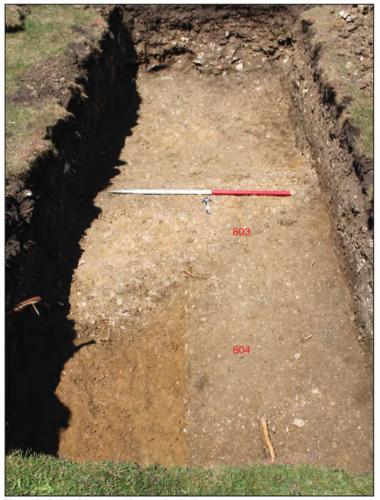
Trench 8, looking north (scale 1m)

2.13 Natural gravels 802 were encountered at the limit of excavation at 0.75m bpgl. They were cut by a shallow, undated, east/west-aligned feature 803, only partially revealed, containing a primary clay fill 805 and a secondary silt-clay fill 804. The latter was overlain by a garden soil 801 which was in turn overlain by topsoil 800.

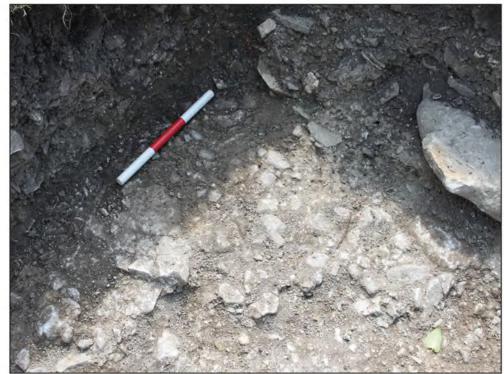
Detail of deposit 902 in the south-west corner of the trench, looking west (scale 0.3m)

2.14 At the limit of excavation, at 0.55m bpgl, a relatively level, compact, deposit of fragmentary limestone, gravel and mortar 902, possibly representing a floor foundation deposit or external stone surface, yielded two post-medieval brick or tile fragments, three post-medieval iron nails, one animal bone and one shell fragment from its surface. It was overlain by garden soil 901 and topsoil 900.

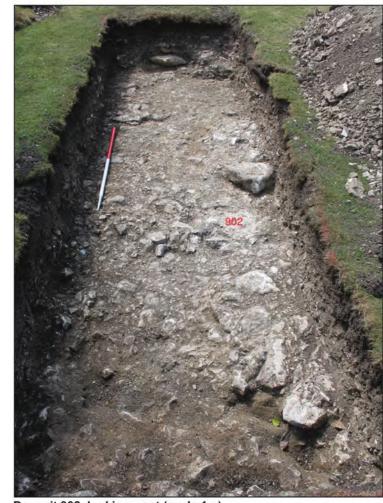
Deposit 902, looking west (scale 1m)

as well as iron nails, were recovered embedded within surface 902 in Trench 9 although it remains uncertain from the limited view afforded by evaluation trenching whether this is a medieval surface or whether any earlier, potentially medieval, structural remains are present beneath it. A French jetton dating to AD 1340 was recovered from floor and possible wall remains 1103, and one medieval pottery sherd from overlying demolition debris 1102, in Trench 11.

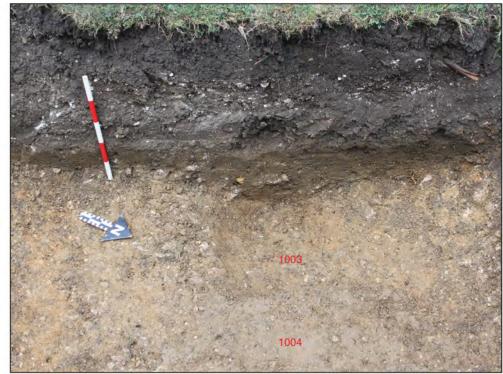
Ditch 1003, looking south-west (scale 0.5m)

2.15 At the limit of excavation, at 0.45m bpgl, natural gravels 1002 were cut by a northeast/southwest-aligned U-shaped ditch 1003 with moderately-sloping sides and a concave base. It contained a single undated fill 1004 which yielded one animal bone fragment. An area of tree root disturbance 1005 was also noted. Ditch 1003 was overlain by a garden soil 1001 and topsoil 1000 which yielded one sherd of late 17th to 18th-century pottery, two residual medieval pottery sherds, one iron object and 12 animal bone fragments.

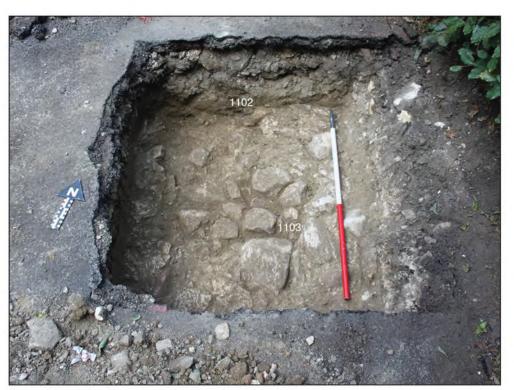
Deposit 1103, looking north (scale 1m)

2.16 At the limit of excavation, at 0.5m bpgl, a relatively level, compact, deposit of fragmentary limestone, gravel and mortar 1103 was noted. The deposit yielded a copper alloy French Jetton (token) dated to 1340 AD. An overlying stone and mortar deposit 1102, likely to represent demolition debris from a former building, produced one medieval pot sherd and two fragments of medieval brick or tile, six iron objects and two animal bone fragments. It was sealed by modern gravels 1101 supporting the tarmacadam surface 1100 of the extant driveway.

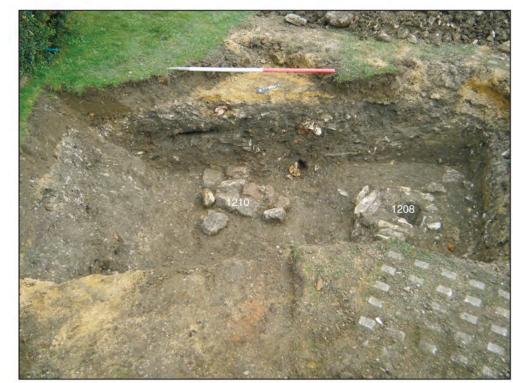
Wall foundation 1210, postpad 1208 and robber trench 1204, looking east (scale 1m)

2.17 Made ground deposit 1206 was encountered at 0.57m bpgl. This was overlain by north-west/south-east aligned rubble wall footing 1210. Construction cut 1207 also cut deposit 1206 and contained post pad 1208, comprising pitched limestones in a yellowish grey clay matrix and clay construction backfill 1209. Post pad 1208 had been disturbed by small rectangular cut 1211, probably resulting from the removal of one of the pitched stones. Backfill 1212 contained a fragment of bottle glass and a copper alloy wire pin both dating to the post-medieval period. The wall foundation

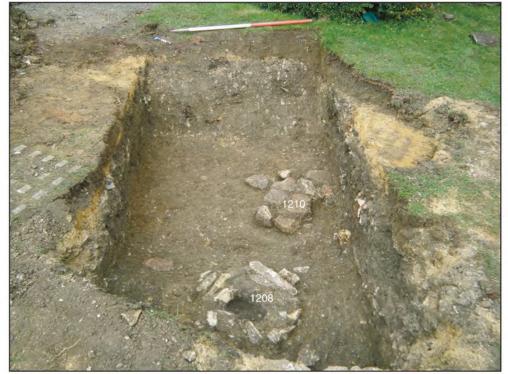
Wall foundation 1210 and postpad 1208, looking north-east (scale 1m)
