Great Wilbraham Solar Farm Cambridgeshire

Archaeological Evaluation

CA Project: 660285
CA Report: 14267

June 2014

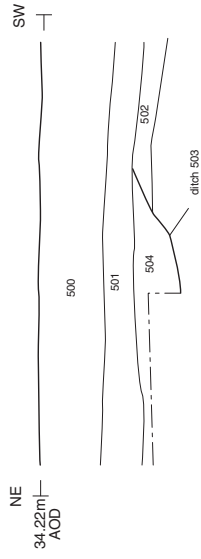
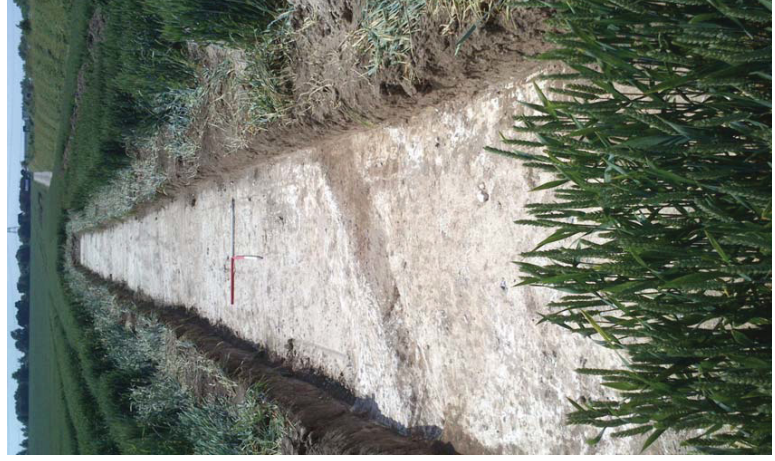
Section AA

- 2.9 Shallow curvilinear ditch 503 (T5; Fig. 3) was aligned east/west, turning to the north-east at its eastern end. This ditch was 0.46m wide and 0.16m deep. Its single fill comprised sandy-clay with flint inclusions. North-west/south-east-aligned ditch 603 (T6) was 0.83m wide at its broadest point and 0.22m deep, with a single fill similar to that in ditch 503. It was unclear if this ditch terminated in the trench, or if it had been truncated by ploughing. Both of these ditches were in an area of plough line cropmarks displaying a general north/south linear trend, although a faint north-west/south-east component is also visible.

Trench 5 looking south-west along the trench with ditch 503 in the foreground (1m scales)

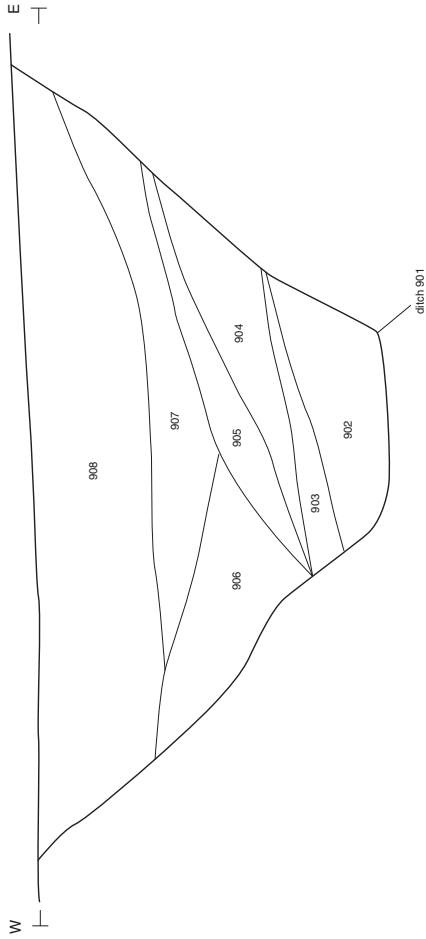
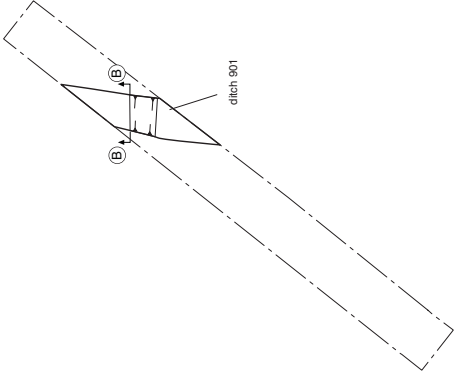
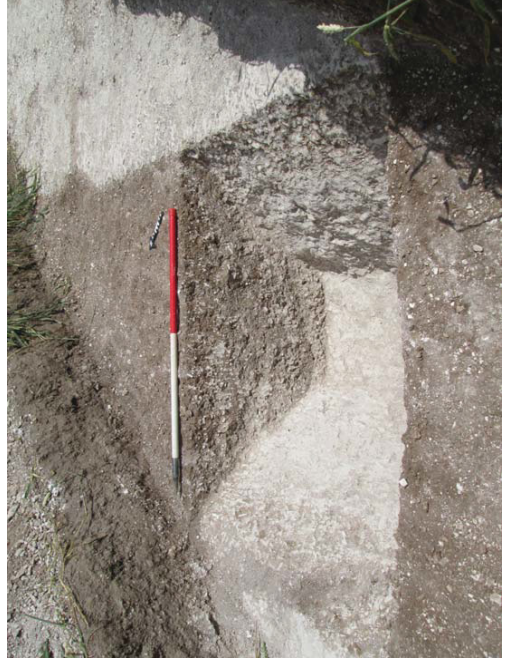
Trench 9: plan, section and photograph

- 2.7 Four ditches were recorded at the site. North-east/south-west aligned ditch 901 (T9; Fig. 4) measured 1.5m in width and 0.68m in depth. It contained a sequence of chalk rubble deposits sealed by a dark silty layer. Its profile was a blunted v-shape. There was no clear cropmark feature corresponding with this ditch.

Ditch 901, looking north (1m scale)

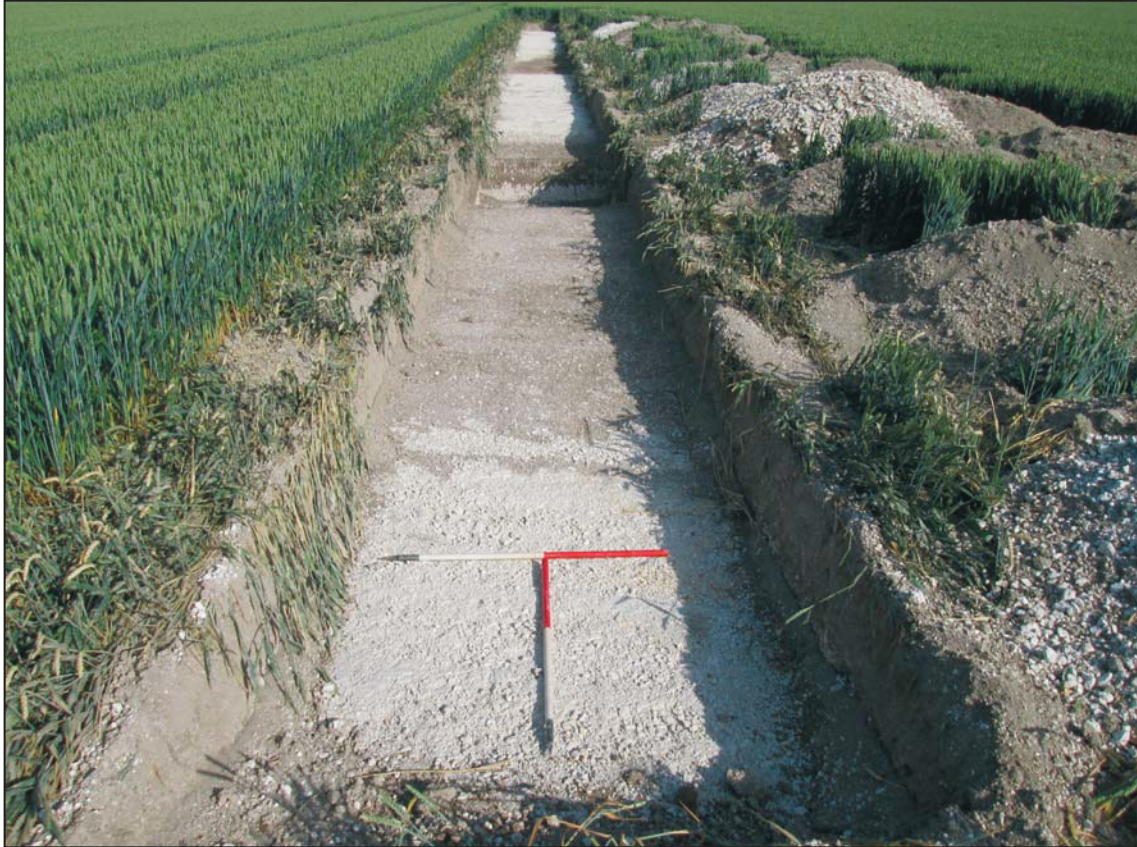
- 2.12 Four large pits were recorded in T12, T24 and T30. In line with the evidence for previous chalk extraction in the area (see *Historic background*, above), these pits were interpreted as post-medieval/modern quarry pits. Pit 1203 (T12; Fig. 5) measured 9.6m in diameter; it was unexcavated. Pit 1205 (T12; Fig. 5) was 12.1m in diameter and 0.65m in depth. Pit 2403 (T24; Fig. 8) was 10.2m long, over 6.8m

- 2.13 The fills of pits 1205 and 2403 were very similar and comprised a sequence of silty layers containing frequent angular chalk and flint inclusions. These layers had been deposited slowly over time, probably as a result of ongoing upcast from adjacent ploughing.

- 2.15 Pits 1203 and 1205 corresponded with clear, pit-like cropmarks. Pit 3003 lay within a dark area visible in the cropmarks, but had no relationship with the more obvious pit-like cropmark visible towards the centre of T30 (no feature corresponding to this cropmark was recorded in the trench). There were no clear cropmarks in the area of T24 matching pit 2410.

5 Trench 12 looking north-west showing quarry pits 1203 and 1205

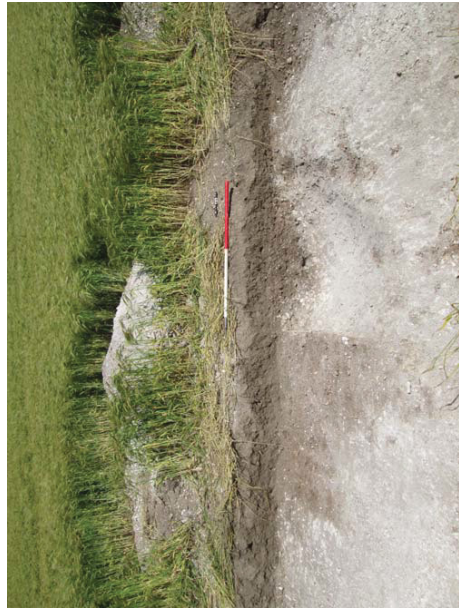
- 2.10 The evaluation recorded a series of undated pits in the northern field. None of these features were visible as cropmarks. Pit 2308 (T23; Fig. 7) was 1.1m in diameter and 0.22m in depth. Pit 2310 (also T23; Fig. 7) had a diameter of 0.45m and a depth of 0.12m. Pit 2703 (T27; Fig. 9) was 0.9m by 0.7m in plan and 0.12m deep. Each of these three pits contained single silty/chalky fills. Pit 1802 (T18; Fig. 6) was 1.85m wide and 0.36m deep, with a weathered chalk lower fill and a silty upper fill. Pit 1805 (also T18; Fig. 6) was 1.5m wide and 0.42m deep, with a similar sequence of fills.

Pit 1802, looking east (1m scale)

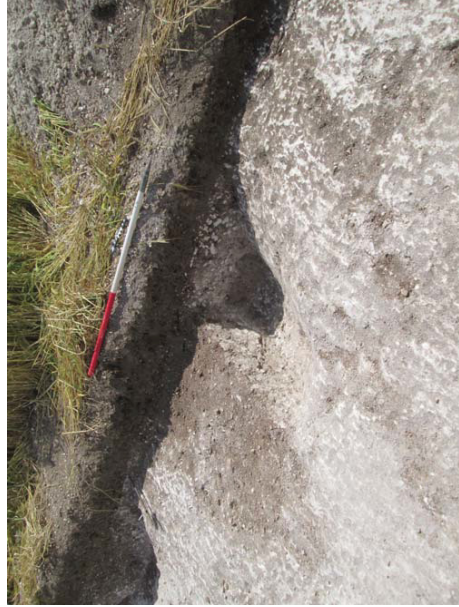
Pit 1805, looking north-east (1m scale)

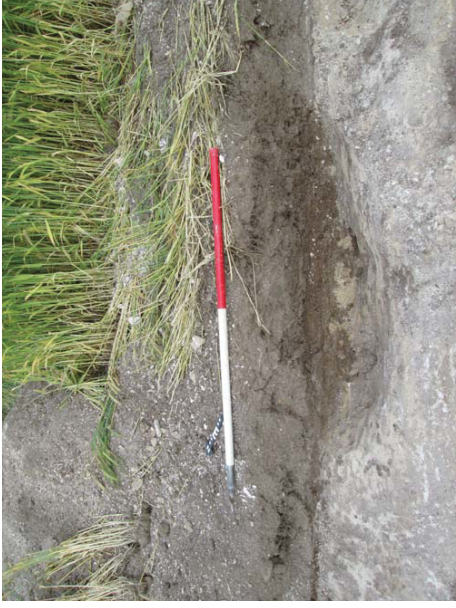
Pit 2308, looking north-east (1m scale)

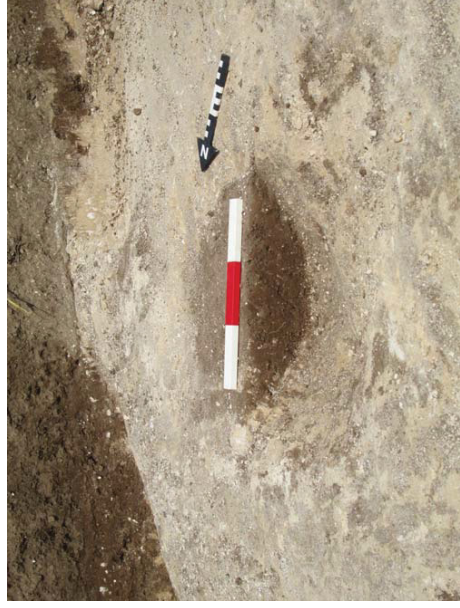
Pit 2310, looking east (0.3m scale)

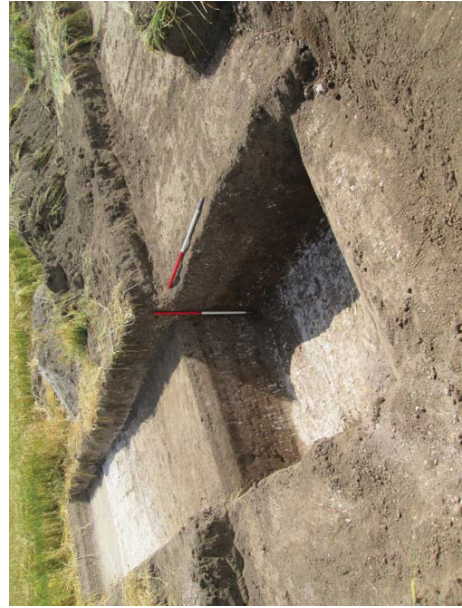
wide, and 1.18m deep. Pit 3003 (T30; Fig. 11) measured 13.62m in length, 11.2m in width and 1.85m in depth.

Quarry pit 2403, looking east (1m scales)

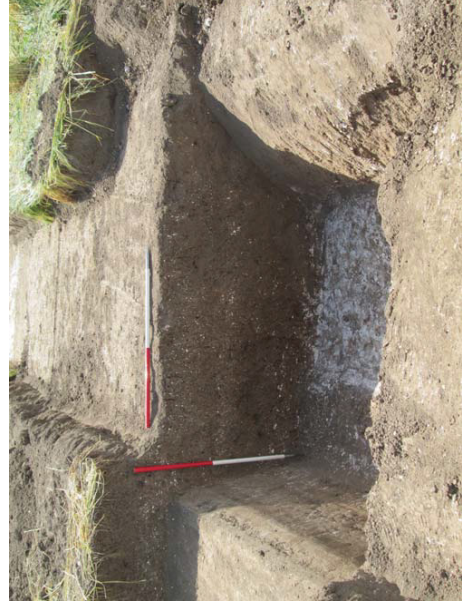
Quarry pit 2403, looking south-west (1m scales)

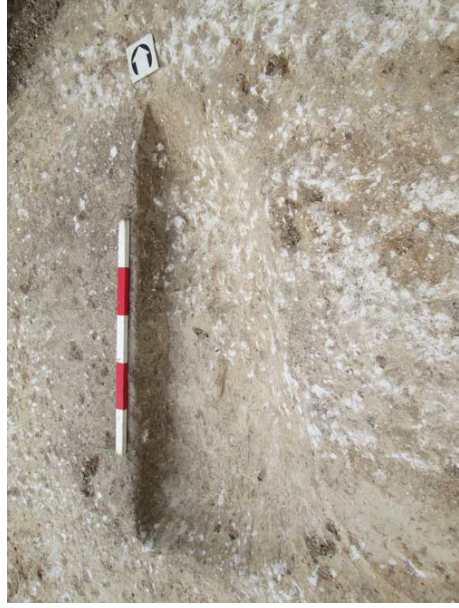
Pit 2703, looking west (0.5m scale)

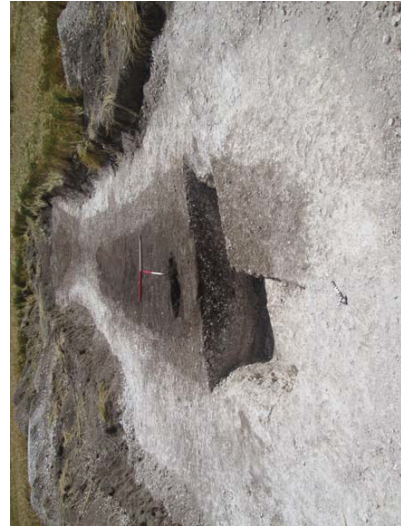
- 2.8 The terminus of ditch 2903 was exposed in T29 (Fig. 10). This north-west/south-east-aligned ditch was 3.35m wide and 0.92m deep, with vertical sides and a flat base. The terminus was broad and square, with rounded corners. Its fills comprised an alternating sequence of chalk rubble and darker silty deposits. Ditch 2903 was on the same alignment as two short linear cropmarks passing through T29, although it not correspond in location with either of them.

Trench 29 extension, showing ditch 29003, looking east (1m scales)

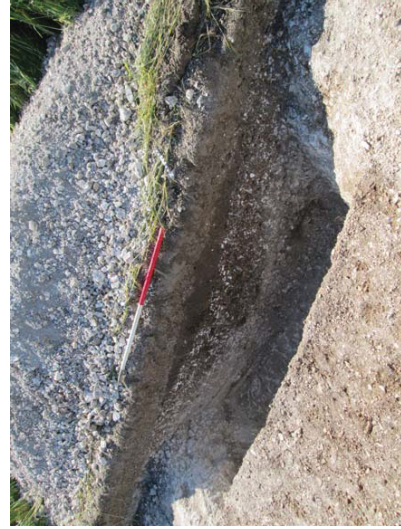
North-west facing section of ditch 29003, looking south-east (1m scale)

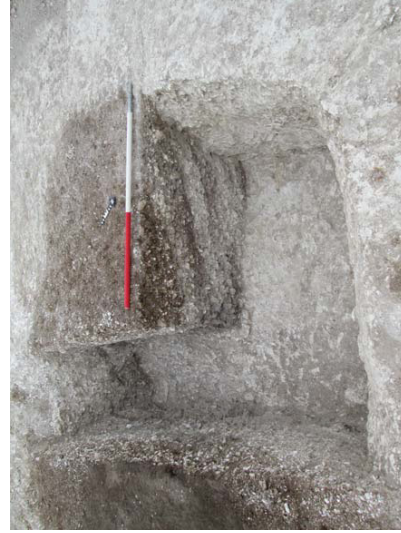
North-east facing section of ditch terminus 29003, looking south-west (1m scale)

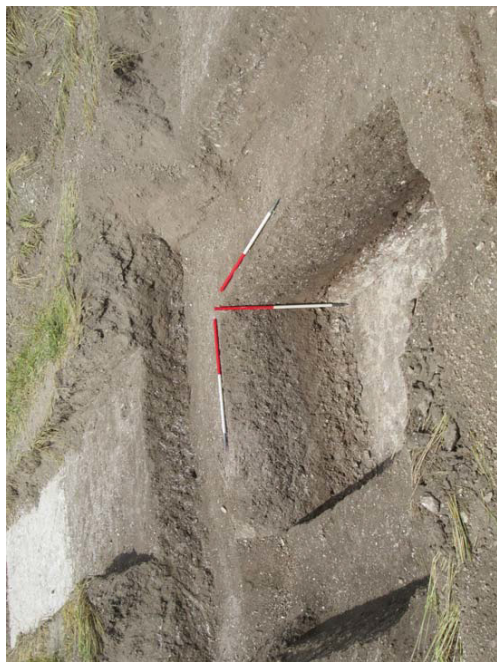
- 2.14 Pit 3003 contained a basal fill (3009) of broken flint nodules in a silty sand matrix, which was covered by 0.27m of gravelly inwash (3010) and brown sandy material (3008). These layers were sealed by a 0.08m-thick dark silty deposit (3007), which was sealed in turn by a further sequence of silty layers similar to those recorded in pits 1205 and 2403. It is possible that dark silty layer 3007 represented a buried topsoil horizon, which would indicate that the partially-infilled pit earthwork was open long enough for a topsoil layer to build up within it.

Trench 30 extension, showing quarry pit 3003 looking east (1m scales)
