**Land at Wellbrook Way
Girton
Cambridgeshire**

Archaeological Evaluation

CA Project: 660313
CA Report: 14347

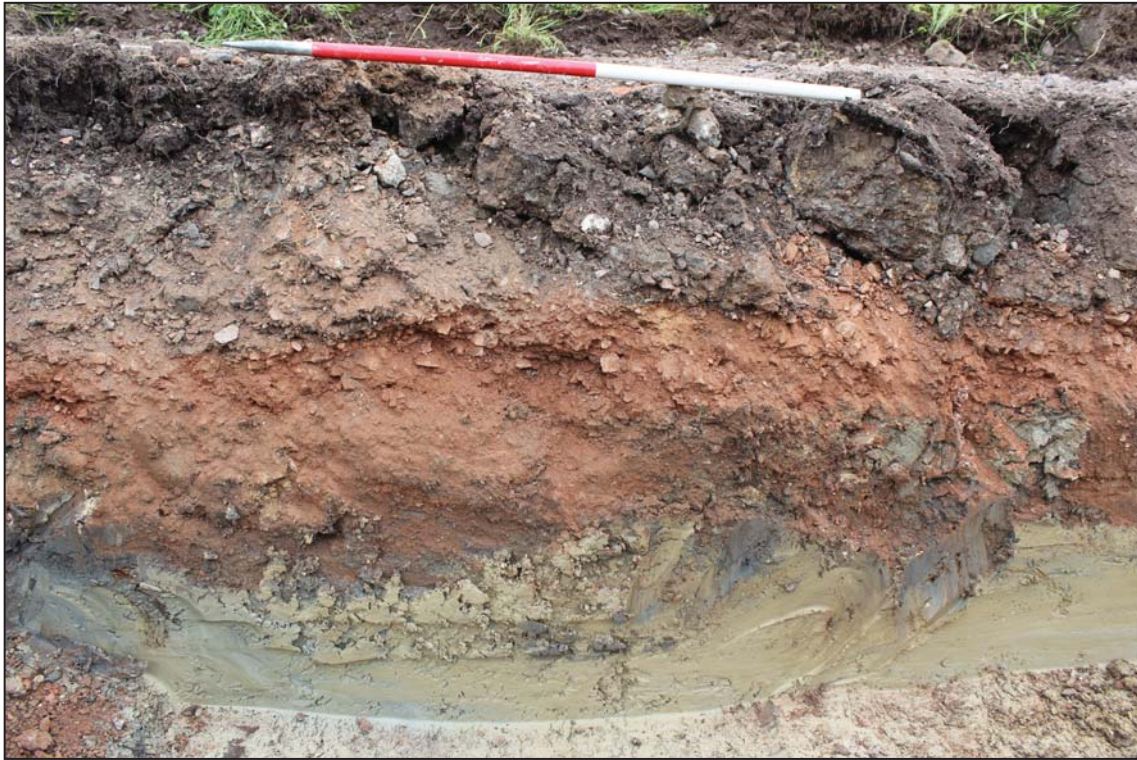
- 2.3 The natural substrate was exposed 1.25m BGL and was sealed directly by modern made ground deposits. No archaeological features or deposits were exposed, and no pre-modern artefacts were present.

3 Representative section of Trench 1, facing south-east (scale 1m)

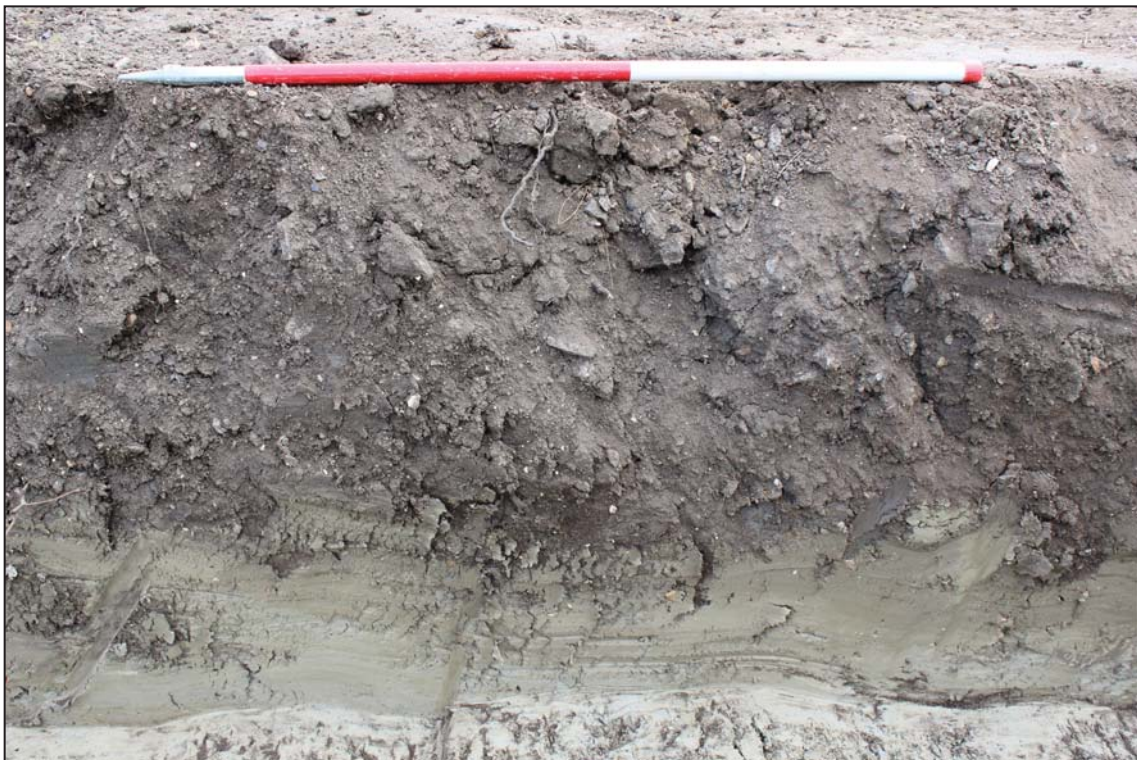
- 2.8 The natural substrate was exposed 0.6m BGL and was sealed directly by modern made ground deposits. No archaeological features or deposits were exposed, and no pre-modern artefacts were present.

4 Representative section of Trench 6, facing south-west (scale 1m)

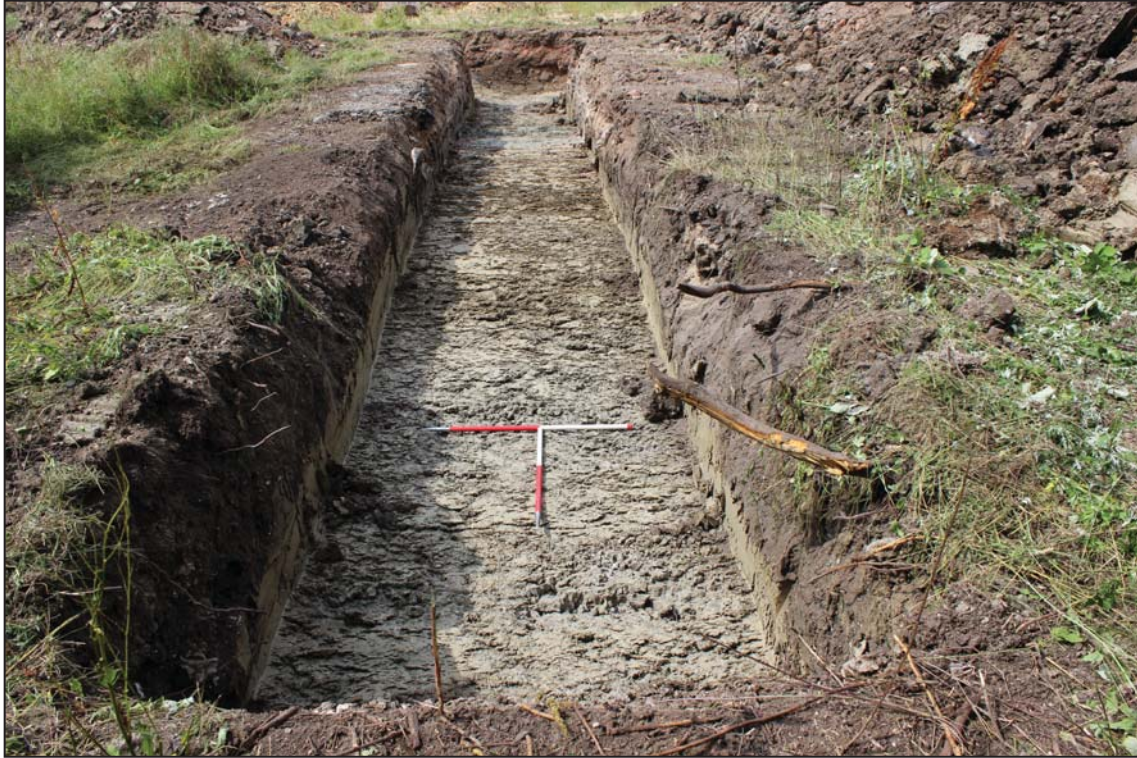
- 2.7 The natural substrate was exposed 0.95m BGL and was sealed directly by modern made ground deposits. No archaeological features or deposits were exposed, and no pre-modern artefacts were present.

5 Trench 5, looking north-west (scales 1m)
