**Allen House
Ashley Down
Bristol**

Archaeological Watching Brief

CA Project: 3906
CA Report: 12258

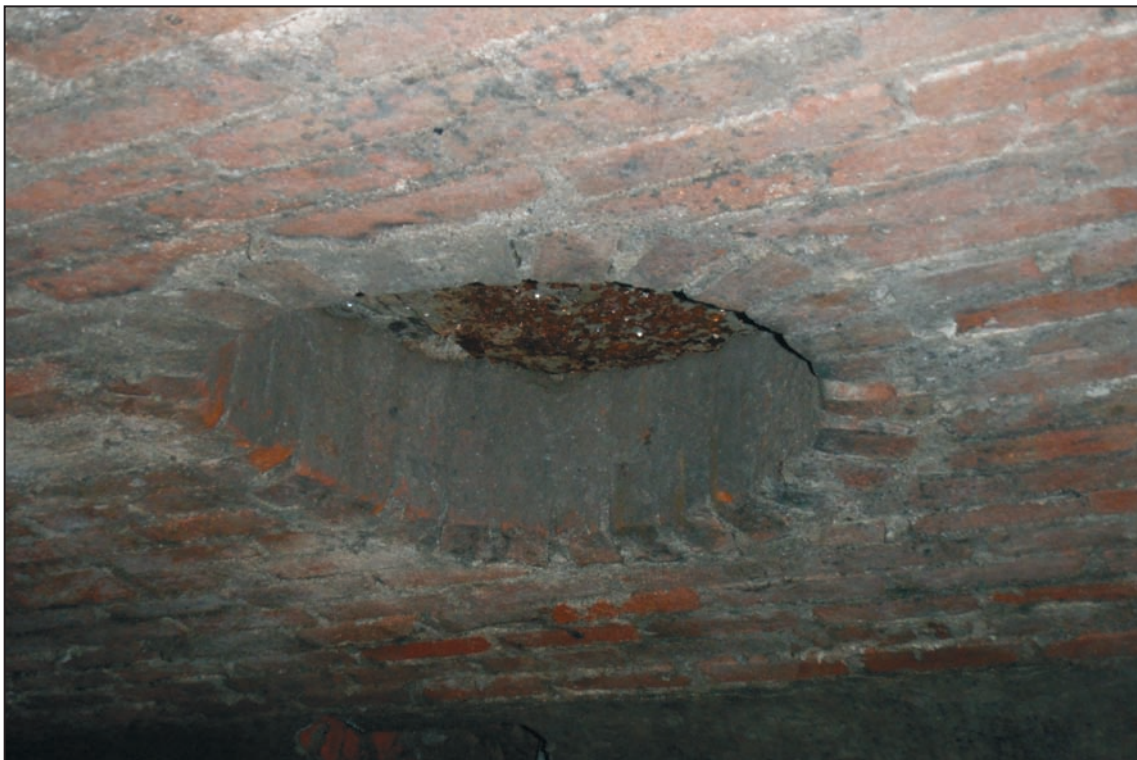
5 Circular access to cistern 501, viewed from below

- 2.6 Two brick-built water cisterns, 501 and 502, were recorded under the floor of Wing A of the orphanage (Fig. 5). They were rectangular in plan with shallow, barrel-vaulted roofs, measuring 6.7m in length and 4m in width, and were connected by an approximately 1m high access hatch through their adjoining wall (Fig. 6). Each cistern had a 1m diameter circular access in its roof (Fig. 7). The cisterns were located underneath rooms labelled 'wash house' and 'laundry' on Foster and Sons' architect's plan of the orphanage (Fig. 3); it is unclear whether they functioned as water storage for the laundry, or as drainage. The most probable function nonetheless, is as general water storage for the orphanage as a whole, perhaps collected rain water.

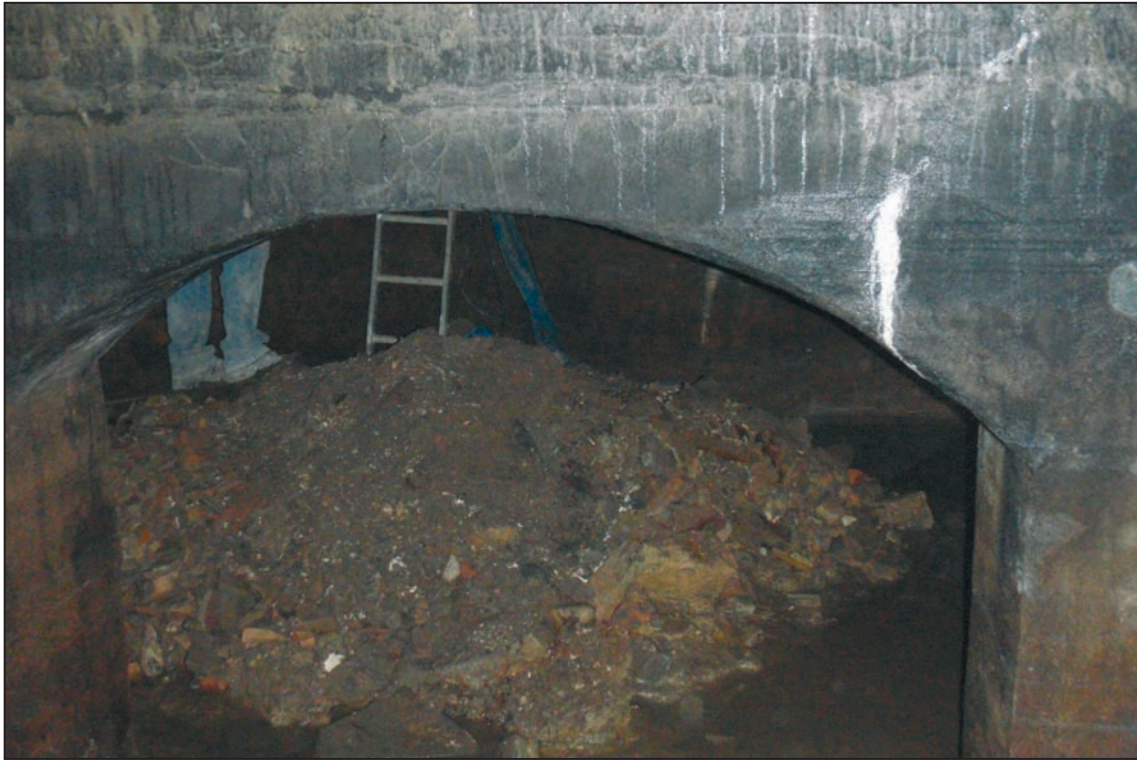
6 Connection between cisterns

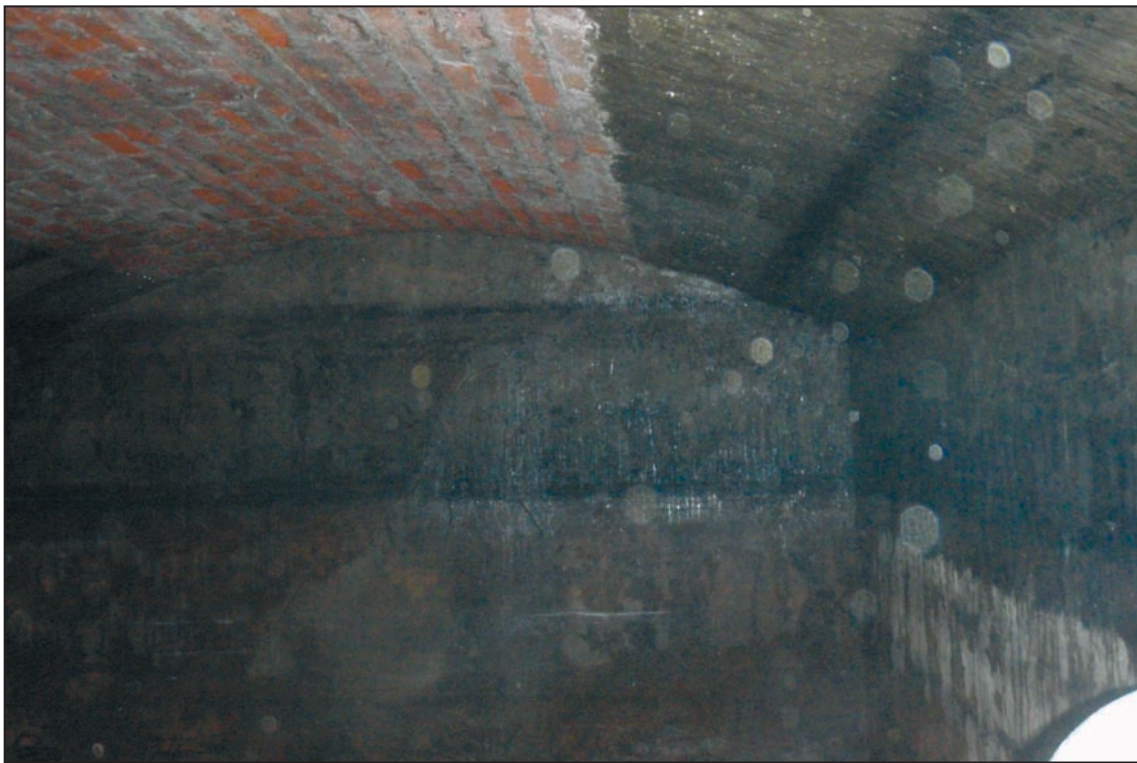
7 The interior of cistern 502

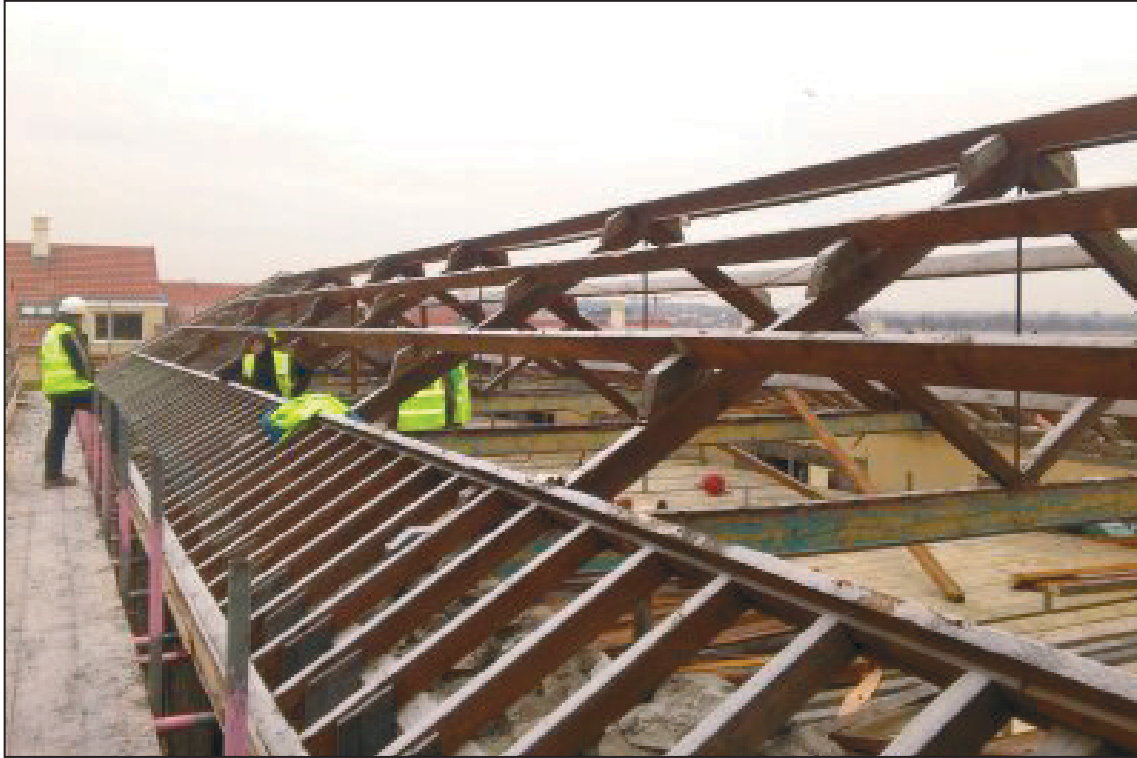
8 Typical roof structure of the main ranges at Allen House, here Wing B, looking north-west

were seen to be of a standard mid 19th-century design. These were straightforward, low-pitched, principal-rafter roofs, each truss being a simple tie beam and principal with raking struts, and a tensioned iron bar in place of a kingpost (Fig. 8). Each roof slope had three purlins resting on the back of the rafters supported by cleats, as was the ridge purlin. Jack rafters neatly jointed into the lowest purlin and below the common rafters, supported a gutter fascia and eaves boards under the projecting eaves (Fig. 8). Ceiling joists were simply jointed from tie beam to tie beam.

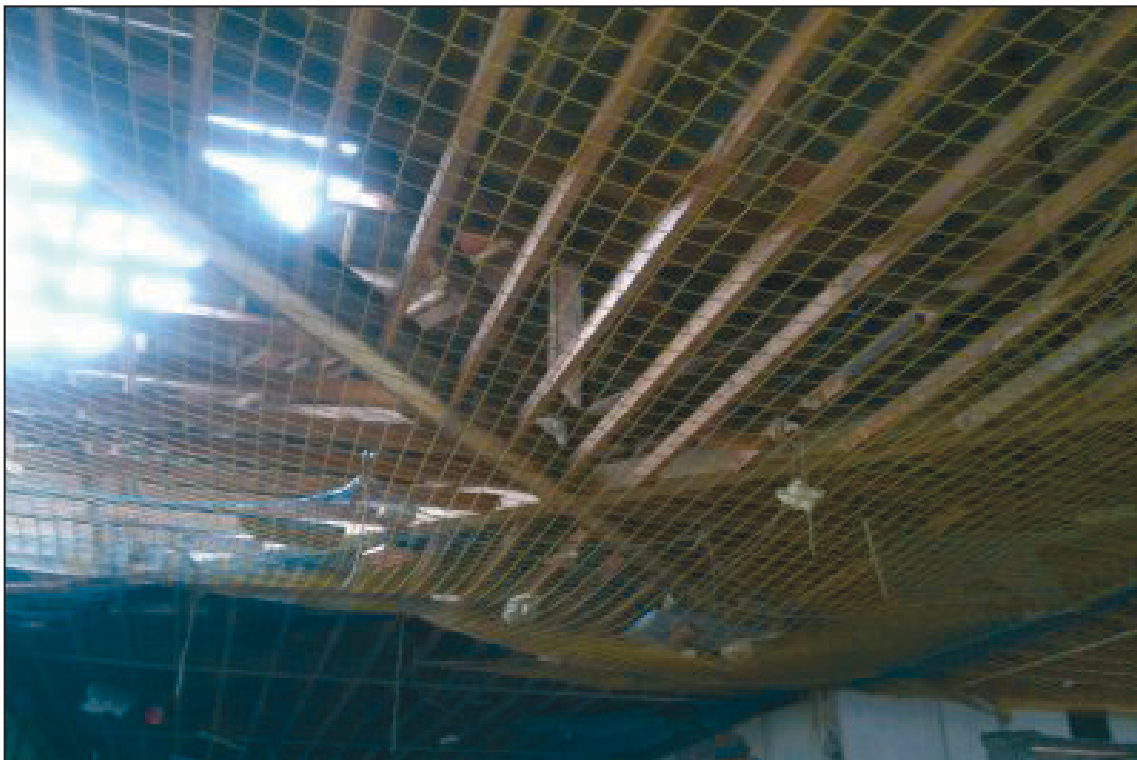
9 Diagonal trusses over the junction of Wings G and D, looking south-east

- 2.8 At the junction of equal height wings (Wings G and D), a full kingpost truss was laid across each diagonal, the shared kingpost being set at 45° to each truss (i.e. parallel with the wings themselves), the four raking struts rising from its haunched base to the principals (Fig. 9).
- 2.9 Further photographic records were made of the post-war steel-framed roof over the single-storey Wing A, but this was a typical and unremarkable example of its kind.

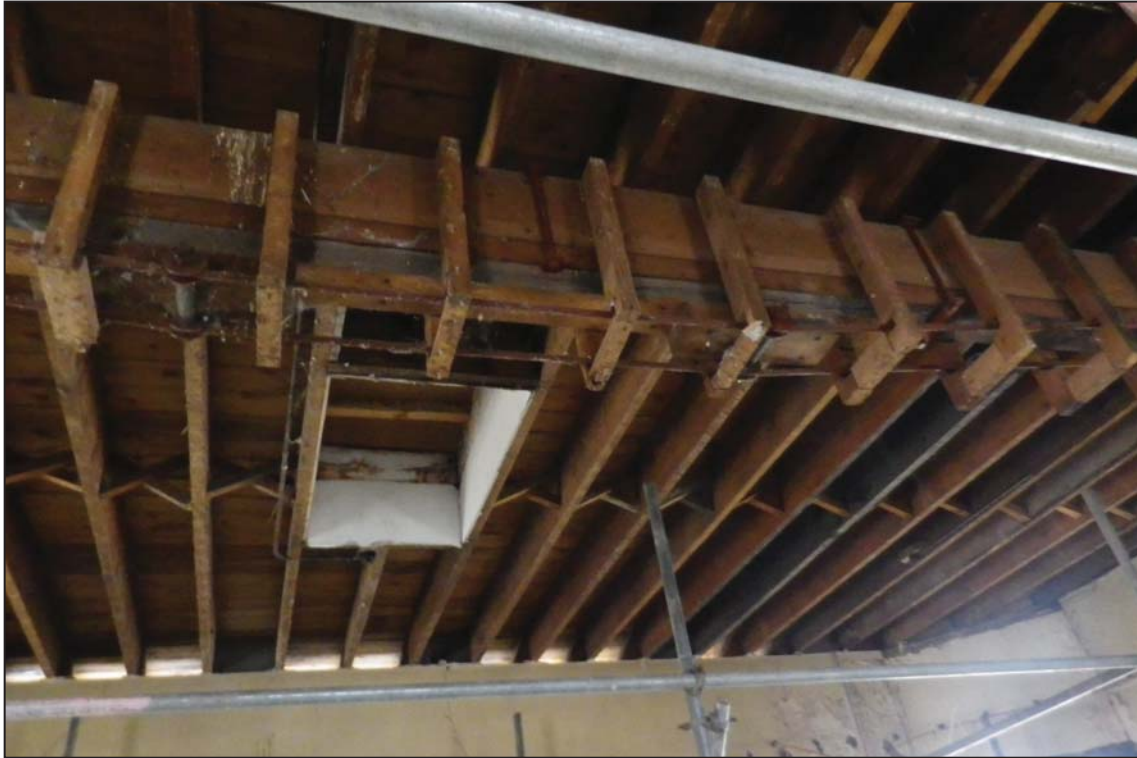
10 One of the pair of trussed beams in the top floor of the central octagon

The beams were of composite construction, two lengths of softwood, side by side, joined by bolted iron saddles and strengthened by a pair of composite tensioning rods running alongside and then below the beam (Fig. 10). The rods were each of three lengths linked together by bolts through expanded lugs at the ends. The lower, horizontal lengths of the rods were stood off from the underside of the beam by two baulks of timber above each linking bolt. This stressed beam construction became popular in the 1840s, although experiments along these lines can be found in the 18th century, using different woods rather than iron. Wendel Bollmann patented this system in the United States in 1851 but had already used a version in 1838 (Vogel 1964). More pertinently, Brunel used it in the earliest phase of the GWR works at Swindon, by 1843 (Cattell and Falconer 2000, 25 and Fig. 30).

These beams supported the lantern over the original cupola, a now-vanished tower structure rising up through the latter, relieving it of load.

It is not clear if metal boxes were employed for the beam ends, although some form of iron fixing for the rod ends does appear in the photographs. The bracing is obviously less sophisticated than the example given by Fidler, but the principle is the same, and presumably reflects the parsimony necessary in building the orphanage.

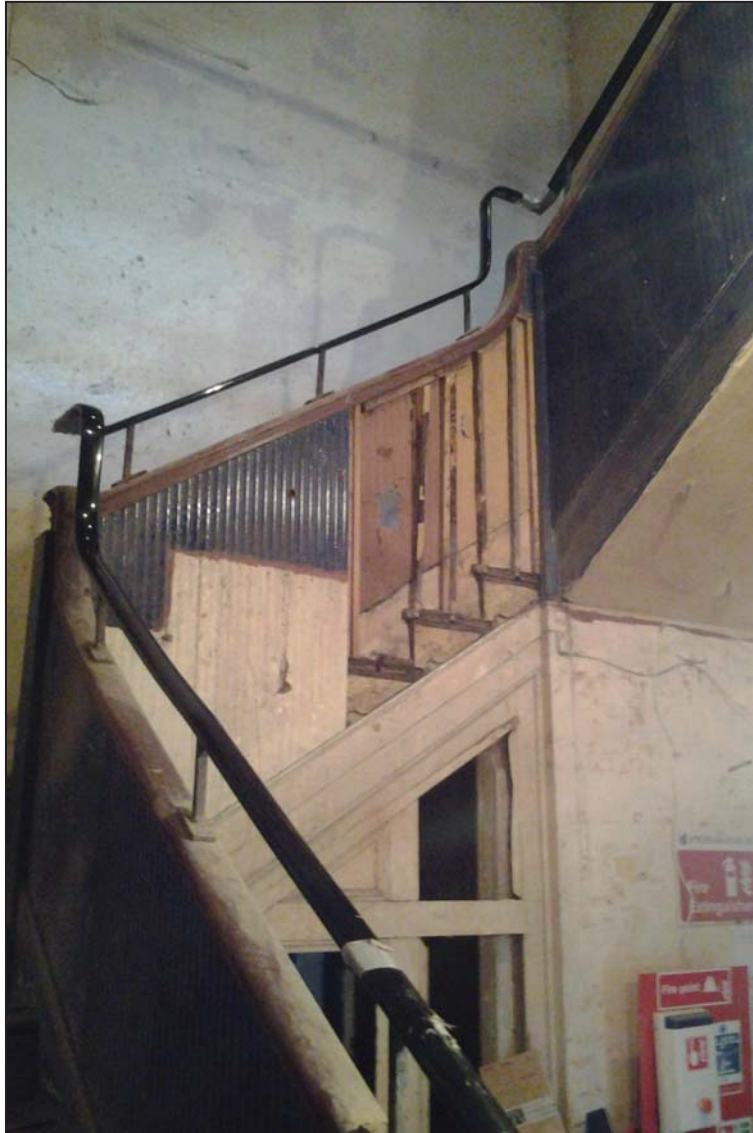
11 The lower flights of the main stair in Wing F

The main stair in the south-western wing was also noted in the original report but the balusters were still clad in fluted fibreboard. The removal of some of this material revealed the simple iron stick balusters, which were also employed in the other stairs in the wings, although this main stair had turned wooden newel posts, and a polished hardwood handrail (Fig. 11). This is to be raised to meet present safety regulations, these having been previously met by the addition of a rail above the original.
