**Belgrave Flyover
Belgrave Road
Leicester**

Historic Building Recording Survey

CA Project: 660226
CA Report: 14136

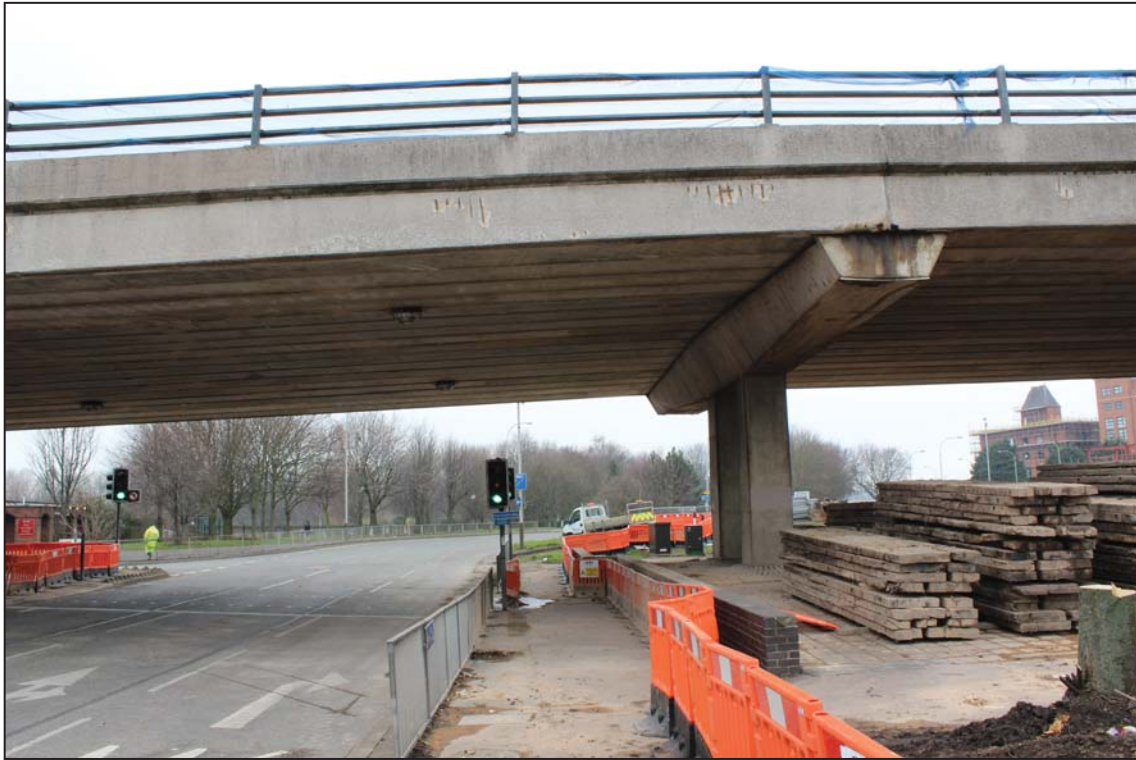
- 3 The crosshead/piers and the pre-cast road deck. The stacked concrete planks are the sawn-up road deck.
- 4 The poured-in-situ posts and crossheads and the underside of the pre-cast road-deck beams. The removal of the road deck has allowed the separate nature of the beams to be appreciated.

- 2.1 The flyover was found to be a combination of poured reinforced concrete structure with pre-cast concrete elements (Fig. 3). The road deck was made of the latter, with close-set parallel beams spanning cast *in situ* cantilevered beams (crossheads) on paired posts (Fig. 4).

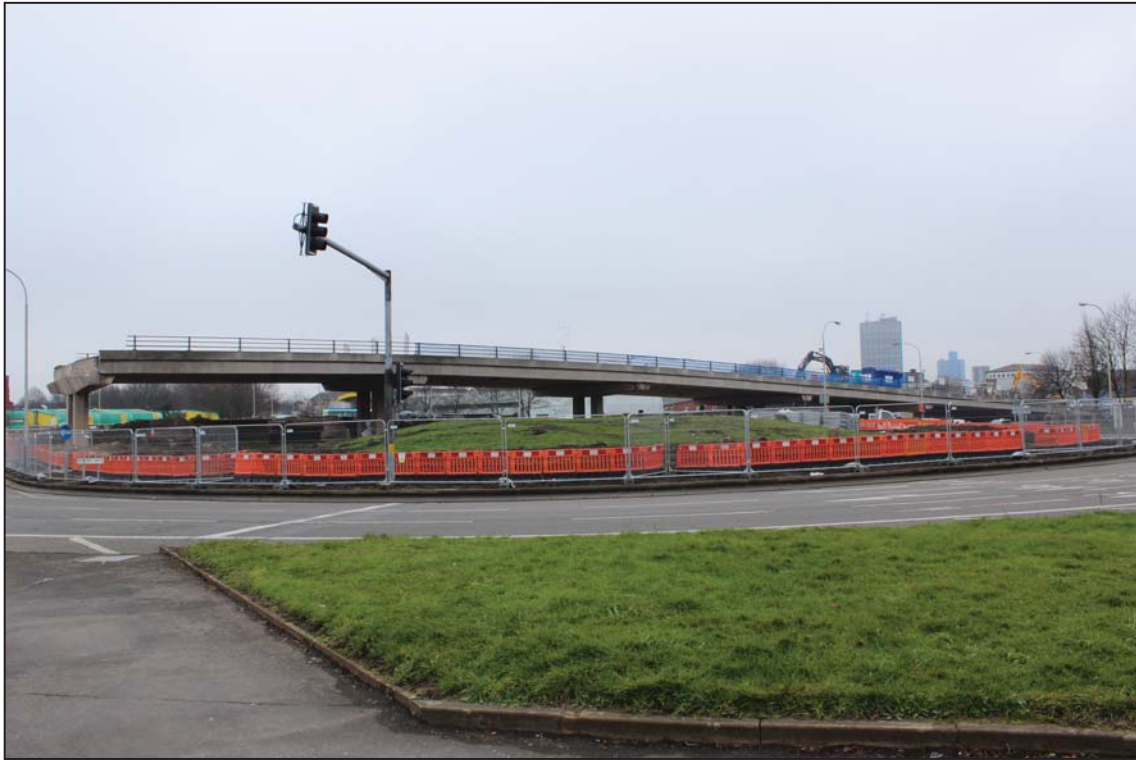
- 5 The southern half of the flyover, showing its general character..
- 6 One of the approach ramps, showing the solid side walls at the base and the side panels.

- 2.2 There were seven supporting crossheads and eight open spans reached by ramped sections at each end (Figs. 5 and 6). The sides of the deck were finished with pre-cast panels of rough-cast textured concrete (Fig. 7). In the end ramps (from almost ground level to a metre high), these panels reached the ground and formed a wedge-shaped cover to the poured, reinforced side walls of the end ramps which were formed in foundation trenches (Fig. 8). The next two bays were closed in with curtains of deeply-ridged concrete panels set some distance in from the edge (Figs 7 and 9). The main spans were completely open.

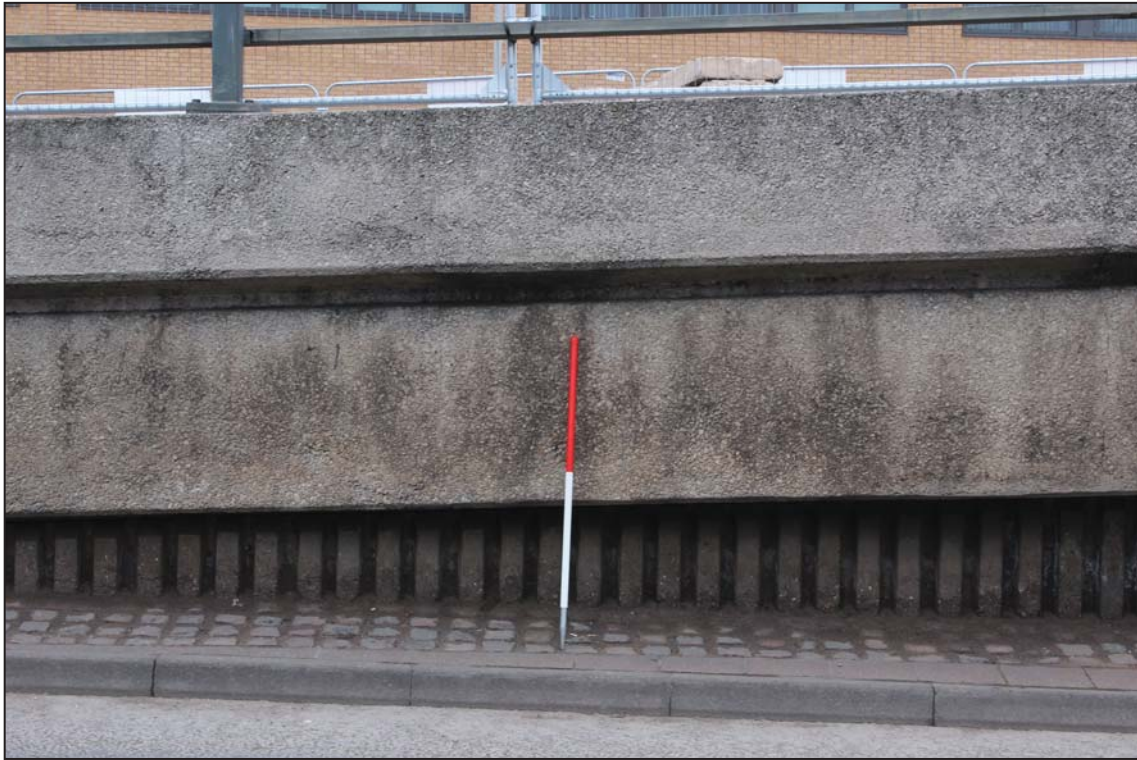
7 The textured pre-cast side panels of the flyover (and the deeply ridged poured base walls) (scale 1m).

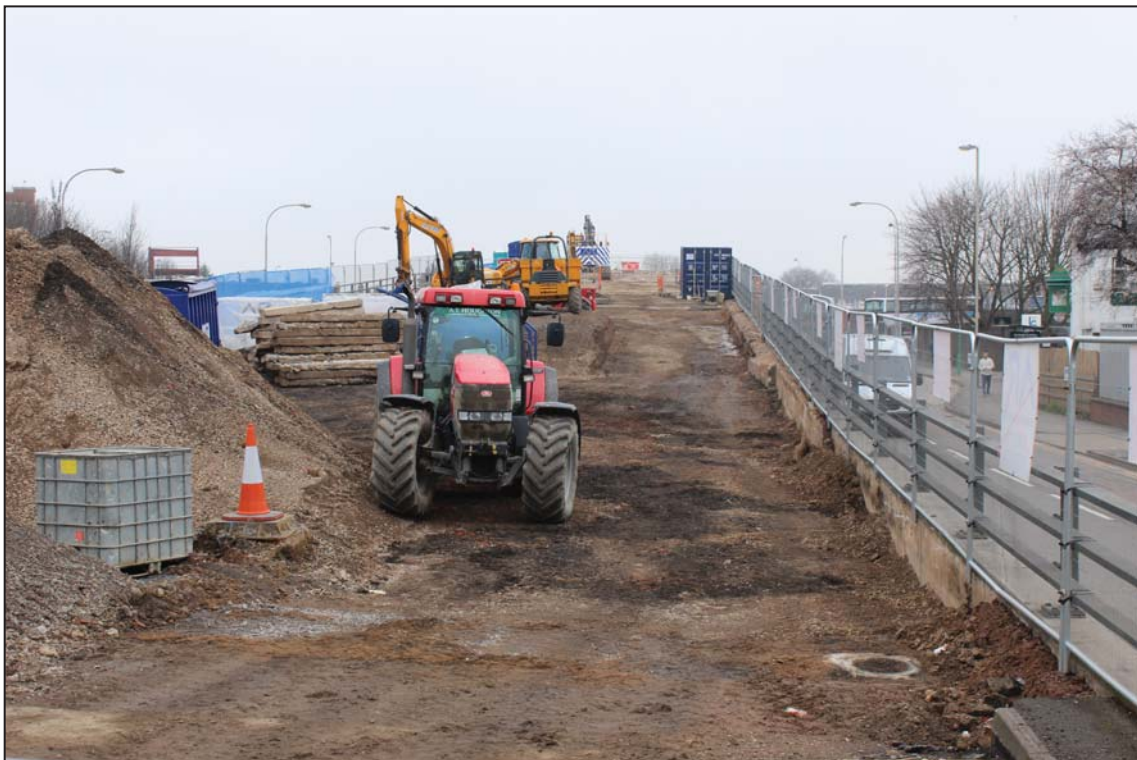
8 The side walls of the flyover at the base of the ramps, road deck removed. Note that they end before the container in the distance.

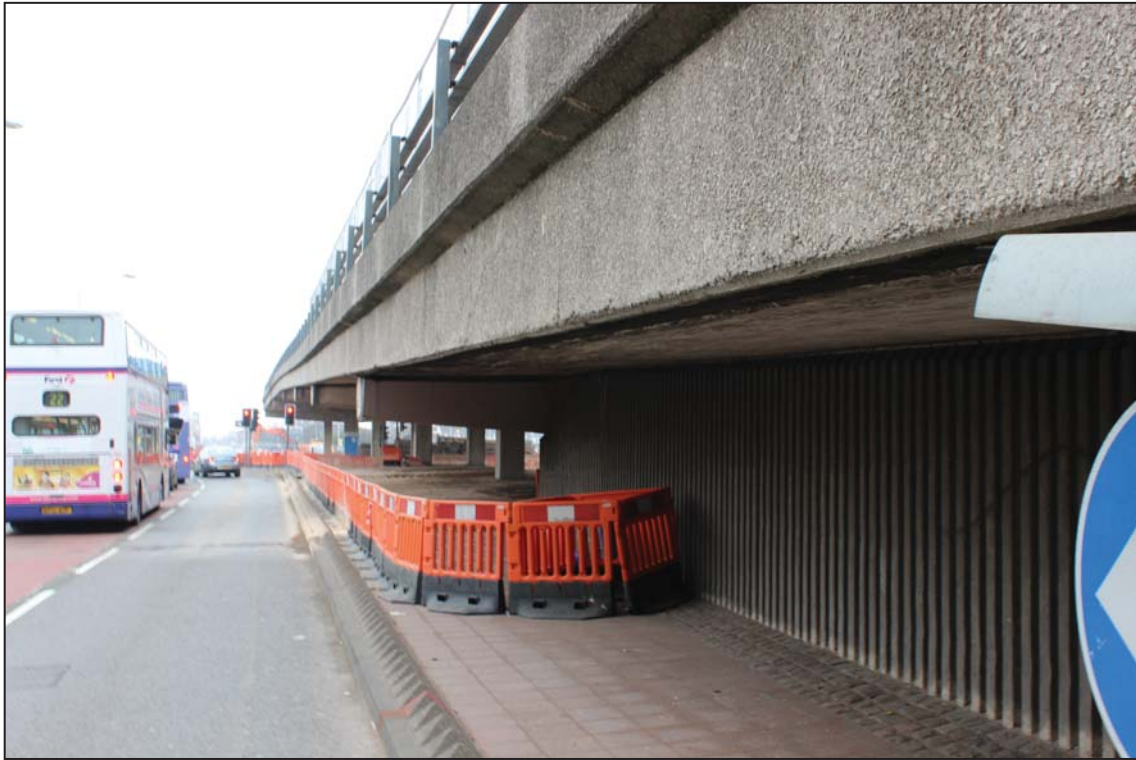
9 The ridged walls of the enclosed underside of the flyover, where the ramps end.

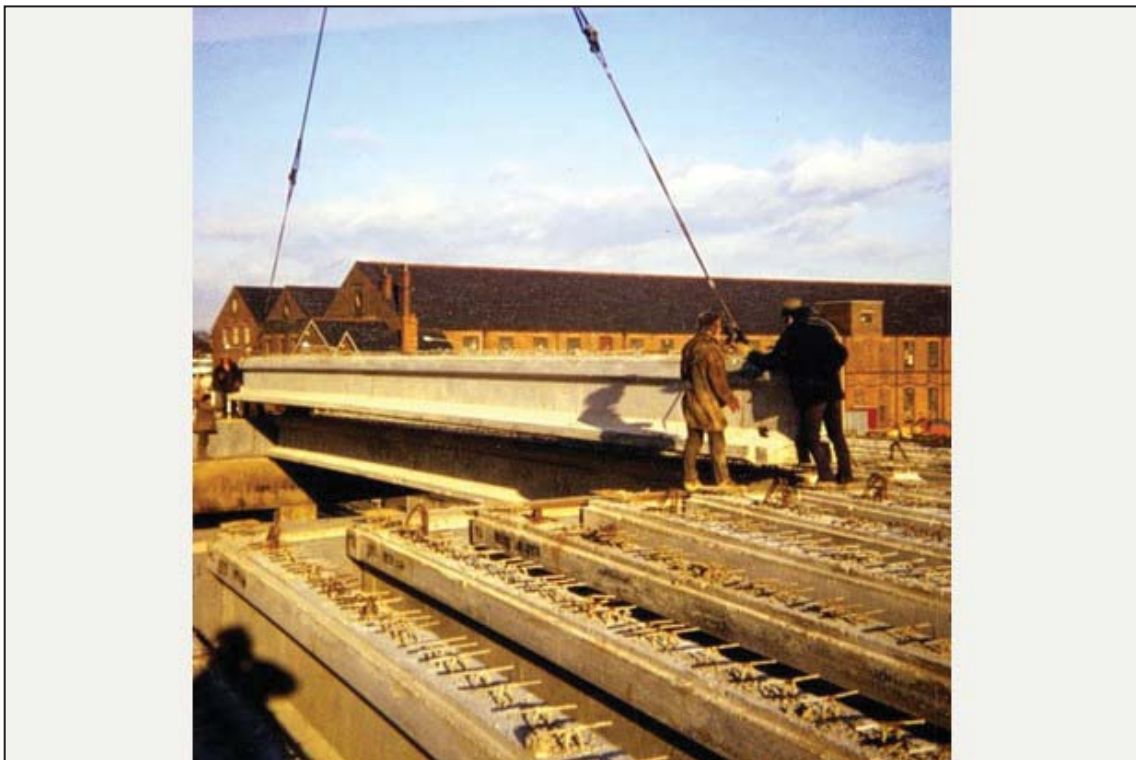
10 The road deck beams being lowered into place on the crossheads in November 1973.

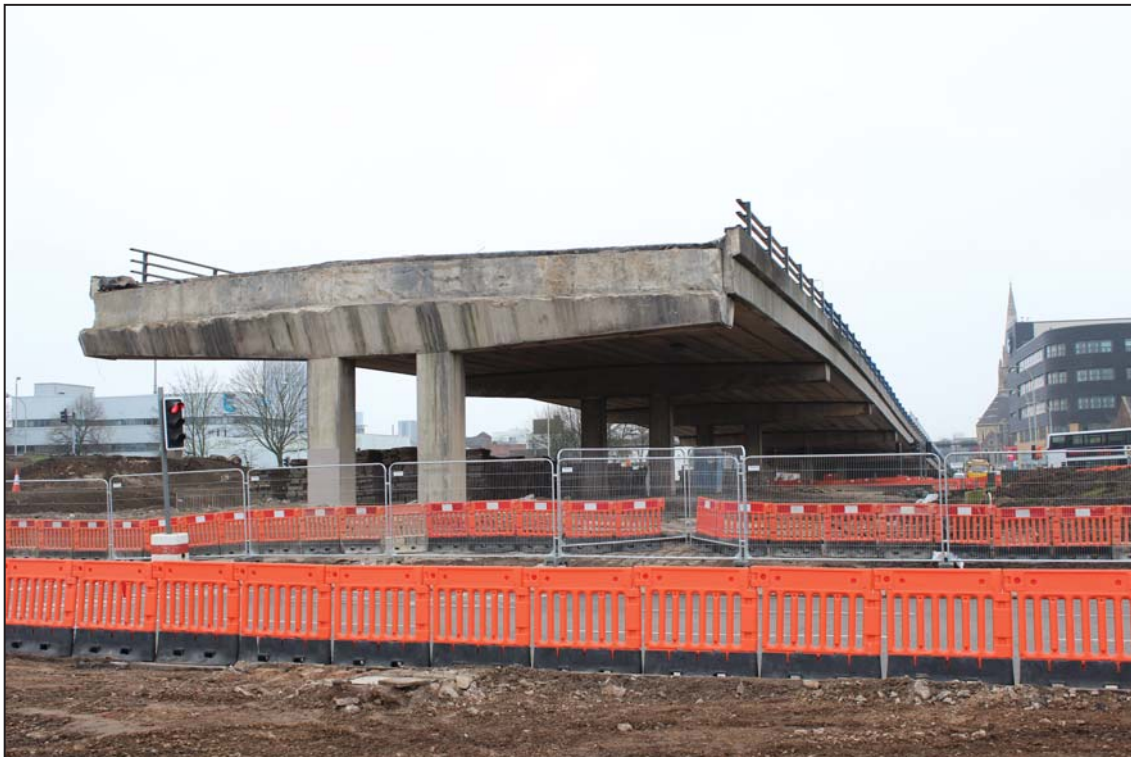
- 11** One of the crossheads fully exposed by demolition of the road deck.
- 12** Spalling of concrete on the pre-cast side panels and under the cross head. This crosshead also seems to show signs of repair or secondary work on the underside.

- 2.5 The cambered ledge on the crossheads on which the road beams rested automatically provided the road camber. Combined with the tapering underside of the cross head, a consequence of the designed loading, and the trapezoidal cross section, this produced a pleasingly elegant elevation to the crosshead (Fig. 11).

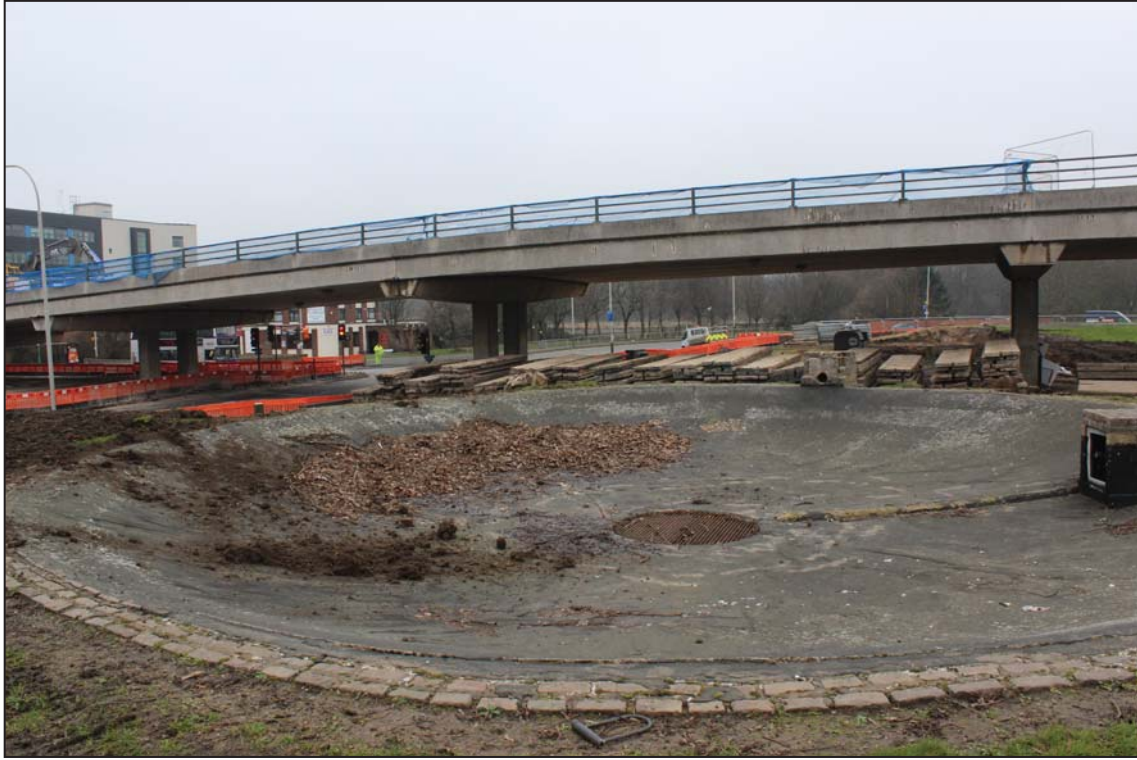
13 One of the two 1974 fountain basins.

- 2.9 The roundabout under the flyover was landscaped in 1974 with two ponds with fountains. These have been “*dry for years*” (Appendix A) but at the time of the building recording survey, the concrete-lined basins were still evident (Fig. 13).

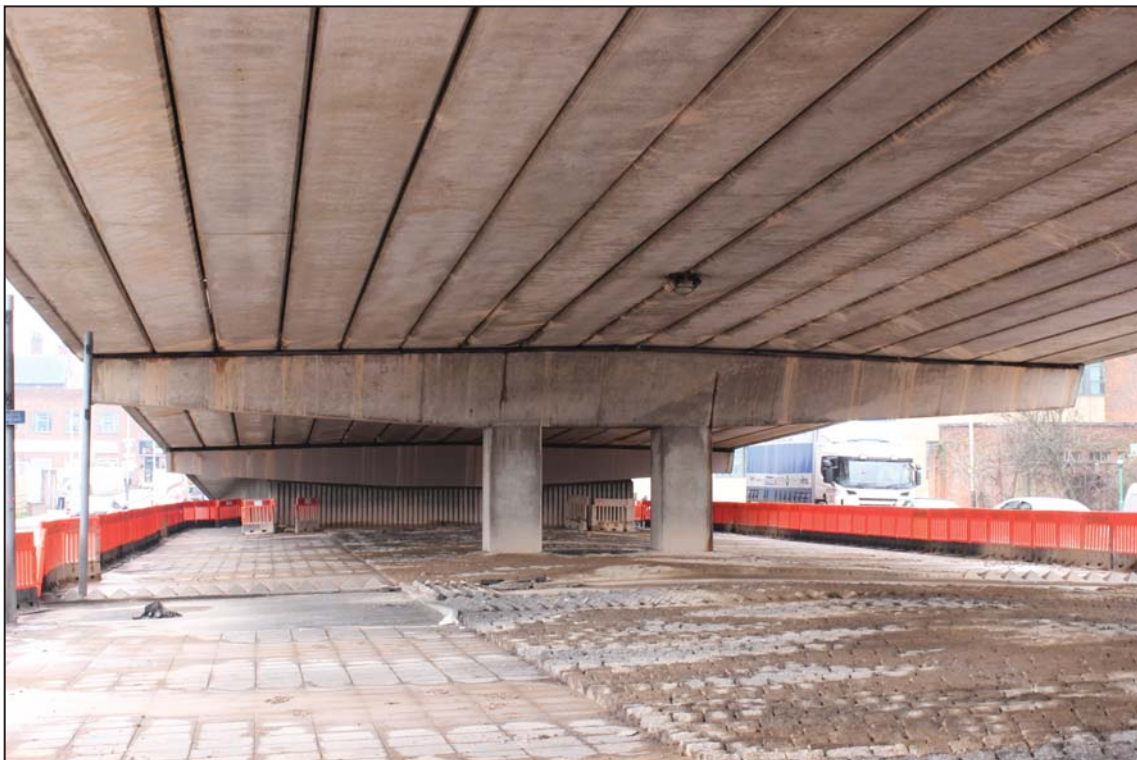
14 The paving under the flyover outside the roundabout.

- 2.10 The strips under the flyover north and south of the roundabout were paved decoratively (Fig. 14), and this appears to have been a later embellishment. The granite stone setts were laid radially in slightly domed discs around the crosshead posts and in pitched rows elsewhere. This latter arrangement gave a textured effect but also clearly discouraged any vehicular use. This stone-set strip extended about two and a half metres either side of the crosshead posts. The rest of the area was paved in square, concrete, paving slabs to just a little wider than the road deck above.
