**Nailsea Glassworks
Nailsea
North Somerset**

Archaeological Watching Brief

CA Project: 4786
CA Report: 14462

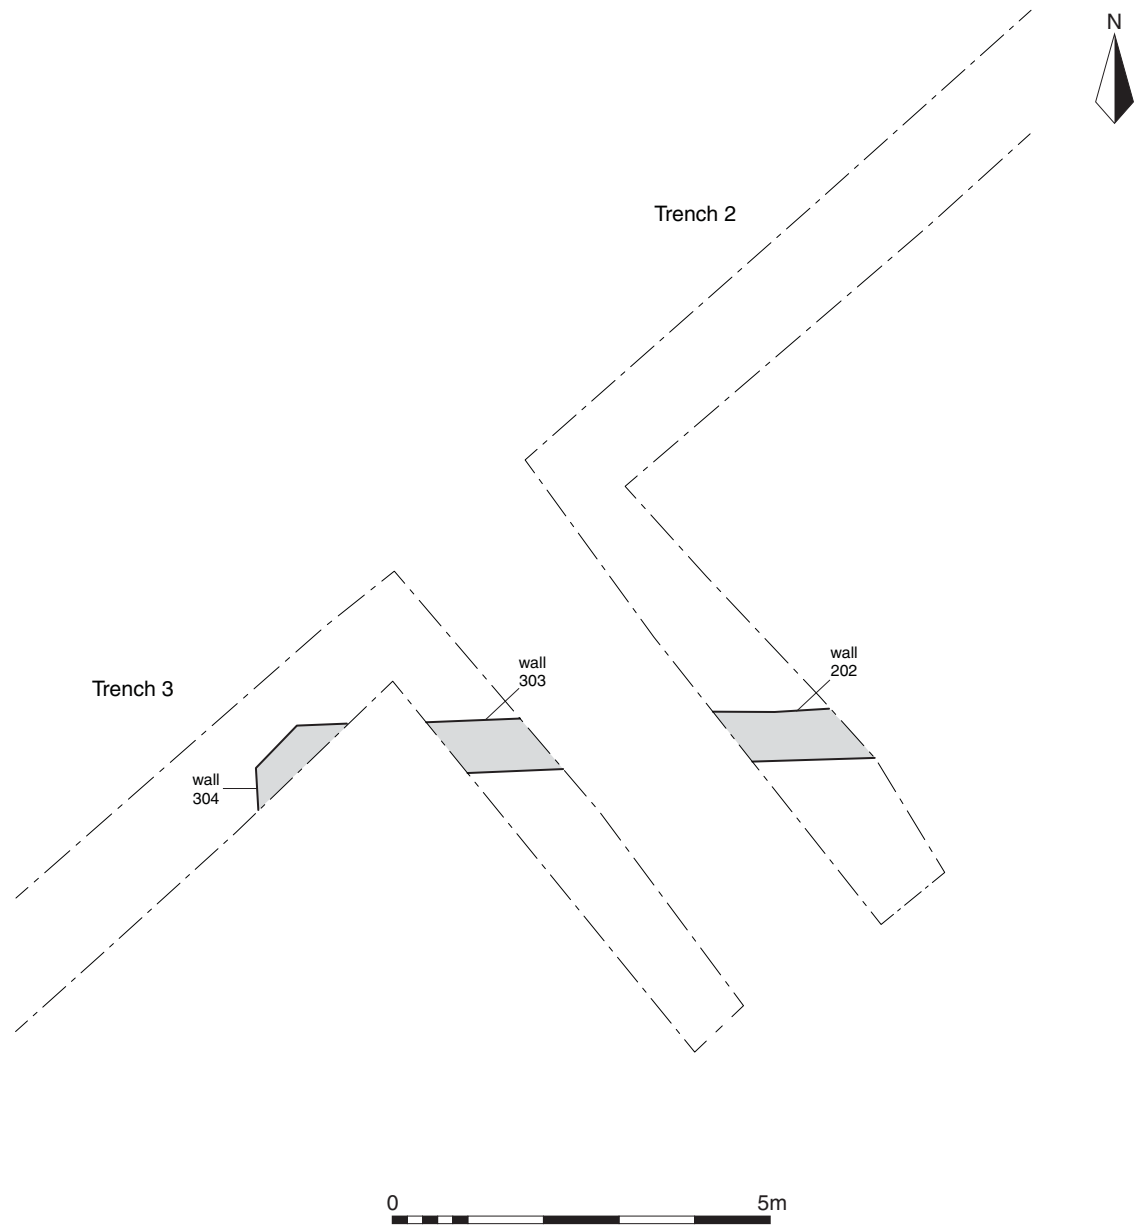
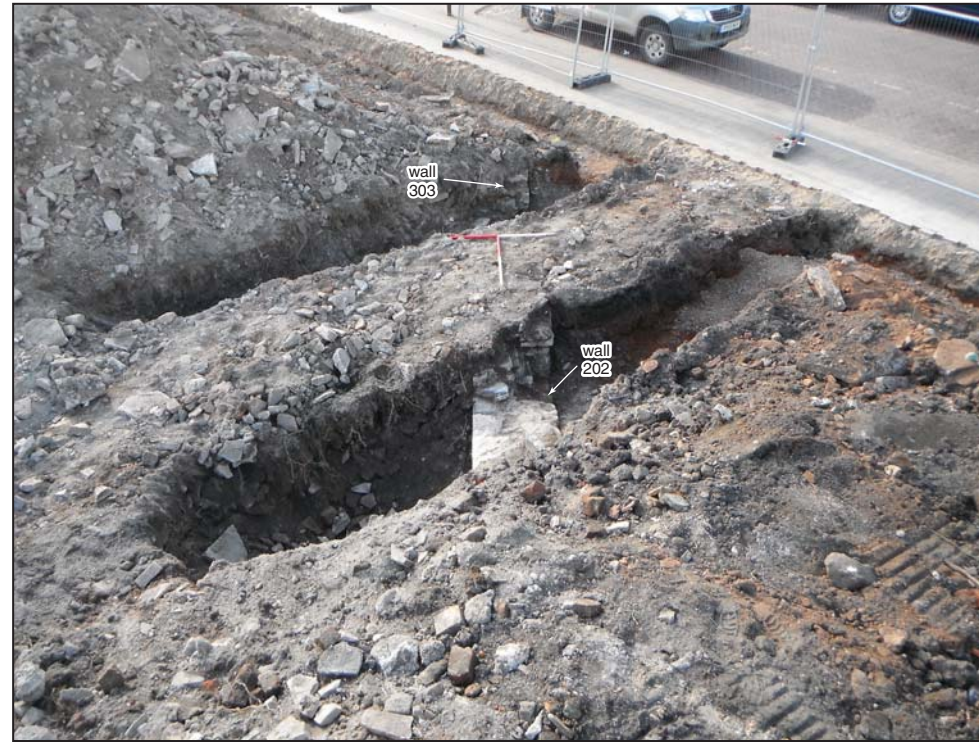
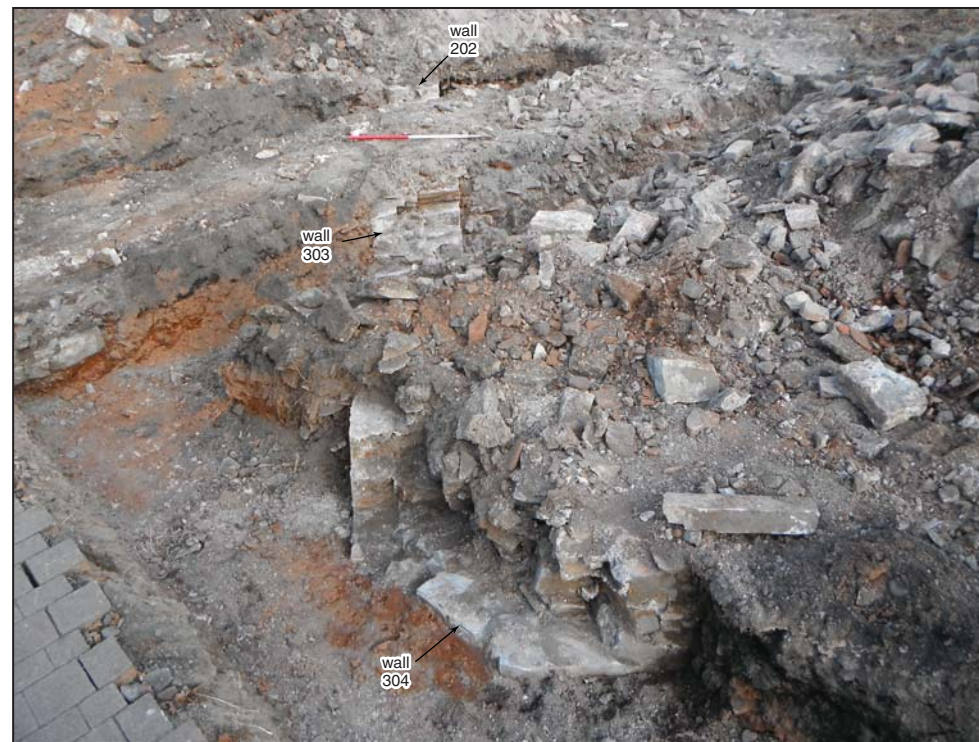
- 2.4 In Trenches 2 and 3 an east/west sandstone wall was exposed, 202/303. To the west this had a north-south aligned return, 304. These walls each measured 0.7m in width, and survived to a maximum height of 0.64m in Trench 2. They were all constructed in random courses bonded with firm sand mortar, and overlain by modern demolition deposit 201, and they appeared to form the north-west corner of a building.

Wall 202 looking north-west (scales 1m)

Walls 303 and 304 looking south-east (scale 1m)

- 3.1 The walls uncovered in Trenches 2 and 3, and cellar/cesspit 504, had not been seen in previous archaeological excavations. Walls 202, 303 and 304, observed in Trenches 2 and 3, correlate with the north-west corner of building 5 as depicted on a plan of the glassworks dated 1870 (BRO Sturge Deposit 37959). This was part of a complex of buildings attached to the north side of the furnace of the 'New House' cone. The building is recorded in the schedule attached to the 1870 plan as a cutting room (Fig. 8).

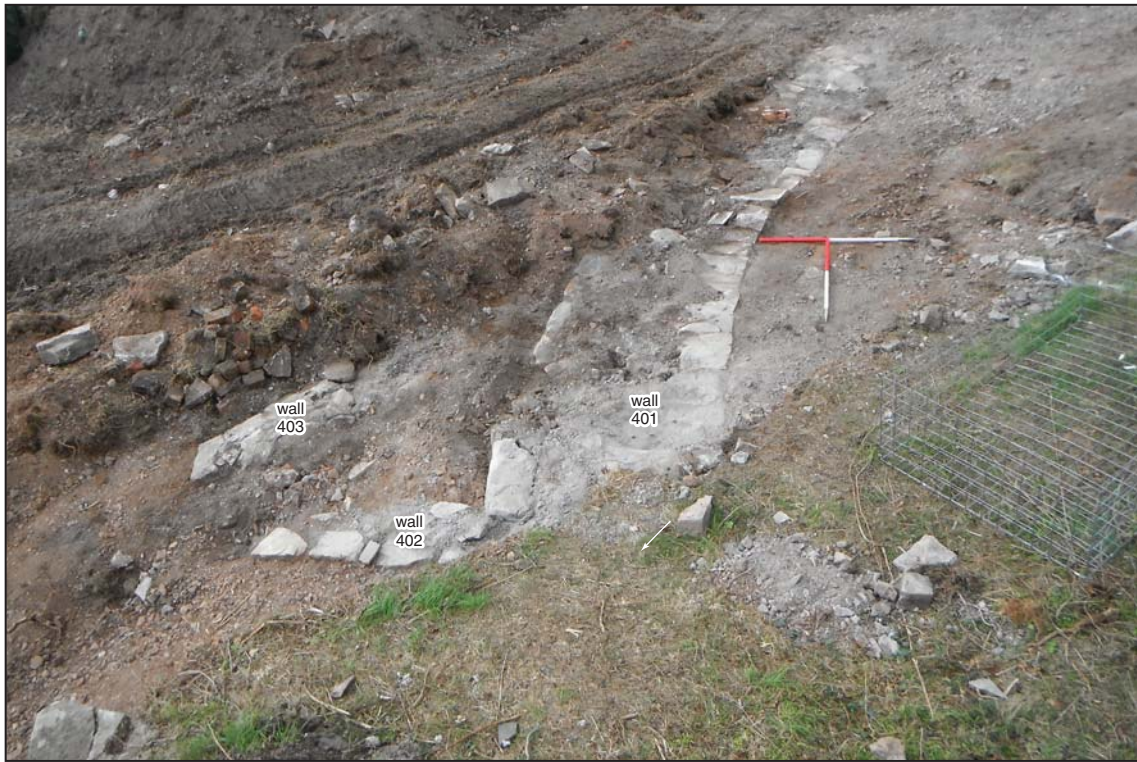
- 2.5 In the south of the site (Trench 4) the excavation for the gabion trench uncovered ten more structures (Figs 2, 4 & 5). Walls and masonry fragments 401, 402, 403, 405, 409 and 410 were constructed in sandstone uneven courses bonded with sand mortar. Wall 404 was constructed in brick and sandstone bonded with lime mortar. Walls 406, 407 and 408 had a maximum height of 0.8m and were constructed in string courses bonded with modern cement. The majority of these had been recorded during previous archaeological works, the possible exceptions being 402, 403 and 408 (Fig. 2).

4 Walls 401, 402 and 403, looking north-west (scales 1m)

- 3.3 The structures revealed to the south of the site (Trench 4) including the cone wall, had largely been previously uncovered and recorded, with the possible exception of fragments 402, 403 and 408 (Fig. 8) The remains were re-surveyed during the watching brief using a Leica Viva GPS, and could be tied in with the previously excavated remains with a high degree of accuracy, demonstrating that the 1980s excavations had been surveyed to a very high standard. Both plans also correlate extremely well with the 1870 plan of the glassworks (Fig. 8).

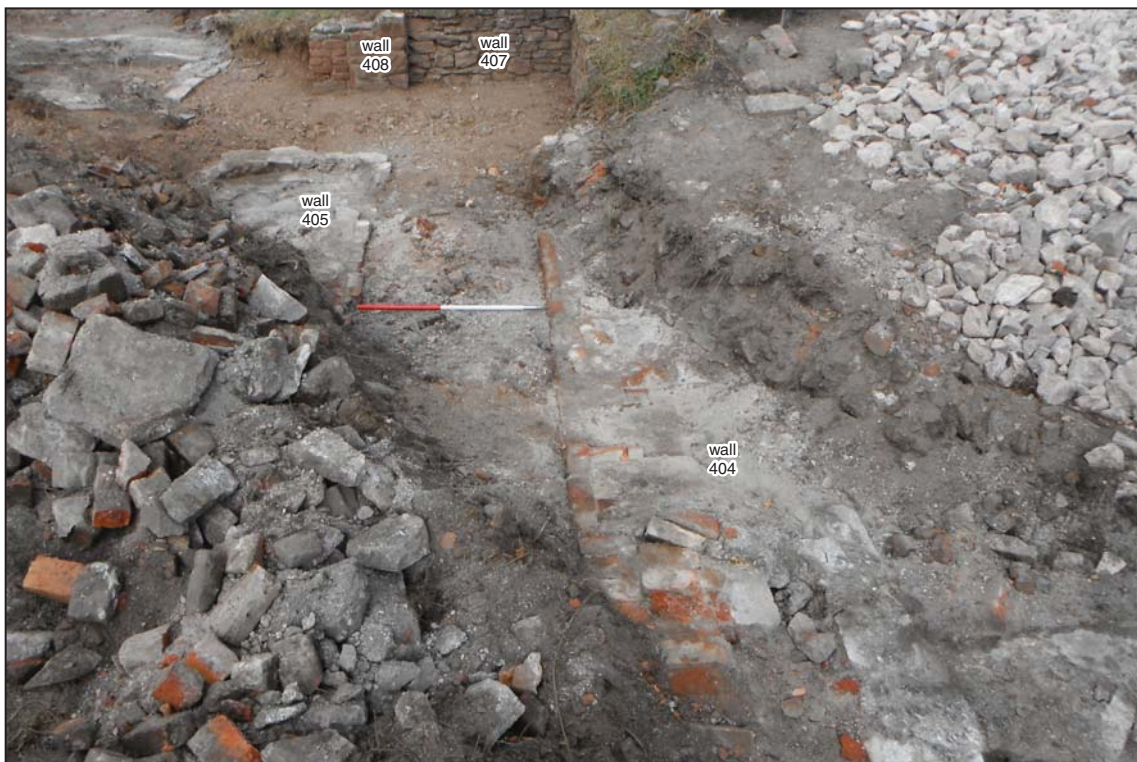
5 Walls 404, 405, 407 and 408, looking north (scale 1m)

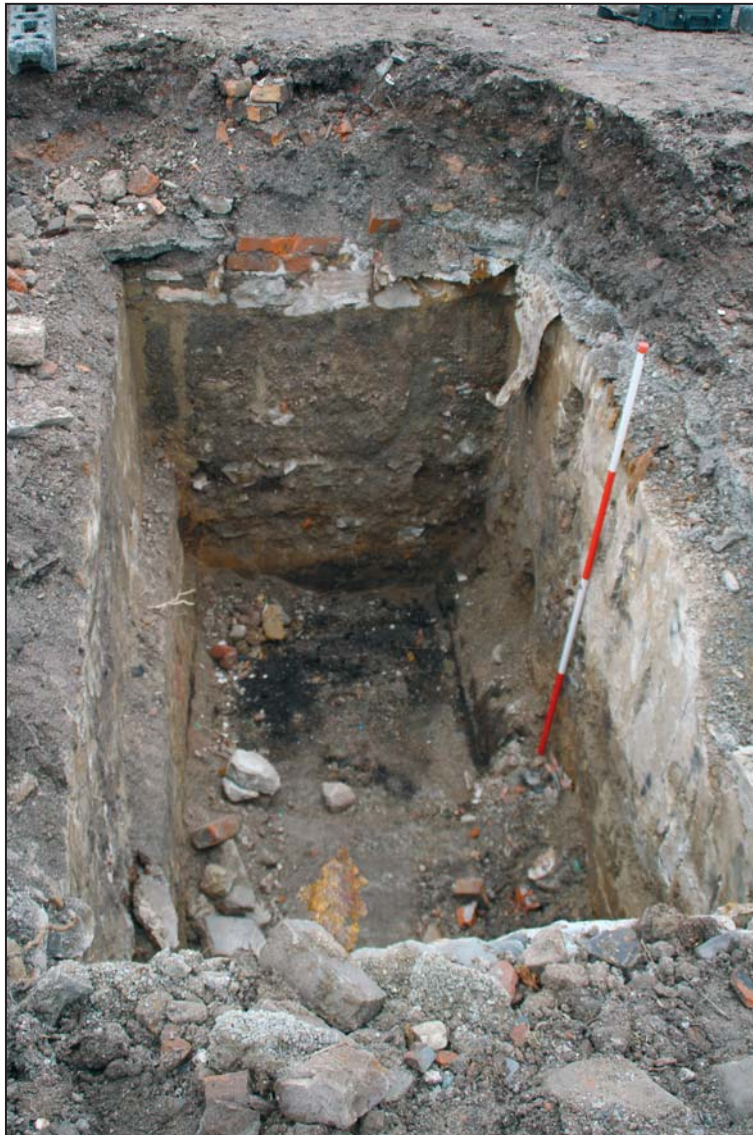
- 2.6 Part of a former cellar, which appeared likely to have been re-used as a cesspit for one of the 20th-century properties that later occupied the glasswork site, was revealed during groundworks to the north of the cone (Figs 2 & 6). A trench was

excavated by the contractors to establish whether there was a continuation of the cellar to the south, although this showed that it had been infilled.

6 Cellar 504, looking north (scale 2m)

- 3.2 Cellar/cesspit 504 corresponds with the north-east corner of building 6, and according to the schedule this was a six-storey building, with two packing and cutting rooms, three pot rooms and a loft for lift machinery (Fig. 8). Wall fragment 104, only partially exposed in Trench 1, matches with the position of the west wall of that building (Fig. 8)

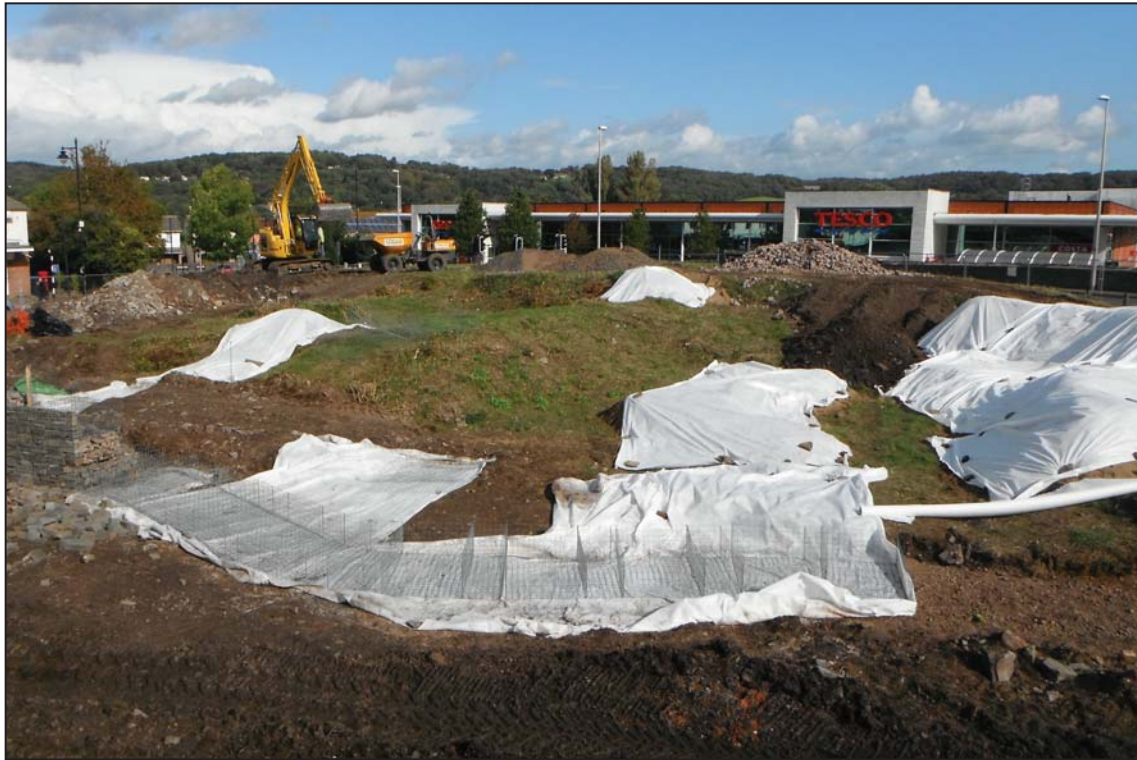
7 Protection and covering of archaeological remains, looking north-east

- 3.5 The protection and covering of the archaeological remains was monitored to ensure that the remains of the glassworks would be preserved in situ beneath the newly landscaped area (Fig. 7).
