Land at Leintwardine Herefordshire

Archaeological Evaluation

CA Project: 5037
CA Report: 14433

September 2014

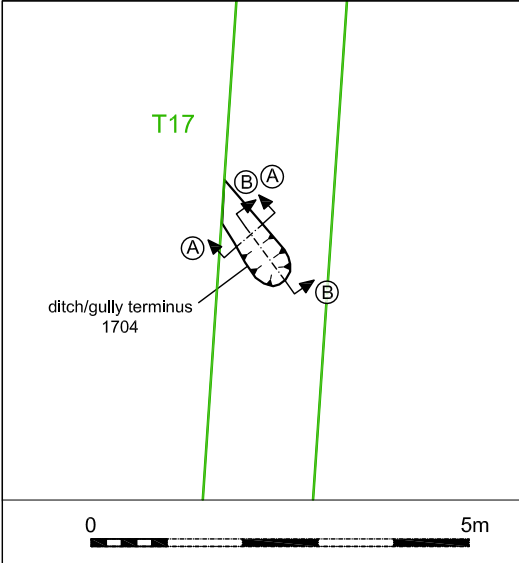
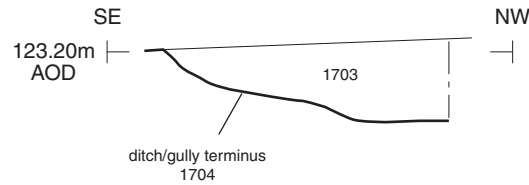
Trench 17: sections and photograph

- 2.3 Narrow, shallow ditch/gully terminal 1704 was identified towards the centre of the trench cutting natural sands and gravels 1702. It was aligned north-west/south-east, had a 'U'-shaped profile and contained a single undated fill, 1703, that was sealed by subsoil 1701.

Section AA

Section BB

- 3.1 The evaluation identified a single, undated ditch/gully terminal within Trench 17. Due to the seemingly isolated nature of this feature, coupled with the lack of dating evidence, its exact function remains unclear.
- 3.2 Despite the close proximity of Roman and medieval remains, identified during previous archaeological fieldwork in the village of Leintwardine (see *Archaeological Background* above), no evidence of further Roman or medieval activity was exposed by the current evaluation.
- 3.3 Demonstrably modern dumped deposits were identified in Trenches 7-11 and 16. Although unproven, these deposits are most probably associated with the construction of the modern houses located immediately to the west of the proposed development area.

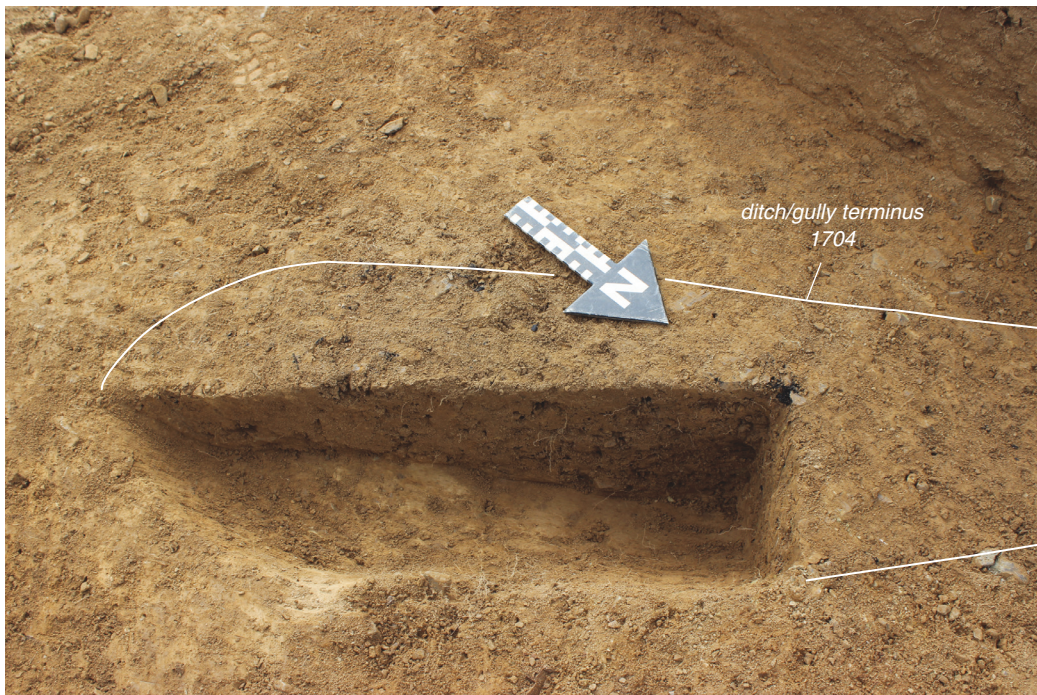
Ditch/gully terminus 1704, looking south-west
