**Woolmarket Car Park  
The Waterloo  
Cirencester  
Gloucestershire**

Programme of Archaeological Works

CA Project: 2383  
CA Report: 14159

June 2014

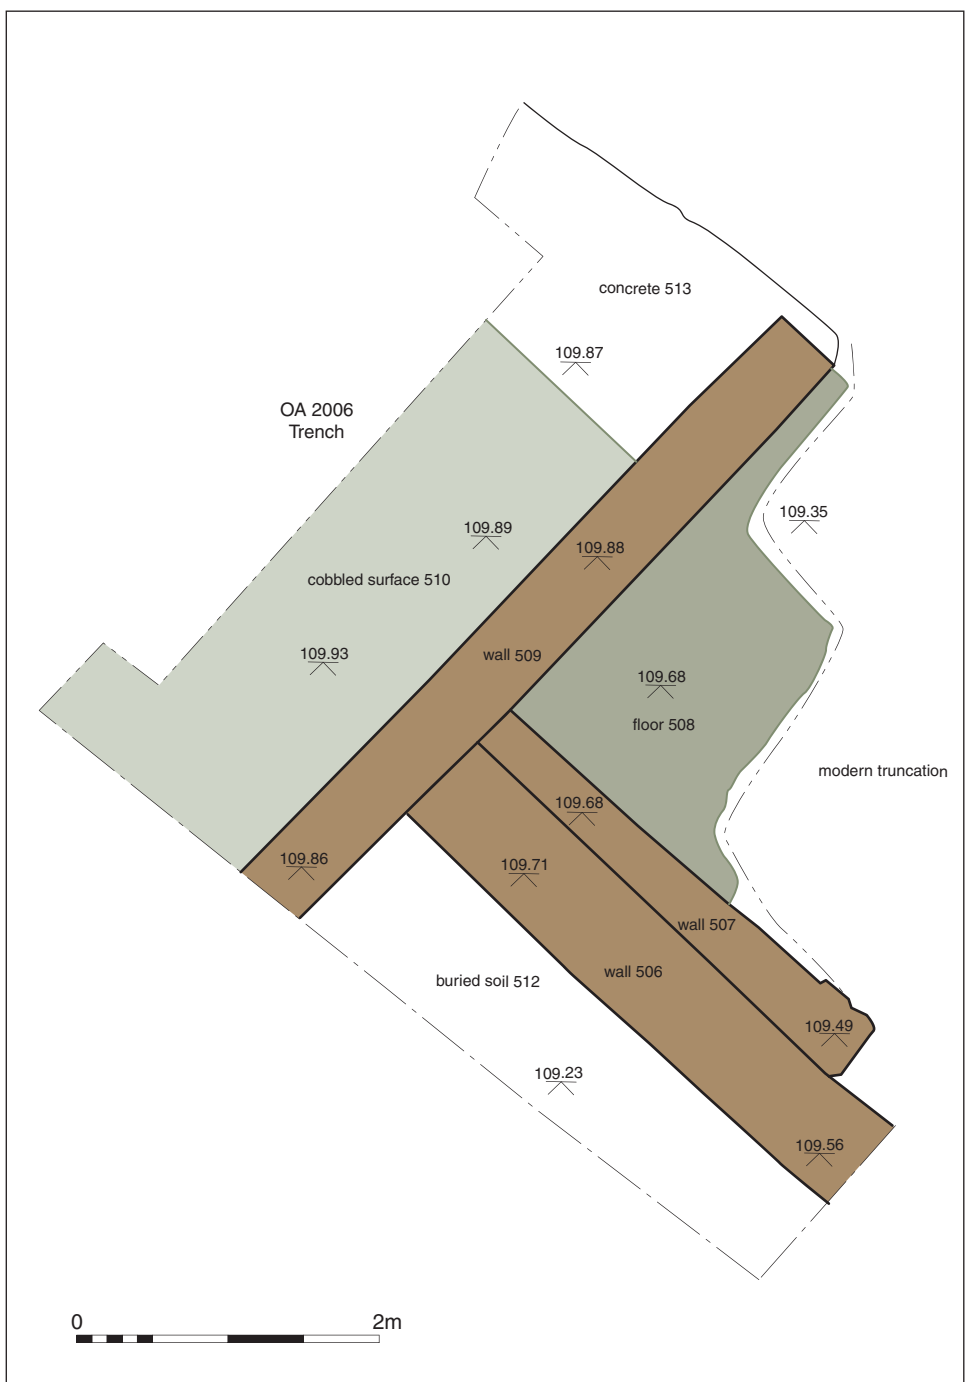
FIGURE TITLE  
 Trench 5: Plan 5.1 and photograph

- 2.10 An extant building known as 'The Barn' was butted by wall 516, that along with walls 518 and 527 (Fig. 3) formed the north-east corner of a building with an entrance between walls 516 and 518, facing towards to the south-east. The walls were approximately 0.5m in width and constructed of regular courses of roughly shaped limestone blocks with a white-grey mortar. They were associated with internal brick surfaces 521 and 520 and cobbled surface 523. Exterior surfaces were formed of pavior bricks 517 and a cobbled footpath 519. Internal surface 521 was overlain by a single layer of red brick, 528, suggesting a raised platform.

Details of 5.1 looking south west (1m scales)

- 3.5 Wall 516, internal surfaces 521, 523 and possible platform 528 all butted the footings of an existing building (The Barn). The structure was possibly an extension of The Barn, and contemporary with walls 506 and 509 to the east that were separated by cobbled surface 510. Together with walls 518 and 527 these walls form parts of the buildings depicted on the 1875 town plan (Fig. 6). Brick structures 108/119 appear to form a rectangular structure added to the south side of boundary wall 112/113 at a later date, and demolished by 1960. Their position is coincident with that of a small greenhouse structure depicted on the 1875 town plan (Fig. 6), and they may relate to a later, larger, greenhouse or garden structure built in the same location.

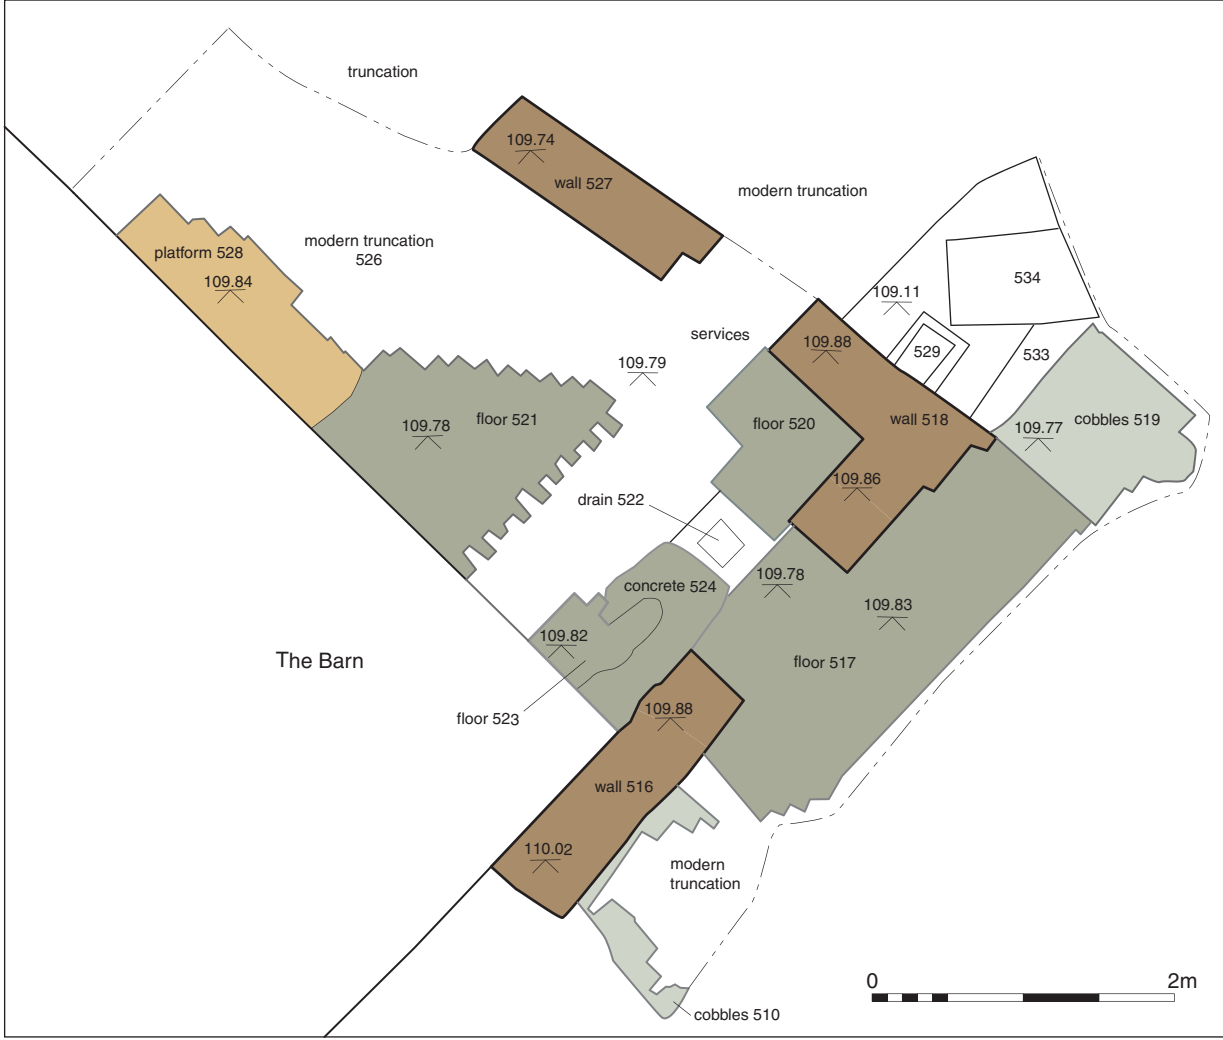
FIGURE TITLE  
**Trench 5: Plan 5.2 and photograph**

- 2.8 Wall 506 was aligned north-west/south-east and measured 0.7m in width and at least 0.34m in depth. It was constructed from regular courses of roughly shaped limestone blocks with sandy lime mortar and was butted by wall 507 against its north-east face. Wall 507 was on the same alignment as wall 506 and constructed from regular courses of roughly squared limestone blocks with a light yellow mortar. It measured 0.39m in width and at least 0.27m in depth.
- 2.9 Walls 506 and 507 were both butted at their north-western extent by wall 509. Aligned north-east/south-west, it measured 0.52m in width, at least 0.45m in depth and was of similar construction to wall 506. Wall 509 and wall 507 were butted (to the south-east and north-east respectively) by floor 508 constructed from limestone slabs covered by a concrete screed.

Details of 5.2 looking west (1m scale)

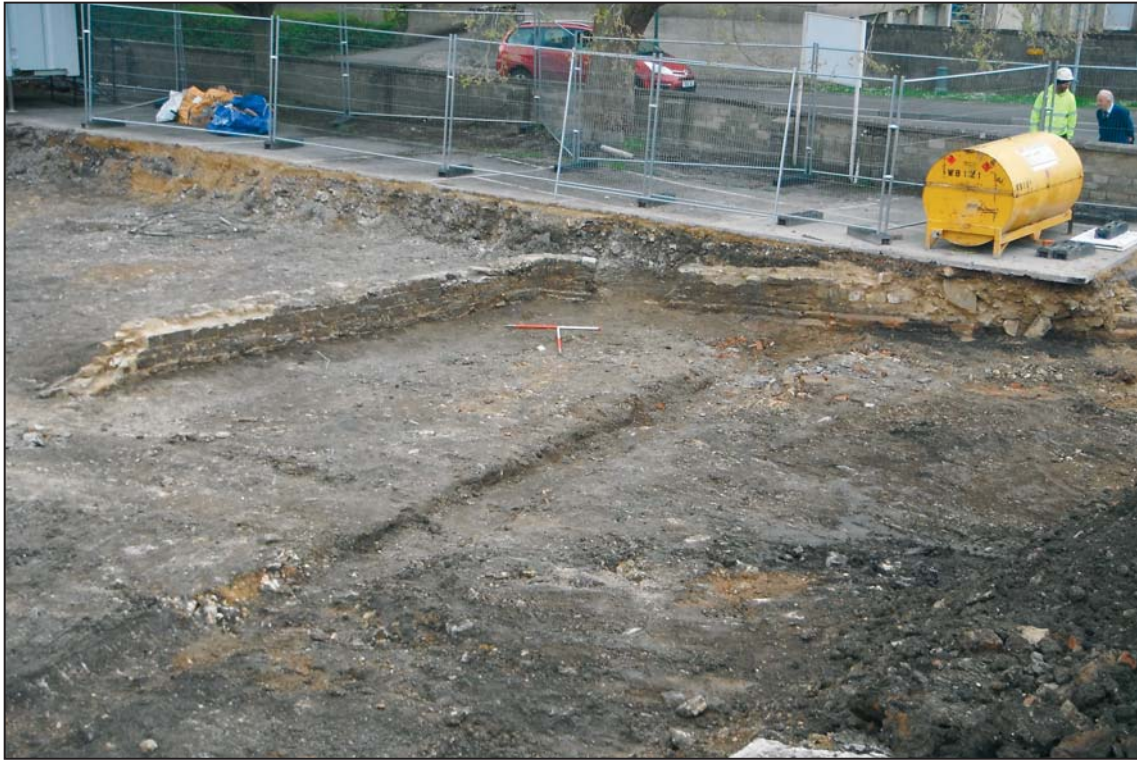
5

- 2.3 The earliest deposit encountered was demolition rubble 124 comprised of light yellow crushed mortar and gravel. This was revealed along the southern edge of the excavation at 0.84m bpgl (108.96m AOD). A single sherd of 2nd to 4th-century pottery and Roman wall plaster was recovered from within the deposit which was sealed by cultivation soil 105.
- 2.4 Walls 107, 109, 112, 113 and 114 formed a boundary wall aligned north-east/south-west, with an east/west return at its northern extent. It measured approximately 0.5m in width, at least 0.8m in depth and was constructed of irregular courses of roughly shaped limestone with a light yellow-grey mortar. Buttress 110 was constructed against the north-west face of wall 107 and measured 0.75m in length, 0.75m in

width and at least 0.7m in depth. No construction cut was observed for the walls. Walls 107, 109, 112, 113 and 114 was butted to the south-east by cultivation soils 105, 104 and 103 and to the north-west by re-worked soil 102. An entrance was recorded between walls 109 and 112 (see Fig. 2 for location). Other sections of these walls were identified during previous investigations (OA 2006 and CA 2013).

**5 Area 5: Wall 107/109/112/113/114 looking north (1m scales)**

- 3.2 The substantial limestone wall (107/109/112/113/114) identified in Area 1 was previously identified during lift pit excavations (see Figure 2 for locations) by CA in 2013 where pottery recovered from deposits stratigraphically below the construction cut and within the backfill of the construction cut for the wall, which was not identified during the current works, dates to between the 12th and 13th centuries (CA 2013). The wall may be medieval in origin and relate to the boundary wall of the rear garden plot of Archibald's Manor which stood on the site of No. 104 Dyer Street from Domesday (see *Archaeological Background* above). It appears to have survived in some form, and been incorporated into the south-eastern wall of a southwest/northeast orientated building by the time of the 1875 town plan of Cirencester (Fig. 6). Its eastward return forms part of an east-west boundary wall depicted on the same plan running along the south side of the former Bull Lane (now The Waterloo). The entrance formed between walls 109 and 112 can also be seen on the town plan, at the junction between the northeast corner of the building and Bull Lane, leading to a pathway to an orchard or formal garden. Buttress 110, which butted against the north-west face of wall 107, appears to be of similar width to buttresses depicted along the north side of the Bull Lane Boundary wall on the 1875 town plan (Fig. 6), lending weight to the suggestion that wall (107/109/112/113/114) was originally a garden or orchard boundary wall enclosing the garden area in the
