**25 Market Place  
Chippenham  
Wiltshire**

**Archaeological Watching Brief**

CA Project: 5069  
CA Report: 14455

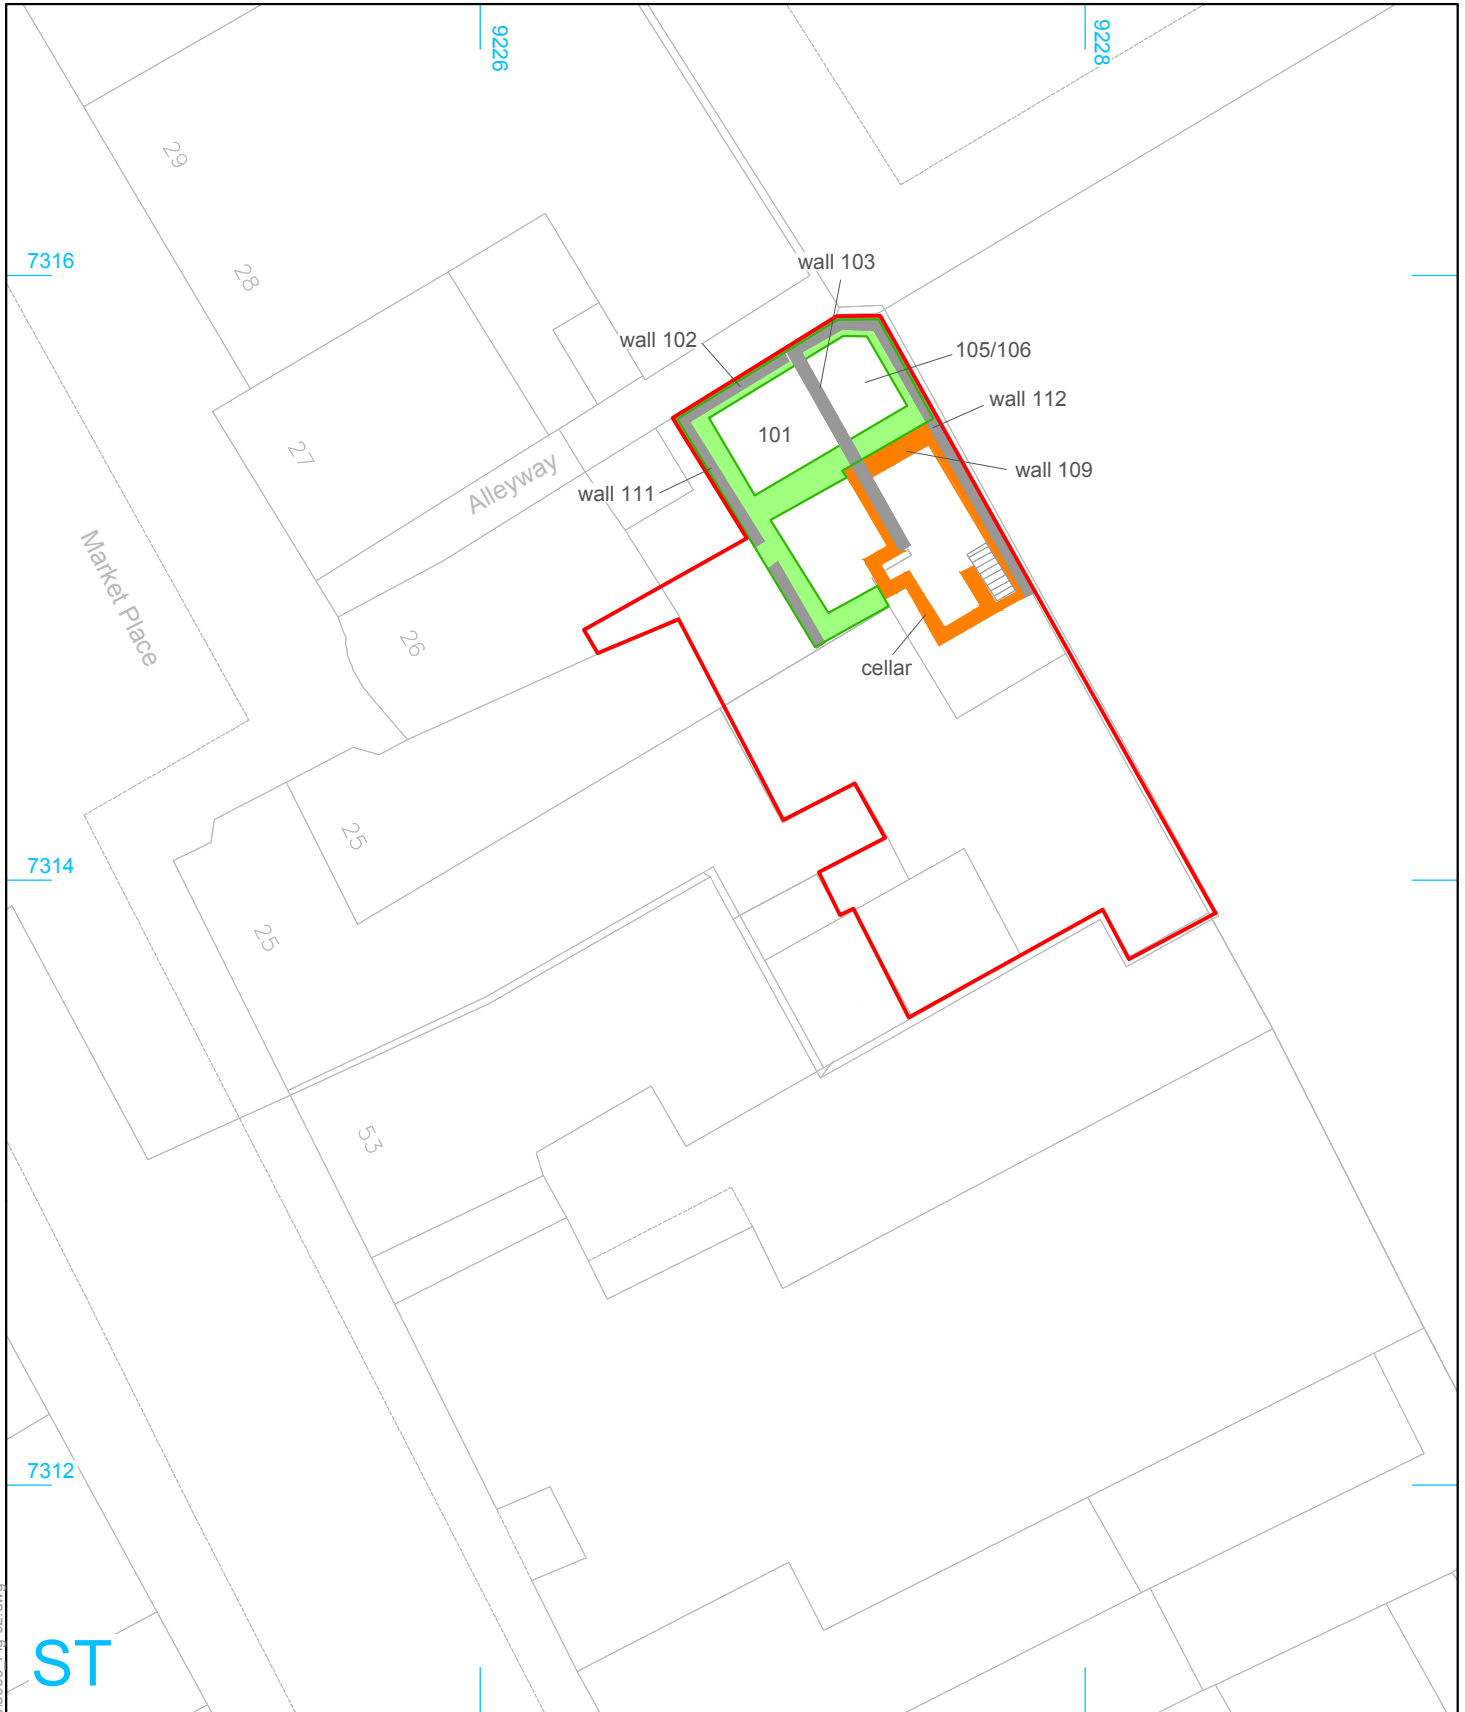
**FIGURE TITLE**  
 The site, showing location of observed  
 groundworks

- 2.1 The watching brief consisted of observing the excavation of foundation trenches for the ground beams of the northern building to be erected on site. These were 0.3m deep below present ground level (bpgl), except along the northern side of the building, against the alleyway where they were 0.7m bpgl.
- 2.2 The excavations revealed the outer face of the north wall of the cellar (109) surviving 0.1m bpgl. This was 0.4m further north than expected and suggests that the cellar walls may be at least 0.75m thick. It was not possible to observe the roof or the other walls of the cellar as they were covered by later walls and a layer of cement. Nor was it possible to confirm the internal dimensions of the cellar as all access points were blocked.

- 2.3 In the base of the foundation trenches two soil layers were observed, 104 and 107 some 0.3m and 0.7m bpgl respectively. However, given the limited exposure of these layers it is not possible to determine their function or relationship with the cellar, beyond the fact that they predate the previous building on the site.

- 2.4 During the ground works it was possible to observe the foundations of the previous building to occupy the site. The western wall (111) has been left *in situ* and will be incorporated in to the new structure. It consists of a limestone rubble foundation with a single skin limestone ashlar wall surviving to roof high. The northern wall (demolished prior to the watching brief) consisted of two elements 102 and 112. 102 had a construction identical to 111 and may be part of the same structure. However 112 and also the internal wall 103 both have foundations of reinforced concrete, suggesting that they are possibly later additions or modifications to the structure.

- 2.5 The space between walls 102, 103, and 111 is occupied by rubble dump 101. This is likely to have been the sub-base to the concrete floor that occupied this space prior to commencement of works. On the eastern side of wall 103 a layer of rubbly concrete 105 may have had the same function or have been a floor surface in its own right. Below 105 in the north eastern corner of the site there was the dark soil and rubbish layer 106. The most likely explanation for this layer is that it is a garden soil and/or rubbish dump.

- 2.6 In the side of the foundation trench it was possible to observe the deposits under the alley, which runs along the northern side of the site. It is clear from these observations and the manholes along the alleyway that much of this area has been disturbed by modern services such as a water main (113).
