**Wheal Harmony
Redruth
Cornwall**

Archaeological Watching Brief

CA Project: 4805
CA Report: 14432

An archaeological watching brief was undertaken by Cotswold Archaeology during groundworks associated with the remediation of mine works at the site.

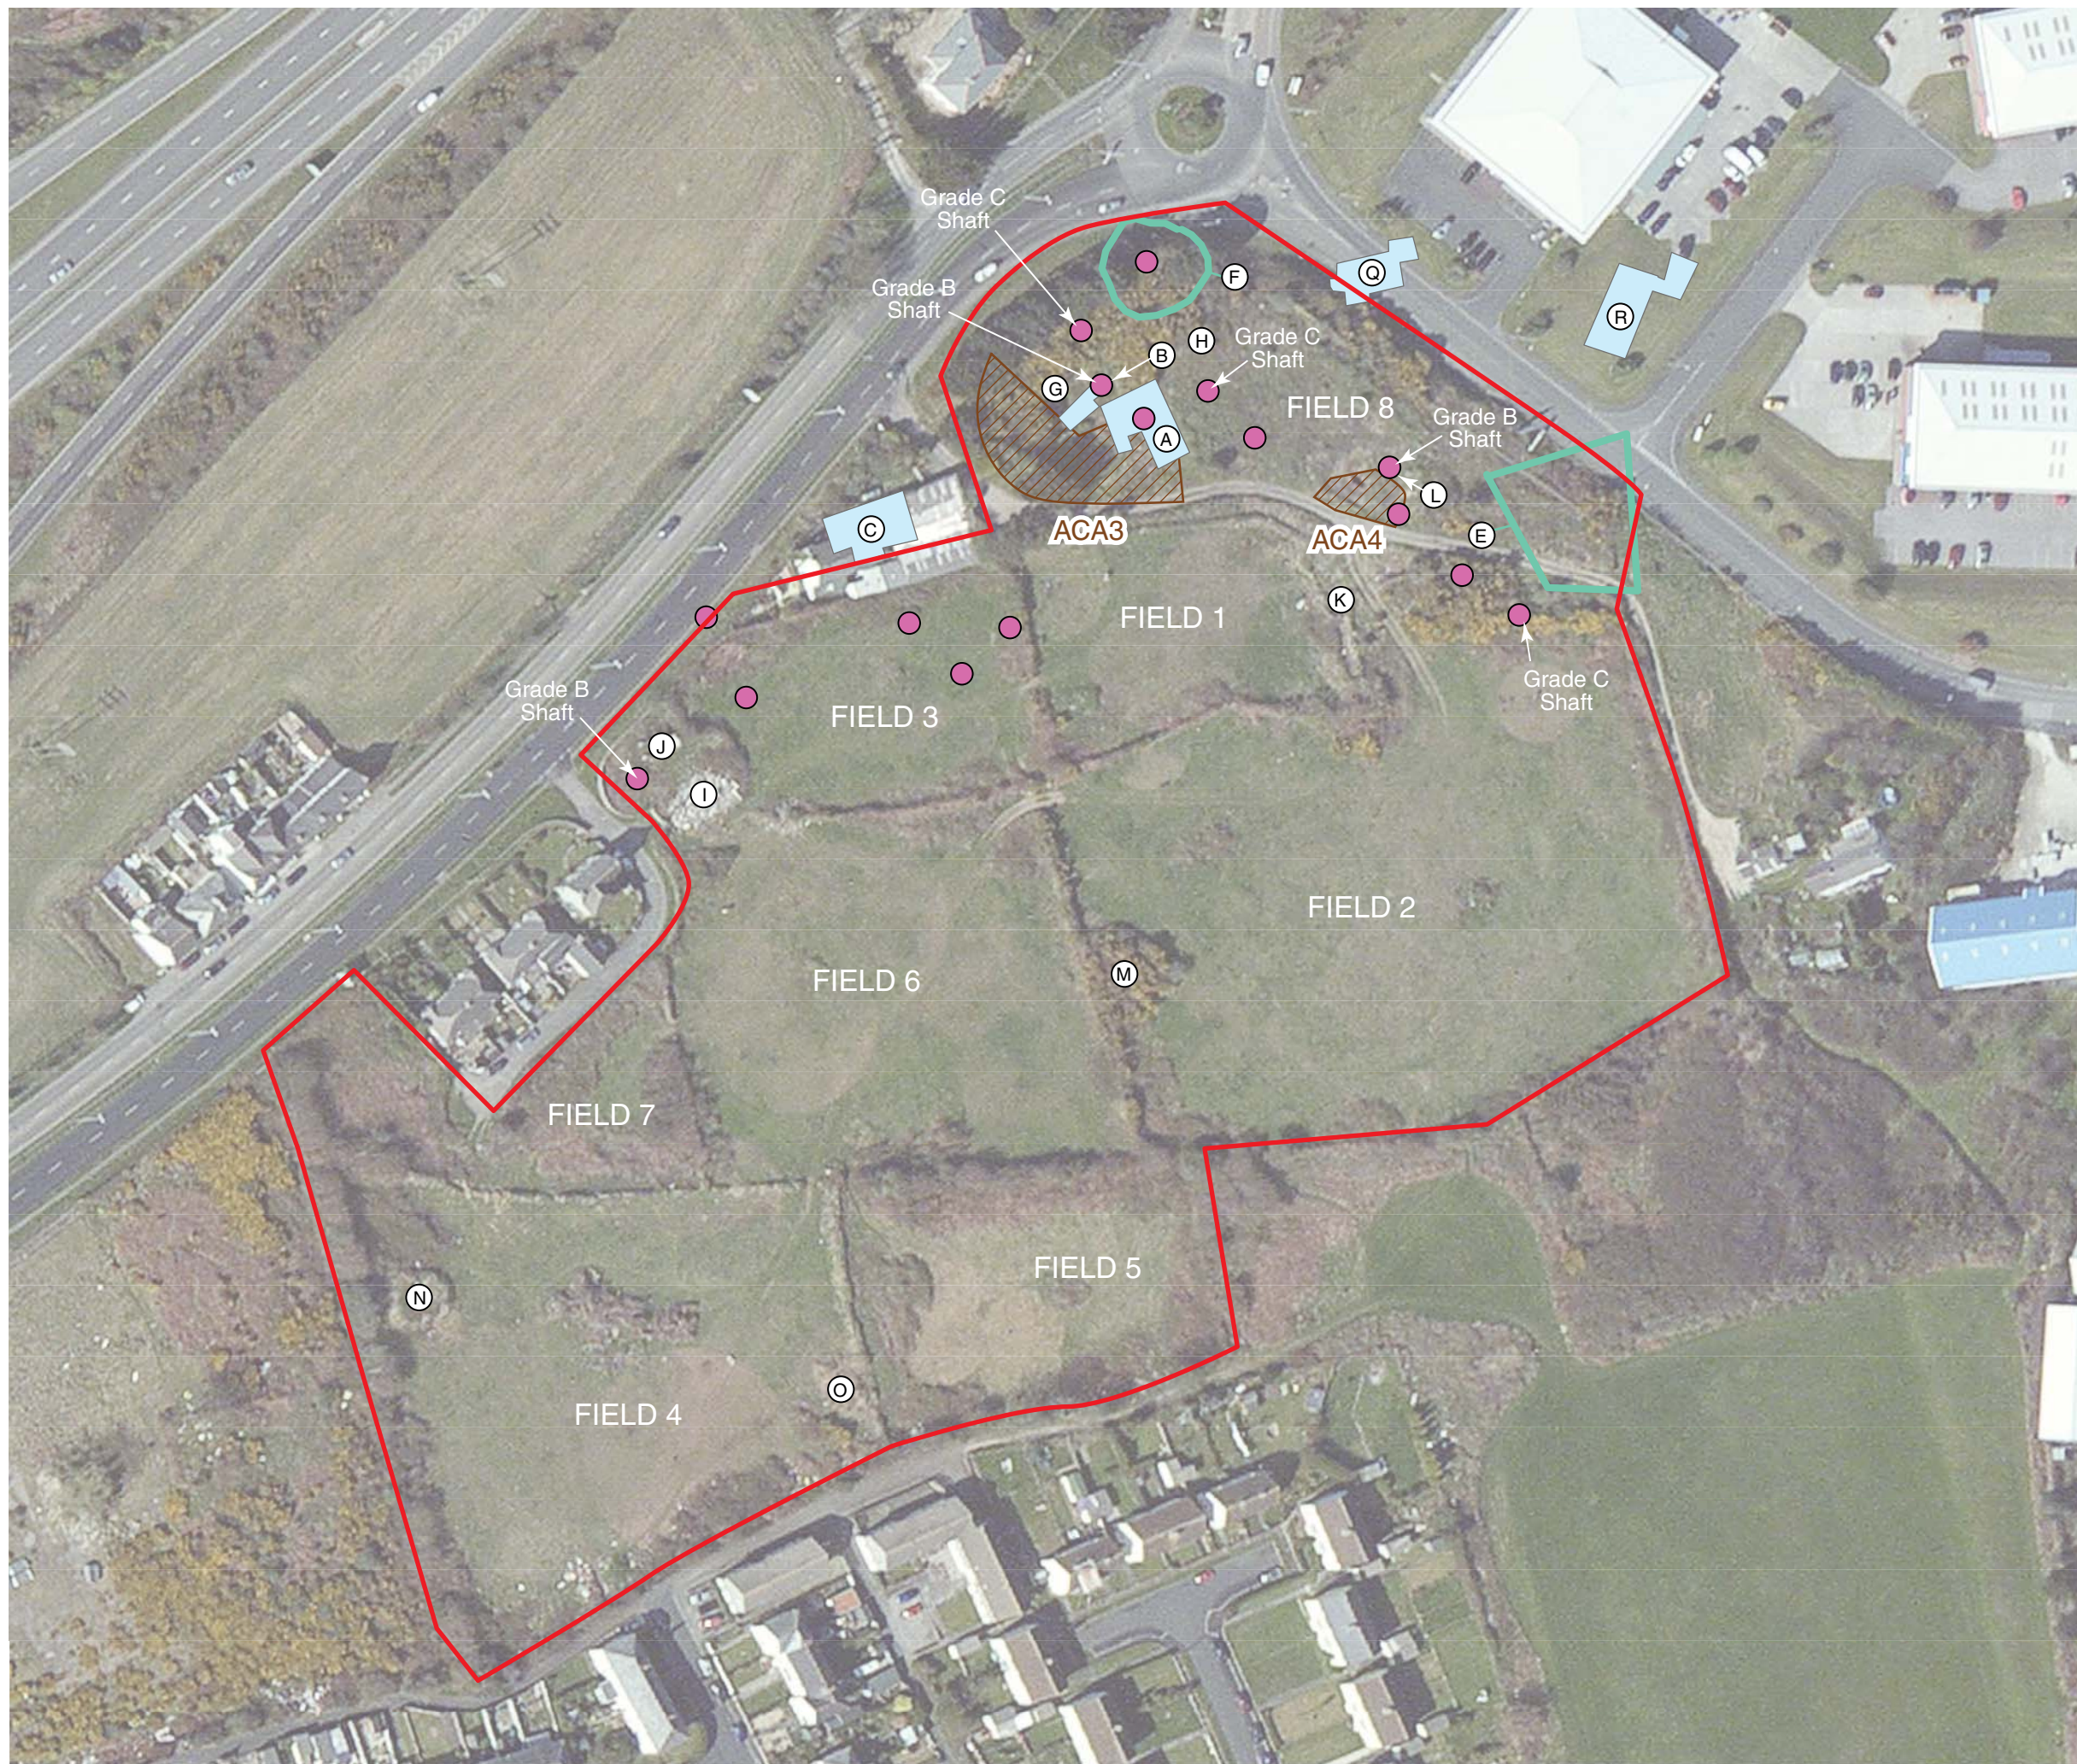
FIGURE TITLE
Satellite image of site showing archaeological monuments and events

- 1.9 The 1841 Tithe Map of Redruth shows the site as fields, with two large mounds against the field boundaries in Field 2, one of which is still visible today (Fig. 2, **M**). This field is recorded as “Burrows Field” in the Apportionment Register. These mounds likely represent spoil heaps from early 1800s (or earlier) phase of mining activities. Field 1 is recorded as “Pooder House Field, Burrows”. Field 4 is recorded on the 1841 map as containing two smaller mounds, still visible today (Fig. 2, **N, O**).

- 1.10 A mine plan of Wheal Montague and Wheal Harmony dating to 1871 shows three shafts: the main engine shaft which it named Treleigh Wood Shaft, Windmill Shaft (Fig. 2, **L**) to the south-east of the mine area and Nutwood Shaft, immediately to the south of the mine buildings. One of these buildings was identified as the accounts house (Fig. 2, **C**), which lies outside the proposed development site.

- 1.11 The 1880 OS map shows three engine houses – a pumping engine house beside Engine House Shaft (Fig. 2, **A**), a winding house to the east of that shaft (Fig. 2, **Q**) and the stamps engine house with dressing floors to the north-east (Fig. 2, **R**). The last two engine houses were situated outside of the site and their remains (if any had survived until the 20th century) were presumably demolished during the construction of Jon Davey Drive and the industrial estate to the north.

- 1.12 The 1908 OS map shows three shafts, all disused: Engine, Windmill and to the west, Nut Bottom Shaft (Fig. 2, **B**, **C** and **D** respectively) rather than Nutwood. It also shows an extant rectangular structure (Fig. 2, **K**) to the south of Windmill Shaft.

- 2.4 A rectangular building corresponding to that depicted on the 1880 Ordnance Survey map was located in the north-west corner of Field 2 (Fig. 2, **K**). Wall 1401 formed the western wall of the building, with walls 1400 and 1402 representing the northern and southern returns. The walls were heavily obscured by foliage and grass and most of the eastern part of the building was demolished prior to the watching brief. The walls were constructed of irregularly mortar bonded rough cut stone.

- 2.5 Two sections of wall relating to the engine pumping house (Fig. 2; **A**) were recorded in Field 8. The walls of the engine house are to be preserved *in situ* as part of the development, therefore the archaeological investigation of the engine pumping house was limited to the removal of covering vegetation and the recording of the standing remains (Figs. 4 and 5).

- 2.13 A large mound was visible against the western boundary of Field 2 (Fig. 2, **M**). This mound is likely to represent spoil heaps from pre-19th-century mining activities (CA 2012) and was not disturbed.

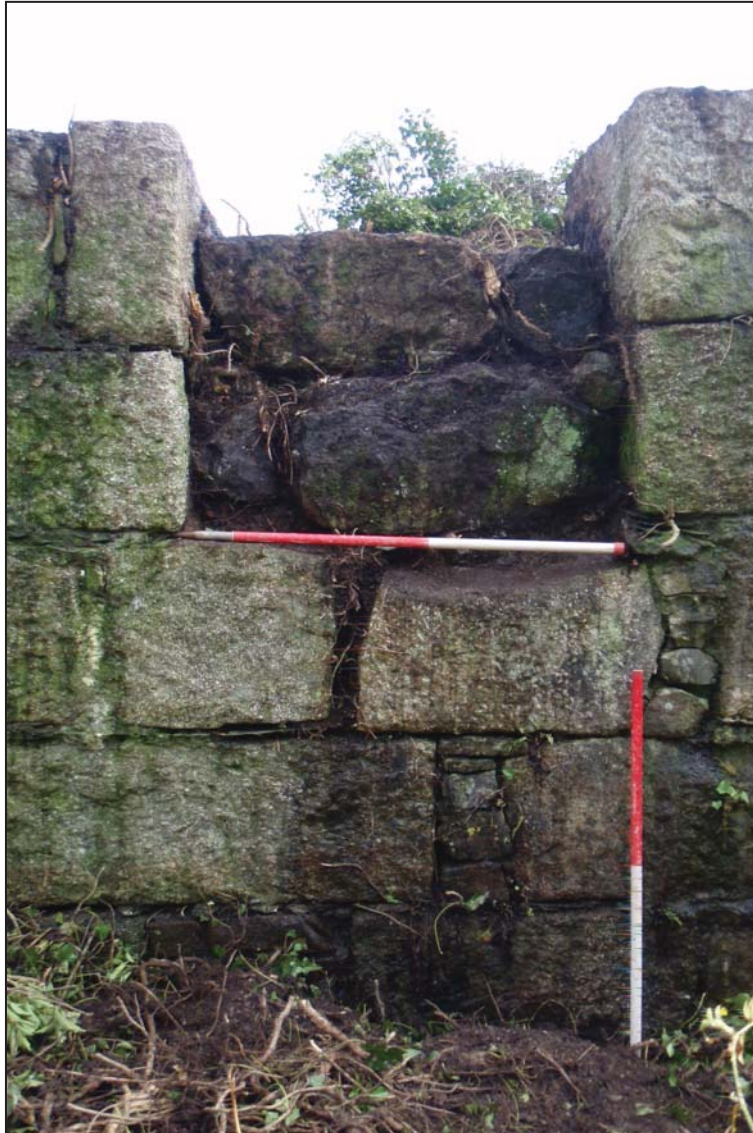
4 Photograph of north facing elevation of Engine House (scales 1m)

- 2.6 A 6m long and 1.65m wide surviving stretch of wall, 803, formed the north wall of the engine pumping house. It was constructed of a granite-rubble and mortar core faced by large granite blocks. The ground level surrounding the engine pumping house had been built up and it is likely that the wall was originally visible to a height of in excess of 2.2m. A 1.2m wide slot in the wall probably housed a beam extending from the building to the adjacent engine house shaft. At some time during the life of the building the slot was blocked up with granite blocks, 804 (Fig. 4).

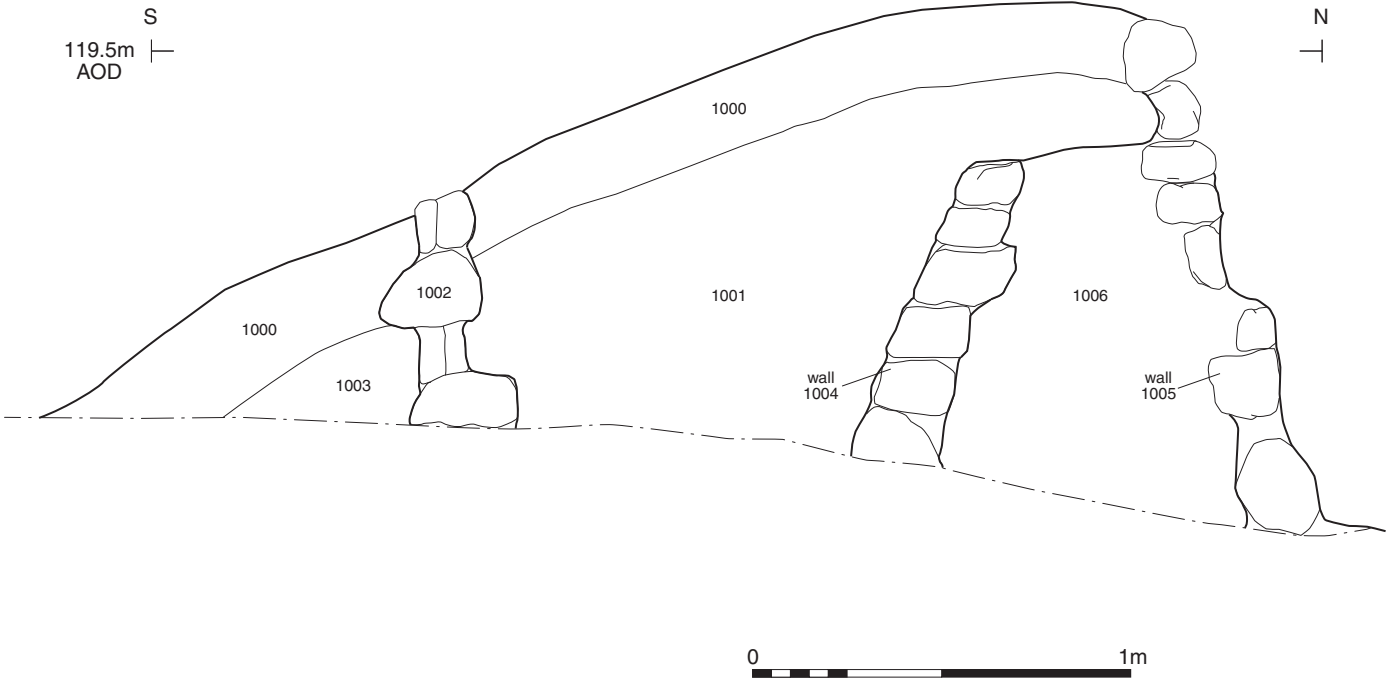
West facing section of hedgebank
along the boundary of fields 1 & 2

- 2.12 A Cornish hedge comprising two observed phases formed the northern boundary of Field 2 (Fig. 6, Section AA). The base of the hedgebank was not exposed during observations. The first phase of hedgebank construction comprised bank material 1006, typically 1m thick, retained by northern stone revetment 1005 and southern stone revetment 1004. The second phase comprised earth core 1001, which directly overlay the first phase material and was approximately 1m in thickness. This was overlain by topsoil 1000. The second phase was retained by northern revetment 1002, and southern revetment 1005. Hedgebank bank material 1003 and turf/topsoil 1000 continued beyond southern revetment 1002.

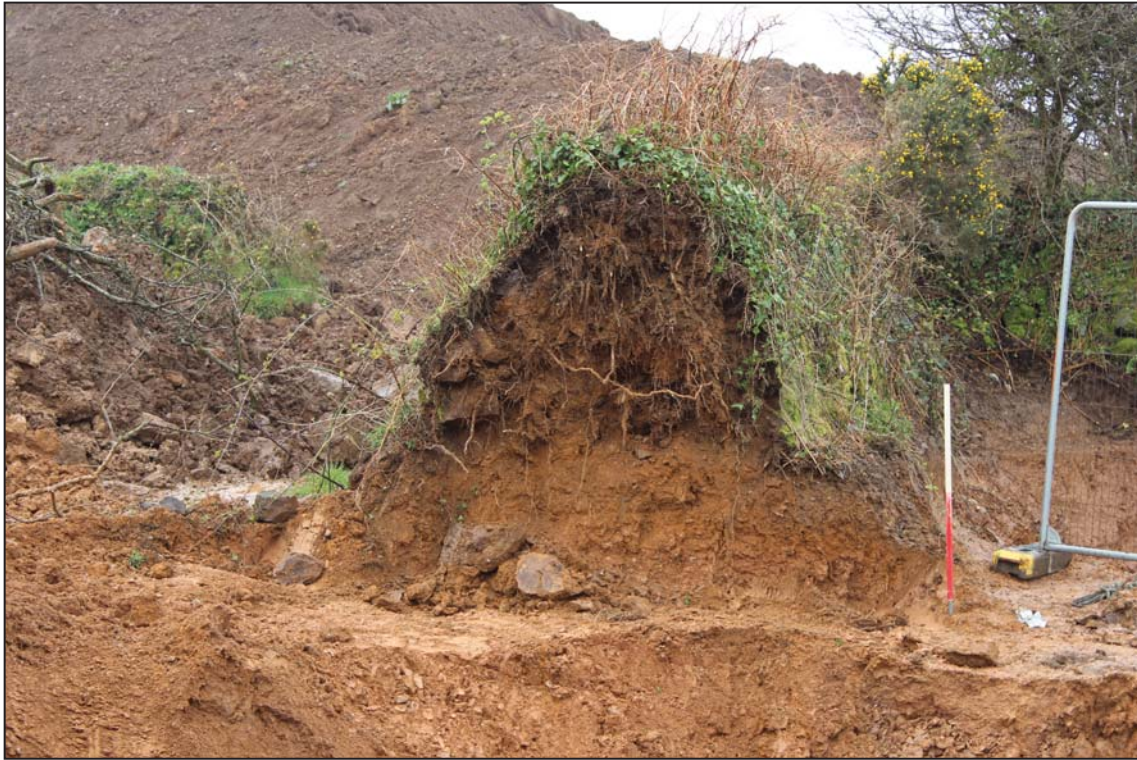
7 Field boundary 1 & 2 - hedgebank: southwest facing section (scale 1m)

- 2.10 A Cornish hedge demarcated the southern boundary of Field 1 and the northern boundary of Field 2 (Fig. 7). The base of the hedgebank overlay natural substrate 1104. The hedgebank construction comprised a 0.88m thick earth core 1101, retained by stone revetments: 1102 to the north and 1103 to the south. Topsoil 1100 (typically 0.25m thick) overlay the bank material.

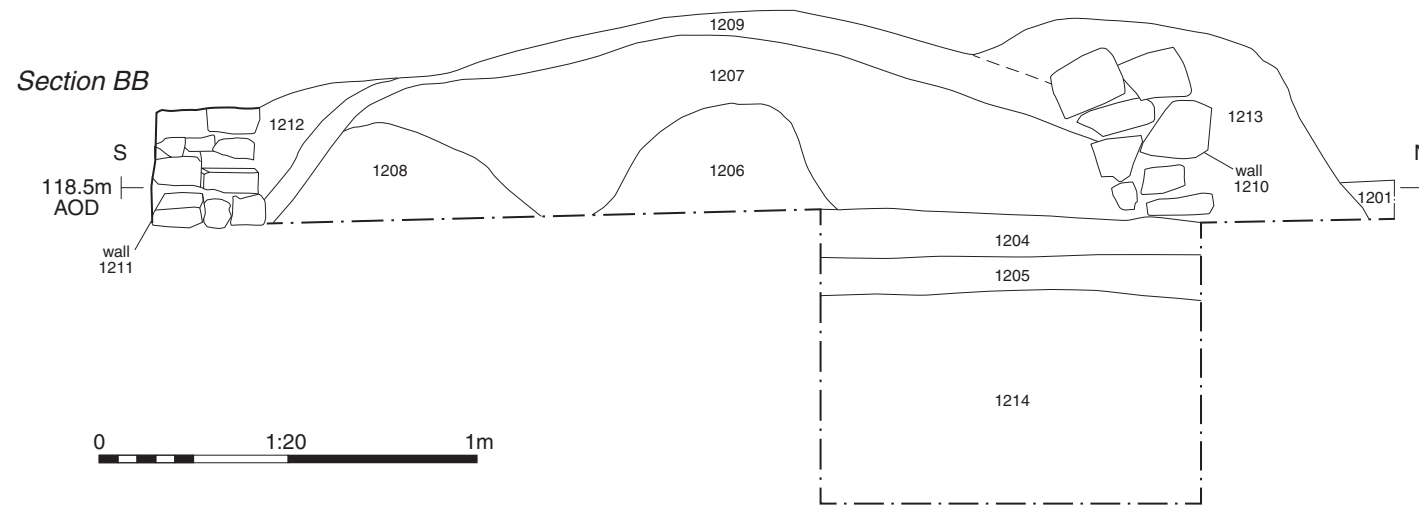
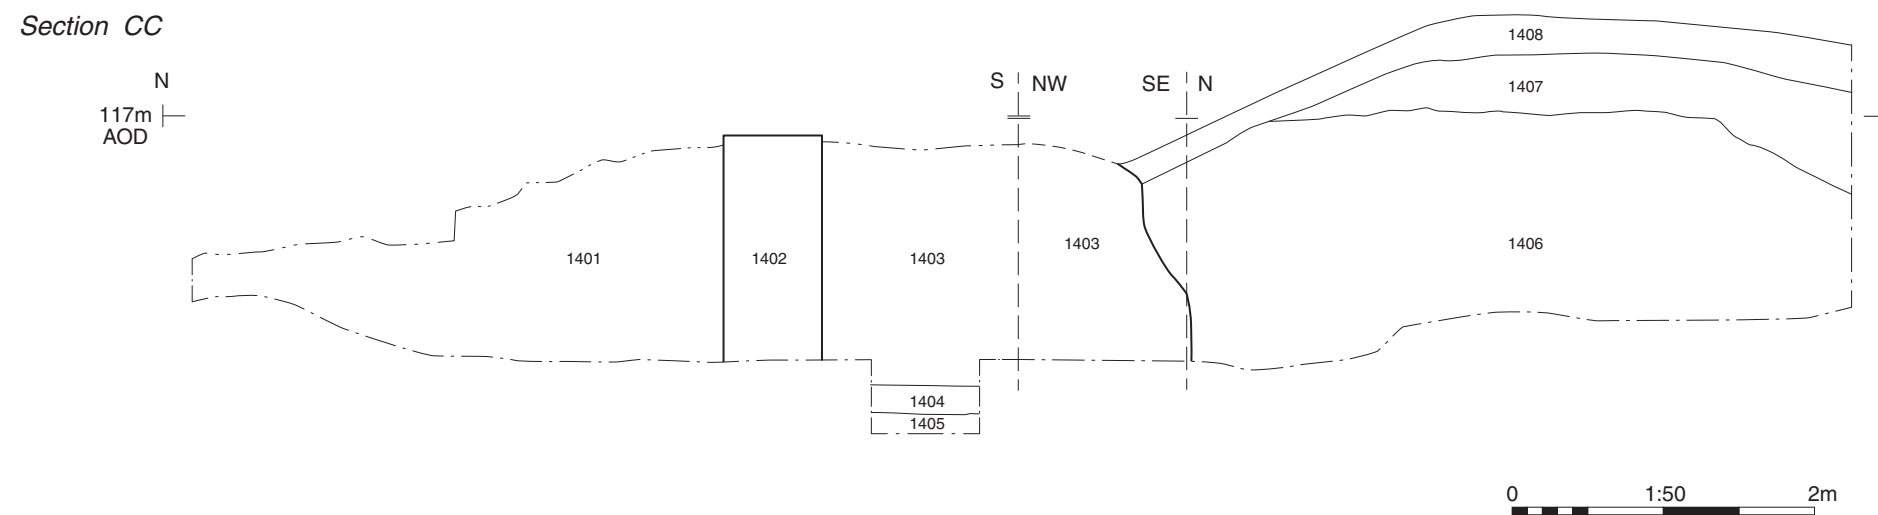
FIGURE TITLE
 Sections of hedgebanks along the boundaries of field 2

- 2.11 A short stretch of Cornish hedge (Fig. 8, Section CC) linked the building to the hedge forming the southern boundary of Field 1. The hedgebank comprised a 2.1m thick core of redeposited natural clay 1406 overlain by clay-silt and rubble deposit 1407. A 0.25m thick layer of topsoil, 1408, overlay the bank material 1407. The hedgebank was revetted to the north by wall 1403, which butted against the southern wall 1402 of building K. There was no visible stone revetment against the southern face of the hedge.

- 2.14 A Cornish hedge formed the north-eastern boundary of Field 8 (Fig. 8, section BB and CC). The base of the hedgebank overlay natural substrate 1214. The hedgebank construction comprised a 1.2m thick mixed bank core comprising stone layer 1206 overlain by deposits of sandy clay 1207 and 1208: both contained large amounts of stone. The core was retained by stone revetments 1211 to the south and 1210 to the north. The core was sealed by a 0.25m thick topsoil layer, 1209. At the northern and southern extents of the hedgebank, redeposited topsoil (1212 and 1213) was observed overlying the revetments
