**Land at Water Oakley  
Bray  
Berkshire**

**Archaeological Evaluation**

CA Project: 770142

CA Report: 14525

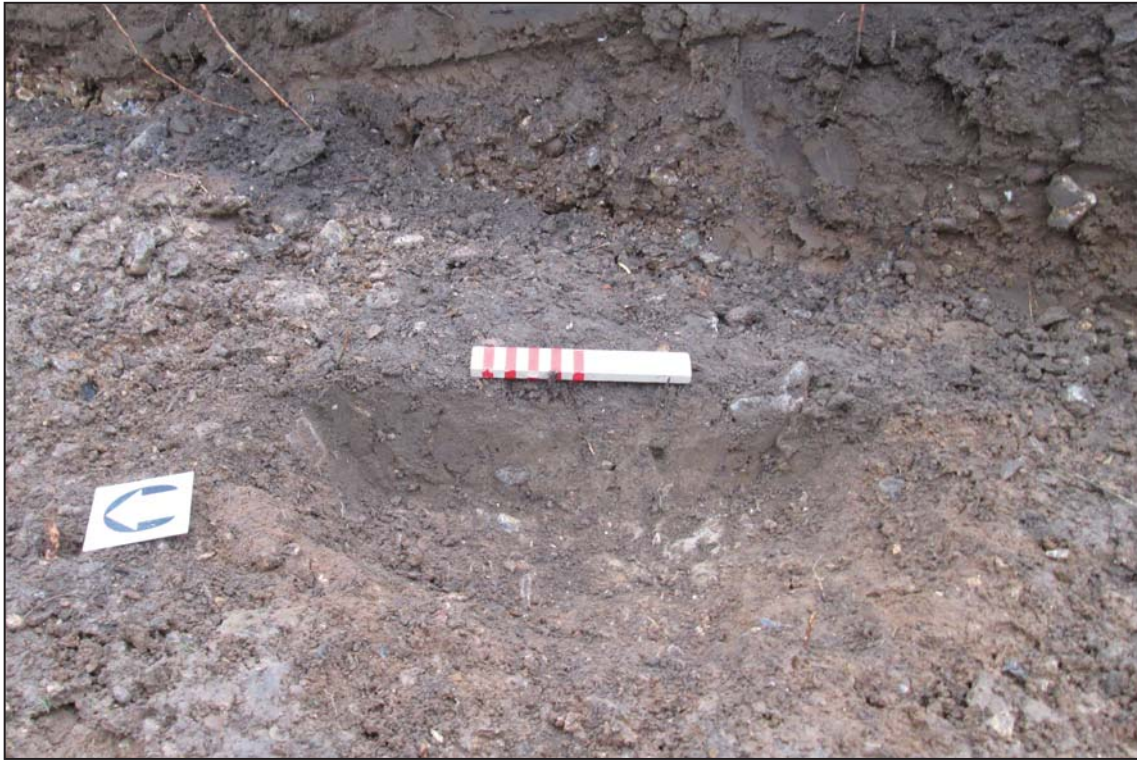
- 2.3 Trench **8** contained one post hole (**803**) located in the eastern end of the trench, it measured 0.51 in diameter and 0.12m in depth and produced modern brick and CBM.

3a Trench 8; Post Hole 803, looking east (0.2m scale)

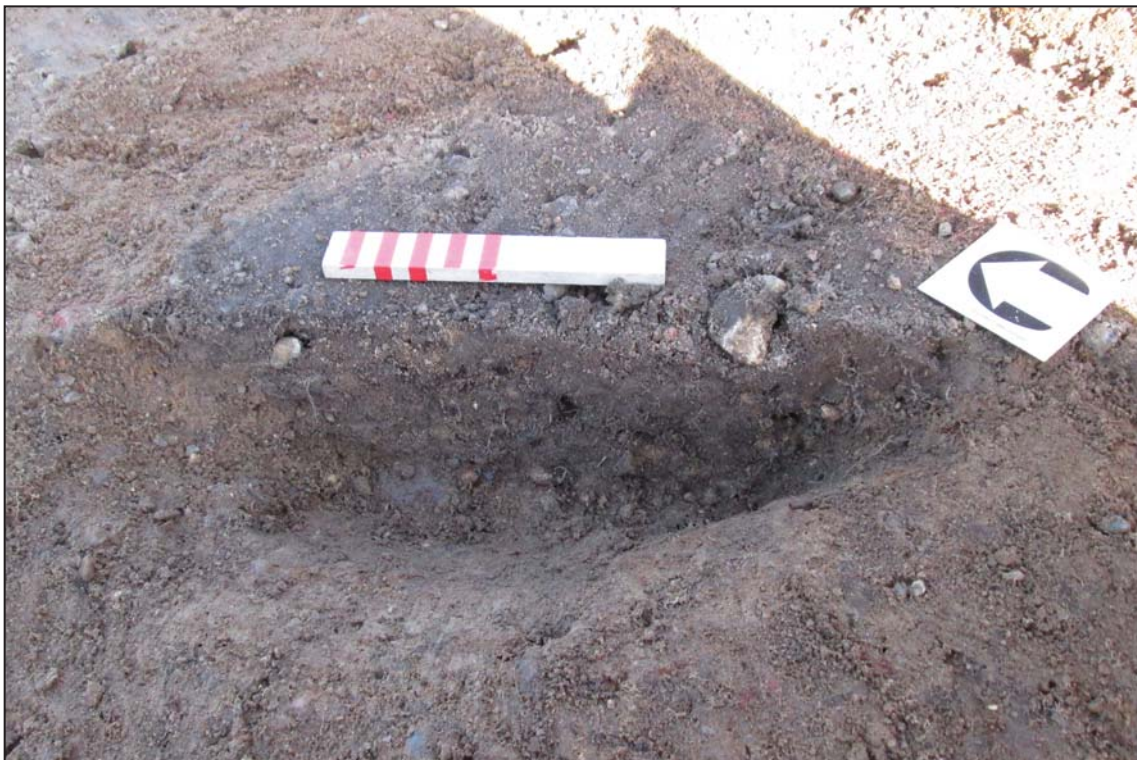
- 2.4 One post hole (**1002**) was identified within trench **10**, it was located centrally within the trench and measured 0.43m in diameter and 0.12m in depth and only produced modern brick and CBM.

3b Trench 9; Post Hole 1002, looking north-east (0.2m scale)

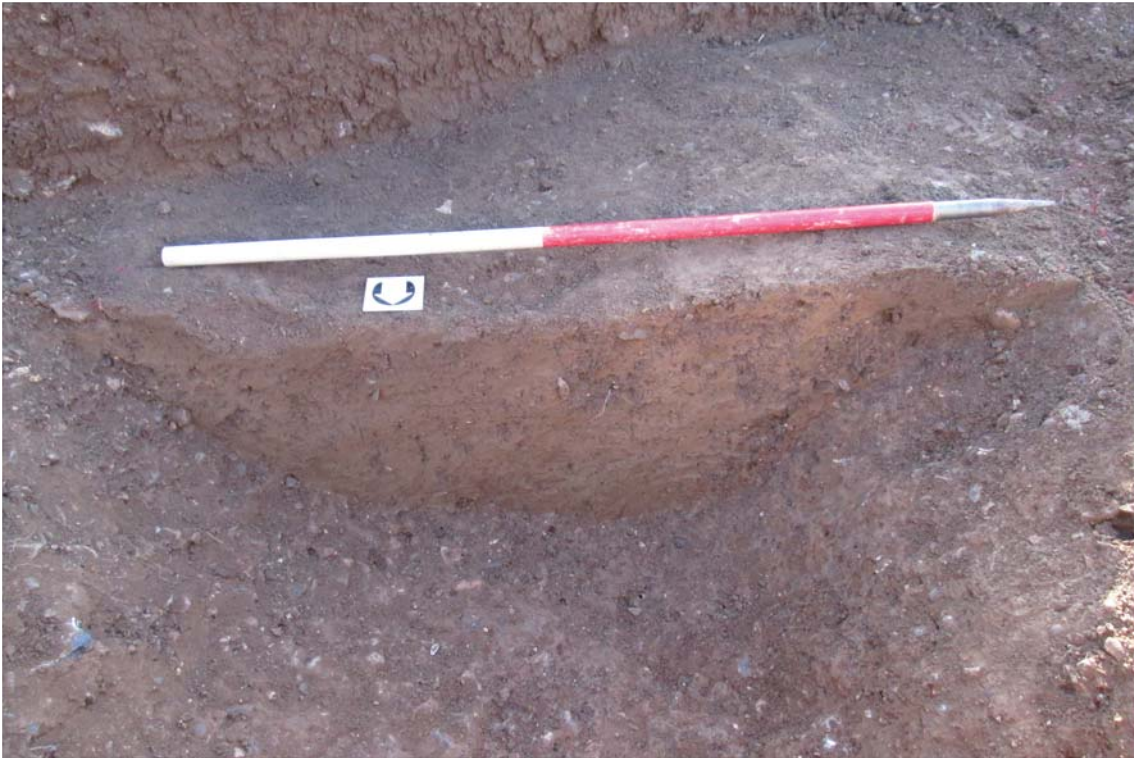
- 2.5 Trench **15** contained one north-south aligned ditch (**1503**) positioned centrally in the trench. The ditch produced fragments of post-medieval/modern ceramic building material and measured 1.40m in width and 0.37m in depth.

Ditch 1503, looking south (1m scale)

- 3.1 The majority of the trenches were blank with only trenches **8**, **10** and **15** containing archaeology. The archaeology consisted of two post holes and one ditch, which contained modern brick and CBM, and It is probable therefore that these are post medieval to modern in date. The ditch is likely to be part of a former post-medieval field boundary. With large amounts of modern disturbance occurring across parts of site, particularly in the north as a result of gravel extraction, there is a strong likelihood that any archaeology that may have been present has been truncated and removed. There was in particular no evidence of any Roman features or deposits relating to the extensive Roman activity identified in previous work undertaken to the west of the site prior to gravel extraction. However, although modern truncation was less evident in the southern and eastern parts of the site no significant archaeological features or deposits were revealed in this part of the site either. This suggests that there is a low potential for the presence or survival of archaeological features and deposits at the site.
