**Berwick Solar Park, Wick Street  
Berwick  
East Sussex**

**Archaeological Watching Brief**

*for*  
**Susenco Management Limited**

CA Project: 770151

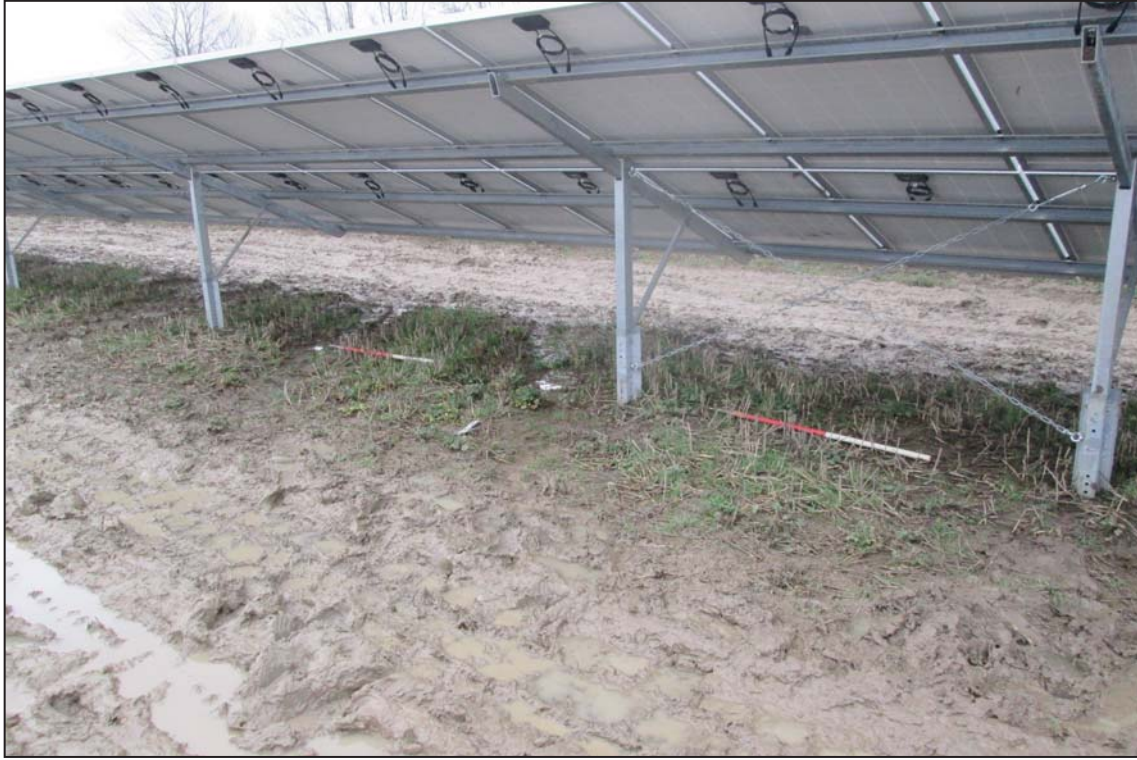
4 View of array 119 from the south-east (1m scales)

- 3.1 Photographic evidence collected on site along with survey data indicates that sufficient effort has been made to avoid archaeological features especially those on row 119 of the Berwick Solar Park design. In addition, despite the wet weather conditions, there was less wheel rutting than anticipated and general impact from construction traffic. This may be due to the greater use of tracked machinery by the constructor, than has been recorded on other recently completed schemes. It will, however, be important in future years that should decommission/replacement be considered that care is taken when removing/replacing the array (or sections thereof) and that new/additional impact to the archaeological resource is avoided. Strategies to consider this issue should be planned and reviewed (by the relevant stakeholders), well in advance of implementation.

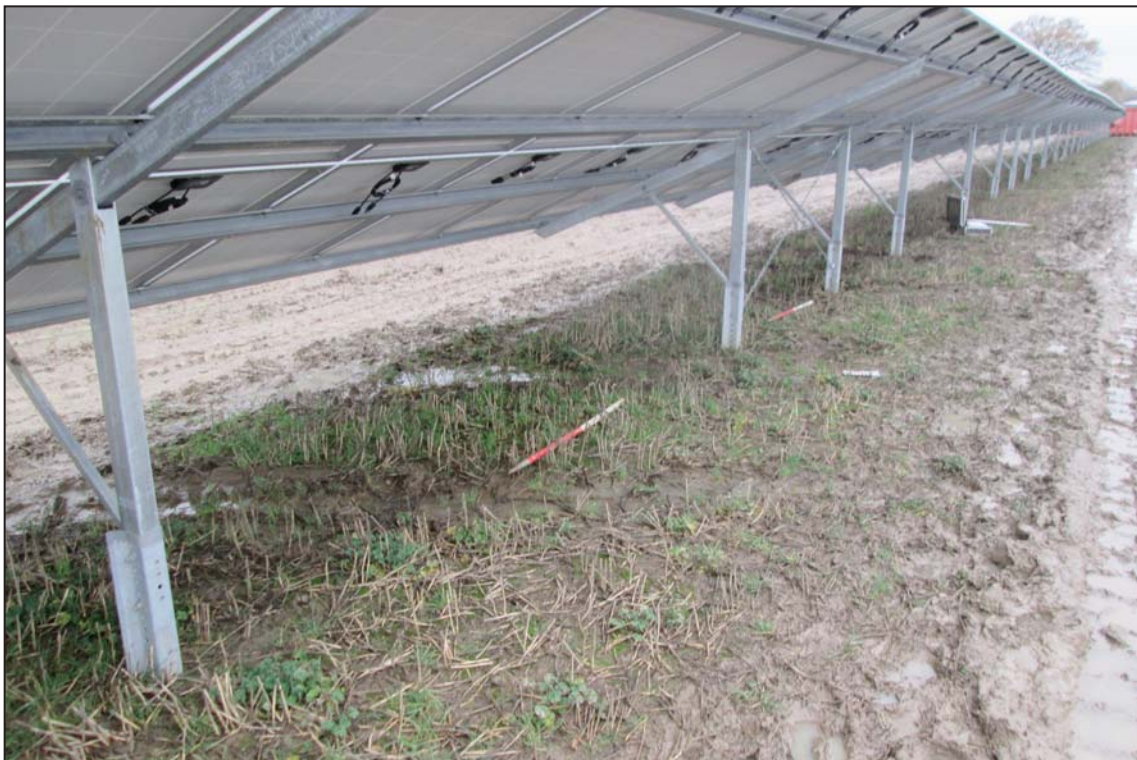
5 View of array from the south-west (1m scales)
