# Kingsmarsh House Gas Mains Replacement Bristol

Archaeological Watching Brief

> CA Project: 5319 CA Report: 15282

> > June 2015

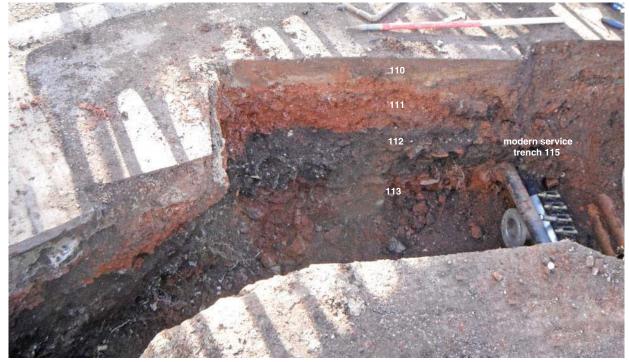
FIGURE NO. 4

North East facing section, showing deposit 113 (1m scale)

#### Section BB

FIGURE TITLE
Deposit 113: section and photograph

- 5.1 Natural geological substrate was not revealed within the trench. The earliest deposits identified were probable demolition deposits and comprised brick rubble deposit 107, overlain by cement mortar deposit 106 (Fig. 3), and a limestone rubble deposit 113 (Fig. 4) situated within the central and northern parts of the trench respectively (Fig. 2). Deposit 107 contained 17th to 18th-century brick fragments (see 6.4 below) as well as rare fragments of peg (roof) tile of 17th to 19th-century date, and pottery dating to the 18th century. Deposit 113 was undated. It is notable that modern finds were absent from all the aforementioned deposits.
