**Lords Hill Outdoor Recreation Centre**  
**Redbridge Lane**  
**Southampton**  
*Archaeological Evaluation*

Archaeological Evaluation

Planning Reference: 15/00093/FUL

CA Project: 770218  
CA Report: 15253  
SOU: 1685

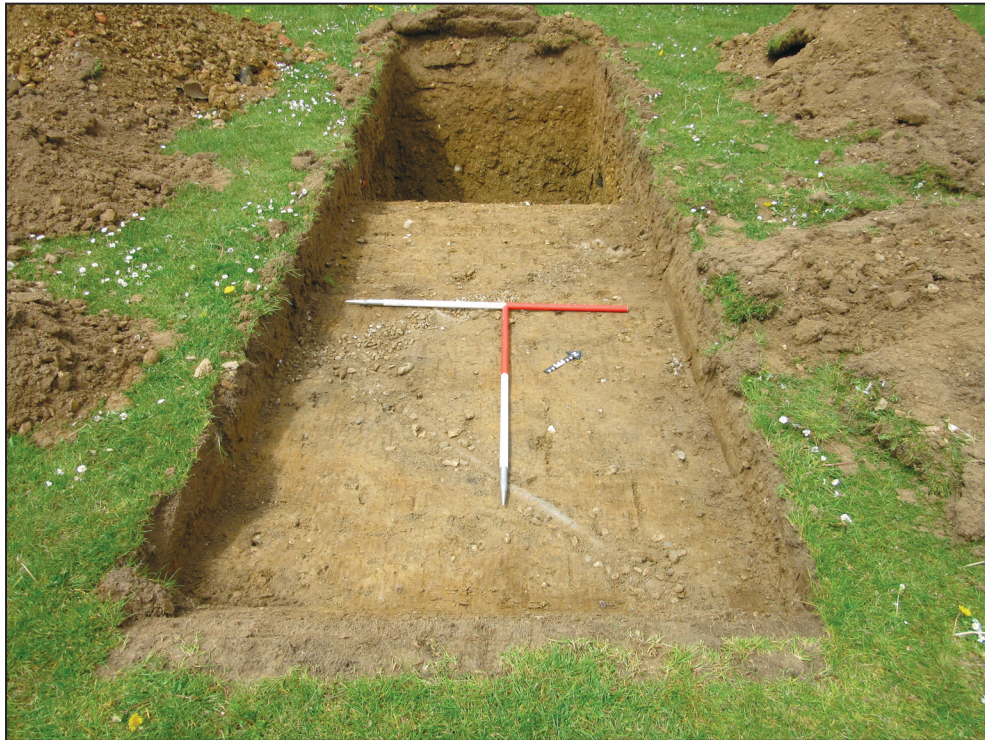
- 3 Test pit 4, looking north-west (scales 1m)
- 4 Test pit 4, representative section, looking north-east (scale 1m)
- 5 Trench 5, representative section (scale 1m)
- 6 Trench 5 (scales 2m and 1m)

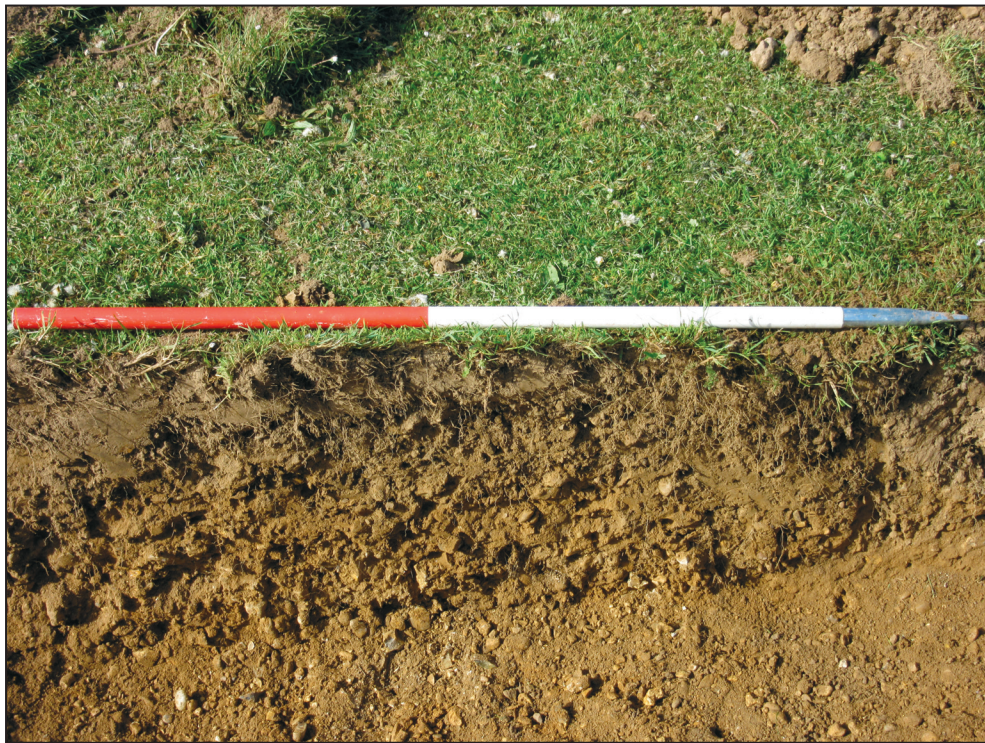
- 5.3 Trench 5 encountered redeposited gravels containing brick rubble at 0.45m in depth and had been truncated by modern land drains associated with the sports pitches and sealed by further amounts of made ground. The trench was partly excavated to a depth of 1.20m to confirm its nature and was seen to wholly contain redeposited gravel due to the presence of brick rubble and fragments within its matrix.

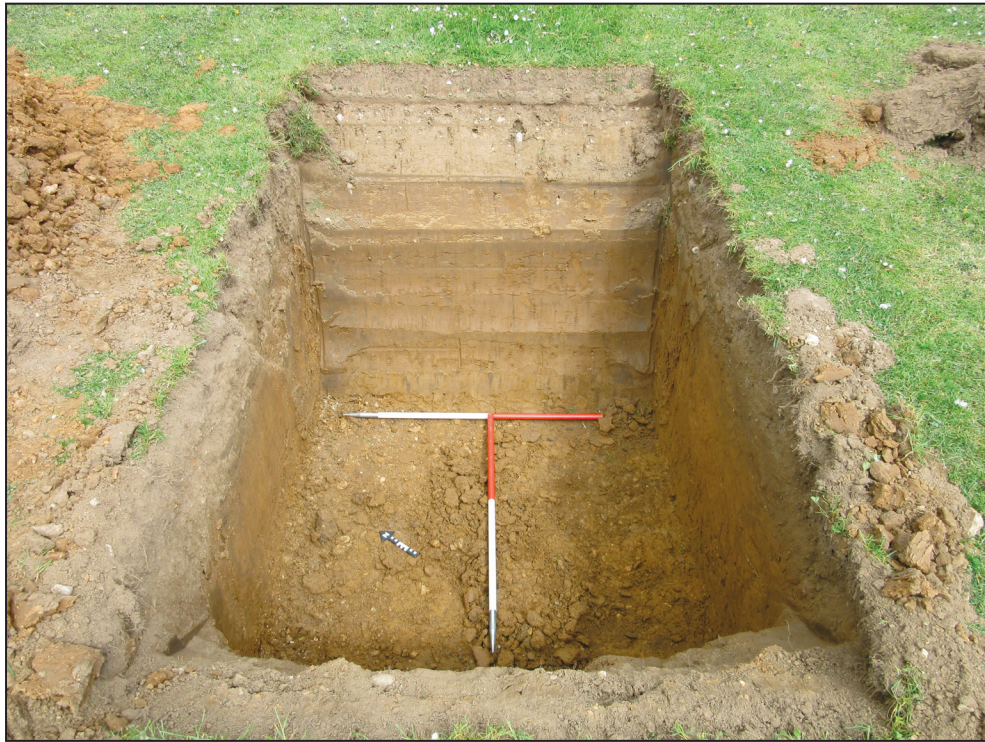
- 5.4 Trench 12 was sealed by a layer of made ground, and at its south eastern end and central area to be made up wholly of modern made ground (1201) to a depth of 1.20m+. At the north east end of Trench 12 and at the very far north eastern edge of the development area a layer of mid brown silty clay (1202), with no inclusions was revealed at a depth of 0.40m below ground level, to be overlying a dark brown silty clay (1203), which overlay a mid brown silty clay with a large abundance of gravel. However, given the modern disturbance within the remainder of Trench 12 it is unclear if this material was insitu deposits or redeposited material. No archaeology was revealed. This may be an indication that small islands or baulks of undisturbed material remain in situ within the north east corner and possibly around the edges of the site despite the extensive quarrying.

- 7 Trench 12, looking north-east (scale 1m)
- 8 Trench 12, representative sample looking south-east (scale 1m)
- 9 Working shot
- 10 Working shot
