**Land at Westbury Sailing Lake  
Station Road, Westbury  
Wiltshire**  
*Archaeological Evaluation*

## Archaeological Evaluation

CA Project: 5511  
CA Report: 15639

<b>Project Name:</b>	Land at Westbury Sailing Lake
<b>Location:</b>	Station Road, Westbury, Wiltshire
<b>NGR:</b>	ST 8582 5130
<b>Type:</b>	Evaluation
<b>Date:</b>	28-31 July 2015
<b>Location of Archive:</b>	To be deposited with Wiltshire Museum
<b>Site Code:</b>	STN 15

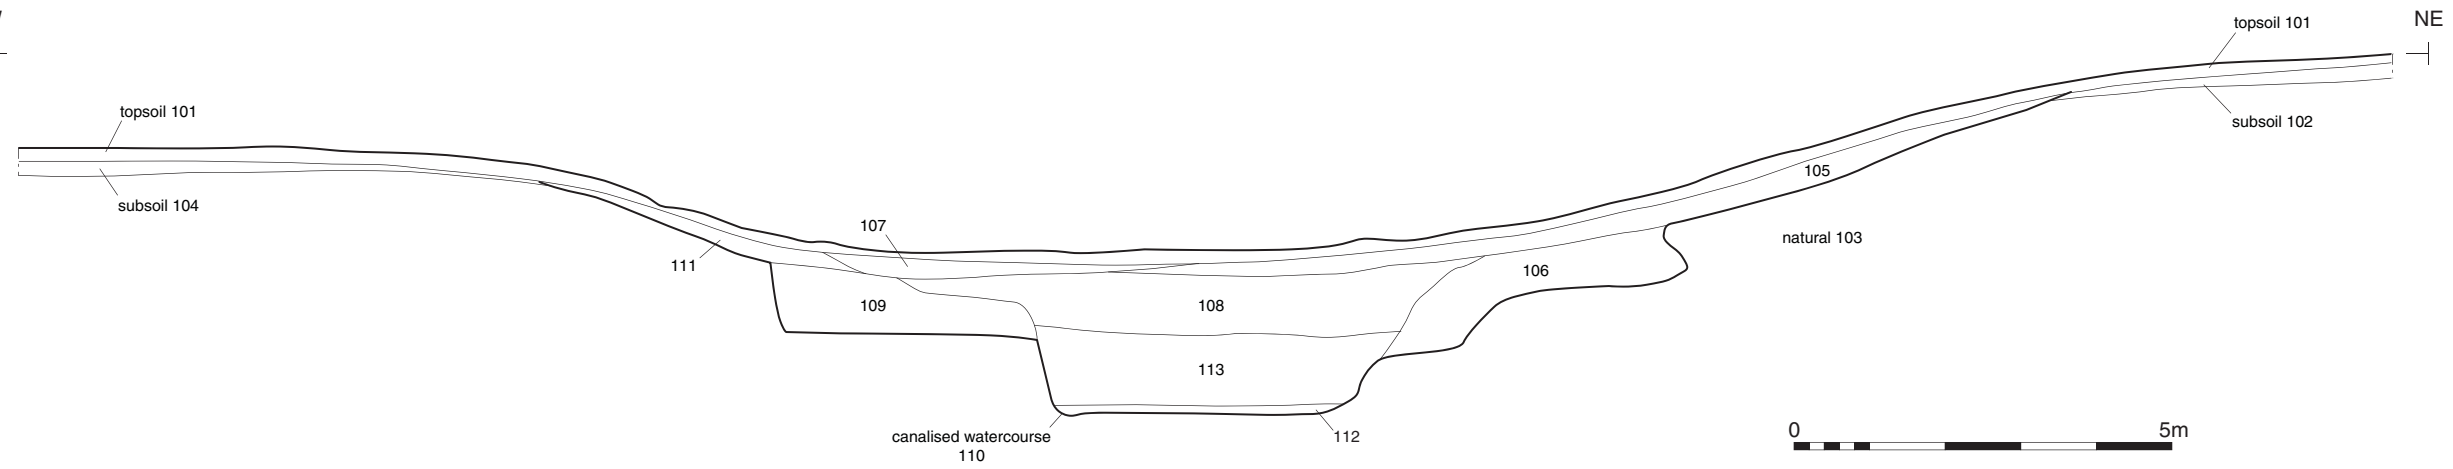
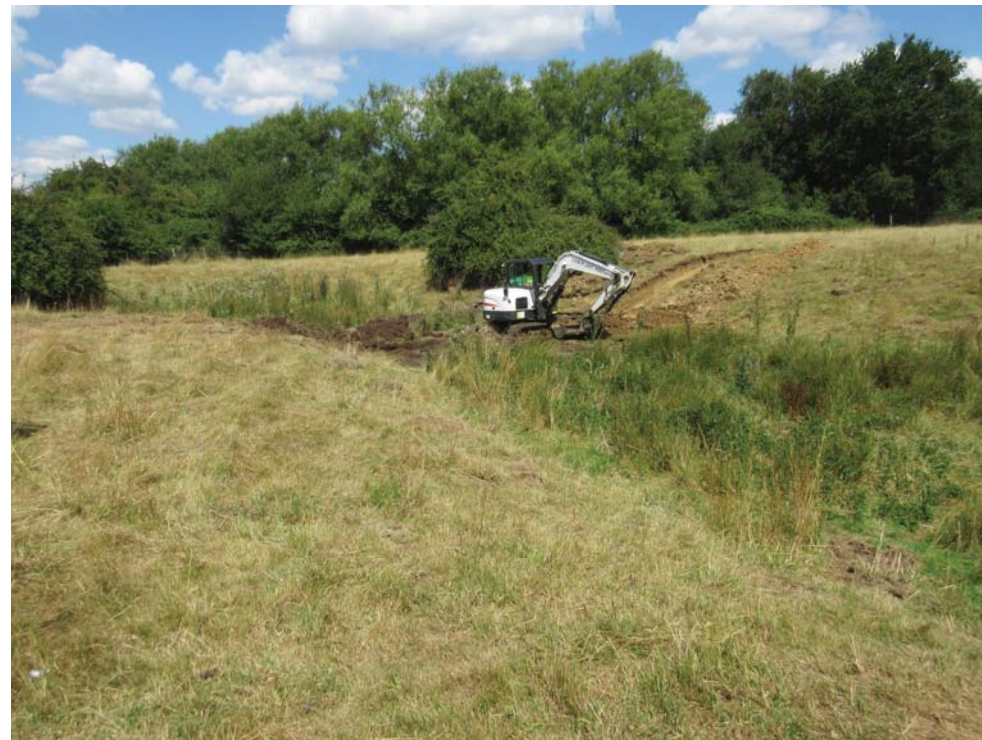
FIGURE TITLE  
**Trench 1: section and photograph**

- 5.4 The trench revealed a single north-west/south-east orientated cut, 110, cutting the natural clay 103 (Fig. 3). It was c. 20.2m wide by 4.7m deep. The tops of the cut initially sloped gently down to a number of vertical/steep sided, flat bottomed steps. There were two steps on the eastern side and one on the western side between 0.4-1m high and 1.8-3.4m broad. The base of the cut had steep sides and a c. 4m wide flat base located at 59.1m AOD.

- 5.5 The basal fill (112) in the base of the cut was very different to the overlying the fills. This consisted of white/light grey clean chalky gravel overlying a thin layer of weathered natural clay with a large number of oyster shells on the boundary between the clay and gravel. It would seem likely that this is a waterborne deposit, and a lack of organic matter and silt would suggest that it is a fast flowing clean chalk stream deposit. A rimsherd from a greyware flagon was retrieved from this fill, broadly dating to from the late 1st to early 3rd centuries AD. However, as it shows some edge abrasion and has a thick, chalky residue adhering to the interior of the sherd, it suggests it may have been in the stream for some time and is possibly residual. In addition, as it is larger and lighter than some of the stones within the deposit, there is a strong possibility that it has been washed along the water course, maybe for some distance from its original point of deposition.

- 5.6 The next fill (113) in the sequence was loose, grey black/brown slightly silty sand with fragments of waterlogged, preserved vegetation. It filled most of the lower portion of the cut. This fill was excavated by machine as it was actively collapsing in to the trench; it was very similar to fills 207, 224, and 225 in Trench 2. It appeared to be a waterborne deposit and, as the grain size of the deposit was smaller than in 112, it is possible to suggest that flow rate through the feature during the deposition of 113 was less than during the deposition of the earlier fill 112.

- 5.7 The other fills in the cut are predominately silt clays, the earliest of which (106 and 109) cover the eastern and western steps in the cut respectively. Because of their similarity to the natural deposits they would seem to be the result of the erosion of the sides of the cut. Unfortunately, because of the collapse of the sides of the trench the relationship between these fills and the sandy fill 113 is not totally clear. However, there was the impression that the upper portion of 113 may have overlain the lower portion of 106 and 109, in which case it suggests that the watercourse may have been re-cut prior to the deposition of 108 and 113.

- 5.8 The clay fill 108 sealed fills 106, 109, and 113 and had a distantly 'cottage cheese' texture, suggesting that it possibly formed in a still or stagnant water environment. As the boundary between 113 and 108 is fairly flat and very sharp, it is possible to suggest that the flowing water environment that deposited 113 relatively suddenly became a still water environment, allowing for the stark change in sediment deposition within the feature.

- 5.9 Overlying 108 was the clay fill 105, and similar fill 111 overlay fill 109. Both fills possibly result from weathering of the upper portion of the cut. Fill 107 would seem to be a peaty deposit forming in the boggy ground between 105 and 111.

View of trench 1 during backfilling, looking north-west

- 8.5 In both trenches the possible platforms would appear in fact to be the result of upcast created during construction and maintenance of the canalised watercourse, rather than building platforms (Fig. 3).

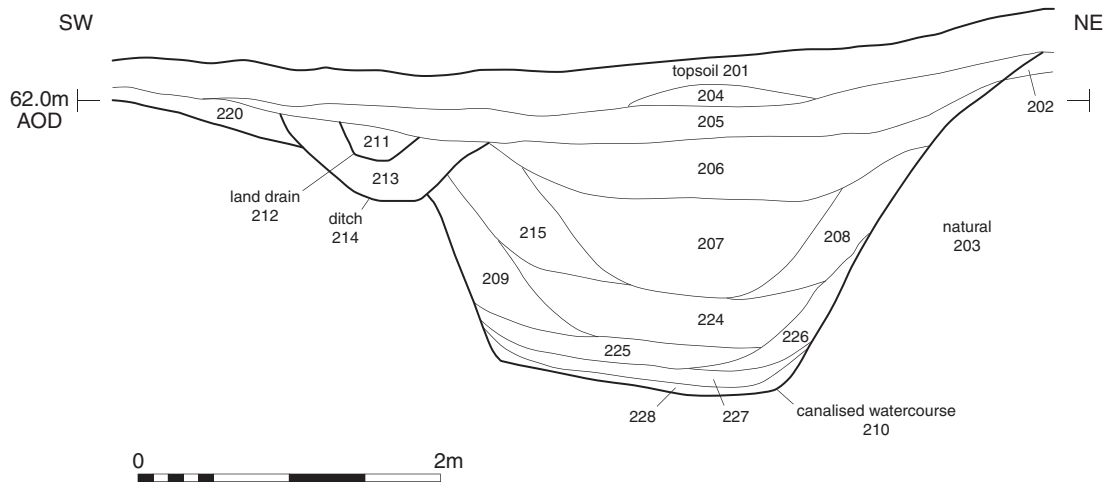
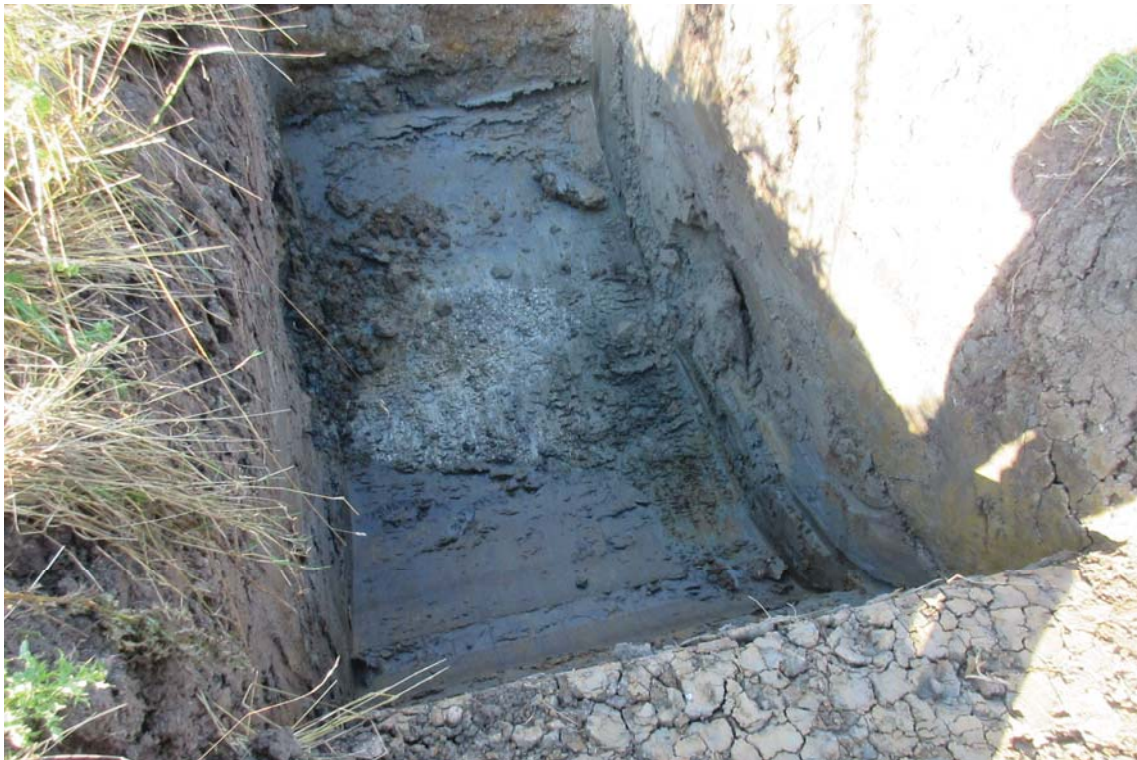
**Trench 2: section and photograph**

- 5.10 At the eastern end of the trench, a substantial north-west/south-east orientated cut 210 was revealed (Fig. 4). It cut the natural clay 203 and was c. 5.45m wide by 2.3m deep. The top of the cut (like 110), on both sides sloped gently down until it was 1.1m (western side) and 1.8m (eastern side) above the base, at which point the sides dive steeply to a flat base. The base of the cut was c. 1.8m wide and located at c. 60.1m AOD.

- 5.11 The cut contained a similar sequence of fills to cut 110 in Trench 1. However, as the sides of the trench were more stable it was possible to observe them in more detail. The basal fill 228 was a 0.05m thick, grey blue sand/silt which probably represents the initial erosion of the sides of the cut. Above this was 0.15m thick, clean chalky gravel 227 (Fig. 4). It was identical to fill 112 in Trench 1, and like 112 it would seem to have been deposited by a fast flowing, clean chalk stream deposit.

- 5.12 Above this there was a succession of silt clay fills (208, 209, 215, and 226) and loose silty sand fills, each with a dark band at their base (207, 224, and 225). Fills 207, 224, and 225 were almost identical to 113 in Trench 1, and would seem to be waterborne deposits laid down in a slower-flowing stream than 227. It is possible these represent a succession of erosional events (226, 209, 208, and 215) and subsequent re-cutting and maintenance of the watercourse, but it was not possible to investigate these deposits at close quarters for the health and safety reasons outlined above.

- 5.13 Clay fill 206 broadly corresponds to fill 108 in Trench 1 and was deposited before ditch 214 was cut. Ditch 214 is a north-west/south-east orientated ditch on the same alignment as 210. It is 1.34m wide by 0.56m deep and contains the single silt clay fill 213. Ditch 214 seems to be a field ditch following the line of 210 and it had had a ceramic land drain inserted into the top of it, prior to the final silt clay fills 205 and 204 sealing both the ditch and the canalised water course 210.

Trench 2: deposit (227) in base of machine dug trench across canalised watercourse [210], looking south-east
