Pond, Swale and Eastern Canal Wall Llanthony Secunda Priory Llanthony Road, Gloucester

Archaeological Evaluation

CA Project: 5833 CA Report: 16272

July 2016

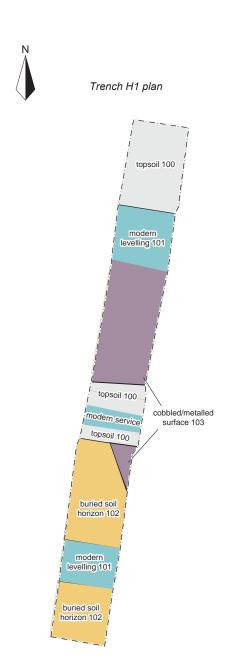
5.2 A metalled surface, 103, comprising tightly packed small stones and pebbles was identified at 1.1m below present ground level (bpgl). This was sealed by buried soil horizon 102 which was *c*. 0.1m thick. Further investigation of these deposits was prevented by the rapid ingress of groundwater into the trench. Possible evidence for hydrocarbon contamination was identified on the surface of the water. The location and height of surface 103 were recorded but the full extent of the surface was not

Trench H1, general view looking north-east (scale 1m)

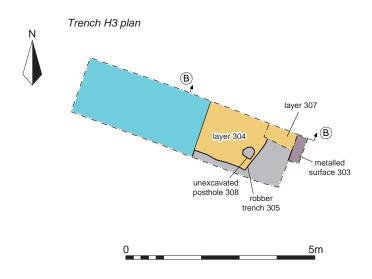
5.7 Limited investigation identified light brown grey sandy silt deposit 307 at the base of the sequence (Fig. 5, Section BB). The upper surface of this deposit coincided with the base of robber trench 305 which also cut deposit 304. The latter comprised compact light pink brown silty clay with frequent crushed mortar inclusions and was very similar in composition to the probable beaten earth floor, 206, identified in Trench H2. Robber trench 305 appeared to be 'L' shaped in plan (therefore possibly representing the corner of a structure); however its south-eastern and south-western

Trench H3, south-eastern end, looking north-east (scales 1m, 0.4m)

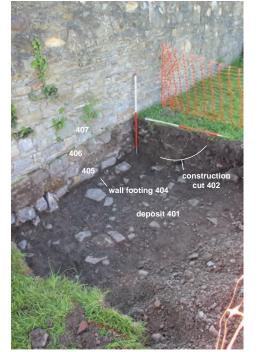
- 5.9 The earliest deposit encountered within the trench, 401, comprised mid brown grey sand silt with fragments of irregular stone rubble. A single sherd of glazed pottery of later medieval or post-medieval date was recovered from this deposit which was cut by construction cut 402 for wall footing 404 (Fig. 6, Section CC). Wall footing 404 comprised a single course of roughly squared, un-bonded, stone blocks which was offset by a maximum of 0.05m from wall 405 which sat directly above. Wall 405 consisted of two irregular courses of roughly squared blocks bonded by yellow sandy mortar. It was abutted by the backfill 403 of the construction cut 402 which was sealed by the existing topsoil 400.

- 5.10 The top of wall 405 was overlain by a single course, 406, of flat fragments of stone laid flat, bonded with a light grey white gravel mortar and which measured *c.* 0.07m in thickness (Fig. 6, Eastern Canal Wall west facing elevation). This course, which continued for approximately 0.7m to the north and south of Trench H4, appeared to represent a break in construction and was overlain by wall 407 which comprised roughly coursed irregularly sized stone blocks bonded with a light grey gritty mortar.

Trench H4, looking nsouth-east (scales 1m)

- 8.4 The Eastern Canal Wall (Structure E) has been described as being 'clearly multiphase' (CA 2016d, 25) and the evidence identified in Trench H4 has further confirmed this view. A single piece of glazed pottery of medieval or post-medieval (13th to 16th-century) date was recovered from deposit 401 which was cut by construction cut 402 for the earliest phase of wall 404. The Eastern Canal Wall was

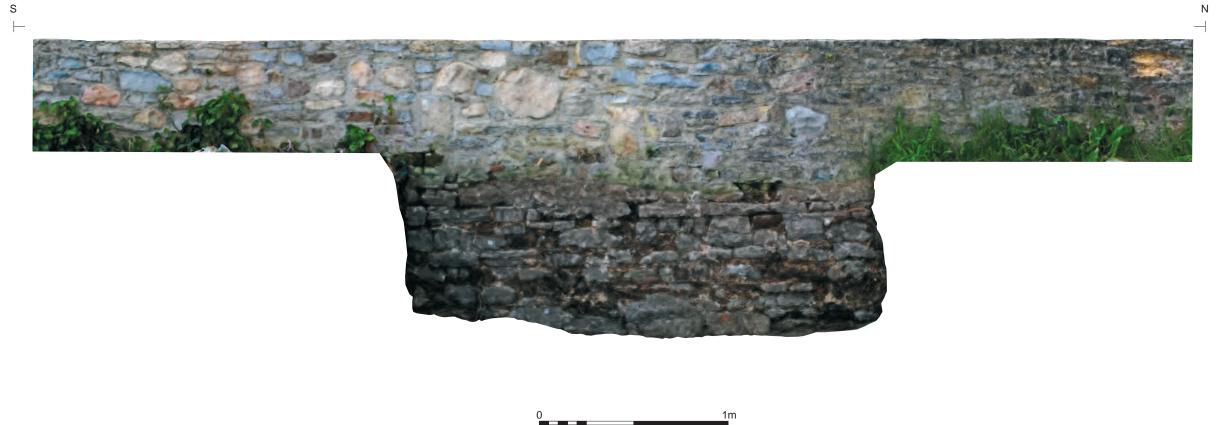
Eastern Canal Wall east facing elevation

5.11 Wall 503, representing the western side of the Eastern Canal Wall was investigated in Trench H5. It was abutted by two layers of modern levelling/made ground and the existing topsoil. Modern artefactual material was observed within these deposits but was not retained. Wall 503 appeared to represent a single phase of construction.

Trench H5, looking south-west (scales 1m)

8.5 Trench H5 confirmed that there is at least 1m depth of post-medieval to modern levelling deposits butting the eastern side of the Eastern Canal Wall. These deposits appear to represent the dumping and levelling of spoil from the construction and/or maintenance of the nearby canal and/or railway sidings. Similar deposits, also seemingly associated with the construction or maintenance of the canal and/or railway sidings, have been identified in a number of previous archaeological investigations in the location of the eastern canal wall (e.g. CA 2003, CA 2016c).
