Pickersleigh Grove Malvern Worcestershire

Archaeological Evaluation and Building Recording Survey

CA Project: 5611
CA Report: 16057
Site Code: PIC 15

January 2016

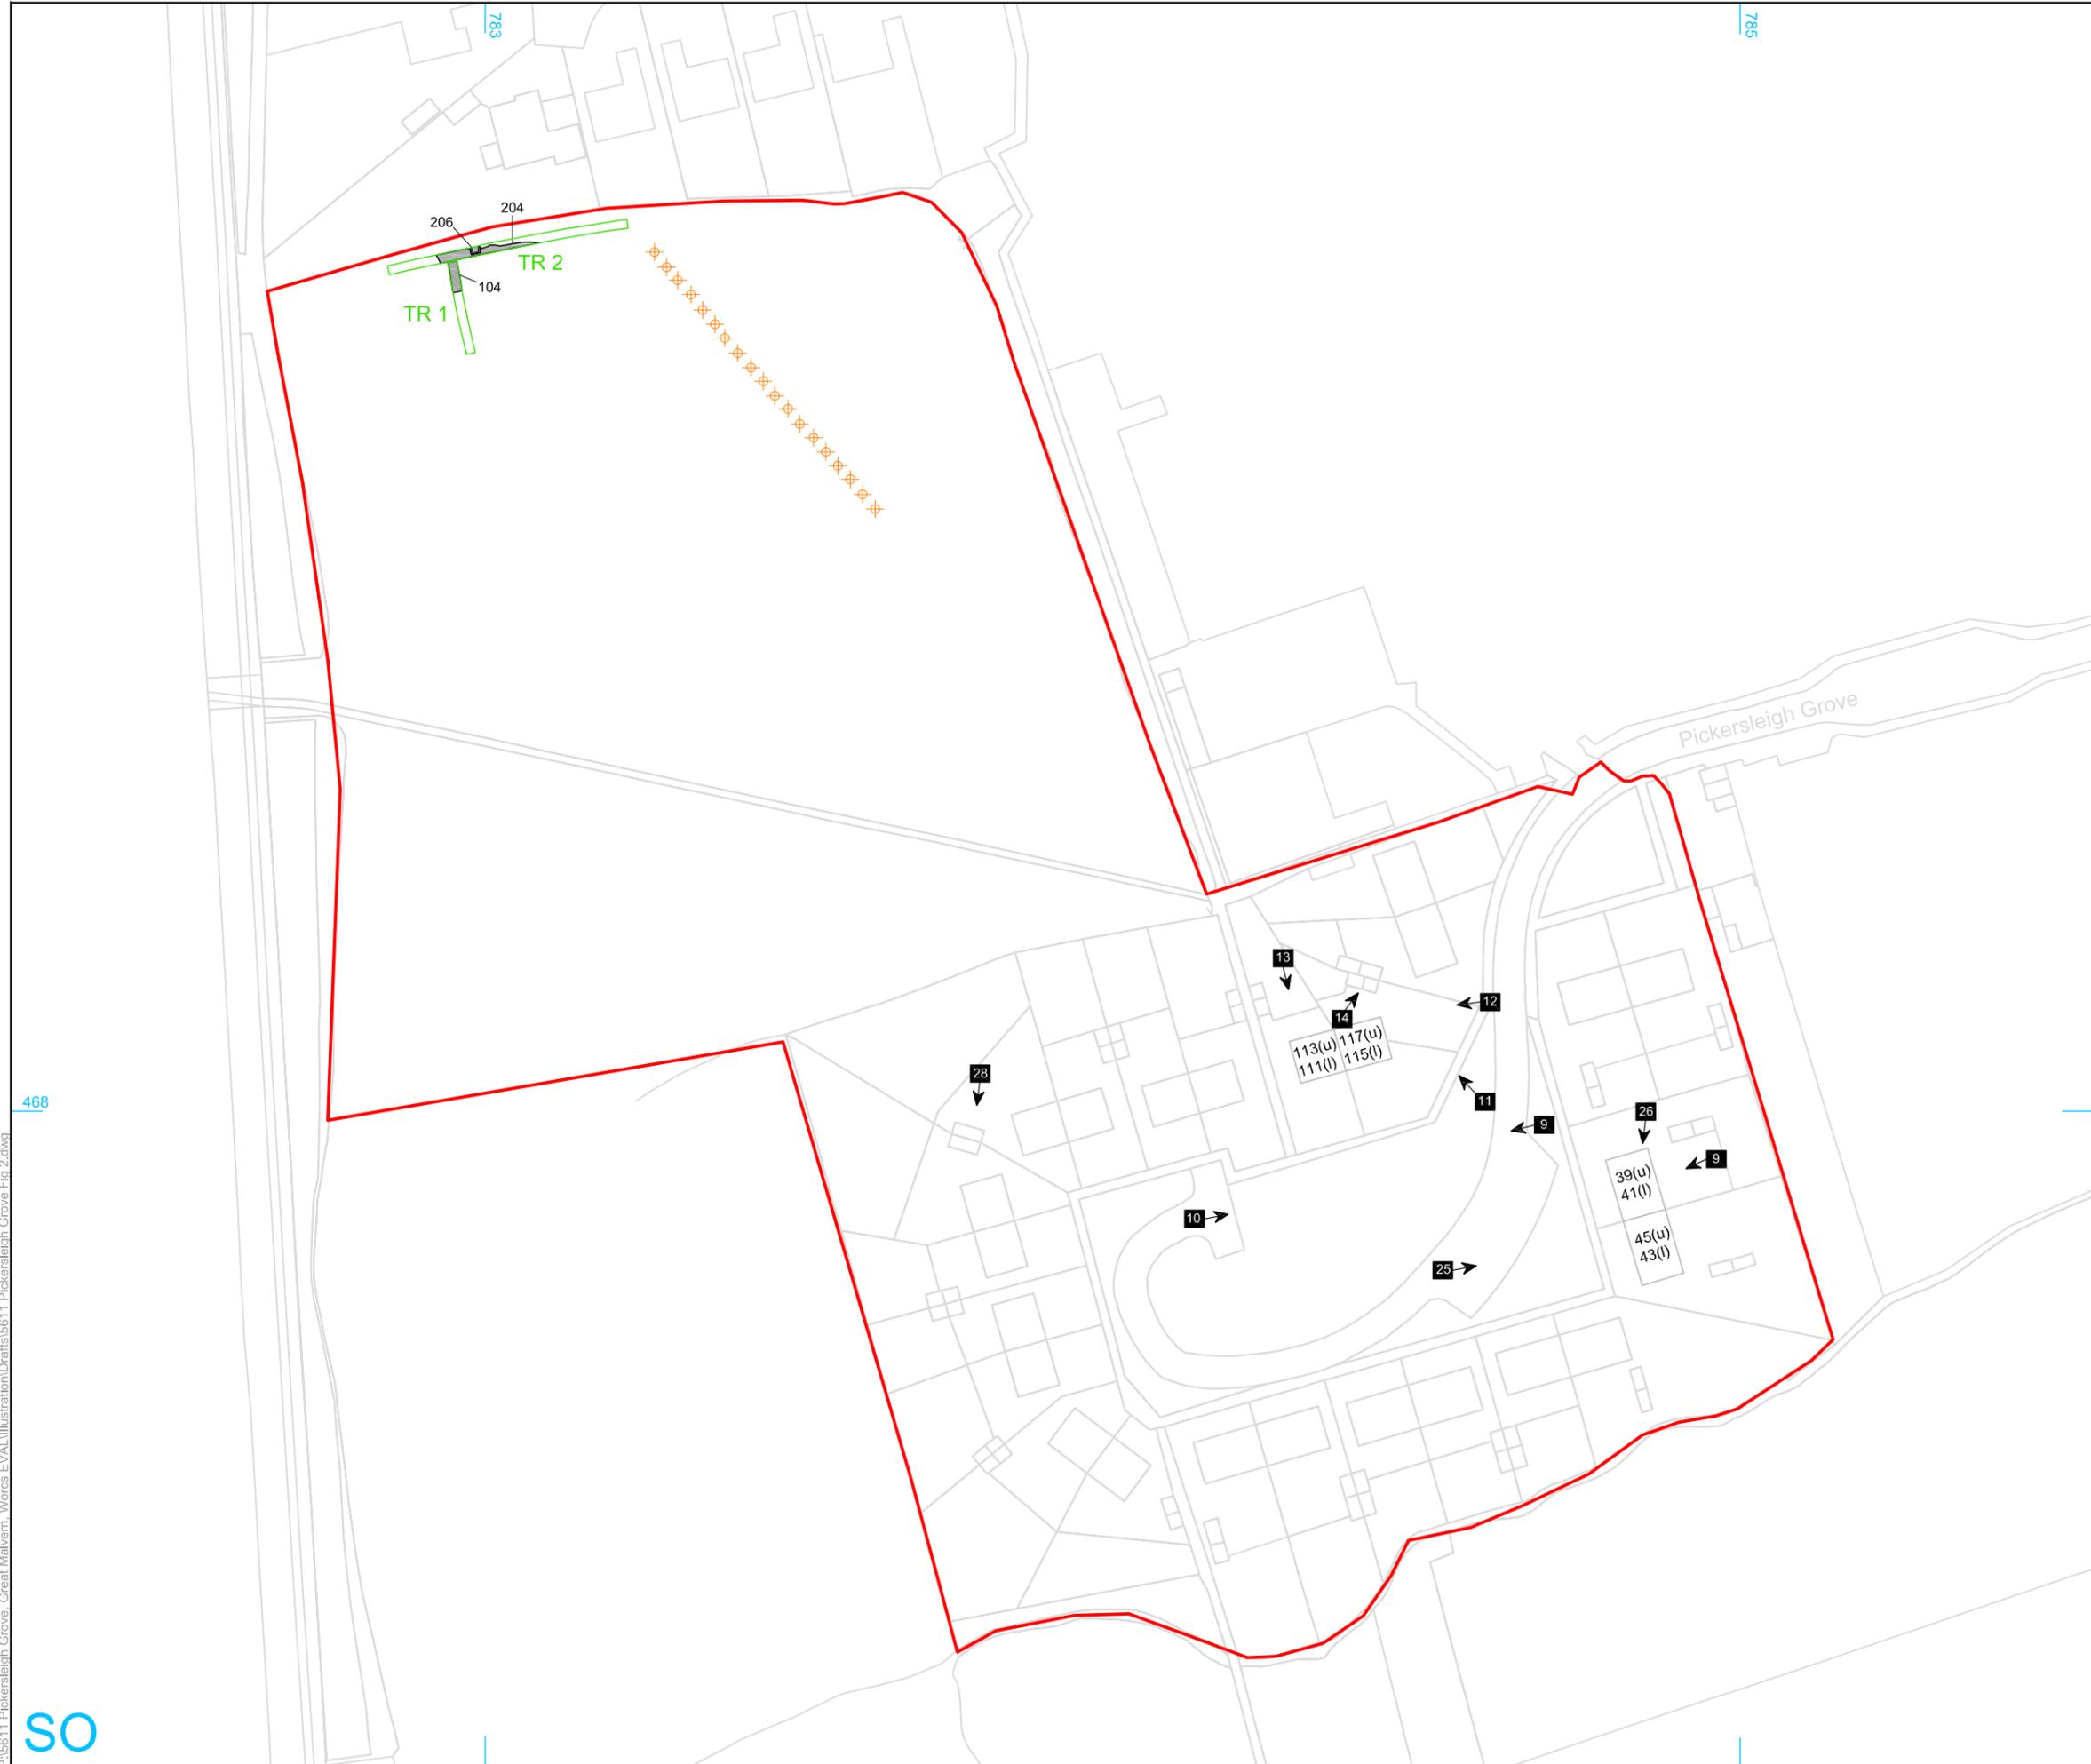
FIGURE TITLE
 Trench location plan showing auger
 survey locations and building
 recording photographic locations

4.1 The fieldwork comprised the excavation of two trenches measuring 40m and 15m long, and an auger survey (Fig. 2). The trenches were set out to target the location of the former farm as identified on historic mapping. Trenches were set out on OS National Grid (NGR) co-ordinates using Leica GPS and surveyed in accordance with *Technical Manual 4: Survey Manual* (CA 2013).

- 4.2 The auger survey comprised a cross-sectional transect through the widest area of wetland in the northern field. The survey was undertaken using a sectional hand auger, fitted with the appropriate heads for the deposits encountered. Bores were taken at 3m intervals along the transect, with the locations surveyed using Leica GPS.

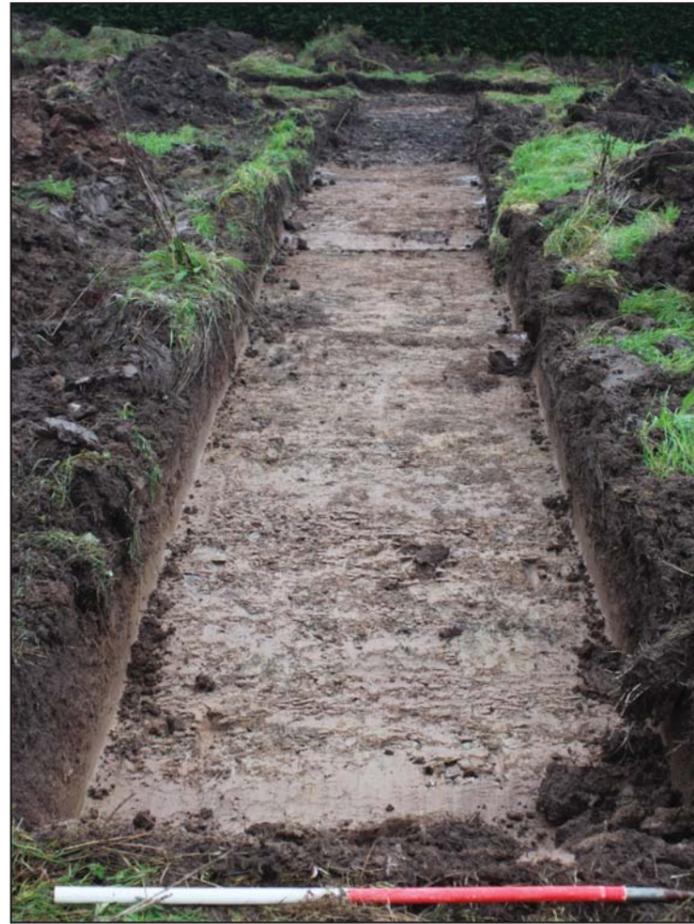
- 5.3 Located at the northern end of the trench was stone surface 104, which comprised a layer, c. 0.15m thick, of broken cobbles mixed with brick rubble and modern debris. The layer extended to the north into Trench 2.

- 3 Site looking south
- 4 Trench 1, looking north (scale 1m)
- 5 Trench 2, looking east (scales 1m)
- 6 Structure 205, looking north (scale 1m)

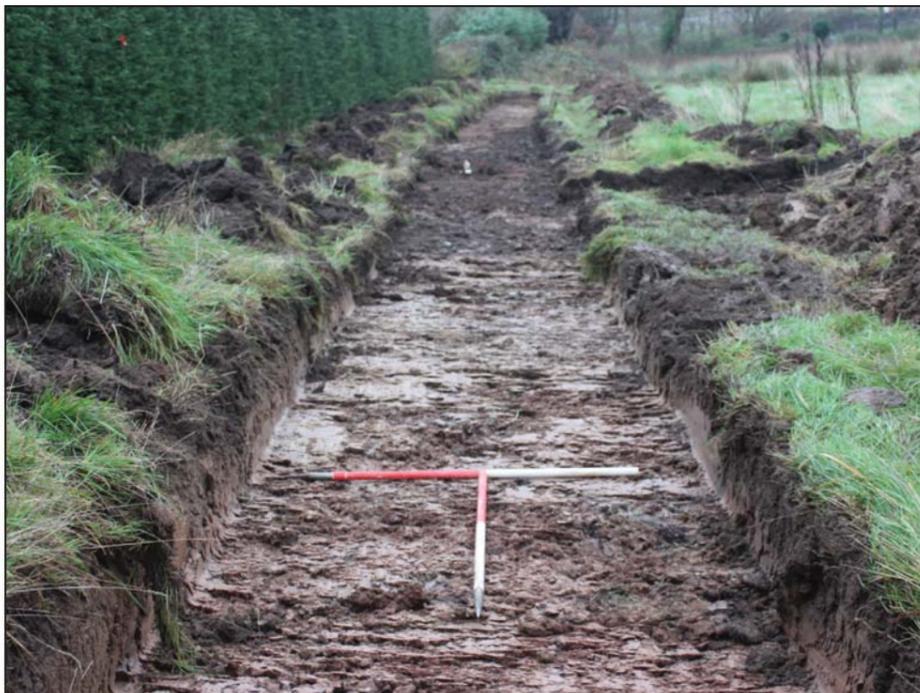
5

- 5.4 Located centrally within the trench, stone surface 204 was a continuation of deposit 104 in Trench 1. The surface abutted a brick-built structure 205, measuring c. 1.4m wide by at least 1.4m long (Fig. 6). Constructed of unfrogged red bricks (average size 230mm x 110mm x 80mm) with alternate courses of headers and stretchers bonded with lime mortar, the structure had an internal lime plaster lining. Demolition material 206, a brick-based rubble mixed with topsoil, infilled structure 205. Modern metal, glass and white china were recovered from all deposits within the trench (not retained).

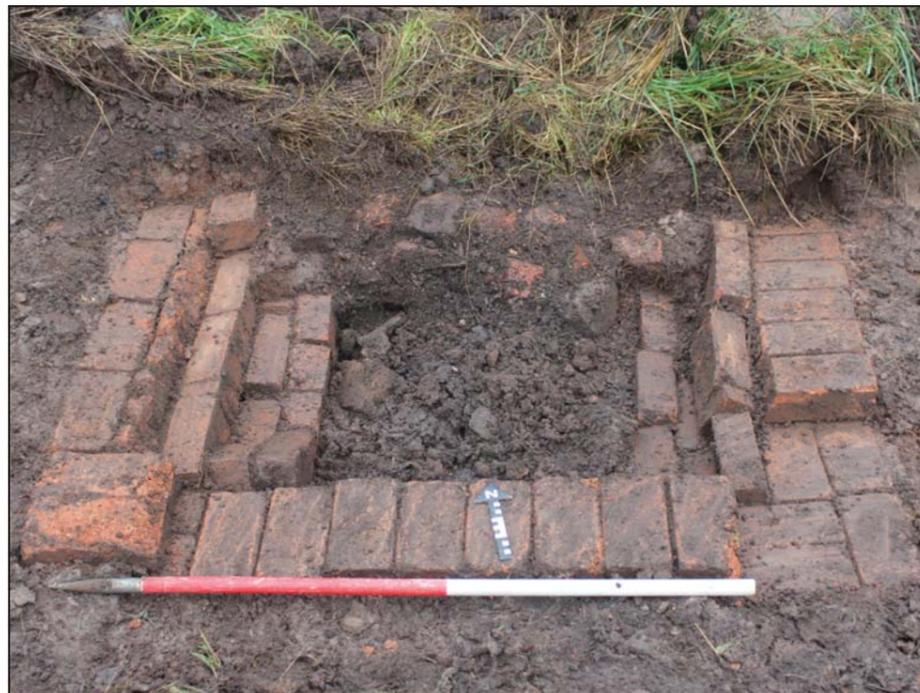
6

| Context No. | Type | Context interpretation | Description | L (m) | W (m) | D (m) |
|---|---|---|---|---|---|---|
| 205 | Structure | water tank | Structure of brick construction with vaulted roof and internal plastered face | >1.15 | 1.56 | >0.3 |

- 7.2 The farmyard surface abutted the remains of a brick-built chamber or culvert that had been backfilled with modern rubble and debris. An internal plaster render suggests that it may have been built to hold water. This was the only structure encountered by the evaluation which relates to the former 19th-century farm buildings.

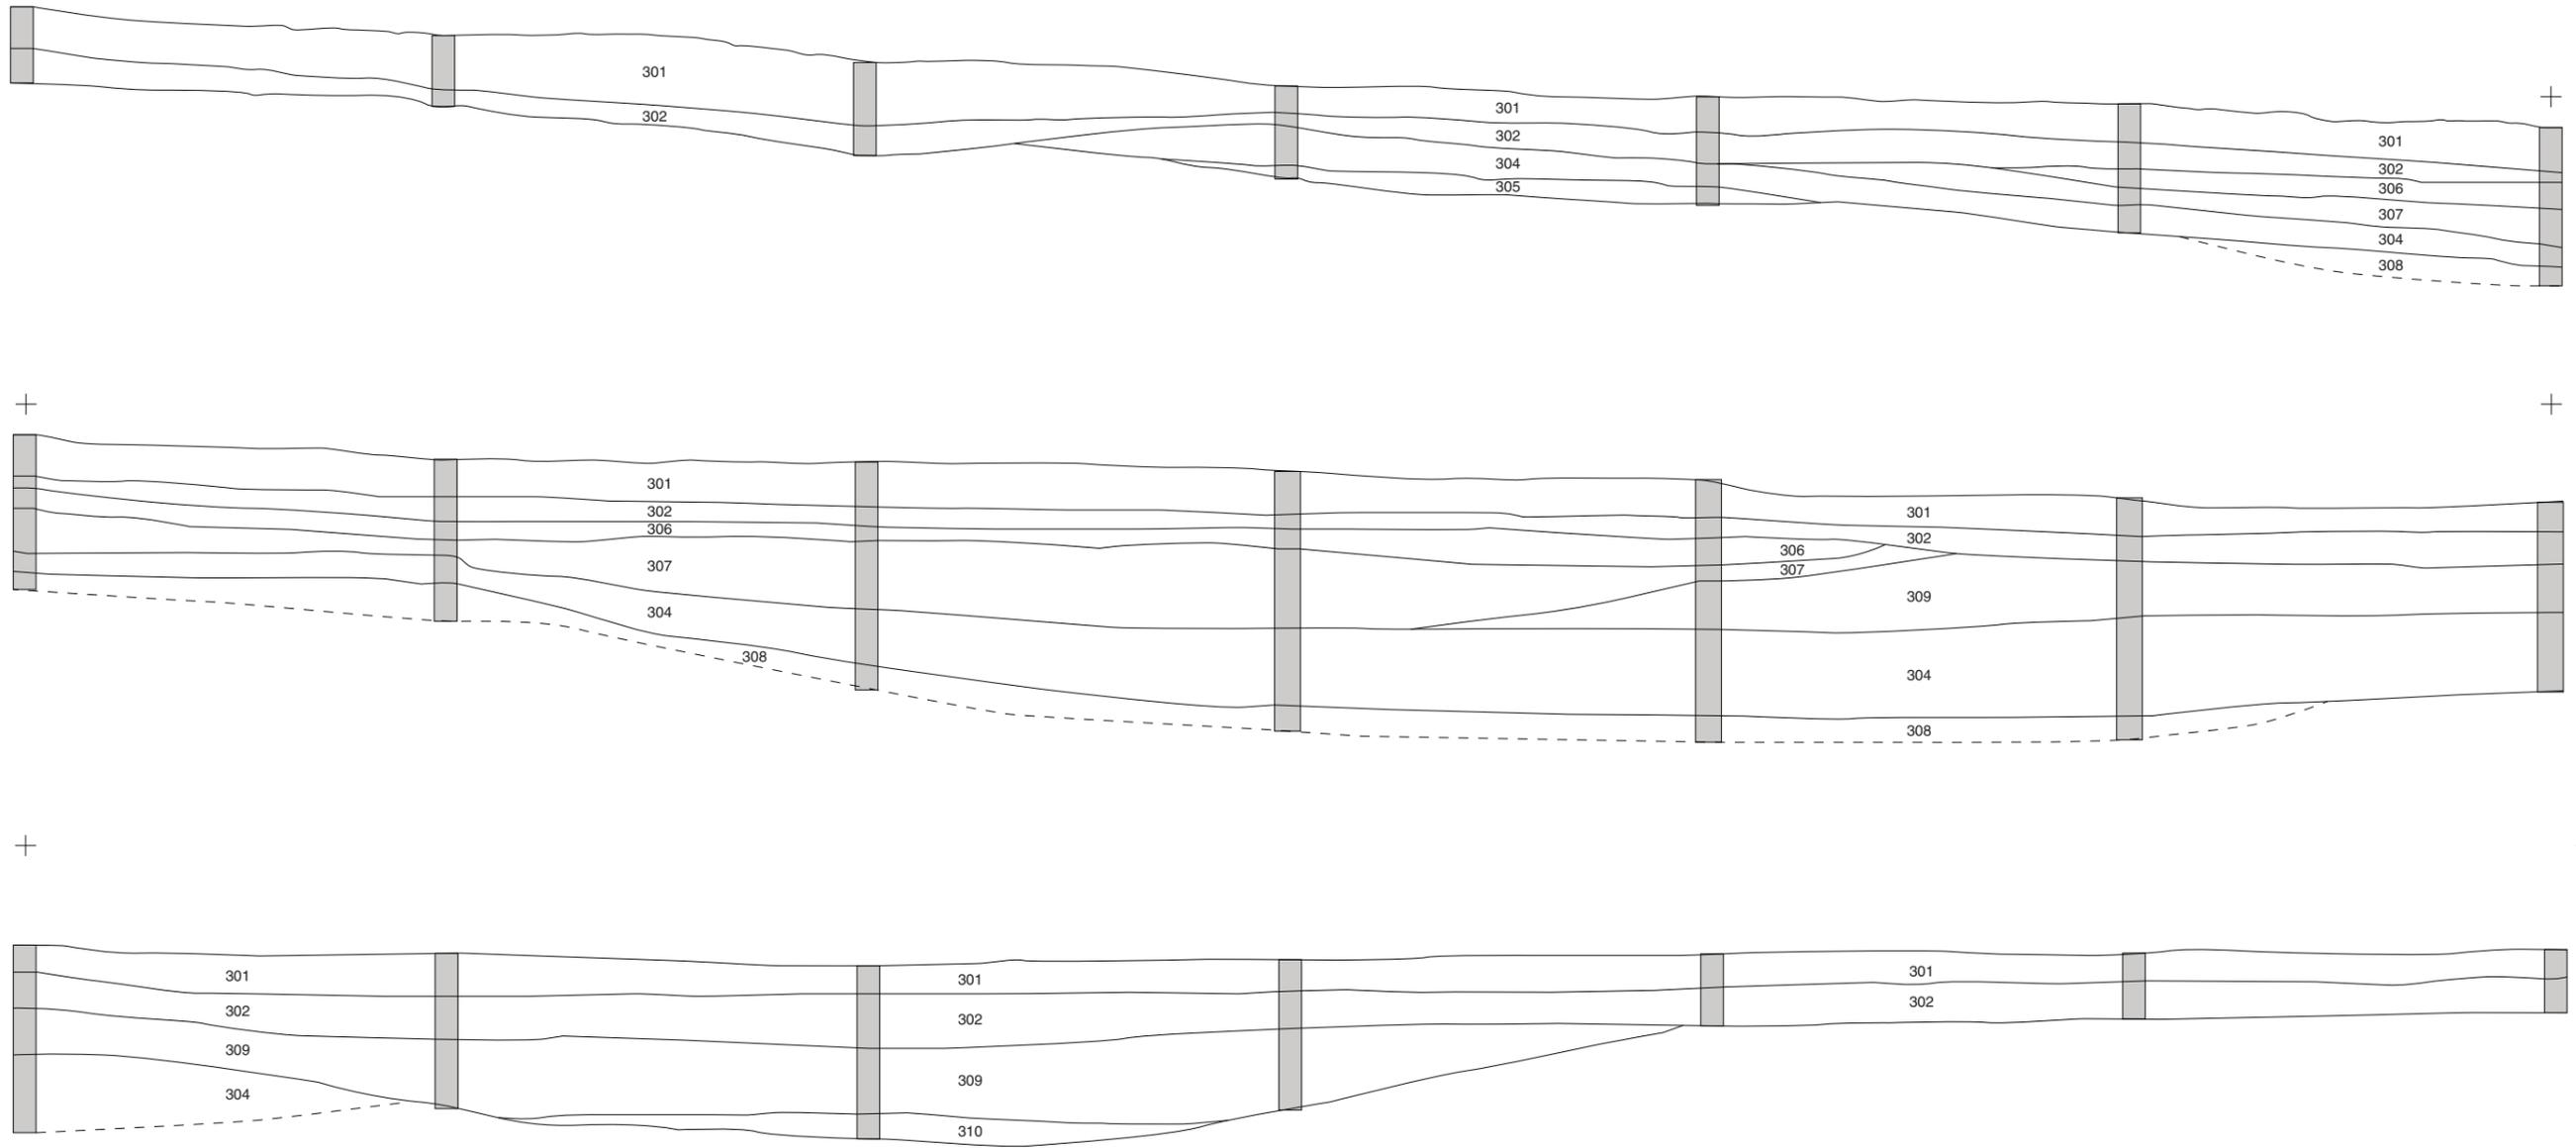
FIGURE TITLE
Profile of the former watercourse

- 5.5 An auger survey was conducted along a 54m long transect, aligned north-west to south-east through the course of a former stream shown on early editions of the Ordnance Survey map of the area. The survey revealed the profile of the channel eroded into the underlying clays and identified seven deposits relating to the former watercourse, consisting of a mixture of silts, gravels and fine clays (Fig. 7). Due to the waterlogged ground conditions and high water table the finer deposits at the lower levels of the former watercourse were too wet to extract and measure with any accuracy. No deposits of archaeological significance or palaeoenvironmental potential (i.e. peats, organic silts) were encountered.

- 7.3 All of the alluvial deposits encountered by the survey were well-sorted and relate to the natural accumulation of sediment alongside the stream (Fig. 7). Possible slumping deposits were located on the edges of the watercourse which possibly indicate a slight migration of the channel or a change in water levels. Sealing the alluvial deposits was a thick layer, up to 0.63m thick, of subsoil/colluvium. It was not clear from the auger survey how this deposit formed, although its mixed nature and thickness (present in all the auger holes) suggests that the channel may have been deliberately infilled. Reference to Ordnance Survey maps of the area show that the stream was open until at last the mid 1960s (CgMs 2013, fig. 4).

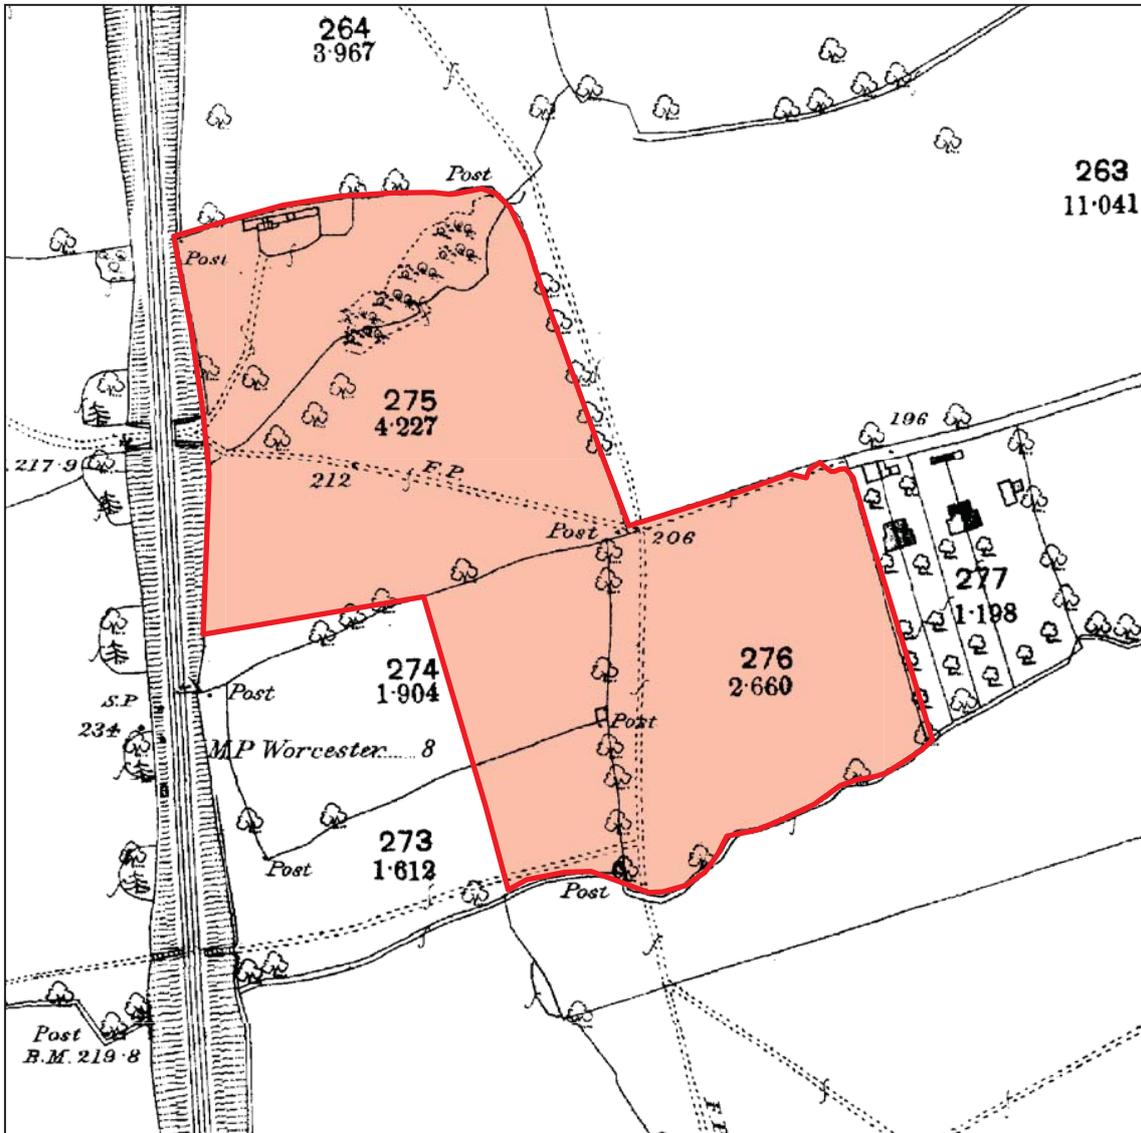
8 Extract from the First Edition Ordnance Survey map of 1888

- 7.1 The evaluation identified a modern farmyard surface and a brick-built chamber/culvert associated with the former farm buildings shown on historic mapping (Fig. 8). The stone/rubble surface revealed in both trenches had no formal structure (i.e. cobbled surface) and appeared to have been laid as a random spread of material derived from various sources, including brick rubble and river cobbles. It is likely that the material was put down to consolidate an area of soft ground. It

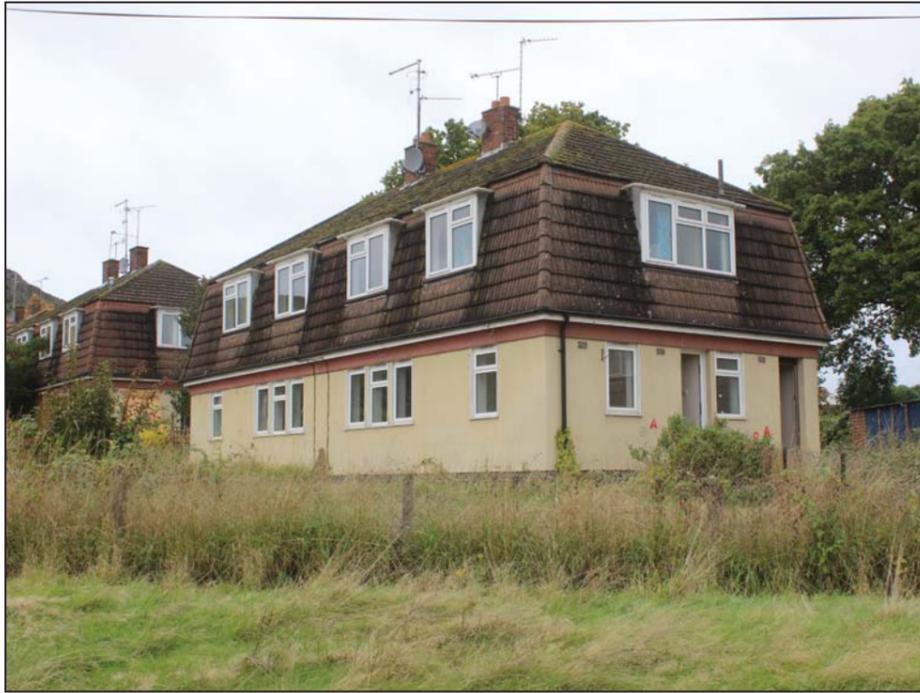
- 6.3 The housing estate comprised a broadly oval arrangement of apartment blocks, constructed around a small access road and forming a cul-de-sac. Each apartment block sits within a self-contained garden and each apartment block contained four flats, each with its own front door into the block.

- 9 Site, looking west
- 10 Site, looking east
- 11 Flats 111, 113, 115 and 117, looking north west
- 12 Flats 115 (left) and 117 (right), looking west
