**Attenuation Tank
Llanthony Secunda Priory
Llanthony Road
Gloucester**

Archaeological Evaluation

CA Project: 6073
CA Report: 16663

December 2016

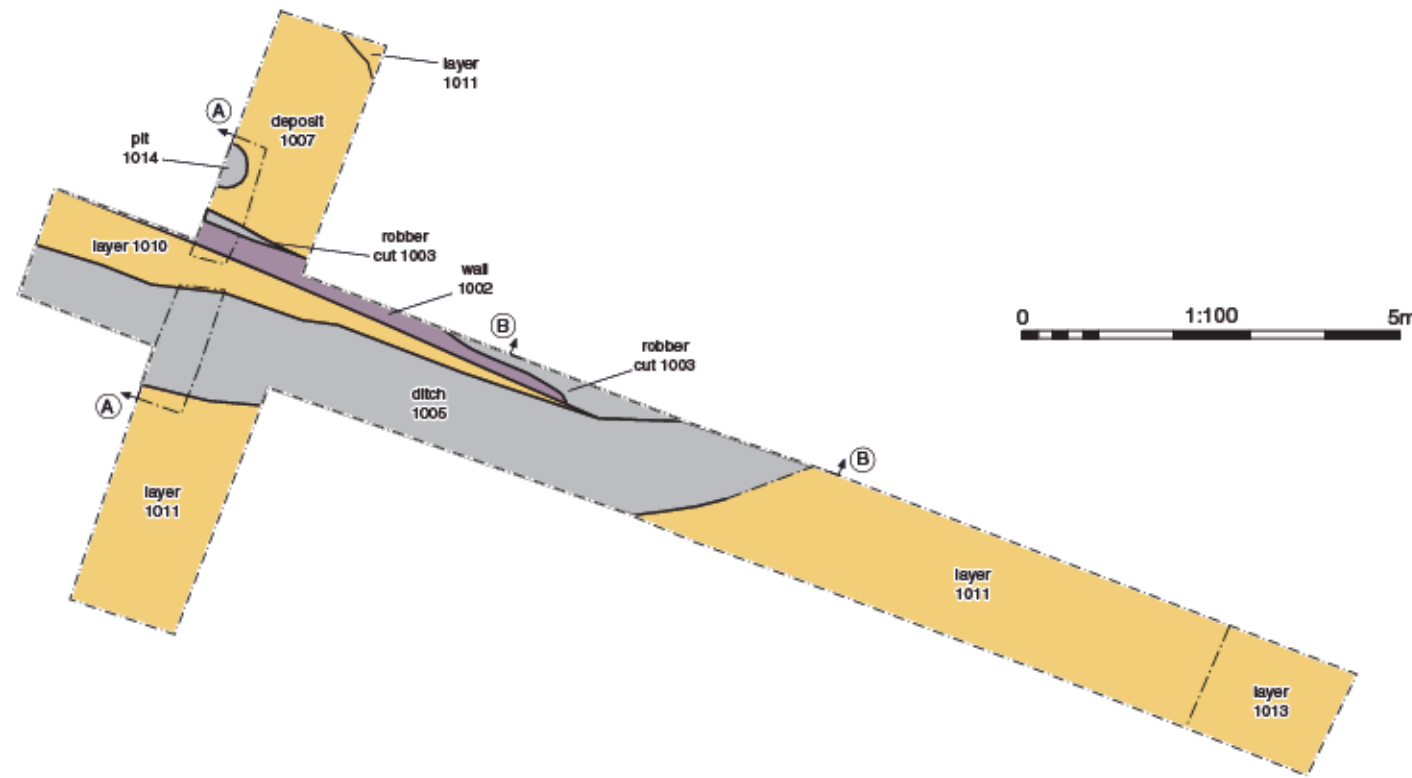
Trench I1 plan

5.2 The earliest deposit encountered within the trench, 1013, comprised mid blue grey sandy clay. This was identified within a sondage towards the south-eastern end of the trench (Fig. 3, plan). Artefactual material dating from the 16th to mid 19th centuries, along with animal bone fragments, were recovered from this deposit. This deposit was overlain by made ground deposit 1011, which was observed through much of the trench and comprised dark grey brown sandy clay.

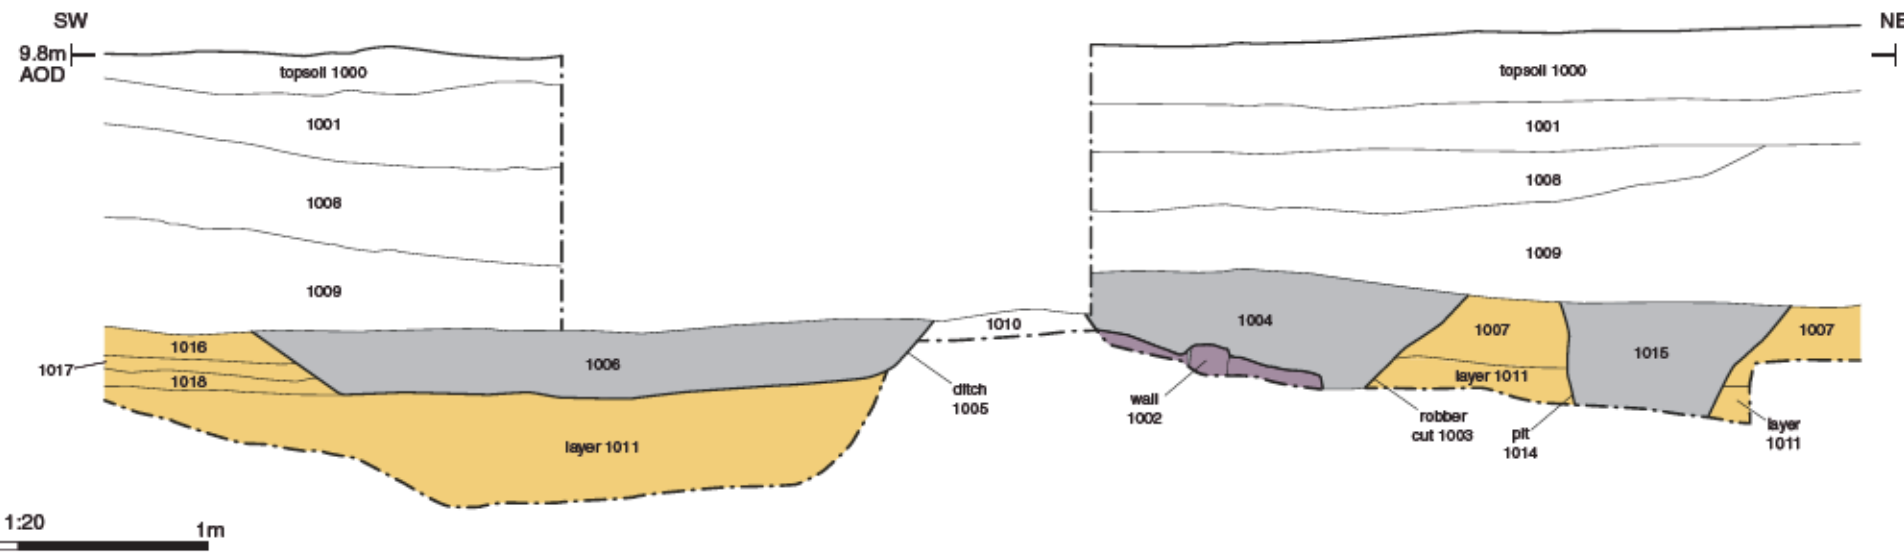
Section AA

5.3 A number of deposits overlay deposit 1011 in different parts of the trench. Within the north-western and north-eastern extent of the trench, deposit 1011 was overlain by made ground deposit 1010 (Fig. 3, Section AA) and possible surface/bedding layer 1007. Wall 1002 was observed on a north-west/south-east alignment. It was roughly coursed and bonded with dark orange brown clay. The south-western side of the wall was more uniform in appearance, possibly representing a visible face for the wall. No clear relationship was visible between the wall and the surrounding deposits as any overlying courses had been robbed (robber trench cut 1003). Both deposits, 1010 and 1007, were also cut by robber cut 1003 which was filled by 1004 (Fig. 3, Section AA). Possible surface/bedding layer 1007 was also cut by pit 1014. The pit was only partially observed and contained one fill, 1015, from which no finds were recovered. Within the south-western arm of the trench, deposit 1011 was overlain by a series of overlaying made ground/dump deposits 1018, 1017 and 1016 (Fig. 3, Section AA).

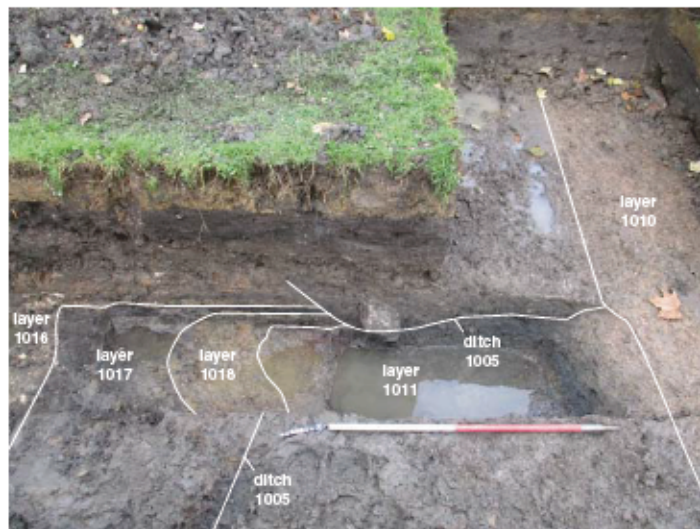
Section AA, south-western end, looking north-west (1m scale)

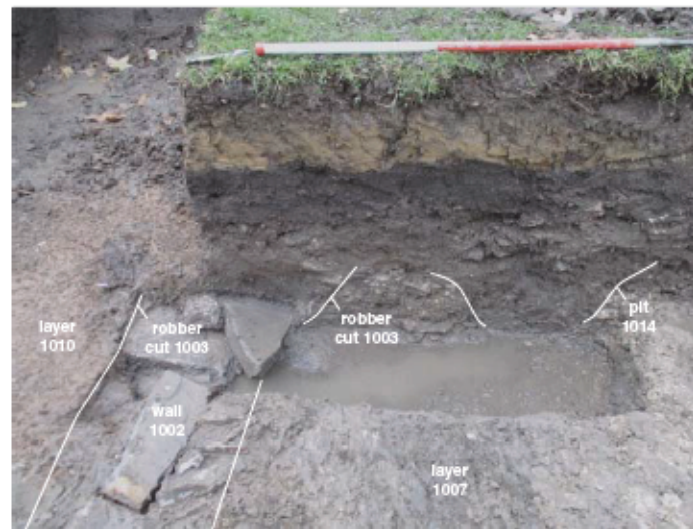
Section AA, north-eastern end, looking north-west (1m scale)

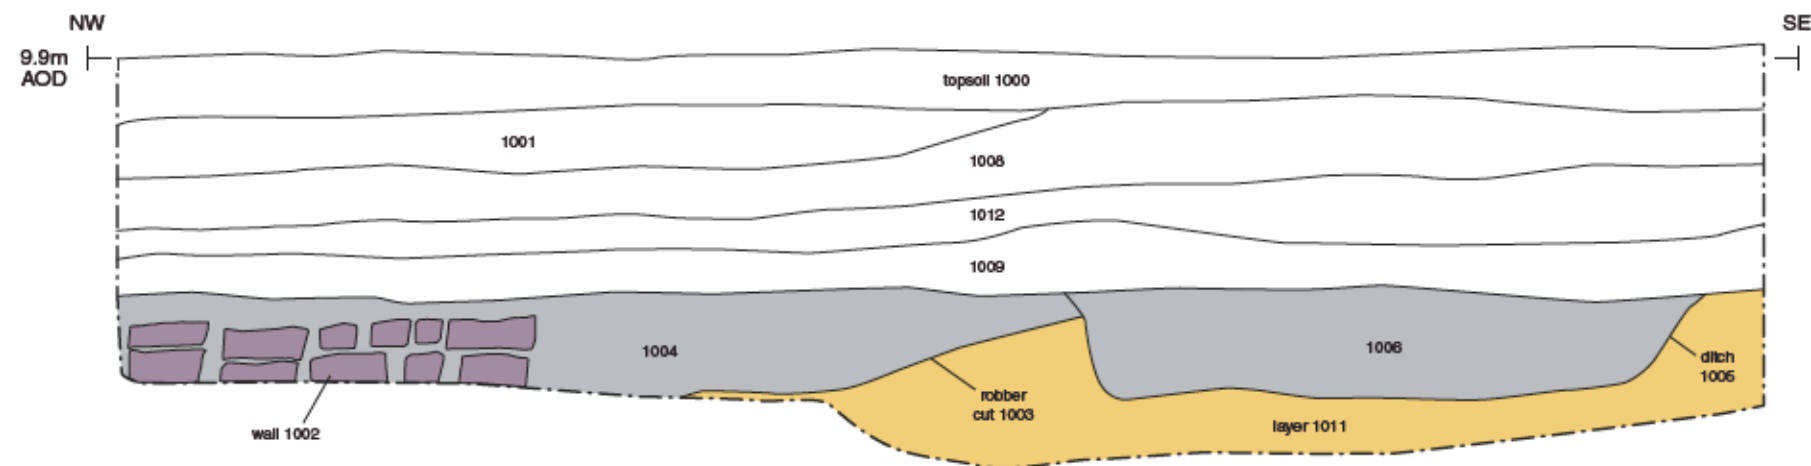
Section BB

- 5.4 Fill 1004 within robber trench 1003 (Fig. 4, Section BB) and deposit 1016 (Fig. 3, Section AA) were cut by ditch 1005. The latter was aligned north-west/south-east with a slight turn towards its eastern end to align broadly east/west. The ditch was very shallow and contained single fill 1006 (Fig. 4, Section BB). Recovered from the fill were two sherds of glazed earthenware pottery dating to the mid-16th to 18th centuries, along with other artefactual material dating to post-medieval to modern period and animal bone fragments. The fill, 1006, of ditch 1005 was sealed by made ground deposit 1009, comprising mid grey brown silty clay containing modern ceramic building material (CBM) and white china (not retained). This was overlain by brick rubble deposit 1012, which was in turn overlain by possible buried soil 1008, followed by modern made ground 1001 and lastly topsoil 1000.

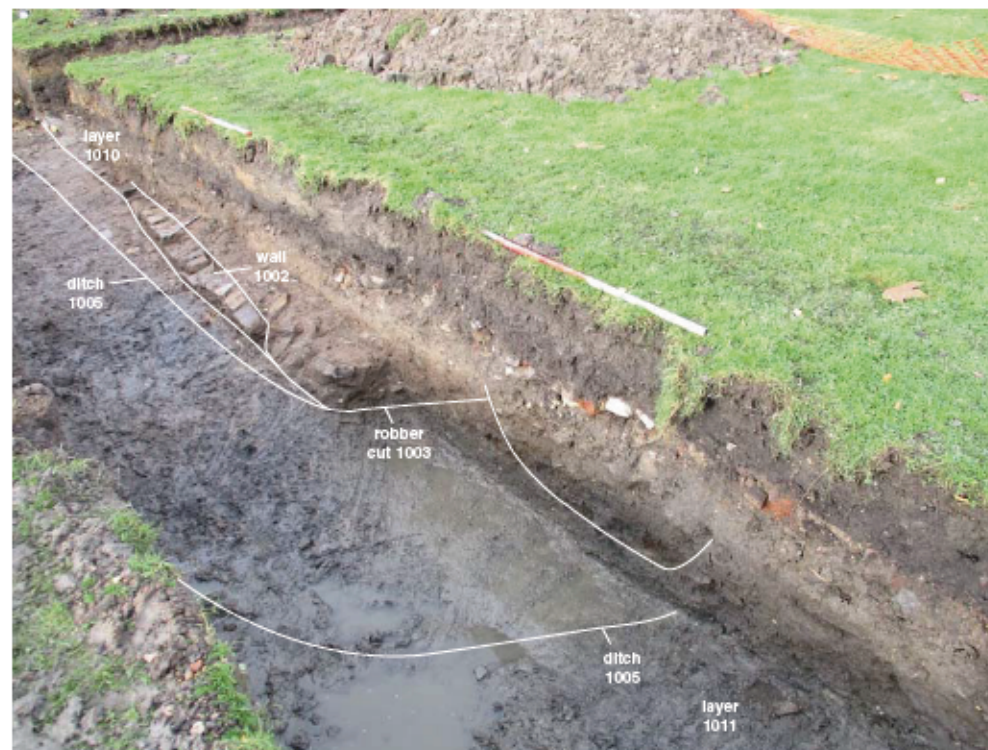
Section BB , looking north-west (1m scales)
