**Coton House (Area C1)  
Rugby  
Warwickshire**

Archaeological Evaluation

CA Project: 660390  
CA Report: 15026

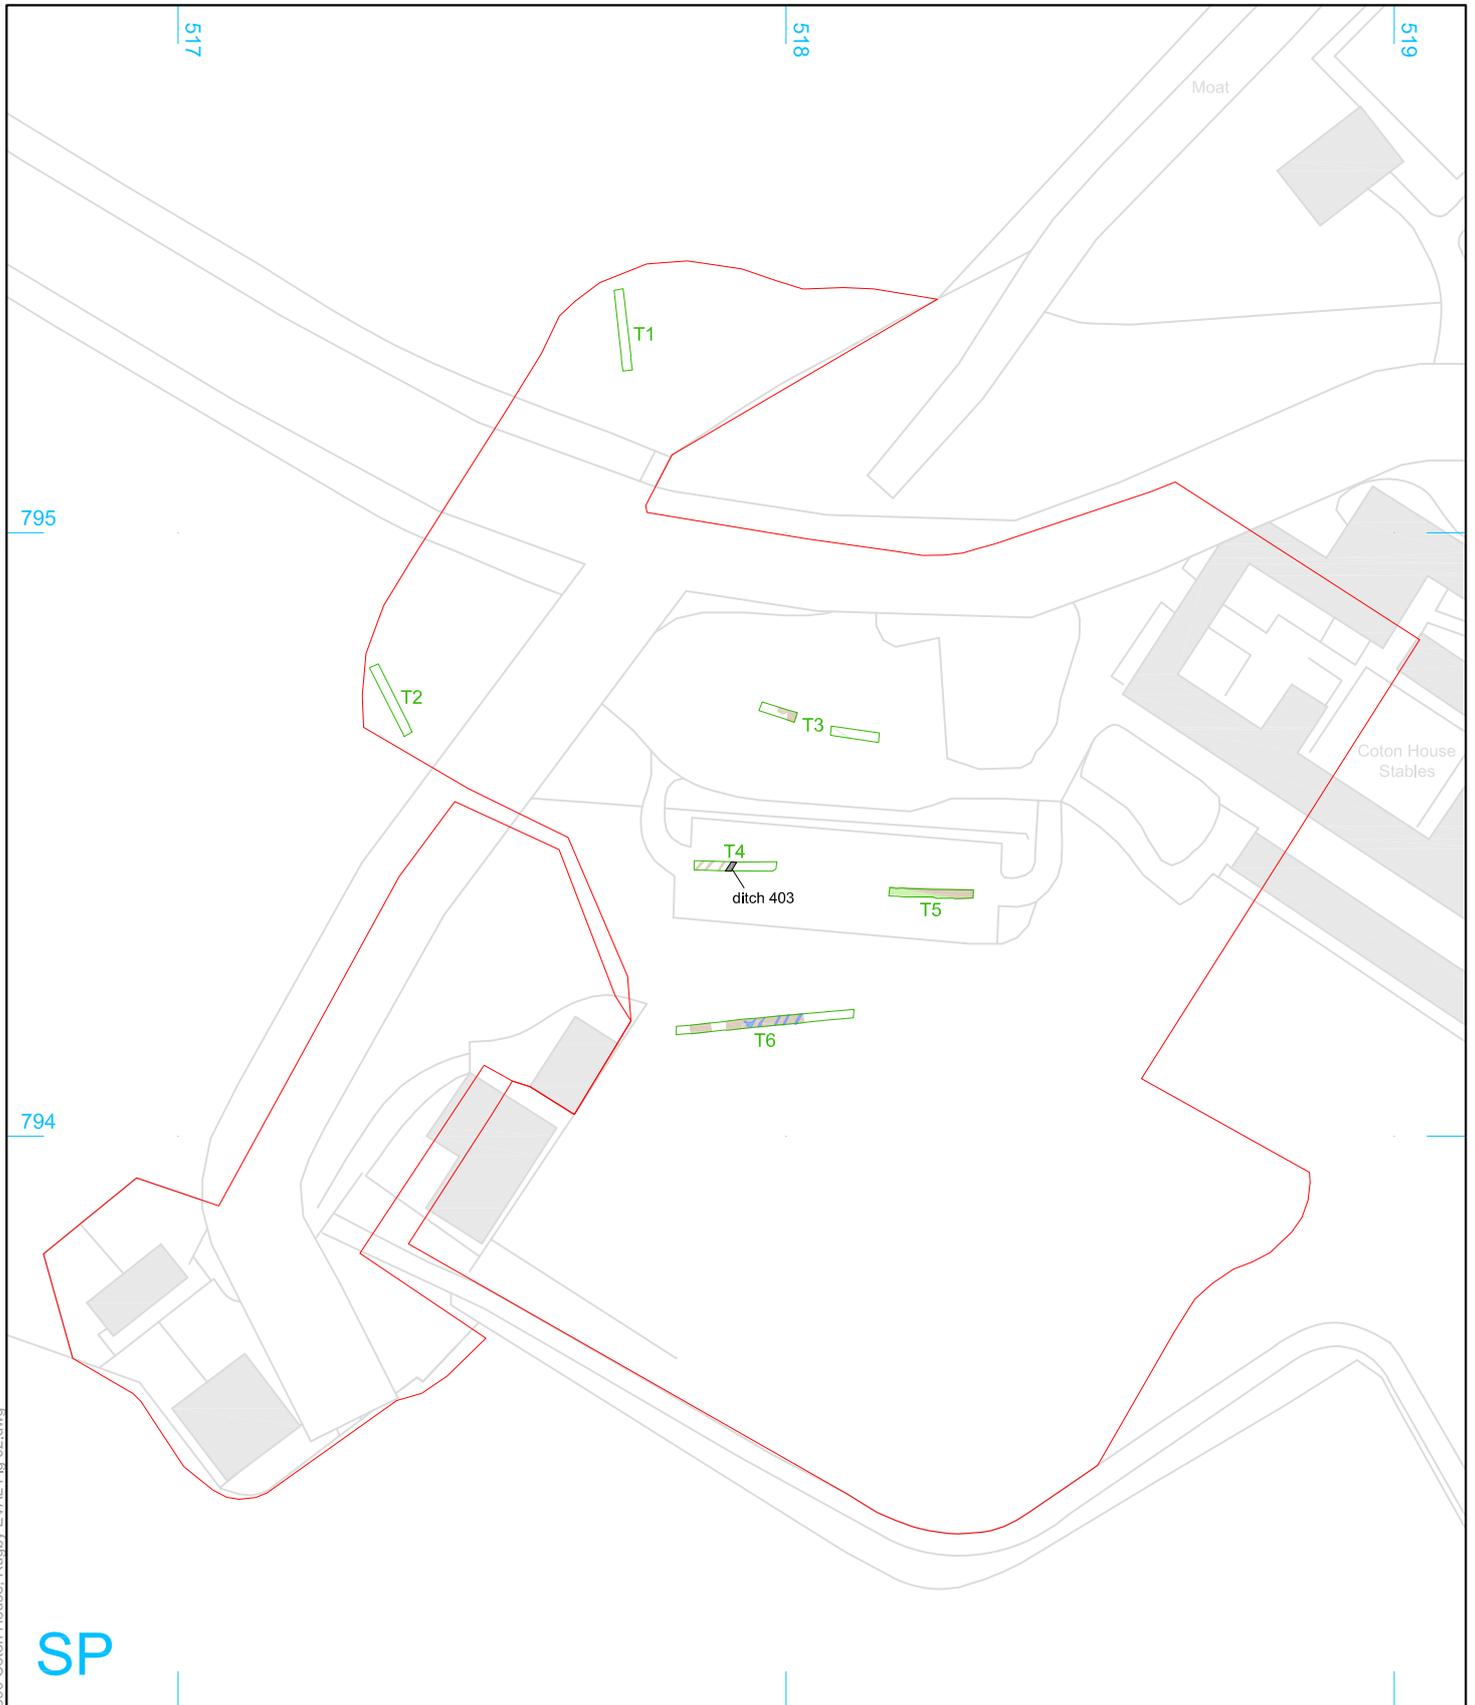
**2**

FIGURE TITLE  
**Trench location plan, showing archaeological features**

- 1.15 The evaluation comprised the excavation and investigation of two 30m and four 15m trial trenches (120 linear metres) in the locations shown in Figure 2. The trenches were all 1.6m wide and positioned to investigate areas that were not accessible when the evaluation by MOLA was undertaken earlier in the year. Trench 3 was not excavated to its full length due to the discovery of asbestos at its western end and a modern service trench in its centre.

- 2.1 The evaluation comprised the excavation and investigation of two 30m and four 15m trial trenches (120 linear metres; Fig. 2). The remains of modern brick walls, a foundation trench and a brick-built conduit were encountered in Trenches 4–6. These features are the remains of 19th-century buildings shown in this location on the 1887 First Edition Ordnance Survey map of the area. No archaeological features were encountered in Trenches 1–3. Details of the features and deposits recorded by the evaluation are presented in Appendix A and are summarised below.

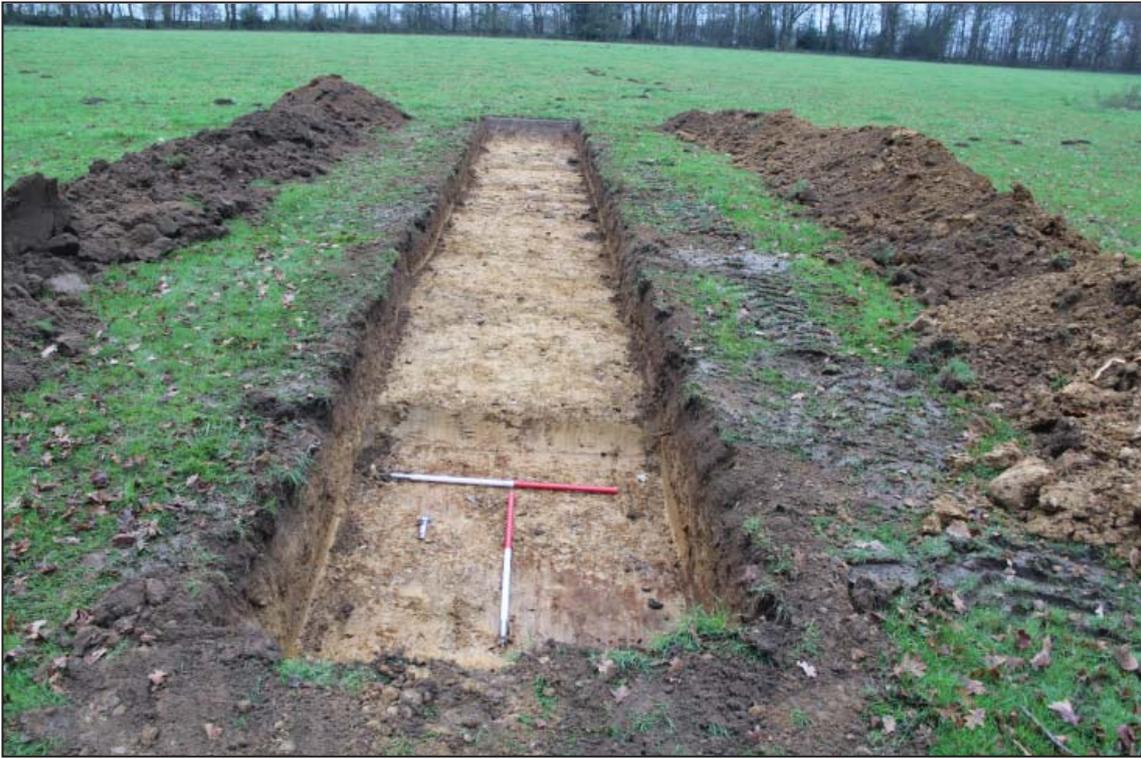
3 Trench 1, general view, looking north (scales 1m)

- 2.2 The geological substrate was typically mid greyish or yellowish-orange sandy clay with occasional to moderate pebbles. In Trench 1 (Fig. 3), which was located in the pasture field to the north of the access road to the site, this was overlain by subsoil, 0.17m thick, comprising mid orangey-brown sandy clay with occasional pebbles (101). The topsoil was 0.22m thick and consisted of mid greyish-brown sandy clay with moderate small sub-rounded pebbles (100). A similar sequence was recorded in Trench 2 (Fig. 4), in the pasture field to the south of the access road, although subsoil was absent.

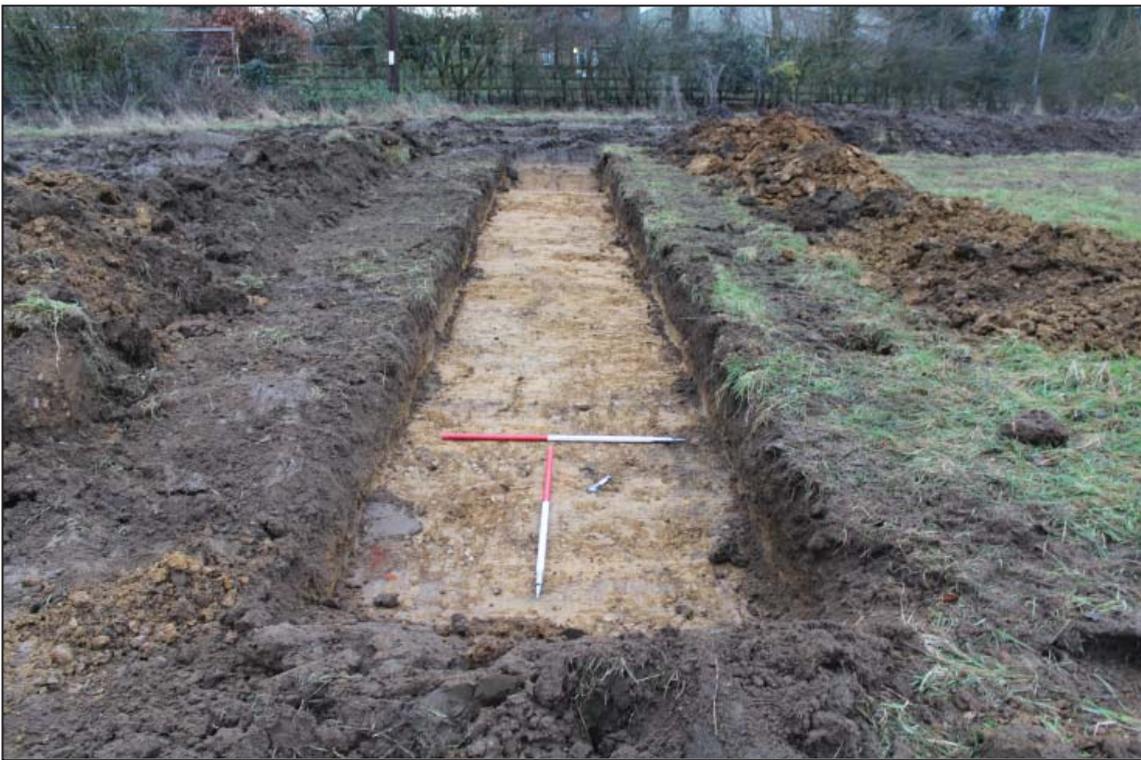
4 Trench 2, looking south-east (scales 1m)

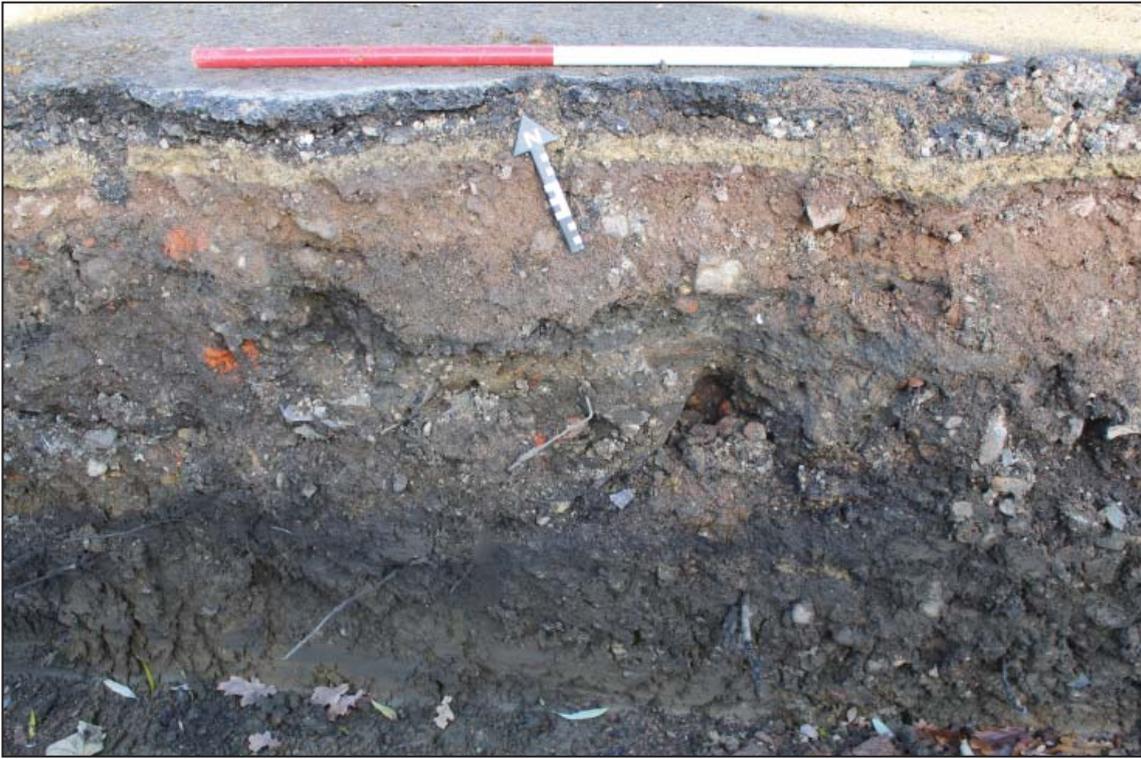
5 Trench 3, made-ground deposits, looking north (scale 1m)

- 2.3 In Trench 3, located in the northern car park, the geological substrate (303) was overlain by a deep layer of subsoil, 0.65m thick (Fig. 5). This was sealed by two

layers of hardcore (302 and 301), with a combined thickness of 0.20m, which formed the sub-base for the car park's tarmac surface (300).

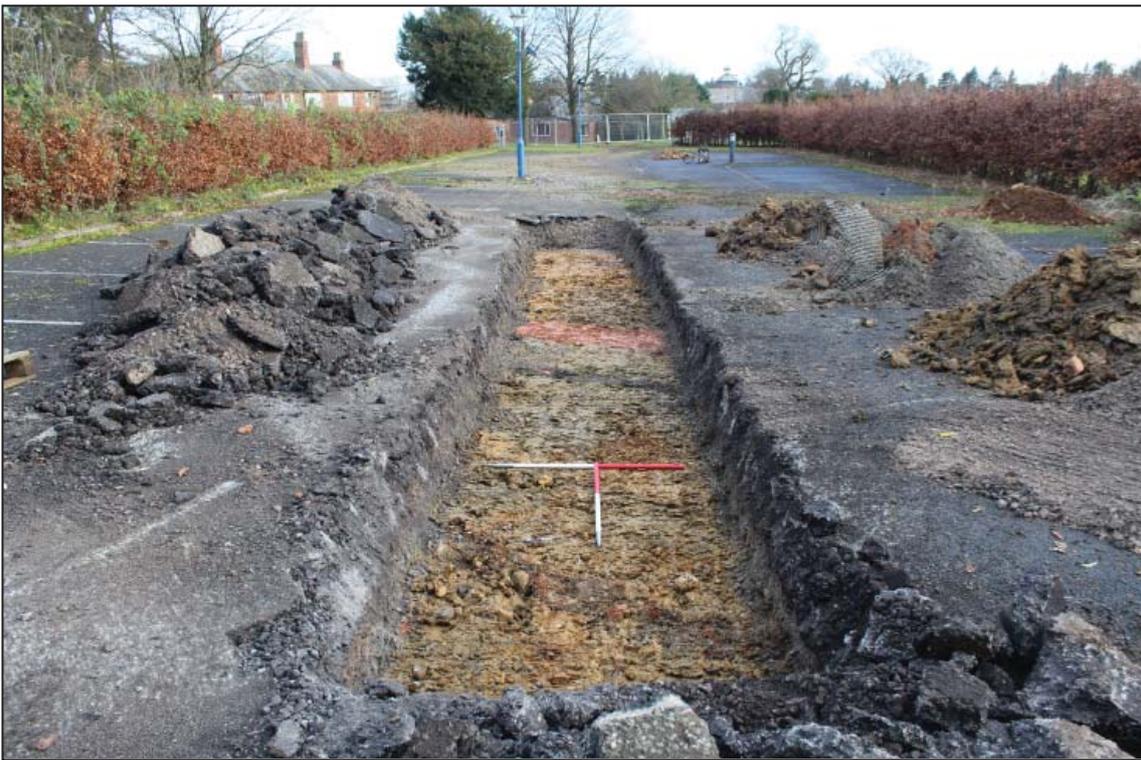
6 Trench 4, general view, looking east (scales 1m)

- 2.4 Trench 4 was located in the western half of the southern car park (Fig. 6). Here, the geological substrate (404) was exposed c. 0.4m below current ground level (bcgl). Cut into the geological substrate near the centre of the trench was the base of a foundation trench (403), aligned north-east to south-west and measuring 0.76m wide by 0.20m deep (Fig. 7). It was packed with crushed brick rubble in a mid orangey-red sand matrix (404). This was overlain by geotextile and a layer of Type 1 stone (401) that formed the sub-base for the tarmac surface of the car park (400).

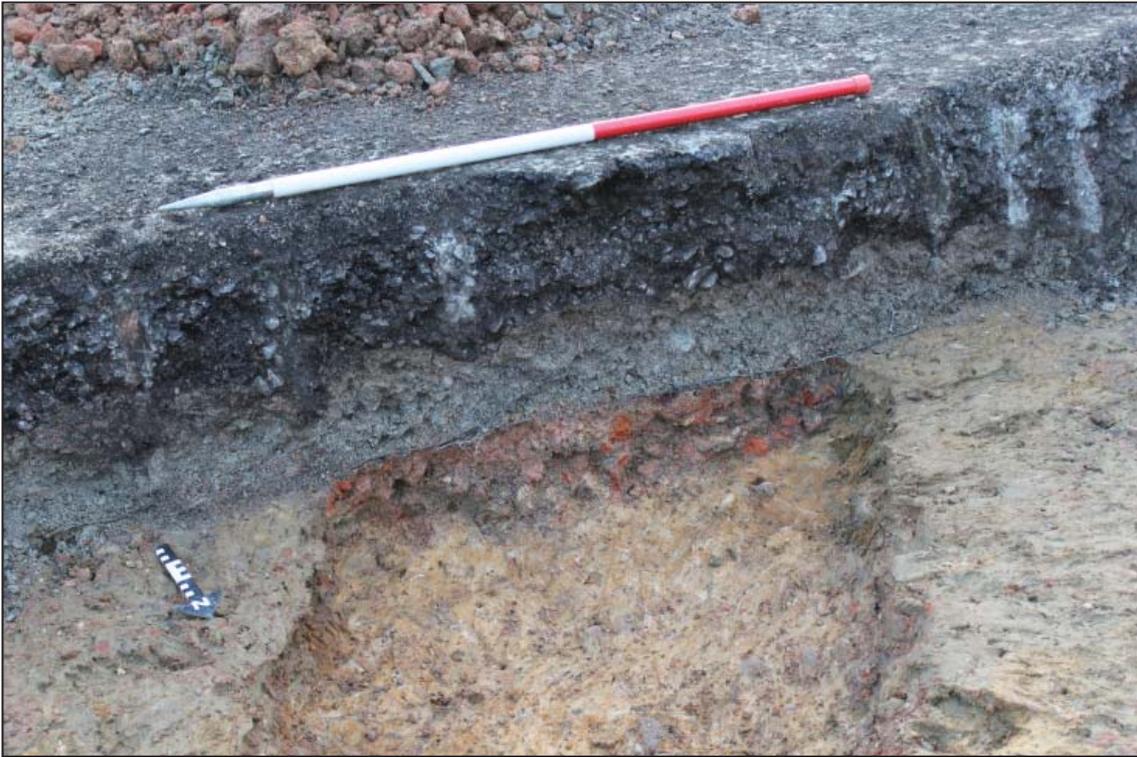
7 Trench 4, modern feature 403, looking south-west (scale 1m)

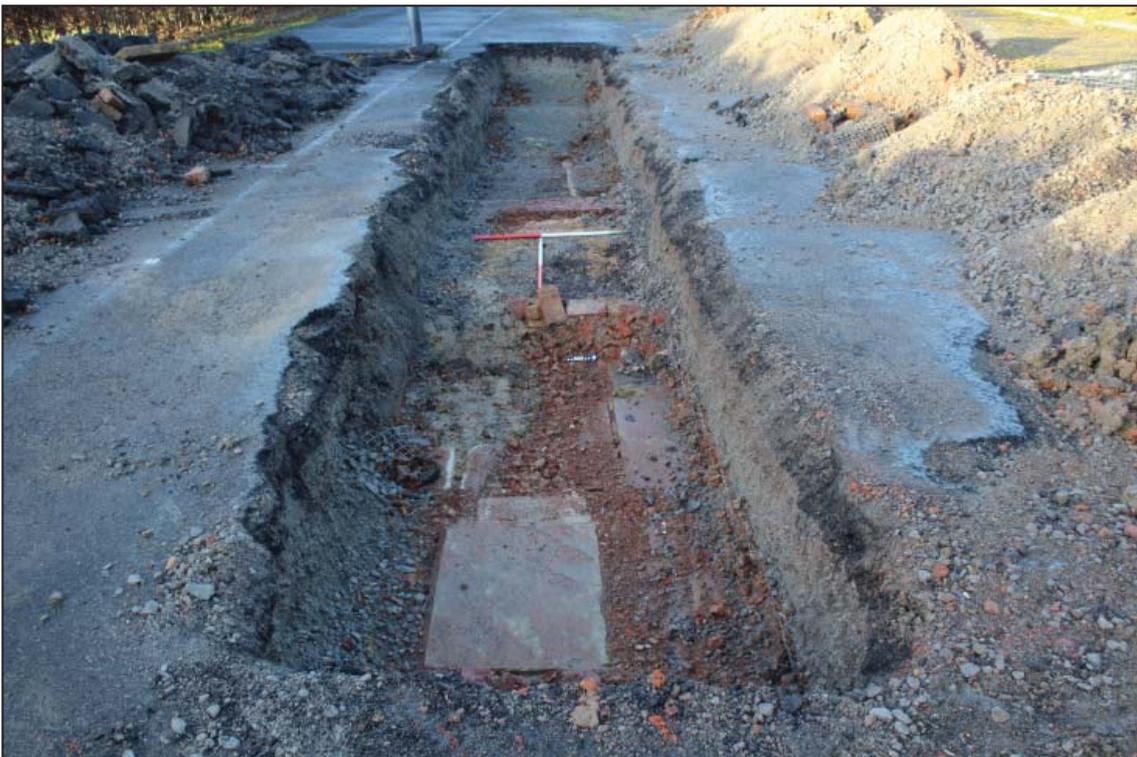
8 Trench 5, modern conduit, looking west (scales 1m)

- 2.5 In Trench 5, which was located at the eastern end of the southern car park, excavation revealed a modern brick-built conduit (505), covered with rectangular limestone slabs (503), which appeared to extend down the length of the trench on an east to west alignment (Fig. 8). The slabs were only exposed at the eastern end of the trench, where a masking layer of gravel and rubble (504) was removed to expose them. In the eastern part of the trench, the foundation for a brick wall (506) had been constructed over the conduit. These remains were sealed by two layers of hardcore (502 and 501), with a combined thickness of 0.35m, that formed the sub-base for the tarmac surface of the car park (500).

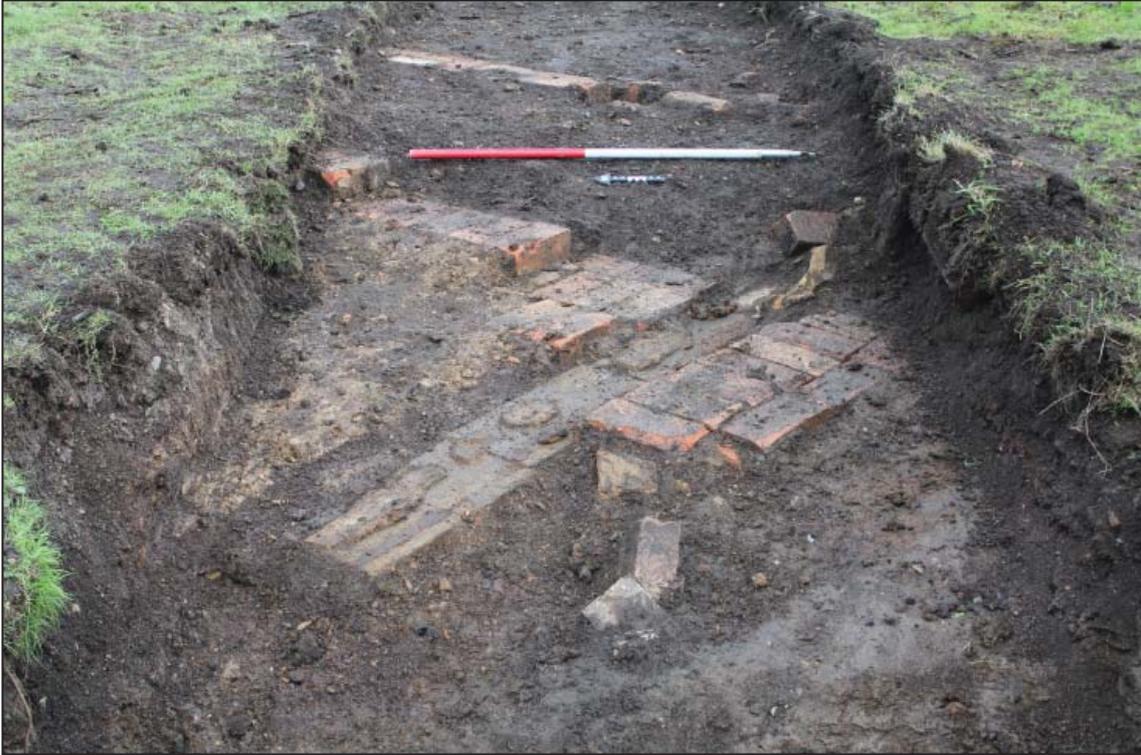
9

**9 Trench 6, modern brick foundations, looking east (scale 1m)**

- 2.6 Trench 6 was situated in a landscaped area to the south of the car parks. Removal of the topsoil (600), which varied in thickness between 0.23m and 0.52m, exposed modern brickwork, consisting of five parallel wall foundations, spaced between 0.9m and 2.2m apart (603, 605, 607, 609 and 615). The walls, which were 0.23m wide, were on a north-east to south-west alignment and were constructed from unfrogged bricks weakly bonded with lime mortar (Fig. 9). The soil between the walls was generally dark greyish-brown charcoal-flecked clayey silt containing small fragments of brick and roofing slate.

- 3.2 In three of the trenches (Trenches 4–6), a modern brick-built conduit and the foundations of a number of modern brick walls were identified. The wall foundations were relatively insubstantial, suggesting that they were the remains of partition walls, although one wall was wider and may have been an external load-bearing wall. The conduit was sizeable, measuring over a metre wide, and it was covered with heavy, rectangular limestone slabs that could only be moved with the excavator. Reference to the 1887 First Edition Ordnance Survey map of the area (Fig. 10) shows three glasshouses and ancillary buildings in the location of these trenches, so it is likely that these features are the remains of buildings in this complex.

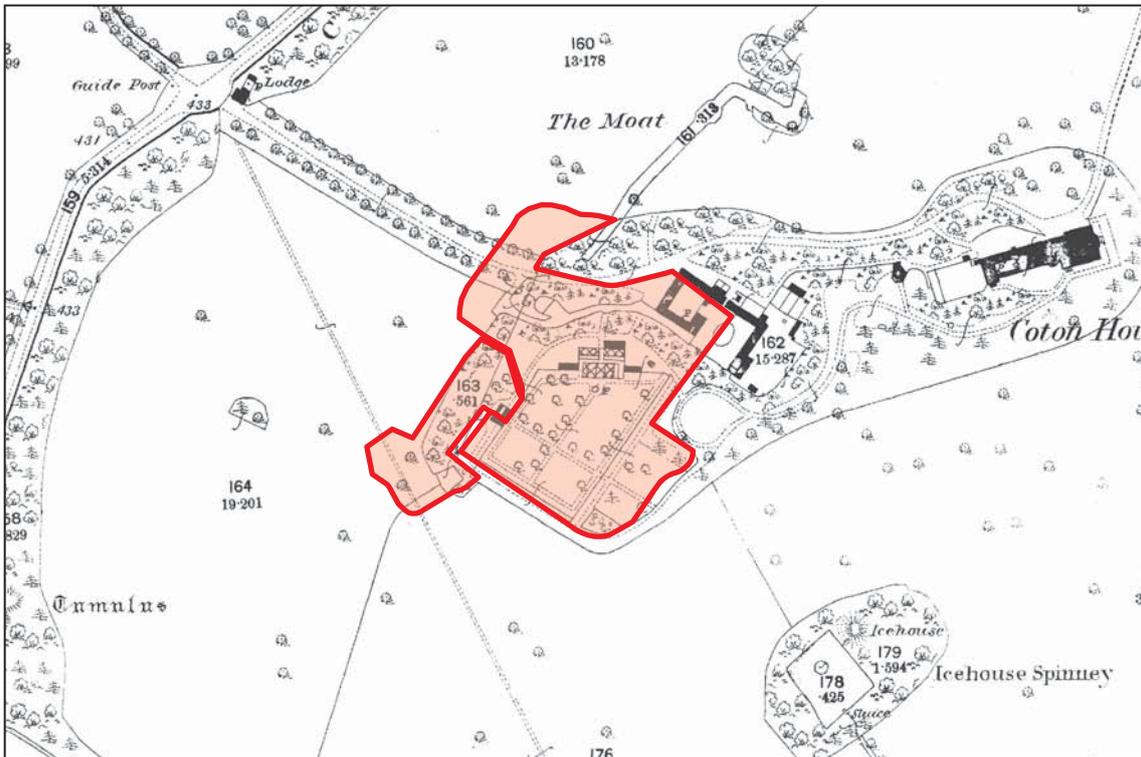
10 Detail from the 1887 Ordnance Survey map of the area
