**2 Manor Farm Cottages
Fulbrook
Oxfordshire**

Archaeological Watching Brief

CA Project: 5068
CA Report: 15058

March 2015

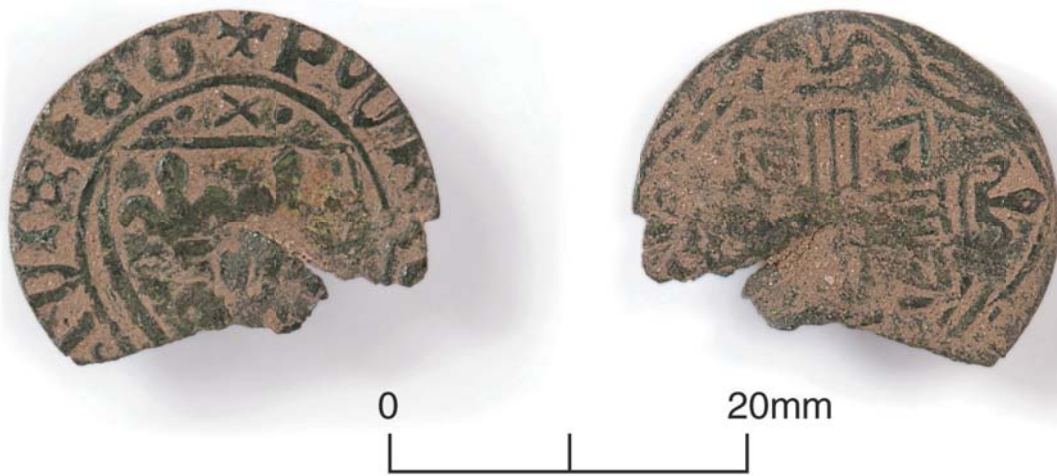
- 2.11 A copper alloy jetton (reckoning counter) was recovered from fill 109 within pit 110. The obverse features the “Shield of France” bearing three fleur de lys. On the reverse is a triple-stranded cross fleuretty (a cross with a fleur de lys at each of the four terminals) within a quatrefoil. This type is of probable mid 14th century date.

5 Copper alloy jetton from pit 110
