Sainsbury's Store Belgrave Road Leicester

Archaeological Watching Brief

CA Project: 660257
CA Report: 15195

April 2015

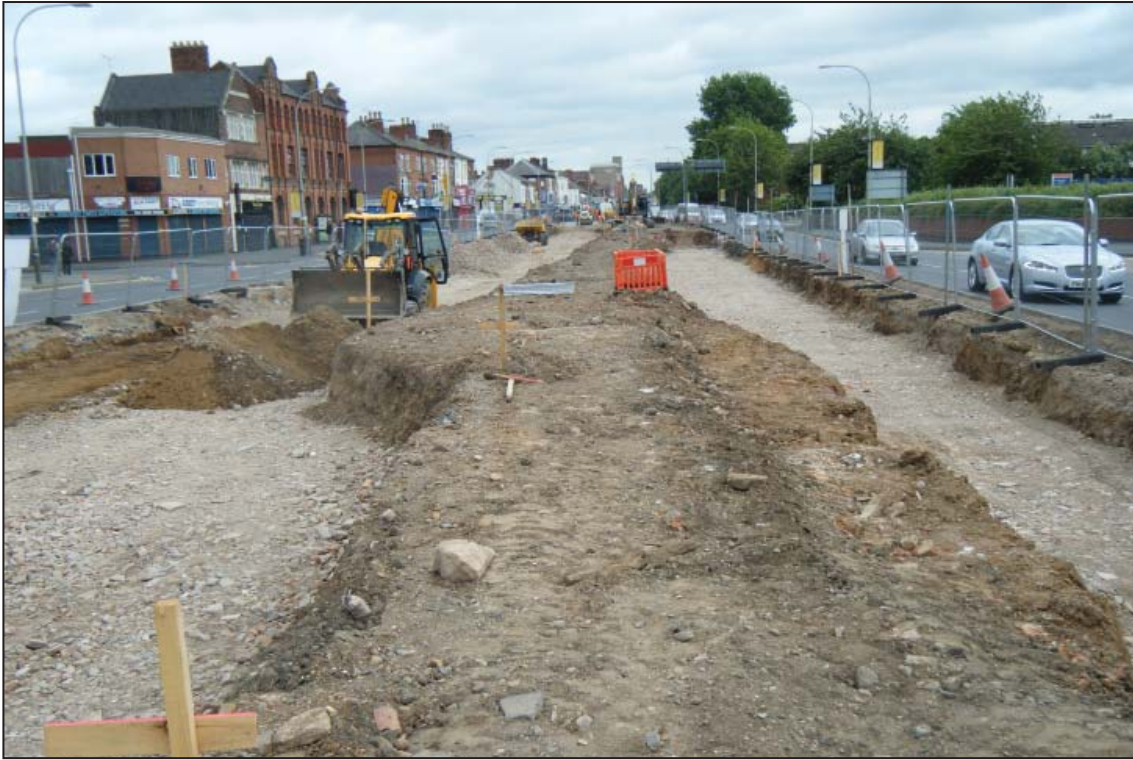
3 Site, looking north-east

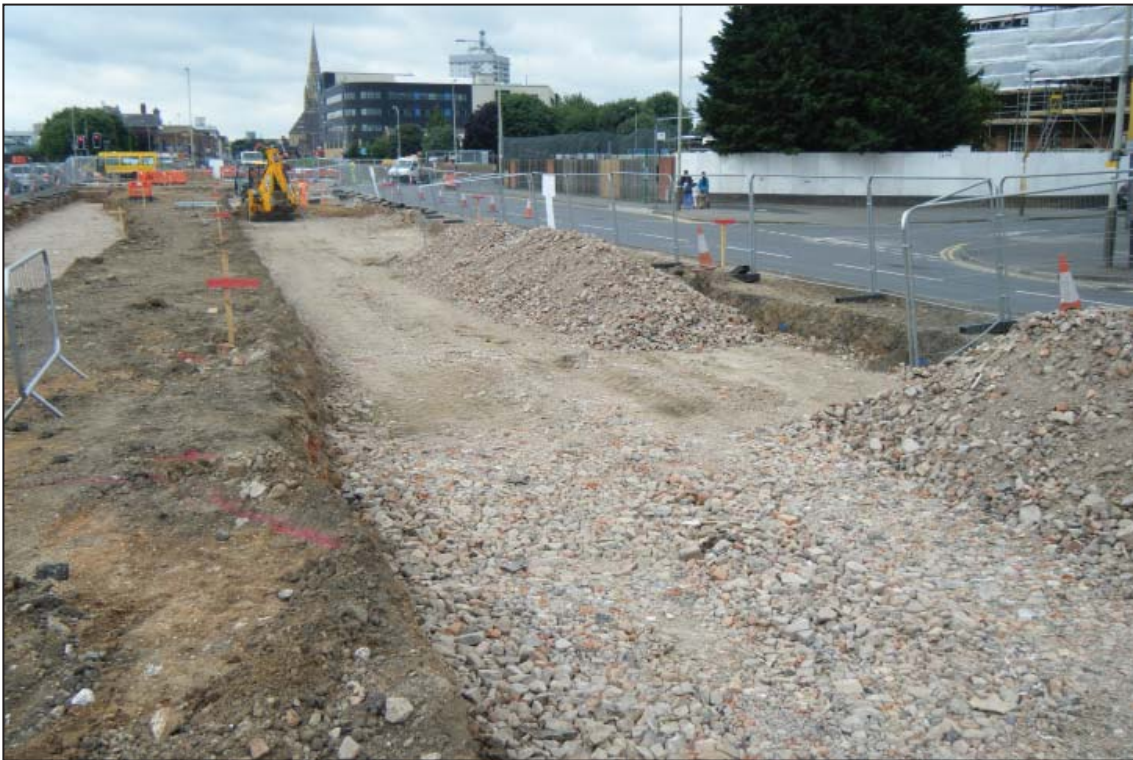
4 Site, looking south-west

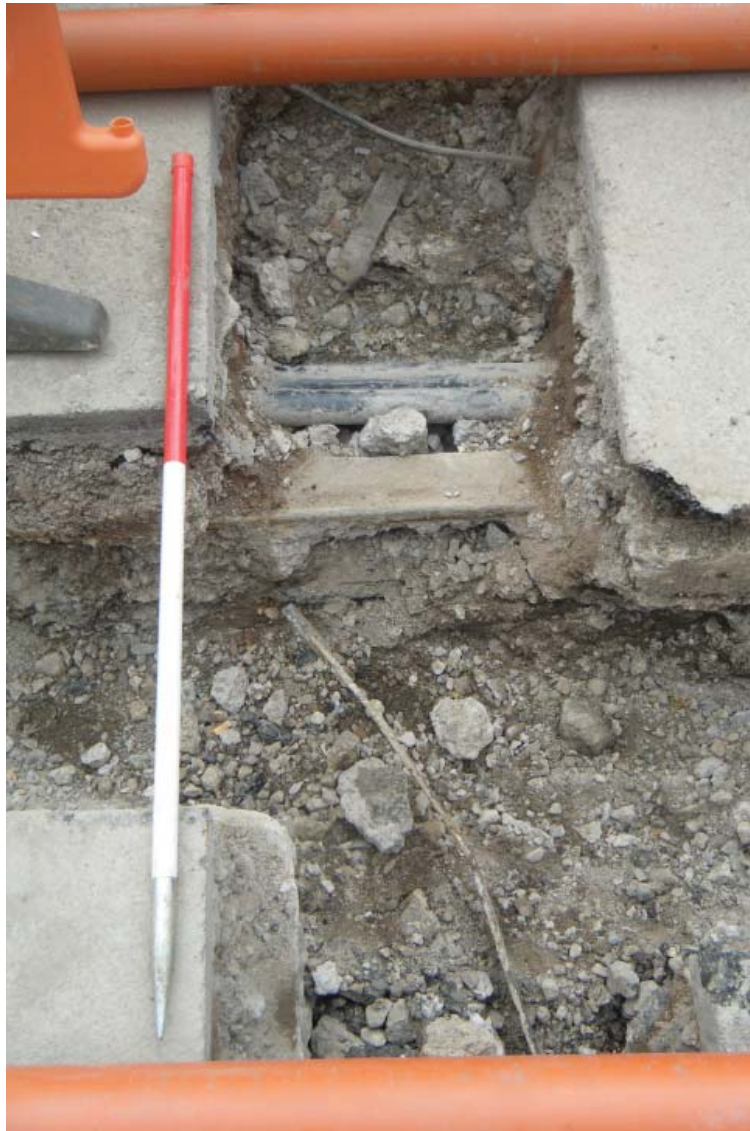
- 5.2 The earliest-encountered deposit was gravel layer 115, which was exposed at a depth of 0.3m below the pre-development ground level (BGL). Bedded onto 115 was a north-east/south-west orientated section of iron rail (109; Fig. 5). Rail 109 was directly overlain by the modern road surface (101) and its associated bedding layer (102).

5 Tram rail 109, looking north-west (scale 1m)

- 7.3 Nineteenth and earlier 20th-century OS maps depict tram lines running along the centre of Belgrave Road. The first tramways in Leicester began service in 1874 and were operated by the Leicester Tramways Company. The service closed at some point between 1933 and 1949 (CA 2012). The iron rail (context 109) observed in Area 2 is presumably part of the Belgrave Road tramway. The red brick structures recorded in Areas 3 and 4 (walls 103, 113 and 118) lie on the course of the tramway, and presumably represent associated structures. All three of these walls are in locations where the historic mapping shows a widening of the tramlines, possibly representing tram stops.

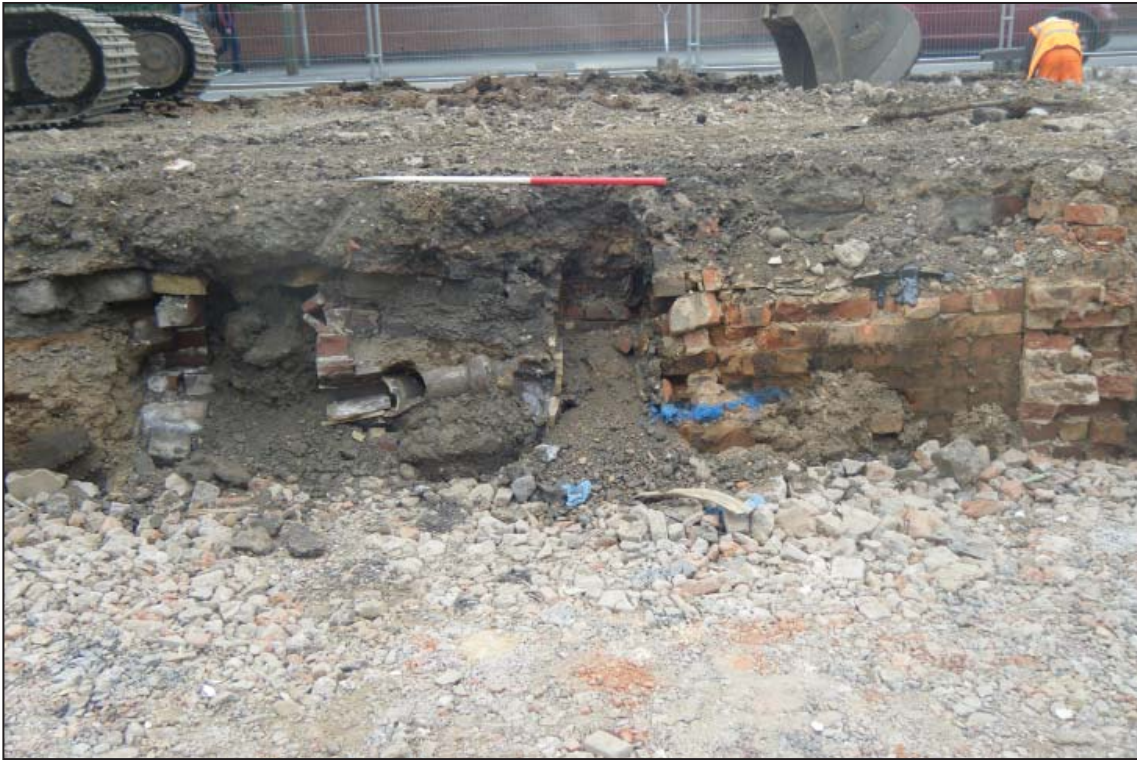
- 5.4 Located at the western extent of the area was a small section of north-west/south-east-aligned wall (113; Fig. 6). This was constructed of red brick, bonded by a soft, cream-coloured lime mortar. Wall 113 was revealed in section only and survived to a height of 0.75m. It was butted by a 3.1m-long section of north-east/south-west-orientated wall (118), which survived to a height of 0.55m and was of similar construction to wall 113. Both walls were fragmentary.
- 5.5 Sandy made ground deposit 105 abutted and overlay walls 113 and 118. This deposit was cut by modern services 107 and 108, as well as by concrete piles 100, which were the remains of supports for the Belgrave Flyover (constructed 1973/74). The piles were overlain/abutted by various bedding/levelling layers and surfaces (101, 102 and 106).

6 Walls 113 and 118, looking north-west (scale 1m)

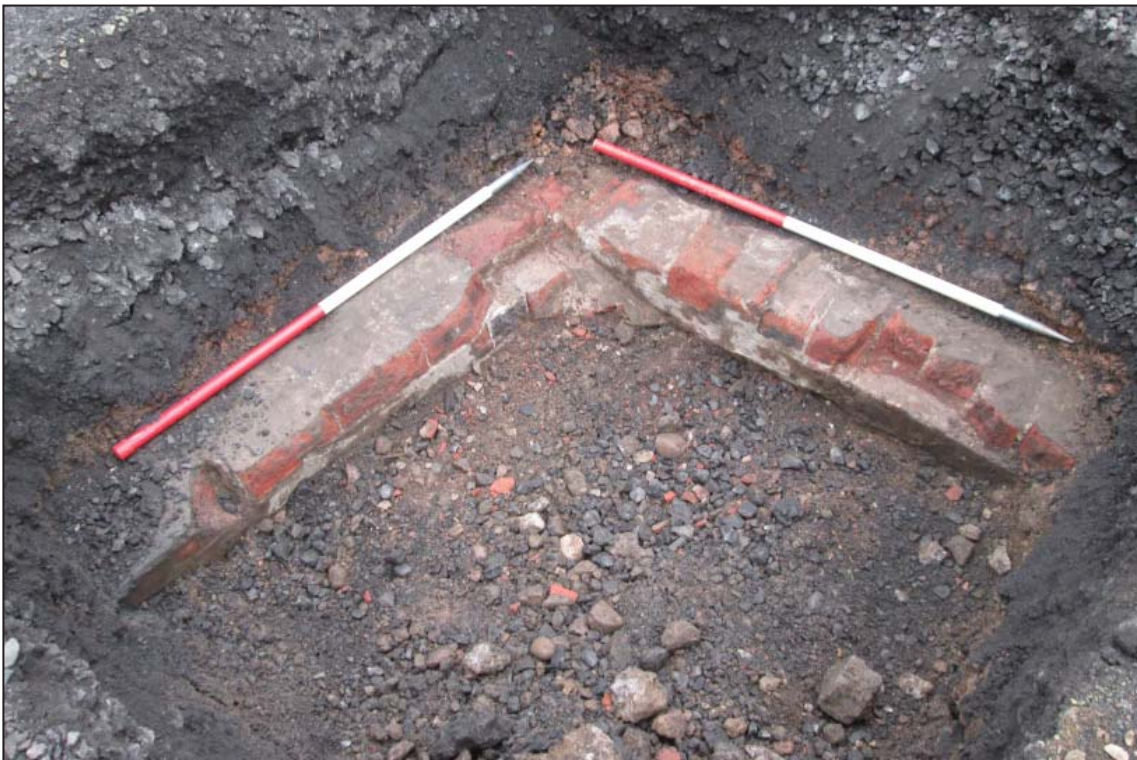
- 5.6 Sandy gravel layer 114 was exposed intermittently across Area 4 at a depth of 0.65m BGL. Towards the southern end of the area, layer 114 was cut by wall 103 (Fig. 7). This structure was orientated north/south, with an east/west return. It was constructed of red brick, bonded by a hard cement mortar. Wall 103 and layer 114 were overlain by modern road surface 101 and associated bedding layer 102.

7 Wall 103, looking east (scales 1m)
