# Stall Street and Lower Borough Walls Bath

Archaeological Watching Brief

> CA Project: 5268 CA Report: 16355

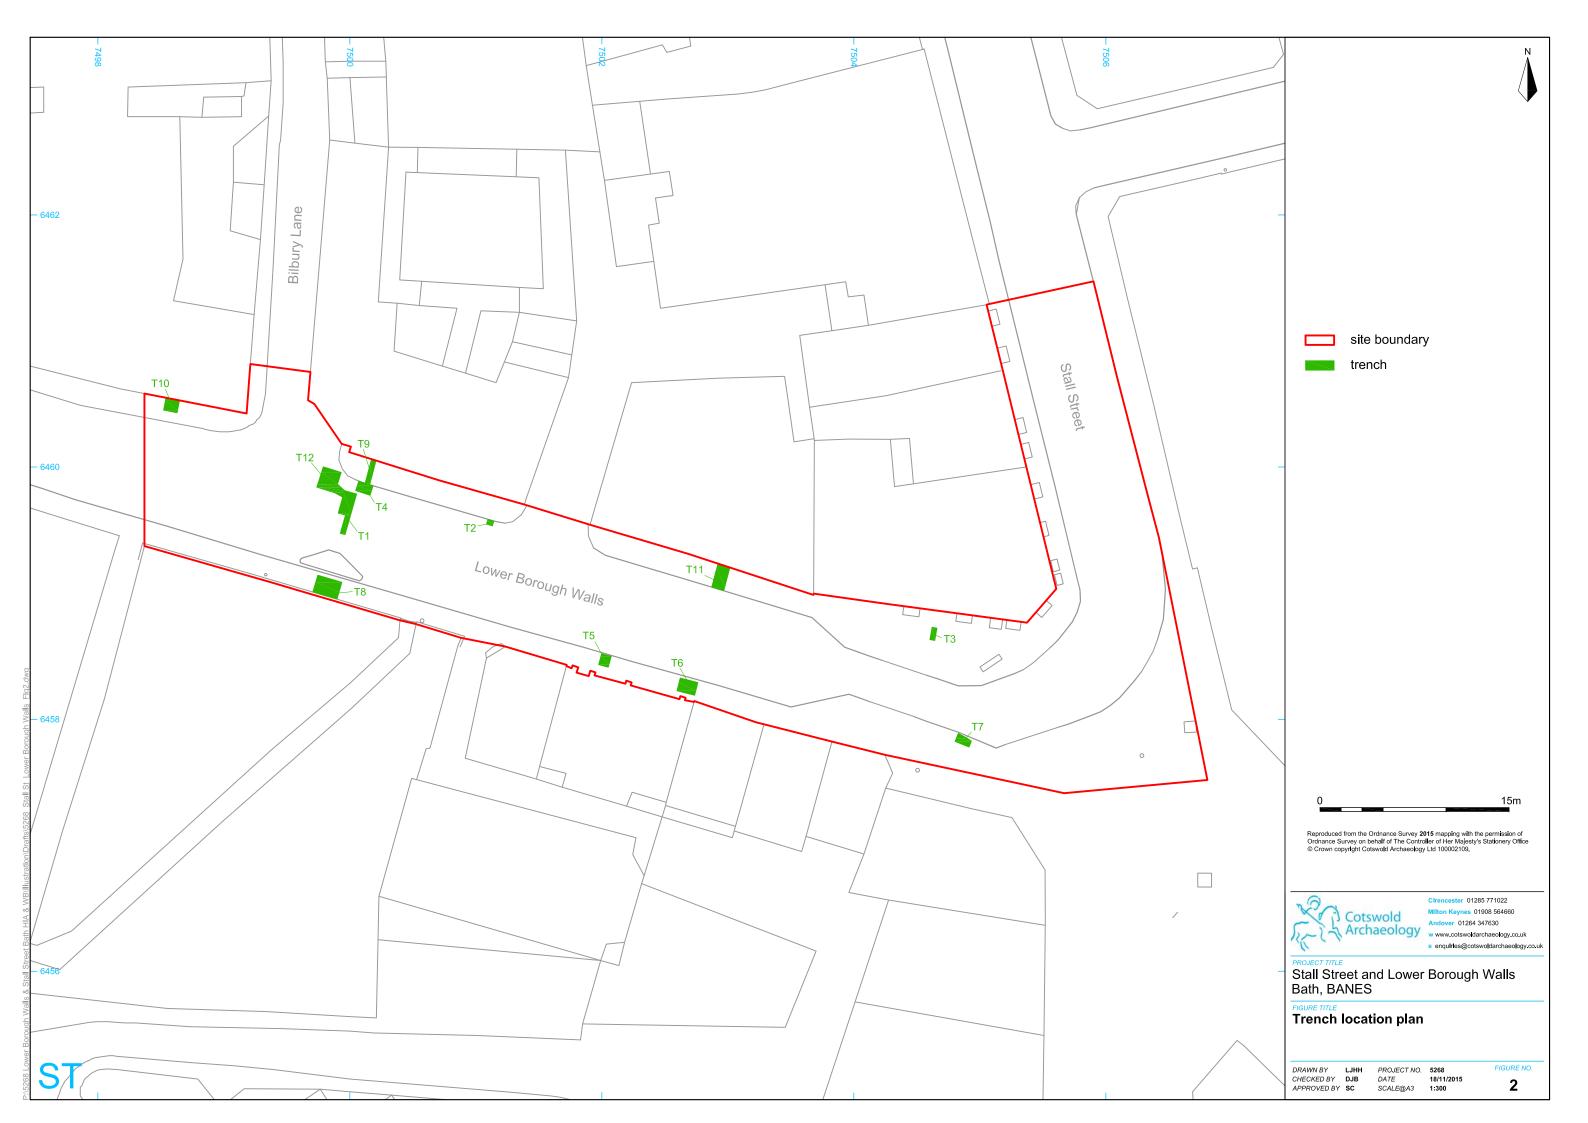
- 4.1 The fieldwork followed the methodology set out within the *WSI* (CA 2015). An archaeologist was present during intrusive groundworks comprising trial trenching and removal of existing street furniture (Fig. 2).
- 4.2 Where archaeological deposits were encountered written, graphic and photographic records were compiled in accordance with *CA Technical Manual 1: Fieldwork Recording Manual* (2013).
- 4.3 The archive from the watching brief is currently held by CA at their offices in Kemble and will be deposited with the Roman Baths Museum. A summary of information from this project, set out within Appendix C, will be entered onto the OASIS online database of archaeological projects in Britain.

5.1 Twelve trenches were excavated along Lower Borough Walls measuring up to 3.6m in length, 1.5m in width and up to 1.4m in depth below present ground level (bpgl). The natural geological substrate was not observed. All the trenches contained a series of silt-clay layers averaging 0.1m in depth interspersed with bedding layers that were overlain by probable road surfaces. All trenches were sealed by modern paving or tarmac. Trenches 2, 3 and 8 were devoid of archaeological remains.

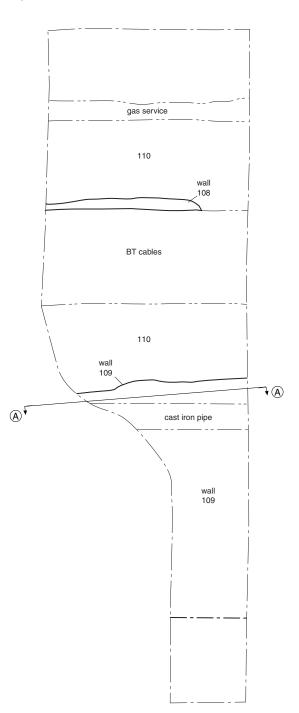
Trench 1, plan

5.2 In the southern part of Trench 1 the north face of the former town wall (109) was revealed at a depth of 0.7m bpgl (Fig. 3) running approximately east-west along the course of Lower Borough Walls. Six courses of roughly rectangular stone blocks set in yellow sand mortar were exposed. The face of the wall appeared to be stepped, widening towards the base. The core of the wall was constructed from irregular stone blocks set in yellow sand mortar. The southern face was not exposed in the trench. However, it was observed a short distance to the west in the cellar of No.6 Lower Borough Walls (previously identified; ADS 2015) giving the wall here an approximate width of 3m. Situated immediately to the north of the wall, ditch 106 was approximately 0.6m in width, >0.4m in depth and was filled by silt-clay (107)

and a fragment of mortared stone work (108) that was interpreted as part of the main wall that had been disturbed by later activity.

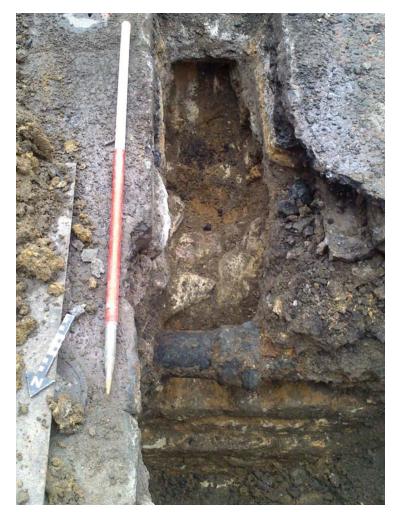
Trench 1, north-facing wall [109] (1m scale)
