Asda PFS Bridgewater Somerset

Archaeological Watching Brief

CA Project: 5651
CA Report: 16207

June 2016

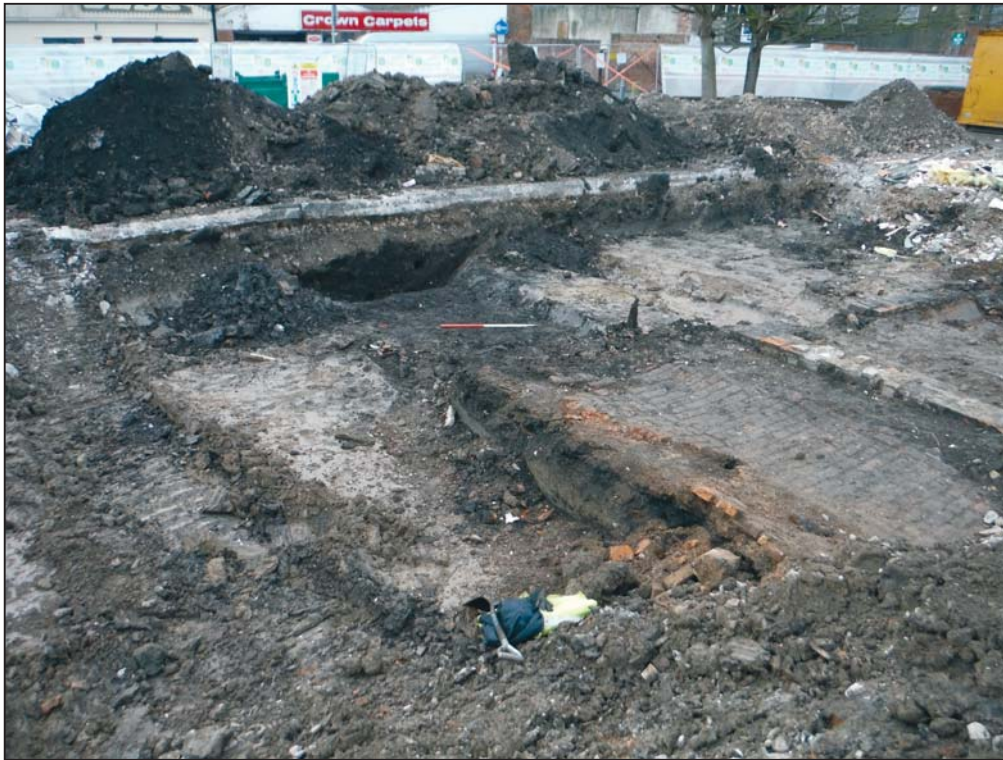
3 General view of the structures looking south (scale 1m)

- 5.4 The corner of a building, 103, and a brick surface, 104, were also identified within the northern part of Trench 1. Wall 103 comprised irregular courses of red bricks bonded with limestone mortar. Brick surface 104 was observed overlying the latest

fill of ditch 107. The stratigraphic relationship between wall 103 and brick surface 104 was could not be identified due to modern truncation. However, they appeared to be broadly contemporary.

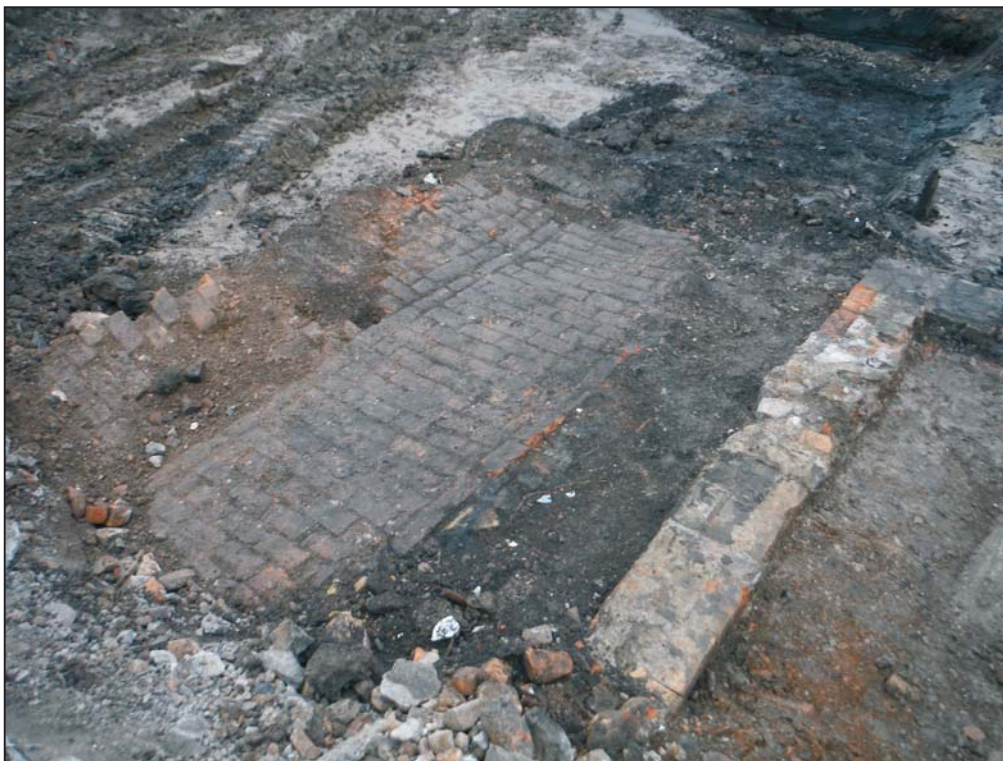
4 Wall 103 and surface 104 looking south-east

- 6.8 The walling, 103, is represented by low density machine made fired- bricks, representing either a red low calcareous fabric (1) or the high calcareous (2) variant. These are all machine made, fired and bonded in a dark grey-black sandy gravelly mortar typical of the late 19th to early 20th century.

- 6.9 The flooring pavers, 104–106, on the other hand are denser sun-dried (cracked) forms which on first appearance (irregular, thin) would suggest that they were much earlier. However, it seems more likely that these in fact are either contemporary or slightly pre-date (1820s-1900) the wall footings as sun-dried shrunken Bath-bricks were widely manufactured from the 1820s onwards in Bridgewater.

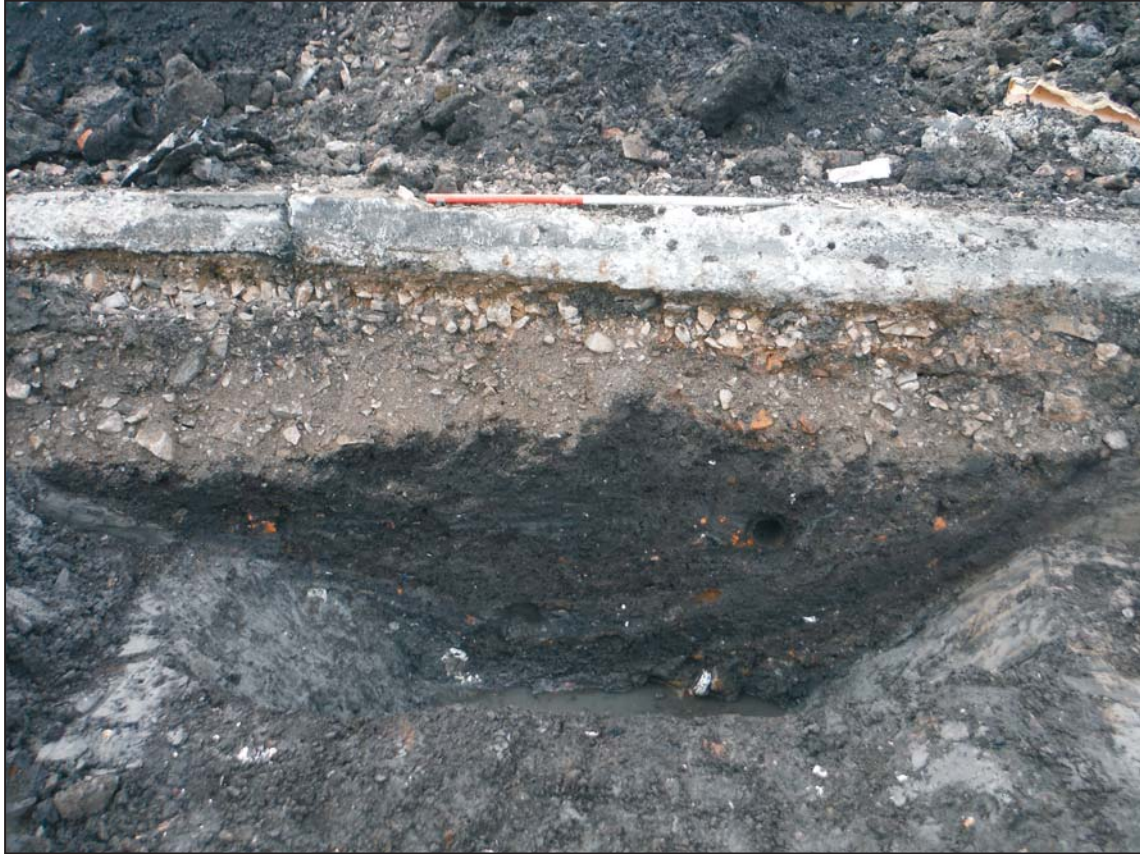
5 Ditch 107, looking south (scale 1m)

- 5.3 A north/south aligned ditch, 107, was identified towards the southern edge of the site (Trench 1) cutting through alluvial layer 115. The ditch had steep sides and a concave base and measured 3.2m in width and 1.2m in depth (Fig. 5). Ditch 107 contained eight fills, 108, 109, 110, 111, 112, 113, 114 and 116. Pottery of post-medieval date was recovered from the fills 108, 109, 112 and 116 of ditch 107. The northern extent of the ditch could not be determined due to the identification of later structural remains (see below).

- 7.1 The north/south aligned ditch seems to be a boundary of post-medieval date according to the dating evidence recovered from its fills.
- 7.2 The structural features identified towards the southern edge of Trench 1, comprising the corner of a building and two surfaces, lie in the area of a dry dock and quay on the east bank of the River Parrett depicted on the 18th-century map of Bridgewater (Gathercole 2002). The construction methodology is entirely consistent with workshops and/or small-scale industrial activity.
