**Overflow Carparking Area  
Beverbrook Sports and Community Facility  
Calne  
Wiltshire**

*Archaeological Watching Brief*

CA Project: 5456  
CA Report: 15567

September 2015

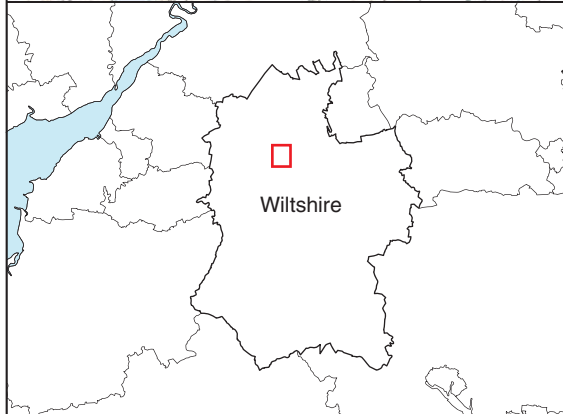
**FIGURE TITLE**  
 The site showing areas of observed groundworks

- site
- observed groundworks
- previous archaeological investigation (Saunders and Alexander 2011)
- previous archaeological watching brief area (CA 2014b)

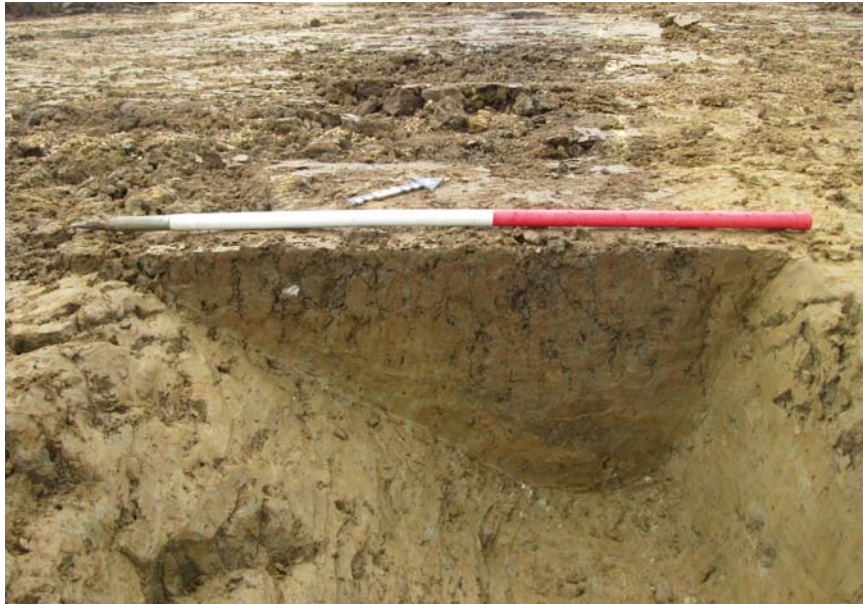
Ditch 102: section and photograph

- 5.3     A south-east/north-west aligned ditch, 102 was identified in the eastern part of the site. It measured 1.02m in width and 0.42m in depth (Fig. 3, Section AA) and contained two fills, 103 and 104. Pottery dating to the 13th to 16th centuries was recovered from both fills.

Ditch 102, looking north-west (scale 1m)
