# Congresbury Yeo Tidal Banks Congresbury North Somerset

Archaeological Watching Brief

> CA Project: 5566 CA Report: 15683

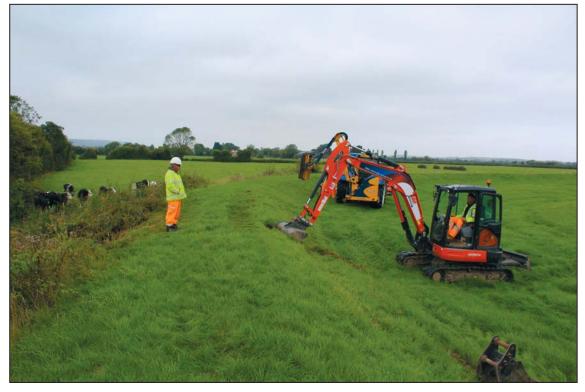
a b	General view of bank prior to excavation, facing west Excavated trench for new water pipe, facing south (0.5m scale)	Andover 01264 347630 Cirencester 01285 771022 Exeter 01392 826185 Militon Keynes 01908 564660 w www.cotswoldarchaeology.co.uk e enquiries@cotswoldarchaeology.co.uk PROJECT TITLE Congresbury Yeo Tidal Banks North Somerset			
		FIGURE TITLE Photographs DRAWN BY LM PROJECT NO. 5566 FIGURE NO. CHECKED BY SS DATE 16.09.2015 APPROVED BY RY SCALE@A4 N/A 3

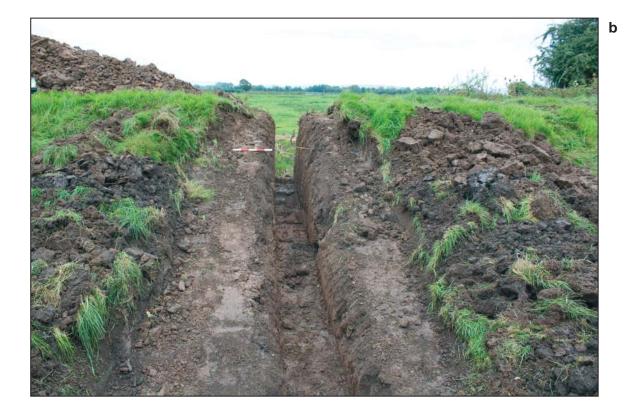
- 5.1 This section provides an overview of the watching brief results; detailed summaries of the recorded contexts are to be found in Appendix A.
- 5.2 The natural geological substrate, consisting of compact blue-brown alluvial clay, was revealed in the base of the pipe trench.
- 5.3 The excavation of the pipe trench revealed a section through the extant earthwork bank to the northern side of the 'East-town Rhyne' ditch. The bank was roughly 10m wide and up to 1.70m high with a flat top. On the southern side, the bank extended down to the water-filled ditch. The bank consisted of single homogenous light brown clay 1002, which lay directly on top of the alluvial clays. The bank was sealed by a uniform layer of grassed topsoil (1000).

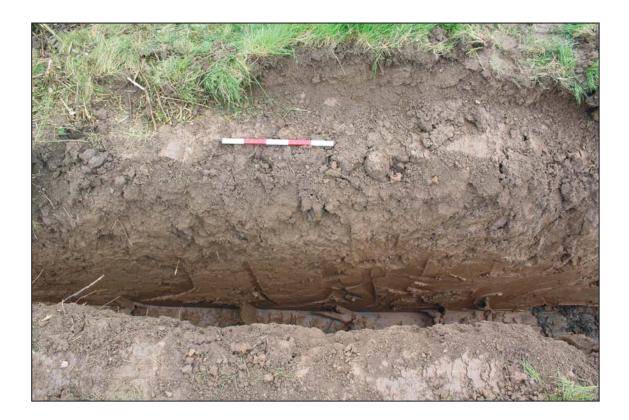
7.1 Despite the excavation of a section across the earthen bank, no artefacts were recovered that would have enabled dating of this feature. The bank itself appeared to sit directly on the underlying alluvial clays, with no indication of a buried soil horizon below. The bank was of only one build and had not been repaired, unlike the bank to the north of the estuary investigated in 2012.

Section through bank 1002, facing west (0.5m scale)	Andover 01264 347630 Cirencester 01285 771022 Exeter 01392 826185 Miton Keynes 01908 564660 w www.cotswoldarchaeology.co.uk e enquiries@cotswoldarchaeology.co.uk PROJECT TITLE Congresbury Yeo Tidal Banks North Somerset
	FIGURE TITLE Photograph DRAWN BY LM PROJECT NO. 5566 FIGURE NO. CHECKED BY SS DATE 16.09.2015 APPROVED BY RY SCALE@A4 N/A 4
