**15, Somerset Place  
Bath  
Bath and North East Somerset**

*Archaeological Watching Brief*

CA Project: 5610  
CA Report: 15739

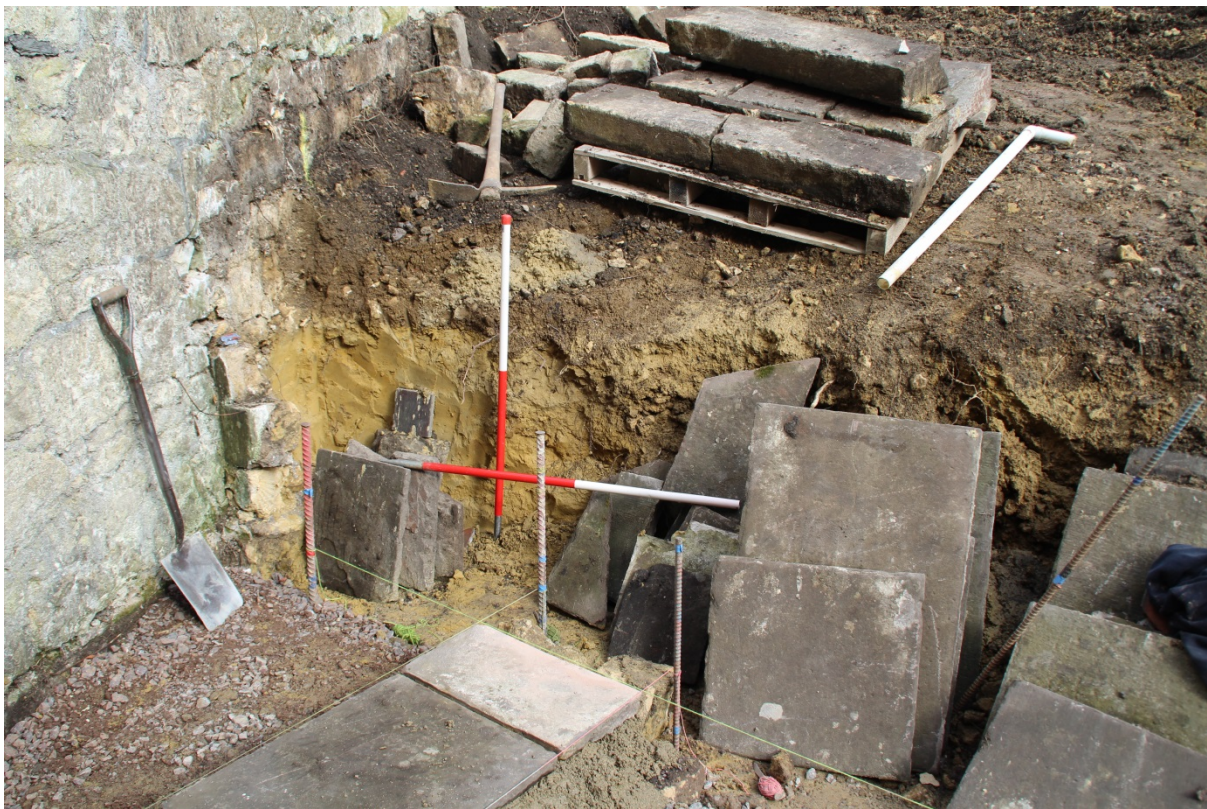
Figure 3. Exposure at south end of garden, looking N, scales 1m

- 5.3 This revealed a 0.6m tall face of Midford sand that had been cut away on the east and the cut filled with a loose, very clean deposit of coarse limestone gravel and coarse sand (Fig. 3). This gravel appeared to be a dumped layer, but the origin of the cut was unclear. Given the exposure of brash seen in the second exposure (below 5.4), this may be a glacial erosion event. Both the sand and the gravel were covered by a mid grey-brown clayey loam.
