Land to the Rear of the Bull Inn  
Redbourn  
St Albans  
Hertfordshire

*Archaeological Evaluation*

CA Project: 660586  
CA Report: 15785

November 2015

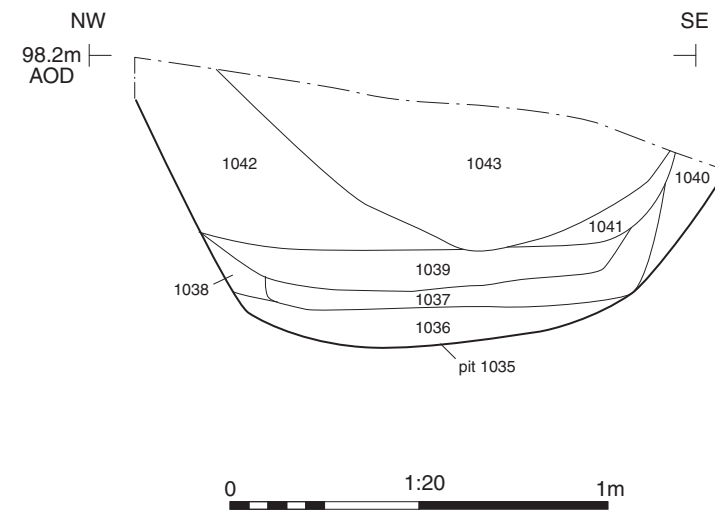
Section BB

- 5.3 Natural substrate 1004 was exposed 0.47m bgl in the north-eastern end of the trench. The only feature cut directly into the natural substrate was undated pit 1035 (Fig. 3, Section BB; Fig. 9), which lay in the north-eastern end of the trench. This pit was 0.78m wide and 0.65m deep. It featured a sequence of seven fills, including a compacted chalk layer (1037). Some of these fills contained quantities of burnt stone and charcoal; pink discolouration of the underlying natural was indicative of *in situ* burning. Pit 1035 and the natural substrate were sealed by 0.33m-thick silty clay layer 1034.

- 7.1 The earliest feature recorded by the evaluation was pit 1035 (T1). Although undated artefactually, this pit was the only feature which pre-dated the truncation episode described below. Pit 1035 contained quantities of burnt stone and charcoal and featured evidence for *in situ* burning, indicating that it might have functioned as a hearth and/or been associated with small-scale industrial activity. This would be consistent with activity in the rear yard of a medieval burghage plot fronting on to the High Street, although without any associated dating evidence this conclusion must remain tentative.

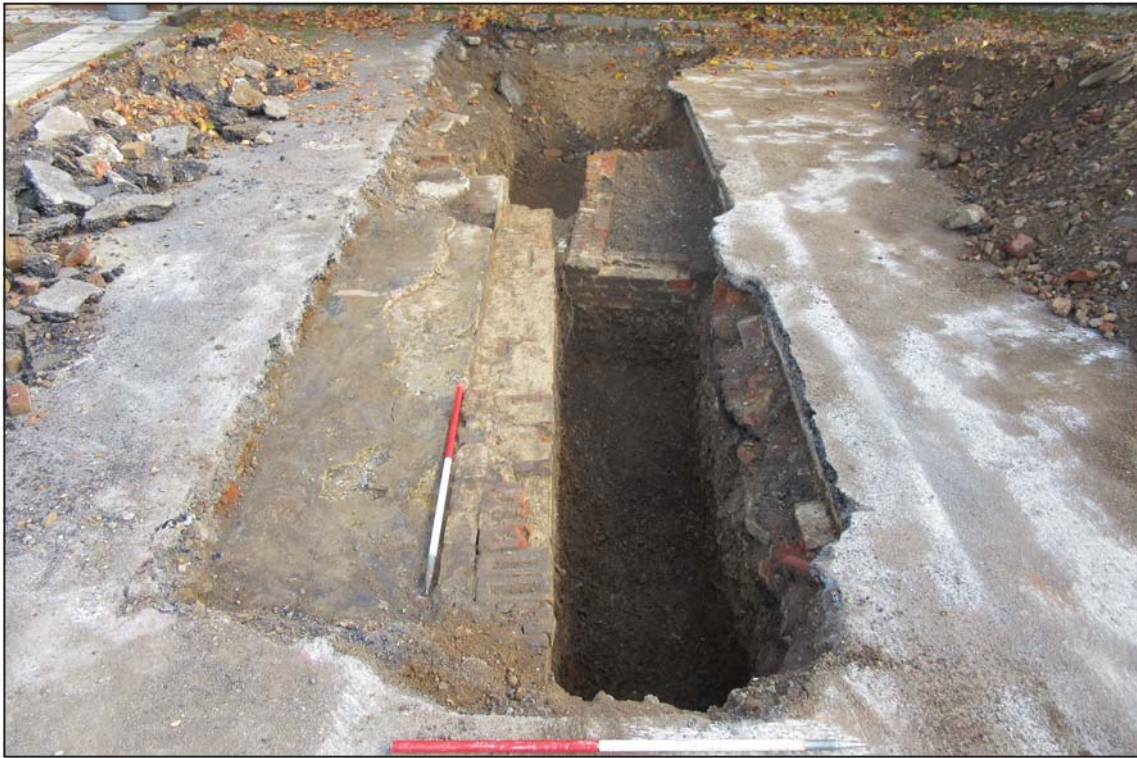
### **Trench 1 (Fig. 4)**

4 Trench 1, looking north-east (scales 1m)

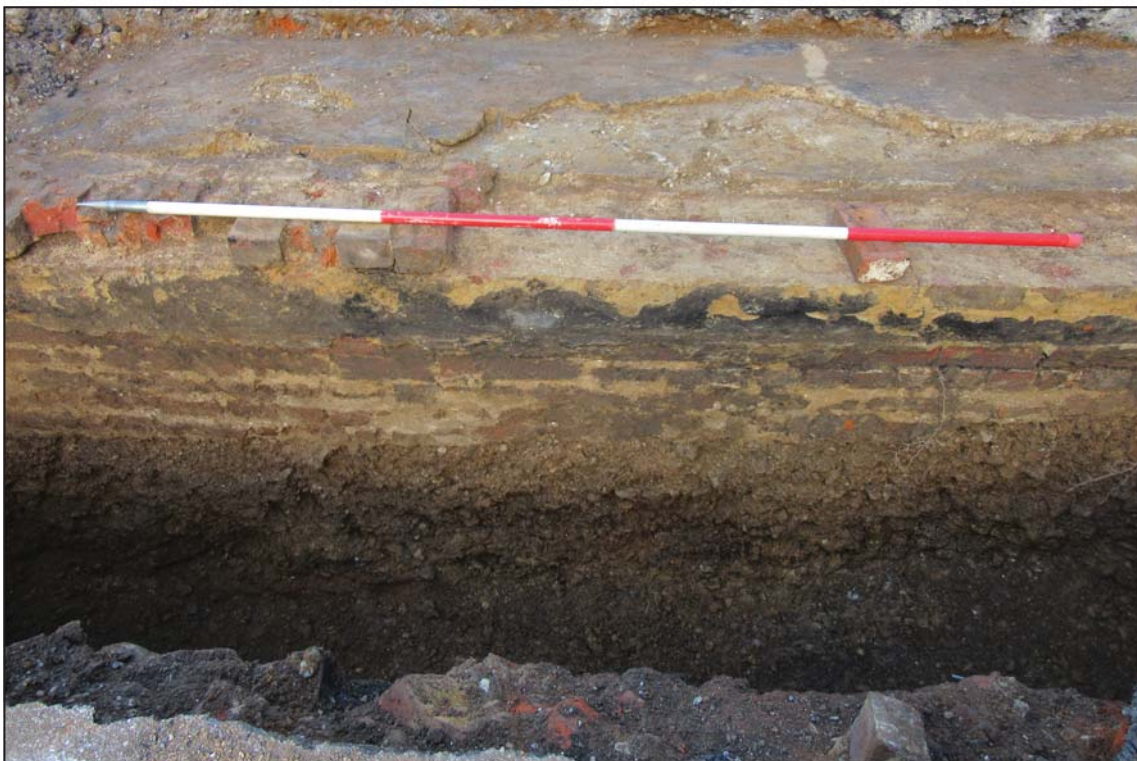
- 5.7 North-east/south-west-aligned wall 1008 (Fig. 5) was 0.36m wide and survived to 0.4m in height. This wall had been cut into made ground layer 1009 (construction cut 1007). It was constructed of bricks dating to the late 19th/early 20th centuries. The northern face of wall 1008 was abutted by two overlying layers of concrete surfacing (1022 and 1023).

5 Profile of wall 1008, looking north-west (scale 2m)

- 6.3 Sample bricks were recovered from three of the structures exposed at the site. Those from structures 1006 (T1) and 5005 (T5) are 17th/18th century in date; those from 1008 (T1) date to the late 19th/early 20th century.

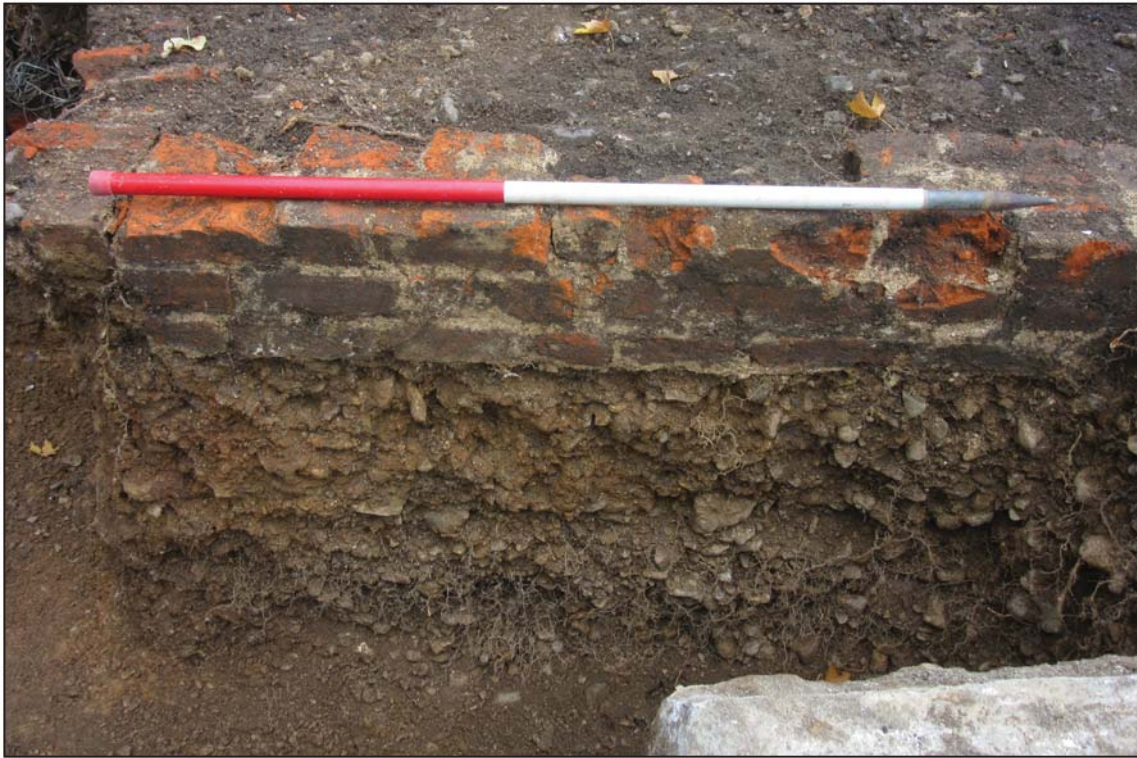
- 5.6 T1 contained a series of red brick-built wall foundations. Wall 1006 (Fig. 6) was cut into made ground layer 1009 (construction cut 1005). This wall measured 0.23m in width and survived to a height of 0.24m. It was L-shaped in plan, with its long axis aligned north-east/south-west. The bricks used in the construction of this wall were of 17th–18th century date. The inner surfaces of wall 1006 were abutted by a deposit of gravel in a silty clay matrix (1024), presumably representing a former floor surface.

6 Profile of wall 1006, looking south-east (scale 1m)

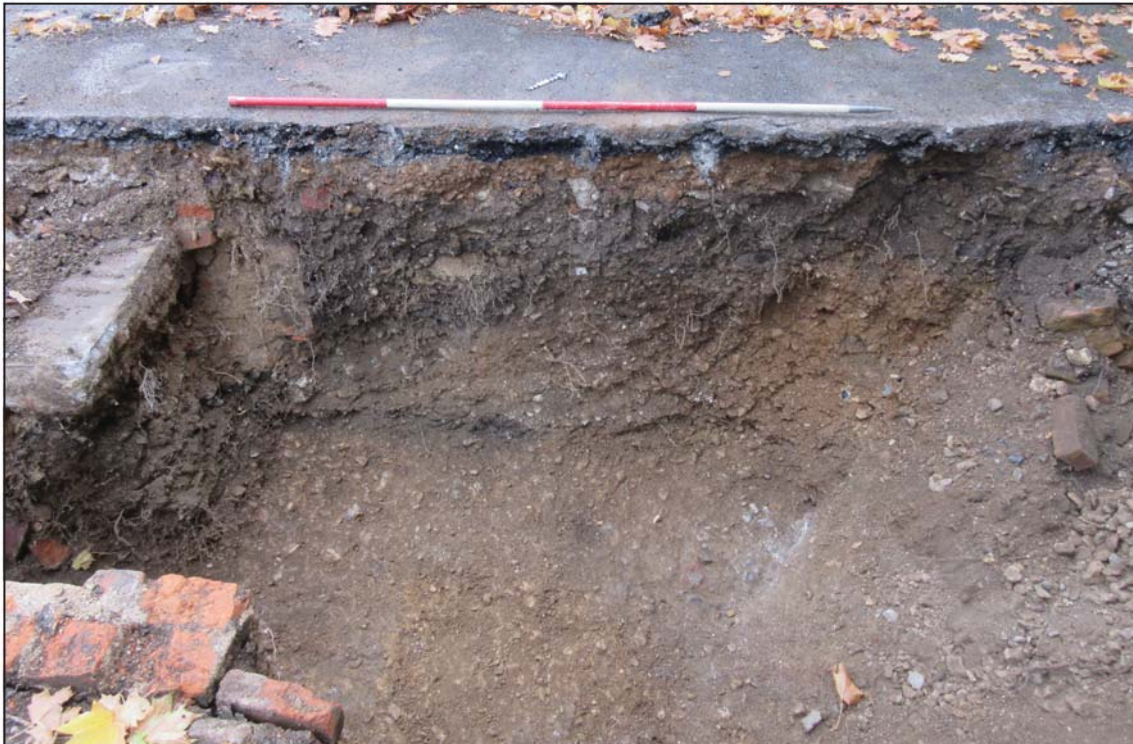
- 5.5 Substantial pit 1027 lay east of trench centre (Fig. 3, Section AA; Fig. 8; this feature was recorded in section only and is therefore not visible on Figure 2). This pit measured 6.6m in width and 1.14m in depth and was cut through made ground layer 1019. It was filled by a sequence of eight clayey/sandy fills, the penultimate of which (1020) contained three sherds of pottery dating from the 12th–early 14th centuries.

8 South-east facing section pit 1027, facing north-west (scale 2m)

- 7.4 The function of substantial pit 1027 (T1) is unclear. Its large size and the nature of its fills were inconsistent with use as a latrine/waste pit in the rear of a medieval burgage plot. It is likely that the pit was excavated in order to quarry natural sand/gravel, which partially survived the undated truncation event in this area of the trench. One of the fills of pit 1027 contained three sherds of medieval pottery. While it is possible that these sherds were *in situ*, they may represent residual material originating from a putative medieval feature removed by pit 1027 as it quarried into the natural.

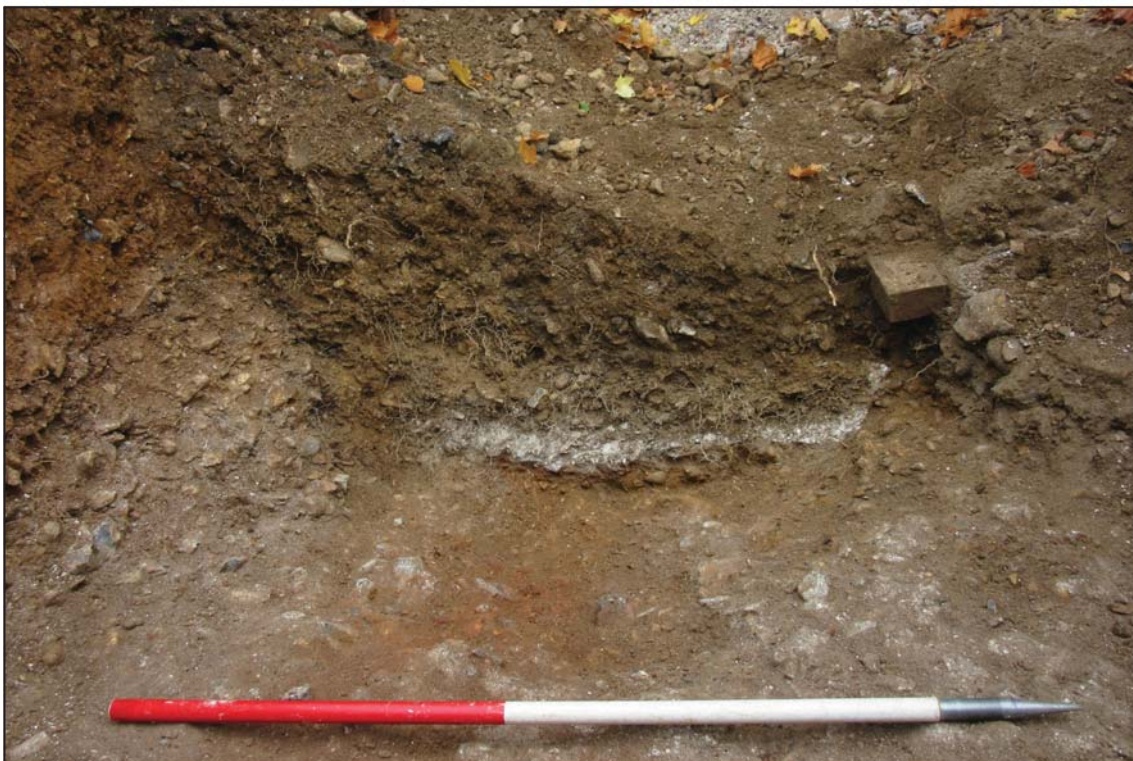
9 South-west facing section of pit 1035, facing north-east (scale 1m)
