St Michael's Church Aldbourn Wiltshire

Archaeological Watching Brief

CA Project: 770060
CA Report: 15849

December 2015

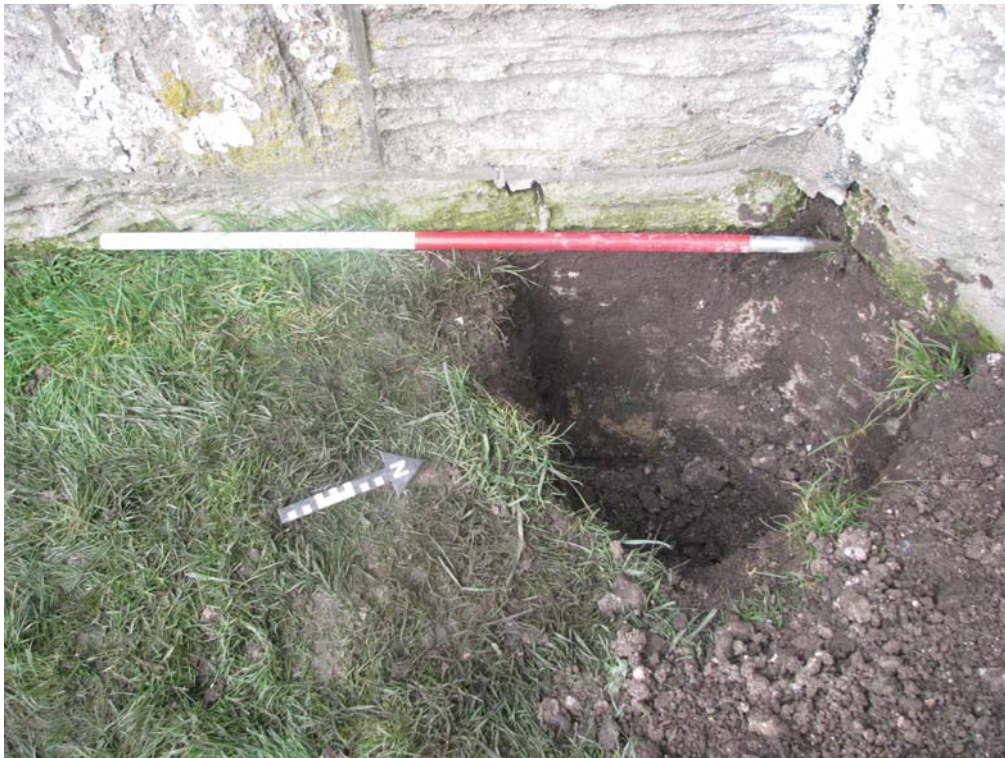
Test Pit 1: plan, section and photograph

- 5.1 **Test Pit 1** was located next to and butting the west side of the south wall of the Tower at the western end of St. Michael's Church. The test-pit measured 0.60m east/west, 0.40m north/south and was excavated to a depth of 0.70m.
- 5.2 The recorded stratigraphic sequence comprised subsoil **101**, overlain by topsoil **100**. No features or deposits of archaeological interest were observed. Disarticulated human remains were observed but not recovered within subsoil **101**. Medieval floor

tile and flat roof tile fragments, dating to the 13th to 15th centuries, were recovered from topsoil **101**. Depth of natural substrata was not established in the test pit.

Section AA

Test Pit 1 looking north-west

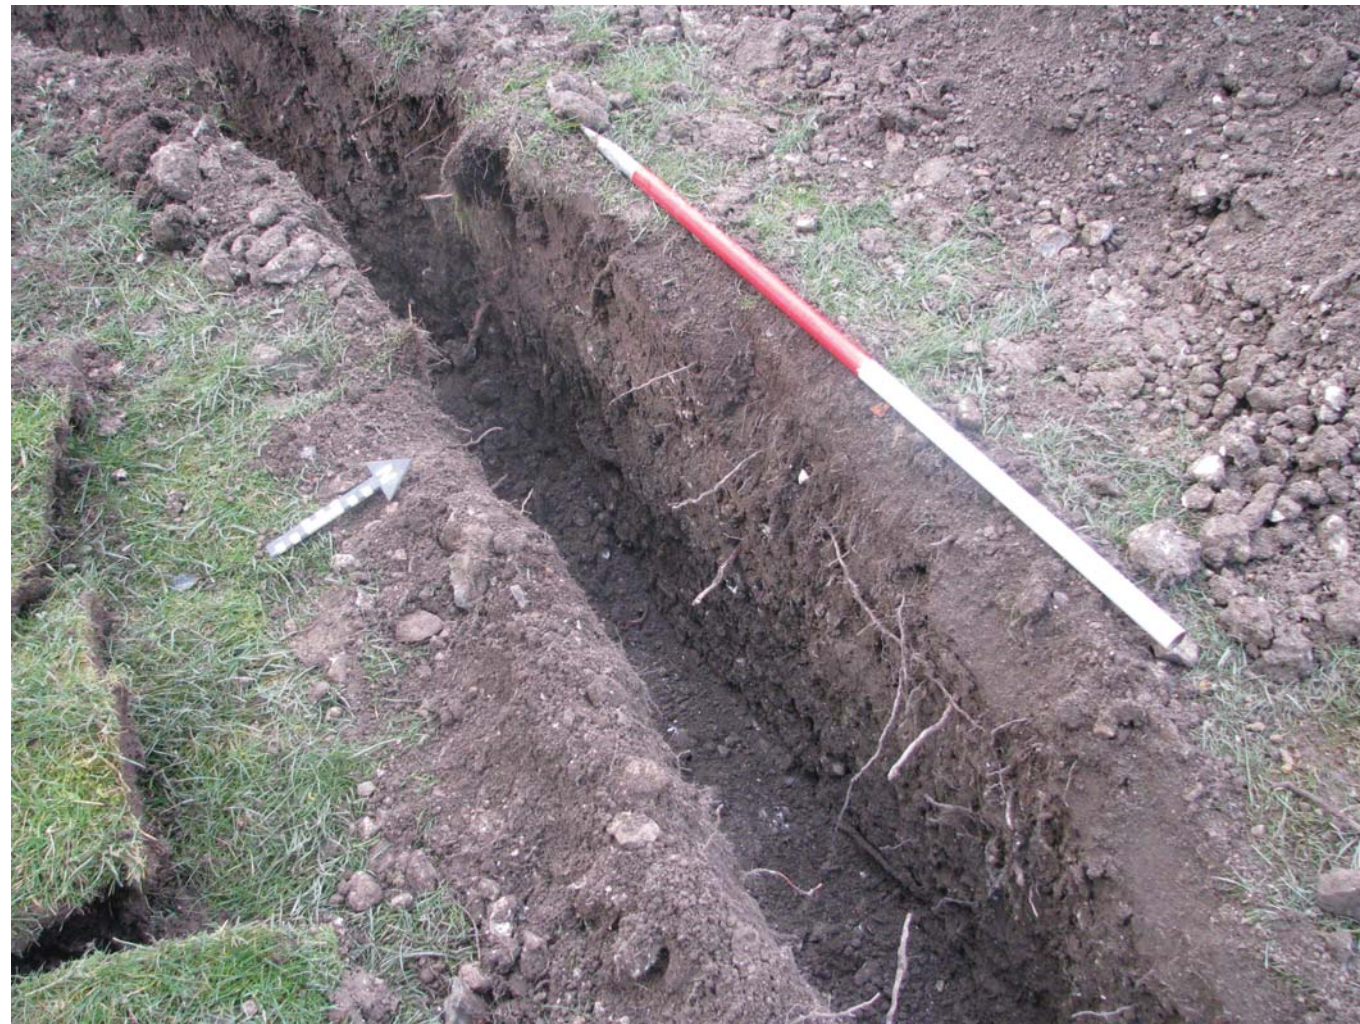
FIGURE TITLE
Trench 2: plan, section and photograph

- 5.3 **Trench 2** was located to the north and north-west of the tower and was 17.5m long, 0.4m wide and up to 0.7m deep.
- 5.4 The earliest deposit within **Trench 2** comprised a buried soil **202**, which was overlain by buried soil **201**. Layer **201** was cut by a modern service trench **203** which contained three modern fills (**204-206**). A final layer of topsoil **200** completed the stratigraphic sequence.

- 5.5 No features or deposits of archaeological interest were observed. Disarticulated human remains were observed but not recovered within buried soil layers **201** and **202**. Medieval painted and glazed floor tile and flat roof tile fragments, dating to the 13th to 15th centuries, were recovered from topsoil **200**. The larger fragment was of a monochrome (green-coloured) glazed type and retained thick lime mortar to its underside. The depth of natural substrata was not established.

Section BB

Trench 2 looking north-west

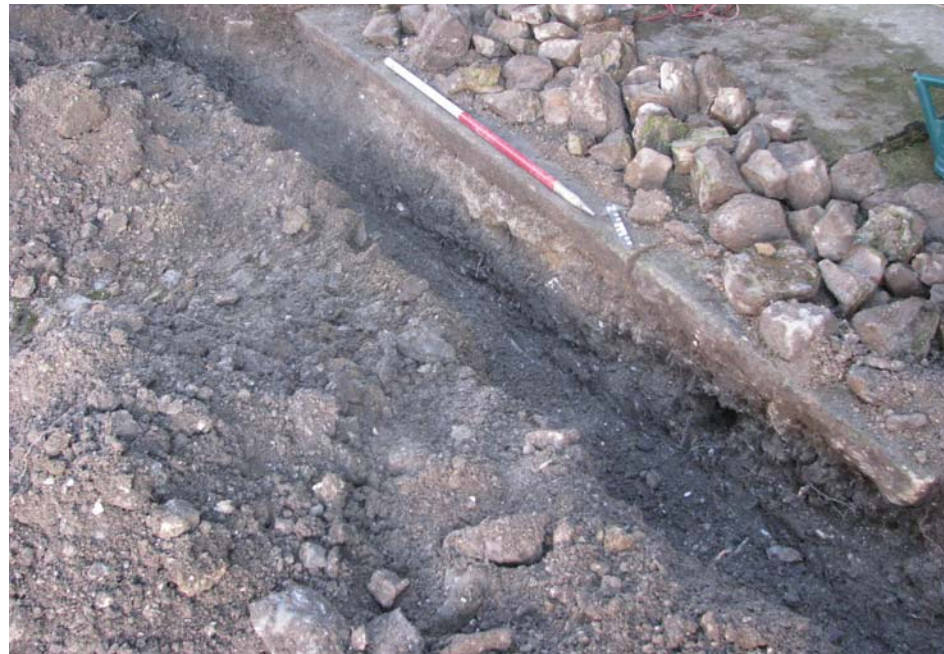
- 5.6 **Trench 3** was located to the west of the tower and cut through an existing pathway. **Trench 3** was 3.7m long, up to 0.6m wide and up to 0.58m deep.
- 5.7 The earliest deposit within **Trench 3** comprised a buried soil **302**, overlain by buried soil **308** and **307**. Buried soil **307** was cut by a modern service trench **305** which contained a single modern fill **306**. Deposit **303** was used as a foundation layer for a cobbled and flagstone pathway **301**. Topsoil **304** completed the archaeological sequence. No features or deposits of archaeological interest were observed. No artefactual material pre-dating the modern period was identified. Disarticulated human remains were observed but not recovered within buried soil **307** and **308**. The depth of the natural substrata was not established.

Section CC

Trench 3 looking north

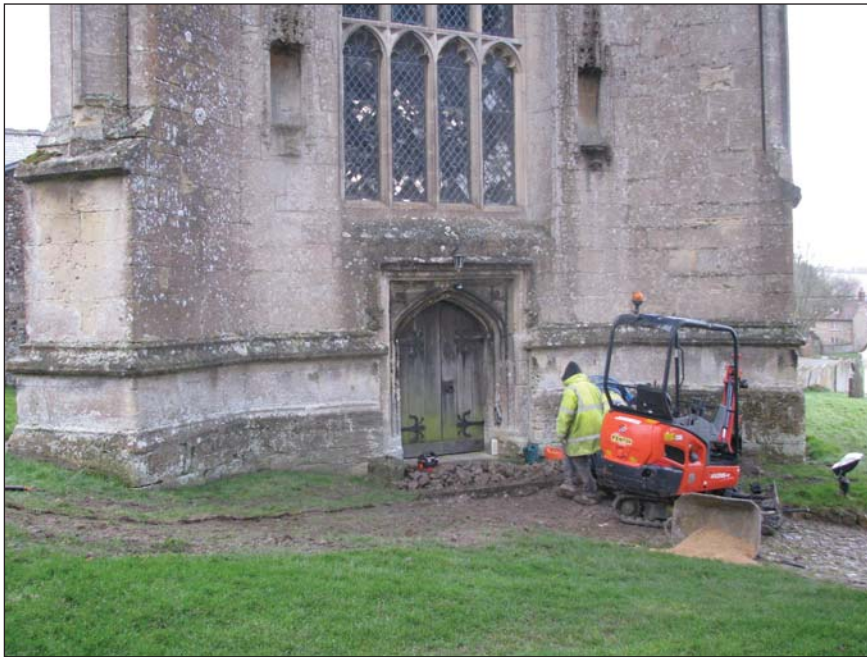
General view south-east of Trench 3

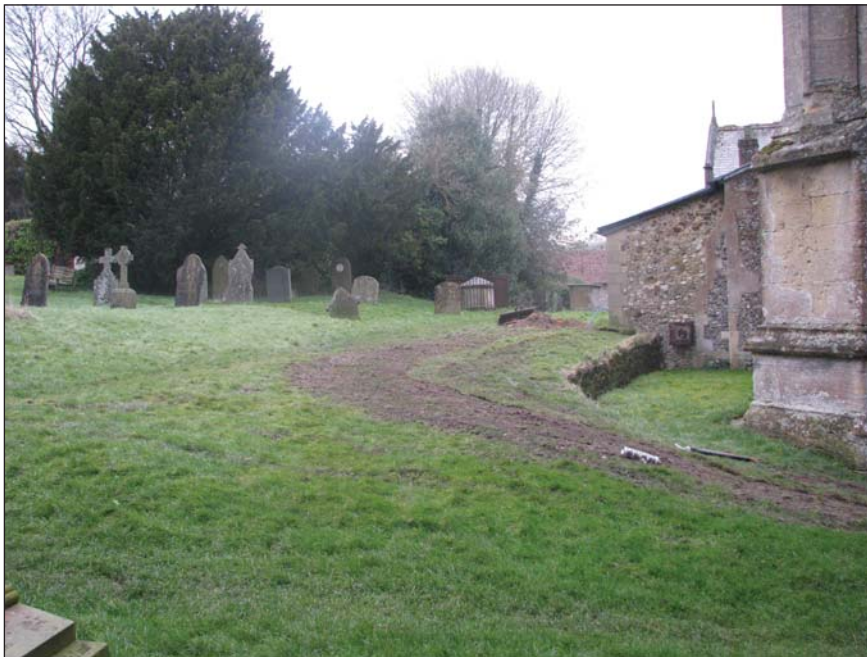
General view east of Trench 2
