**New Car Park
Cirencester Hospital
Cirencester
Gloucestershire**

Archaeological Watching Brief

CA Project: 5393
CA Report: 16036

February 2016

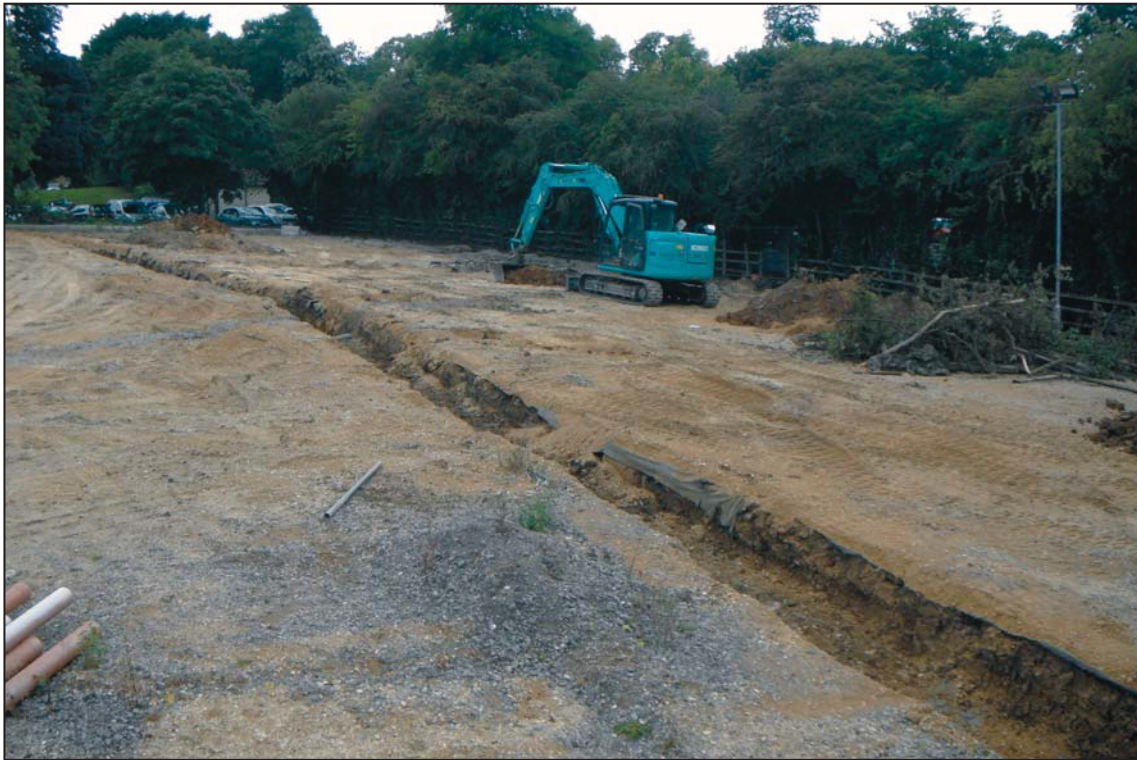
3 The site, with Trench 2 in foreground, looking north-west

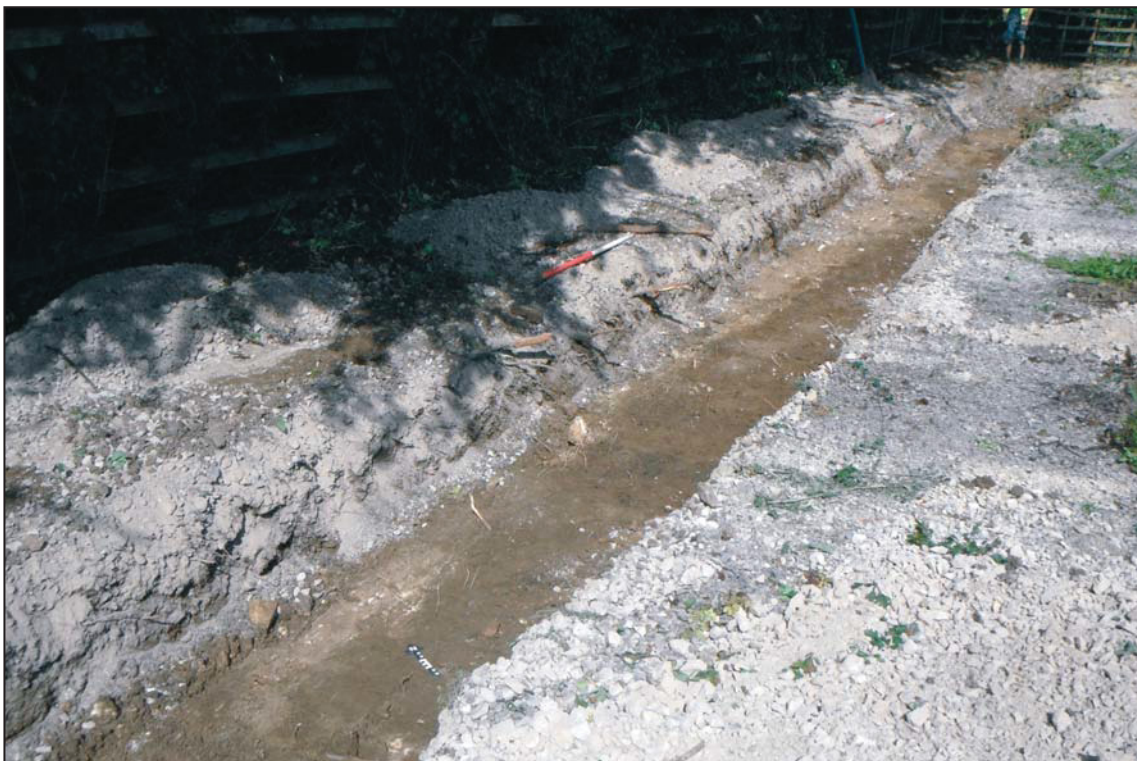
- 5.1 The natural geological substrate, comprising limestone brash, was encountered at a typical depth of 1m below present ground level (bpgl) within the two service trenches. This was covered by a layer, up to 0.35m thick, of brown silt subsoil, which was in turn sealed by a dark silt layer, 0.2m thick, which appeared to represent a buried topsoil. This layer was subsequently sealed by 0.6m of modern levelling deposits, comprising a stony made ground layer that formed the bedding for a hardstanding surface laid prior to construction of the car park.

4 Trench 1, looking north-east (1m scales)
