Land at Bakers Quay Gloucester Gloucestershire

Archaeological Evaluation

CA Project: 5811 CA Report: 16119

April 2016

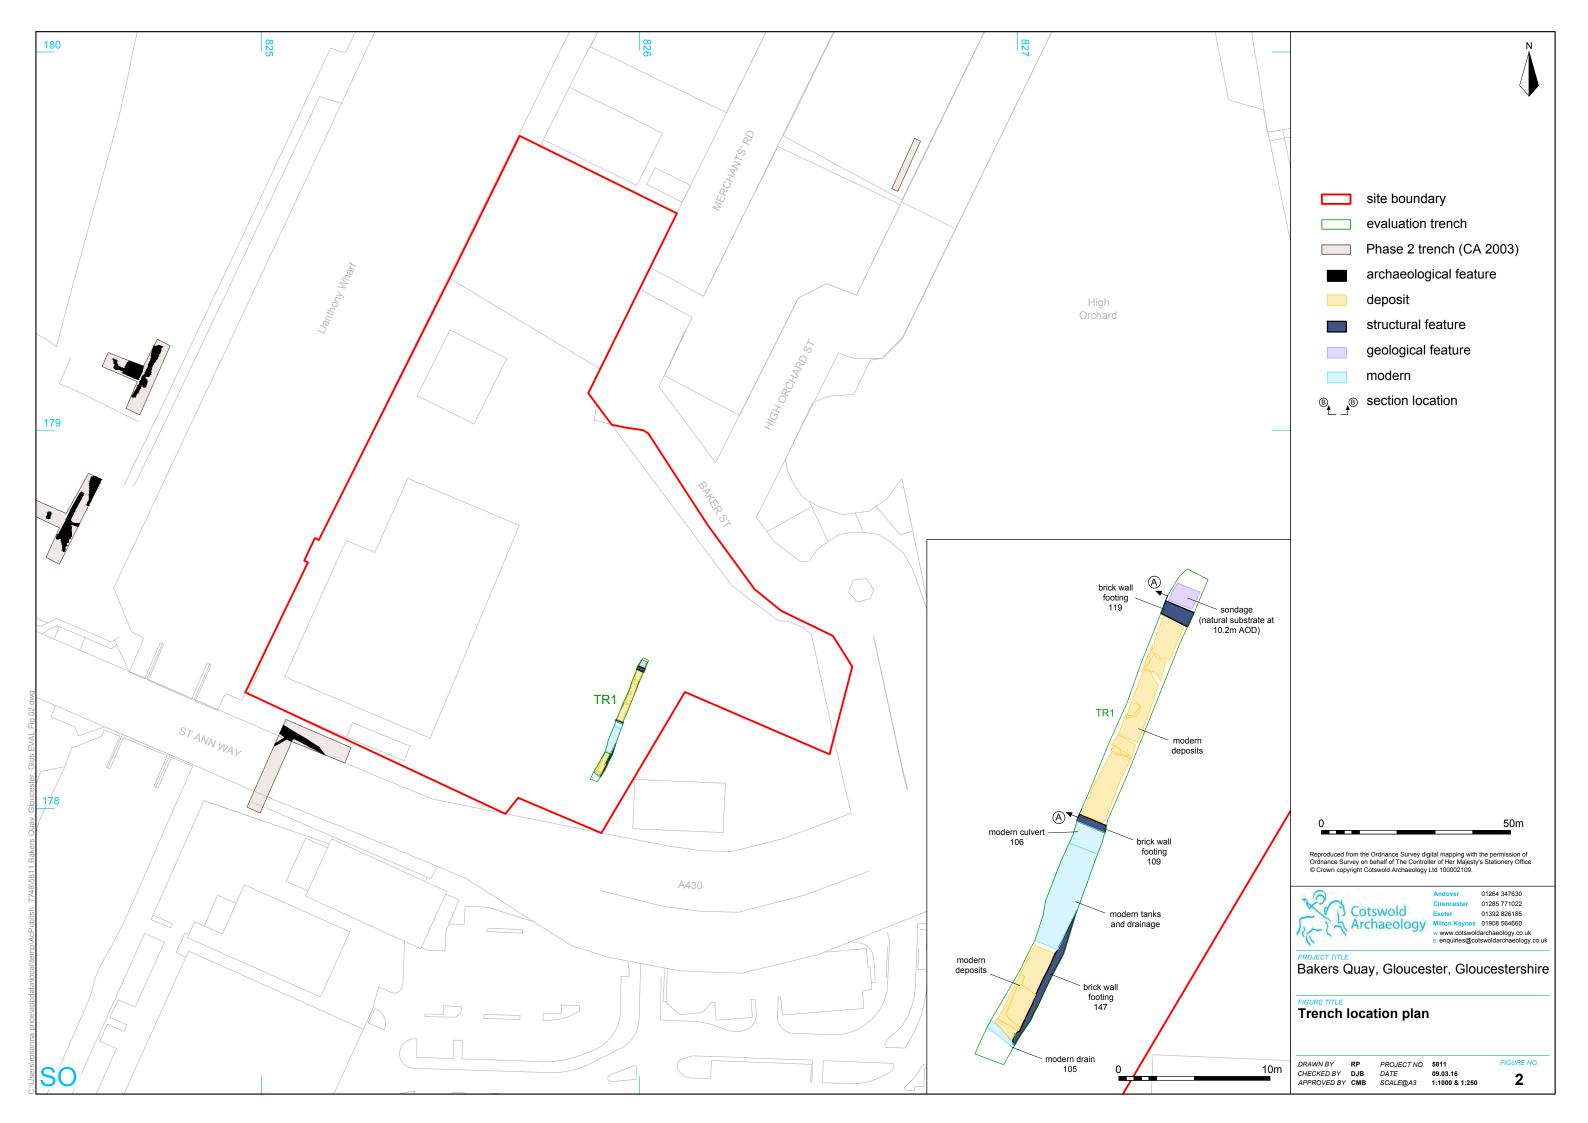
- 4.1 The fieldwork comprised the excavation of a single trench measuring 35m in length and 1.8m in width (see Fig. 2 for location and extent). The trench was set out by the client and subsequently surveyed by CA in accordance with CA Technical Manual 4 Survey Manual. It was excavated by mechanical excavator equipped with a toothless grading bucket. All machine excavation was undertaken under constant archaeological supervision to the top of the first significant archaeological horizon or the natural substrate, whichever was encountered first. Where archaeological deposits were encountered they were excavated by hand in accordance with CA Technical Manual 1: Fieldwork Recording Manual.

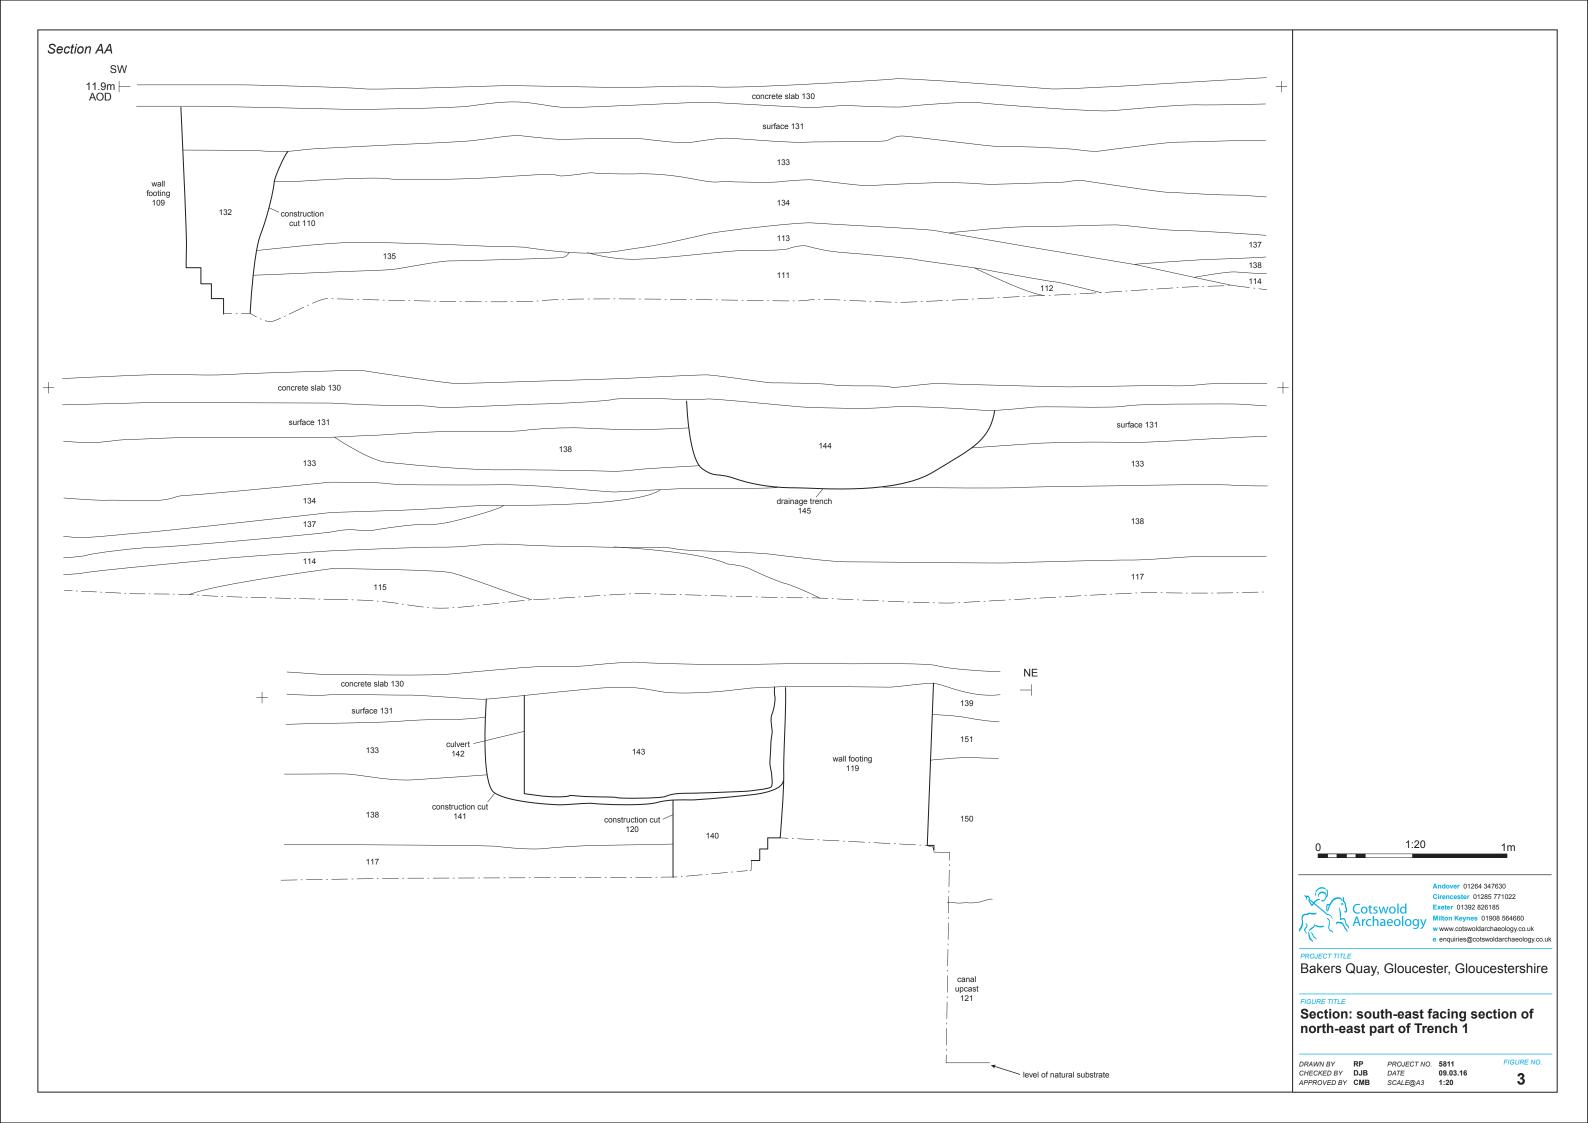
- 5.1 Natural substrate 149, comprising blue lias clay, was revealed at a depth of 2.1m below the present ground level (bpgl) within a sondage excavated at the north-eastern end of the trench. This was directly overlain by redeposited natural clay 121 which measured 0.86m in thickness and from which a single sherd of pottery of 19th-century pottery was recovered.

- Sealing the dump deposits within the north-eastern part of the trench was a layer of yellow clay, 133, that had a relatively uniform thickness of 0.3m. It may represent a levelling/consolidation layer established prior to the construction of Provender Mill. It was cut at its south-western end by construction cut 110 for a north-west/south-east aligned brick wall and footing 109. A parallel, and most probably associated, wall footing (119) was identified at the north-eastern end of the trench. Sealing layer 133 and butting wall 109 was brick surface 131.

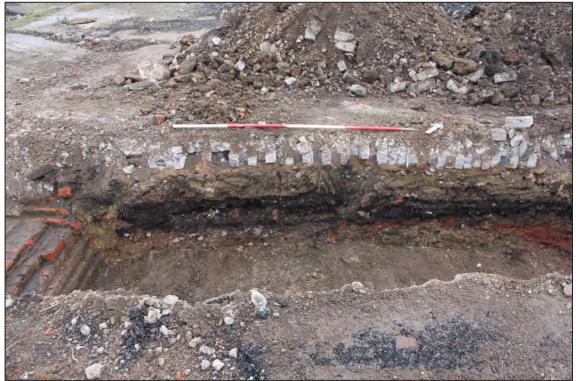
- Wall footing 109, looking north-west (2m scale) 4
- Wall footing 119, looking north-west (2m scale) 5

- 5.5 Surface 131 was cut by two probable drainage trenches, 141 and 145, containing fills 143 and 144 respectively. Abutting the south-western face of wall 109 was brick culvert 106 that was infilled by rubble fill 108.

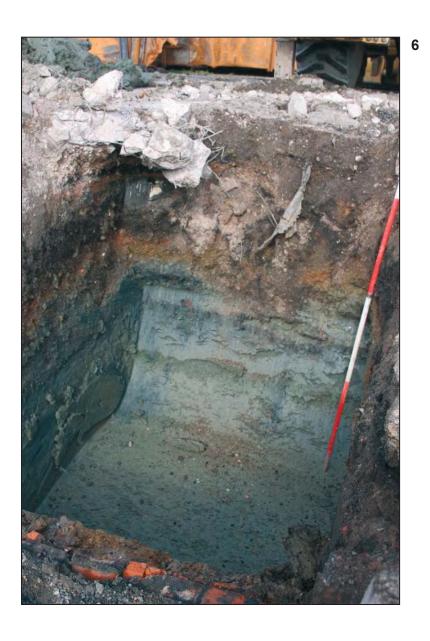
6 Sondage at north-eastern extent of trench, revealing natural clay substrate, looking north-east (2m scale)

- 8.1 The depth of the natural substrate identified within the sondage excavated at the north-eastern extent of the current trench broadly correlates with observations undertaken during the previous archaeological works within the vicinity (CA 2003; Trenches B1-B5 and D1-D3; Fig 2, also see Appendix C of the current report).
