Thornbury Castle Thornbury South Gloucestershire

Archaeological Evaluation

CA Project: 5809
CA Report: 16134

April 2016

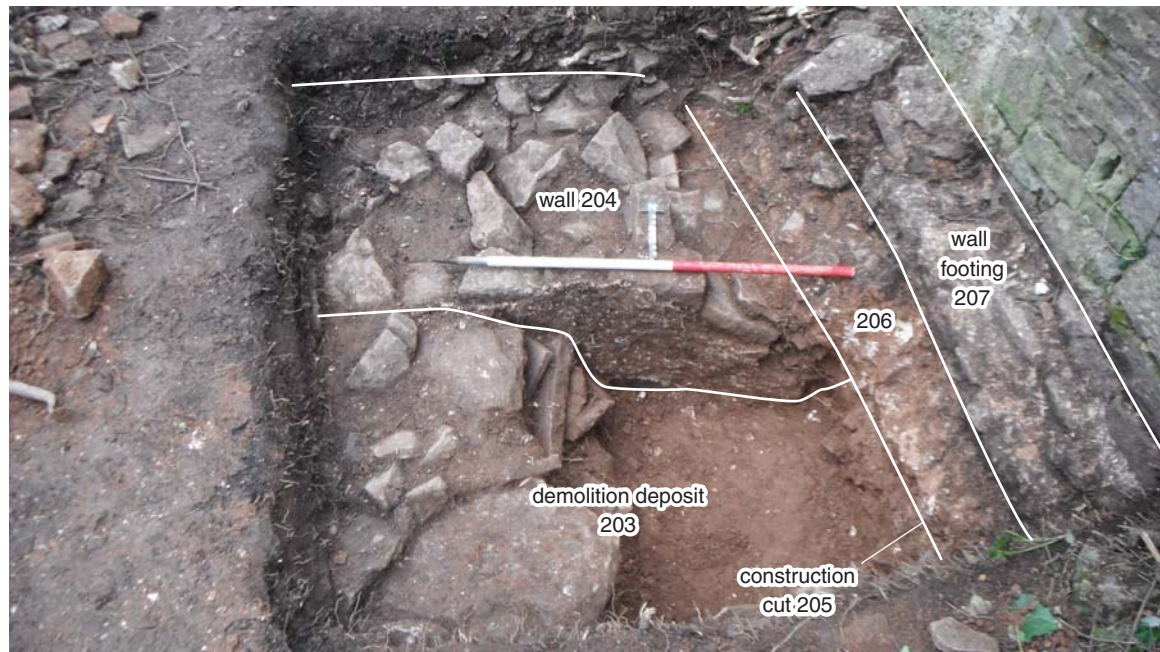
DRAWN BY **DJB/RP** PROJECT NO. **5809** FIGURE NO.
 CHECKED BY **LM** DATE **17.03.16**
 APPROVED BY **SS** SCALE@A3 **1:50 & 1:20** **4**

- 5.4 Stratigraphically, the earliest deposit encountered in Trench 2 was partially exposed east-west aligned wall 204, which was identified at a depth of 0.3m bpgl. It measured at least 0.5m in width and survived to at least 0.5m in depth. It was of

rough limestone block construction, bonded by a friable grey mortar. The south-eastern face of the wall exhibited evidence of being covered by lime plaster.

- 5.5 Wall 204 was overlain by deposit 203, which contained numerous mortar, plaster and limestone fragments, indicative of demolition. Demolition deposit 203 was cut by north-west/south-east aligned construction cut 205 for wall footing 207, which appeared to represent the footing of the extant West Range. The foregoing deposits were sealed by homogenous make-up/levelling deposits 202 and 201 which contained quantities of modern artefactual material. The latest of these deposits, 201, was sealed by topsoil.

Walls 204 and 206, looking north (scale 1m)

- 7.3 Wall 204, identified in Trench 2, confirms that structures survive below the existing ground level in the vicinity of the trench. The function, extent and date of the wall remain unclear. However, it is stratigraphically earlier than the extant wall of the West Range (understood to have been constructed between 1511 and 1521, see *archaeological background* above). Furthermore, the presence of plaster on its southern face coupled with its construction in stone suggests that it is associated with a building of some status. The survival of the wall plaster also suggests that wall 204 is likely to survive to a depth beyond the limit of the current excavations, and that contemporary floor levels may also survive beneath demolition deposit 203.

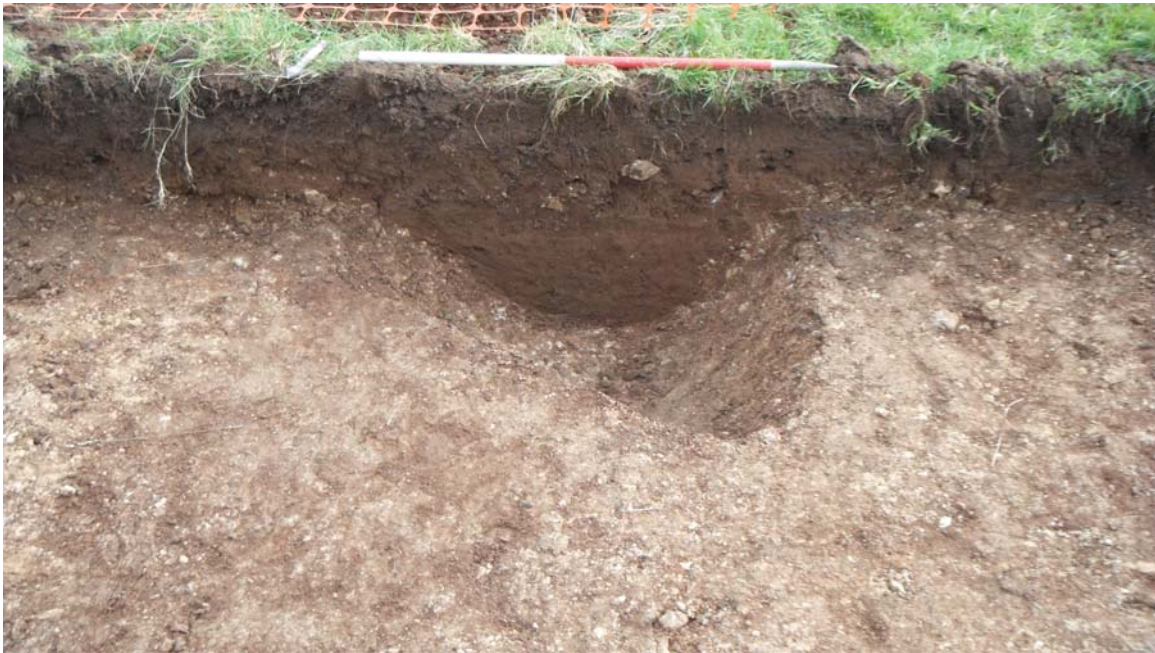
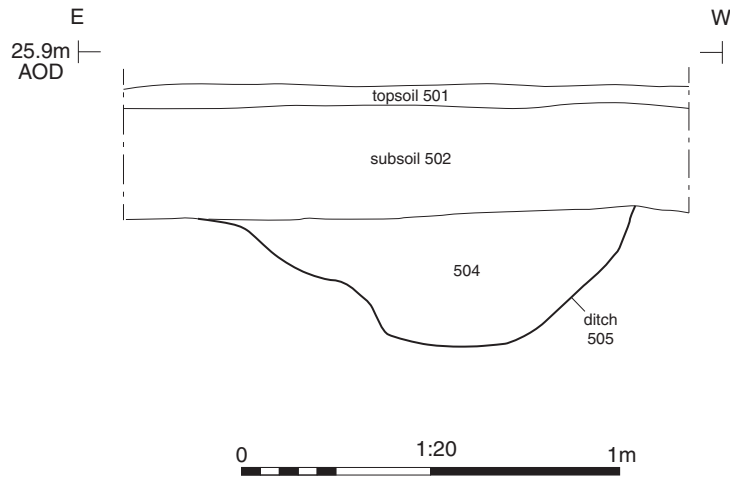
Trench 5: section and photograph

- 5.6 The natural substrate was identified at 0.5m bpgl within the trench. It was cut by north-south aligned ditch 505 which had an irregular but generally 'U'-shaped profile and contained a single undated fill, 504. The ditch broadly corresponds with part of a linear geophysical anomaly (AS Ltd 2016). The fill of ditch 505 was sealed by subsoil which was in turn sealed by topsoil.

Ditch 505, looking south (1m scale)

- 7.14 Undated ditch 505, identified in Trench 5, broadly correlates to part of a linear anomaly depicted by a preceding geophysical survey (AS 2016). The function of this ditch remains unclear, however its irregular nature and the sterility of its fill suggests that it most probably relates to agricultural land management, drainage or division.

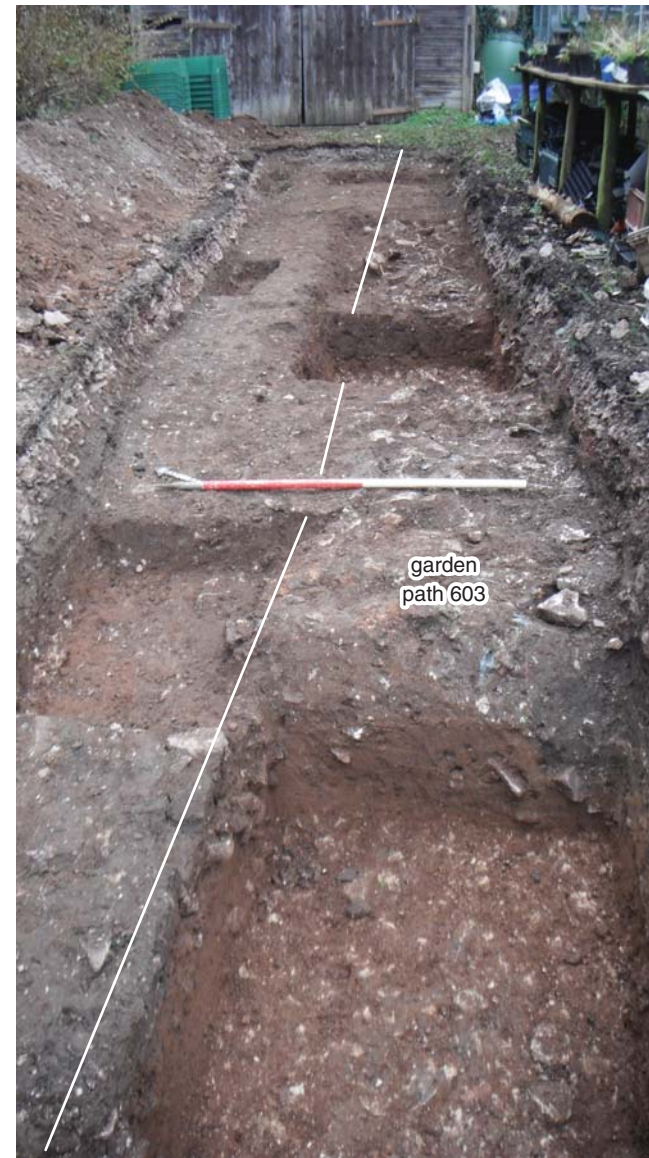
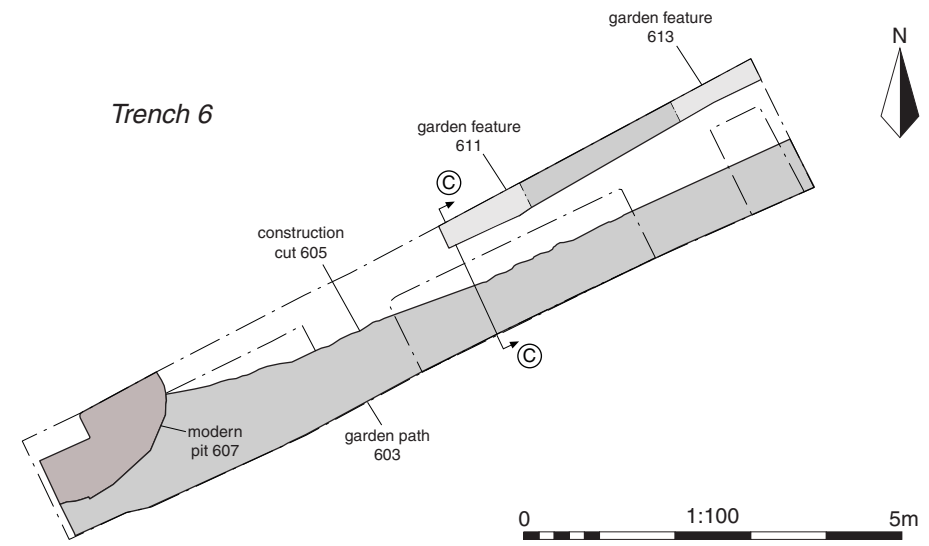
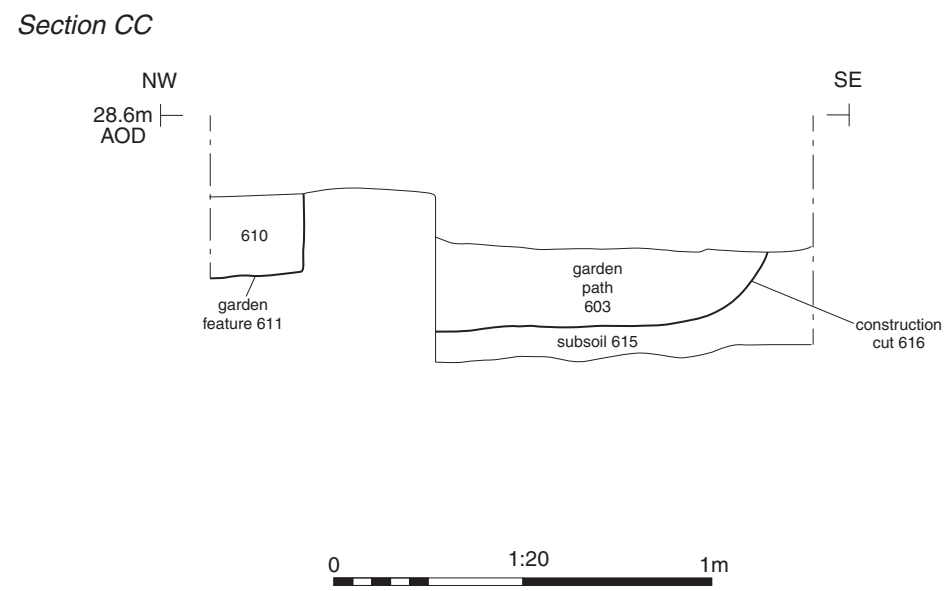
- 5.7 The natural substrate was exposed at a depth of 0.7m bpgl within the trench. It was overlain by subsoil 615, typically measuring 0.25m in thickness. The subsoil was cut by construction cut 605 for deposit 603. It comprised a layer of highly compacted limestone and red brick fragments and may represent part of a surface or path associated with the Kitchen Garden. Deposit 603 was overlain by undated make-up/levelling deposit 602 which was in turn sealed by a further undated make-up/levelling deposit, 601. At the north-eastern end of the trench, deposit 601 was cut by vertically sided, flat bottomed feature 611/613. It contained a single, undated fill 610/612, and probably represents the edge of a modern garden bed or border. At the south-western extent of the trench deposit 601 was cut by pit 607, the fill of which, 606, contained red brick fragments, modern glass and plastic. The fill of these features were sealed by modern gravel path 600.

Garden path 603, looking north-east (scale 1m)

7.9 Compact stony deposit 603, identified in Trench 6, appears to correspond to part of linear feature (possibly a representing a path or surface) depicted on the OS First

Edition map. This feature appears to have been removed shortly after this as it is no longer depicted by subsequent OS editions.

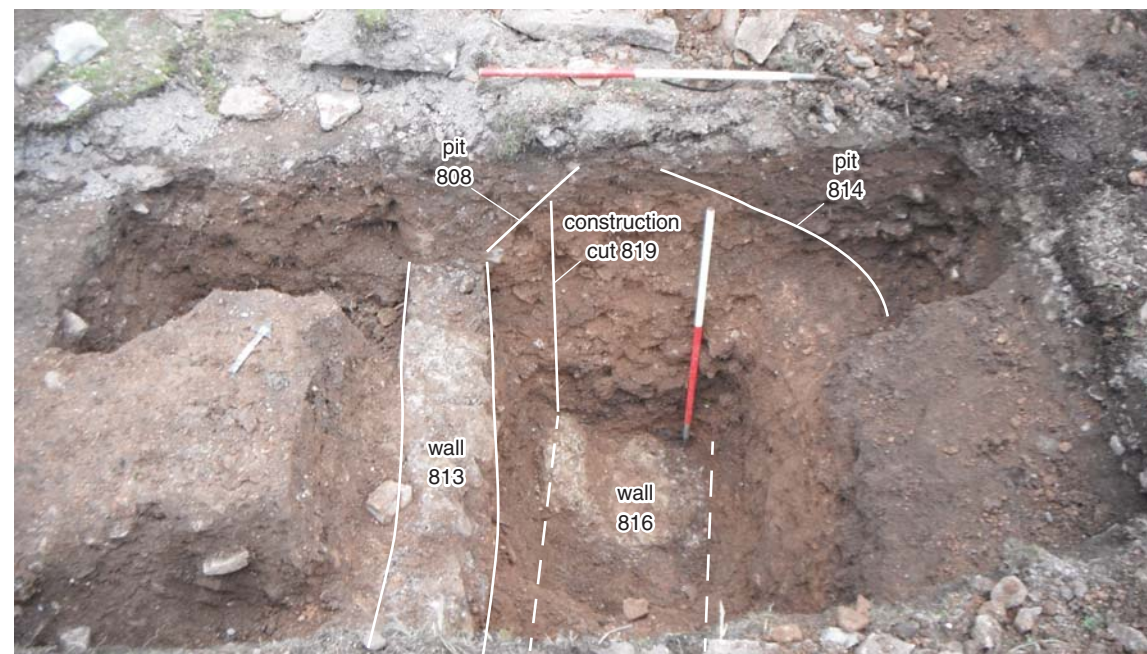
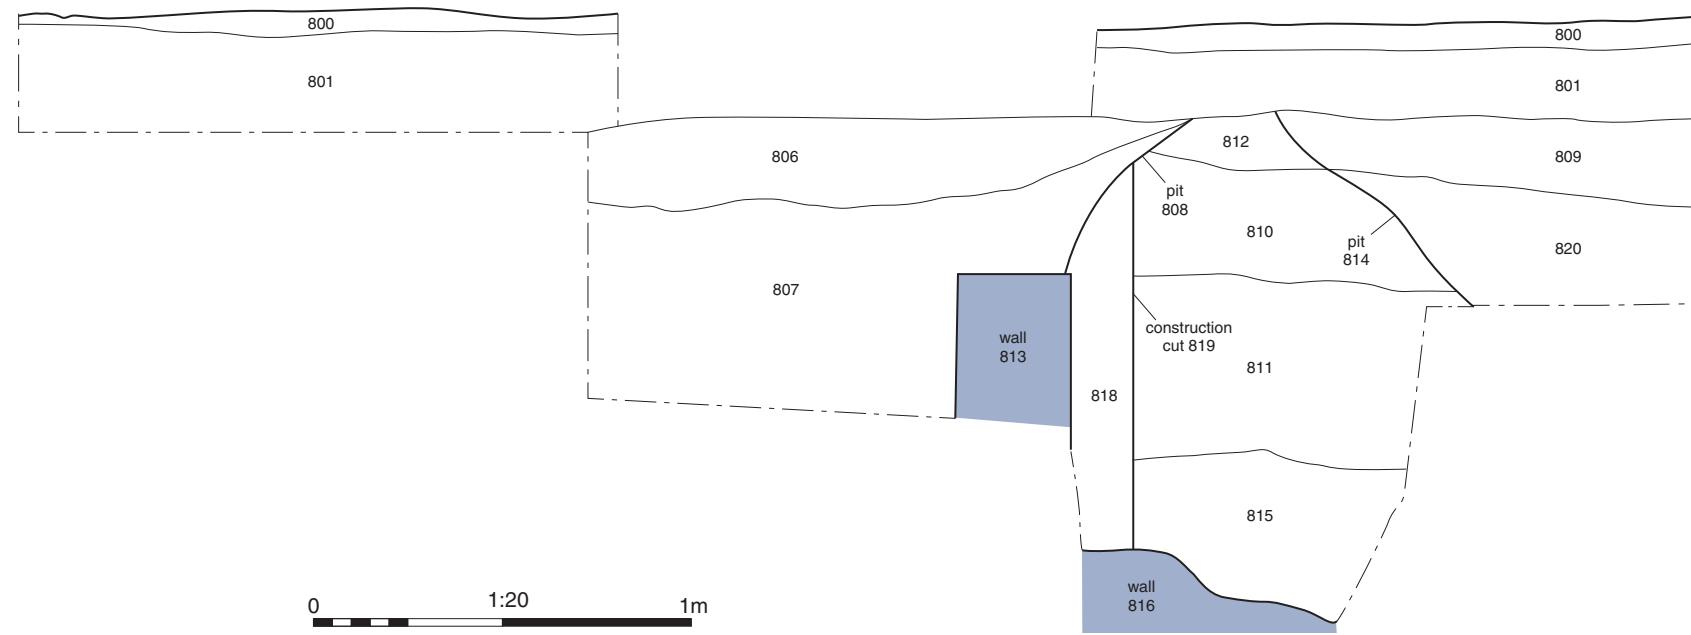
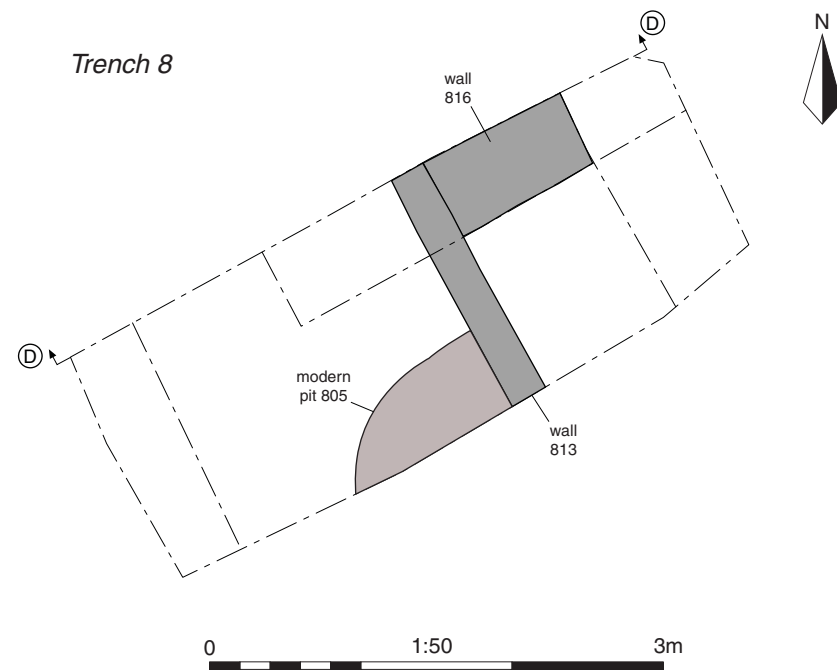
- 5.8 The earliest deposit encountered within the trench was north-west/south-east aligned wall 816, which was partially exposed in a hand excavated sondage at a depth of 1.55m bpgl. It was of rough limestone block construction bonded by a compact yellow-white sand mortar. It measured at least 0.5m in width and at least

0.25m in depth. Wall 816 was overlain by probable demolition deposit 815 comprising mixed clay silt with frequent limestone rubble and mortar fragments. This deposit was in turn overlain by two further deposits, 811 and 810, both of which contained fragments of limestone, mortar and charcoal, as well as other inclusions indicative of demolition. The earliest of these deposits, 811, contained a fragment of Ceramic Building Material and an iron nail of post-medieval date.

- 5.9 Deposit, 810, was cut by north-west/south-east aligned construction cut 819 for wall 813. Wall 813 was constructed from rough limestone blocks bonded by a friable blue-grey mortar. It measured 0.3m in width and survived to a depth of at least 0.5m. Wall 813 was cut by irregular, steep sided pit 808 which contained two fills, 807 and 806, the latest of which, 806, contained a single sherd of 17th to 18th-century pottery and a fragment of post-medieval CBM. Deposit 810 was cut by two further partially exposed pits, 805 and 814. The fills of these pits contained modern material including string, plastic and wire. These were sealed by modern gravel surface 801 which was in turn overlain by topsoil.

Trench 8, showing wall 813, wall 816, construction cut 819 and pits 808/819; looking north-west (1m scales)

7.7 Substantial wall 816, was identified at a depth of 1.55m bpgl in Trench 8. The depth at which this wall was identified limited its exposure within the trench precluded any clear interpretation of its function or extent. Furthermore, the lack of secure dating evidence for this wall frustrates our ability to accurately place it within the sequence of occupation of the castle itself. That said, due to the depth at which it was discovered, it is possible that the wall represents a continuation of the medieval/Tudor structures known to be located immediately to the south of the Kitchen Garden within the Scheduled area. It is also possible that the identified undated or post-medieval demolition deposits within Trench 8 (810, 811 and 815), directly overlying wall 816, relate to the 18th-century demolition of these structures (see *archaeological background* above). However, without further evidence both of these suggestions remain necessarily speculative.

7.8 Wall 813, also identified in Trench 8, remained artefactually undated but is stratigraphically later than post-medieval demolition deposit 811. It appears to correspond with the location of a small rectangular structure or walled area depicted by the First Edition 1881 OS map. This feature is shown on all later editions of OS mapping until 1973-1977, after which it is no longer depicted.

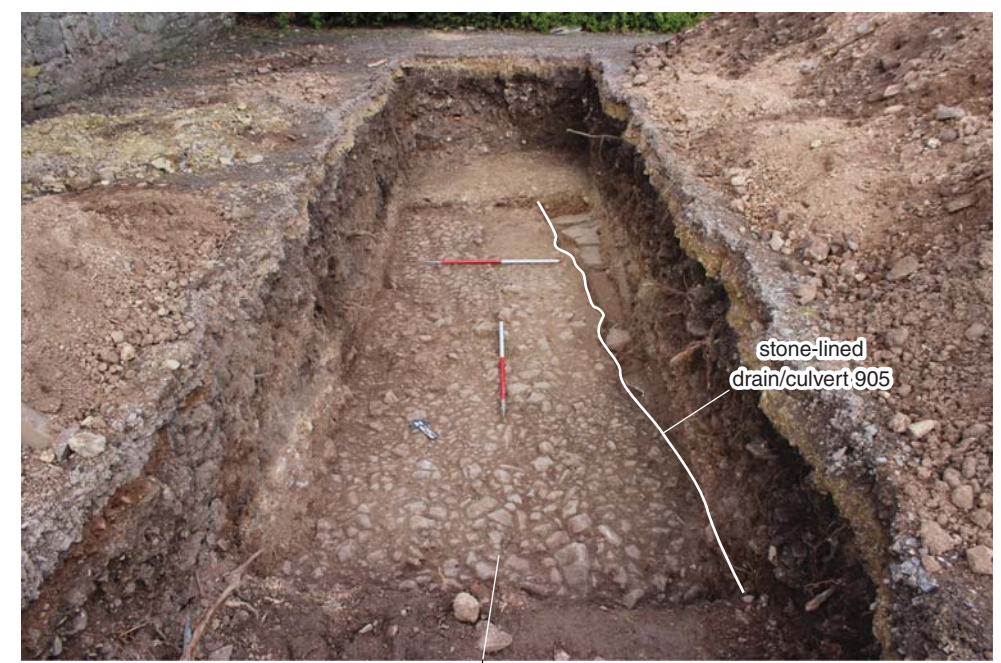
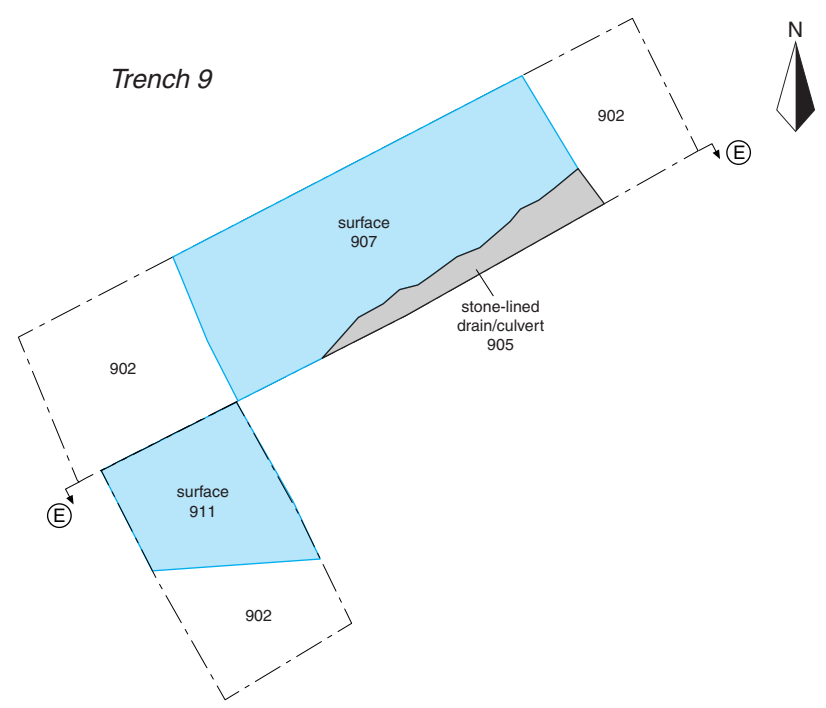
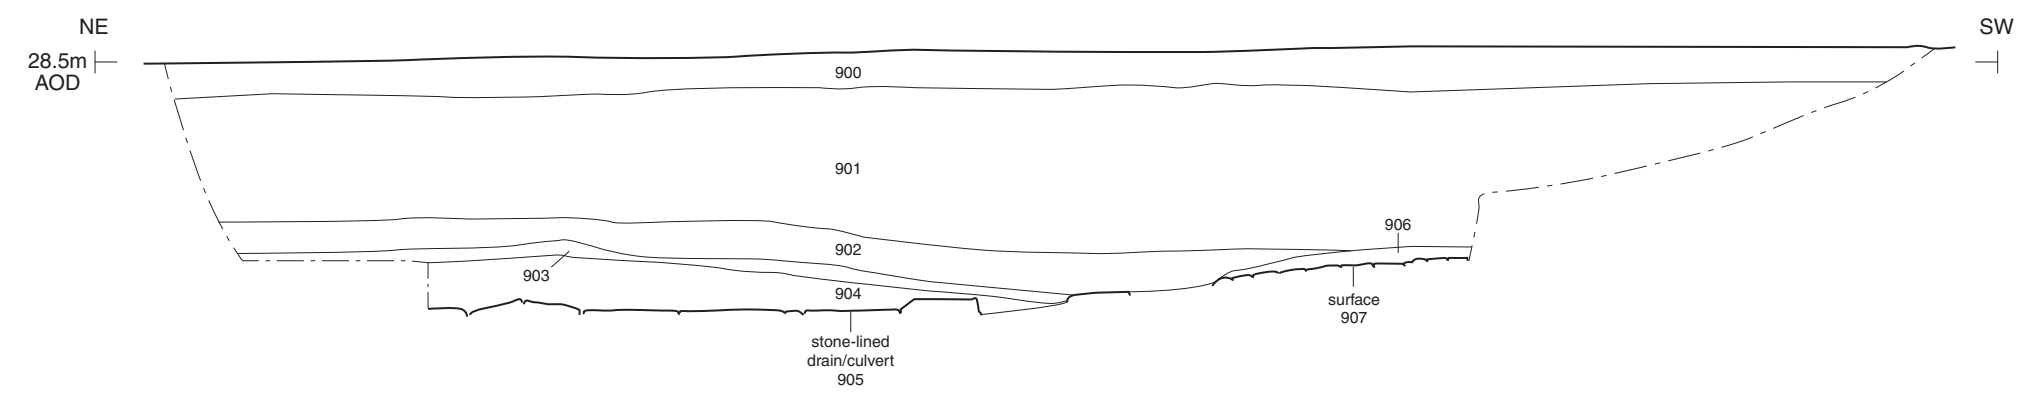
- 5.10 The natural substrate was exposed at a depth of 1.3m bpgl within the trench. It was directly overlain by surface 907/911 comprising highly compacted irregular limestone fragments that was partially overlain by thin, undated deposit 906, indicative of silting, that measured up to 0.08m in thickness.
- 5.11 Deposit 906 was cut by north-east/south-west aligned construction cut 912 for stone-lined drain/culvert 905. Stone-lined drain/culvert 905 was in turn overlain by a series of undated make-up/levelling deposits, 904, 903, 902 and 901. The latest of these deposits, 901, was overlain by modern gravel car park surface 900.

- 7.11 Surfaces 907/911 and 1007, identified at 27.48m AOD and 27.75m AOD in Trenches 9 and 10 respectively, comprised similar highly compacted layers of limestone fragments. The exact function of these surfaces remains unclear, although their rough nature would suggest that they represent parts of a courtyard or outside space rather than the interior surface of a building. Both surfaces were overlain by similar thin silt deposits, 906 and 1006 respectively, which may have accumulated during the use of the surfaces. In Trench 9 surface 907/911 and silt deposit 906 were clearly cut by the construction cut for stone-lined drain/culvert 905 suggesting that the drain/culvert was constructed sometime after the laying of the surface. Stone-line drain/culvert 1111 is of similar construction to drain/culvert 905 identified in Trench 9 and may represent the western continuation of 905. As such, they may at least be broadly contemporary.

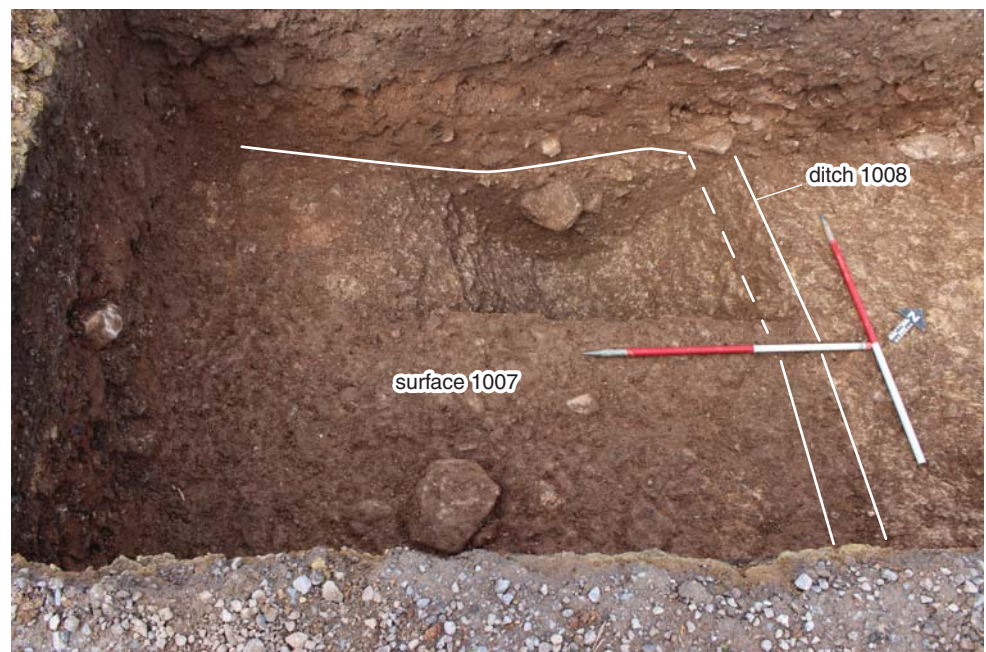
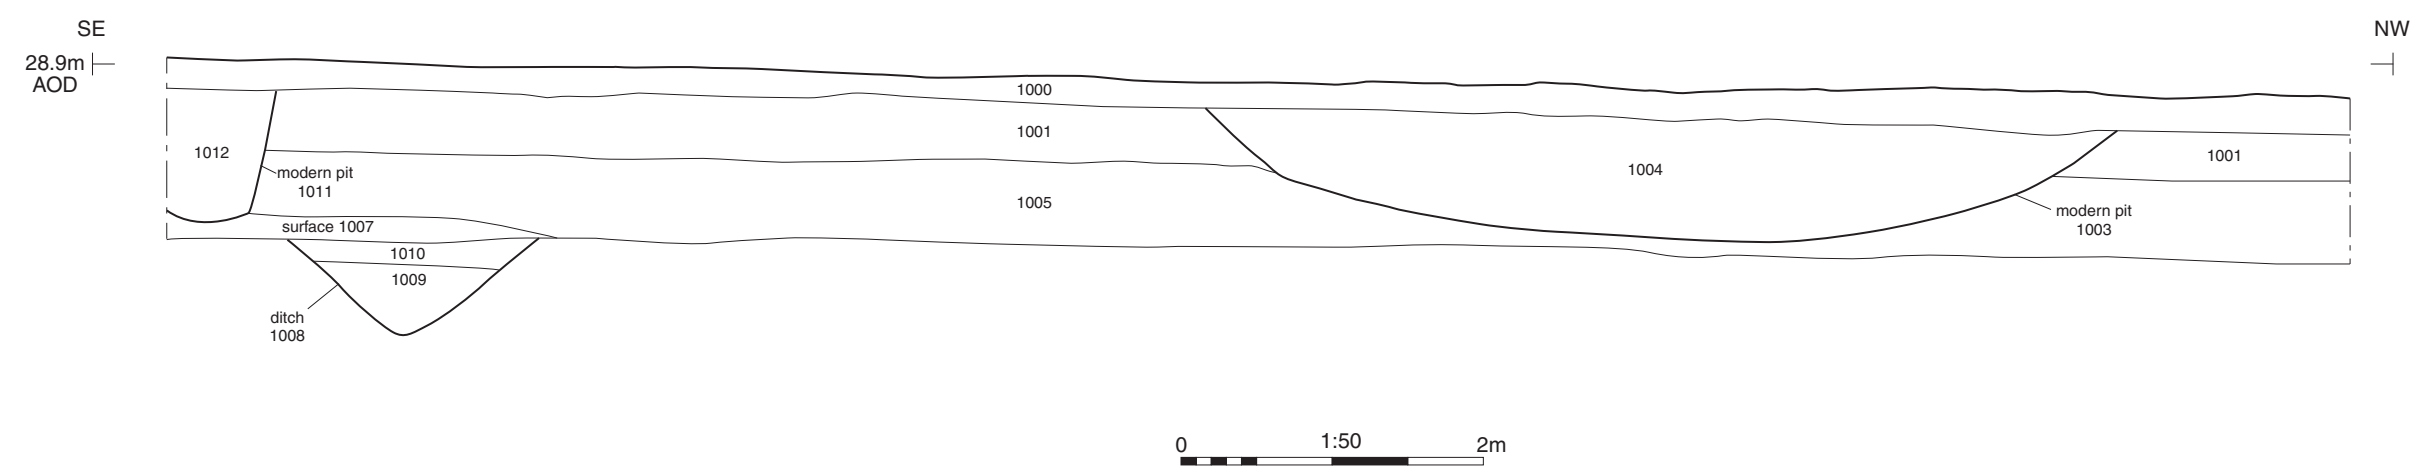
Trench 10

- 5.12 The natural substrate was identified at a depth of 1.2m bpgl. It was cut at the south-western end of the trench by north-west/south-east aligned ditch 1008. It had a rounded 'V'-shaped profile and contained two distinct fills, 1009 and 1010. A fragment of medieval (14th to 15th-century) floor tile were recovered from the earliest of these fills, 1009. The latest fill, 1010, was partially overlain by surface 1007 comprising a layer of highly compacted irregular limestone fragments.

- 5.13 Surface 1007 was partially overlain by thin patchy deposit 1006 (not illustrated), indicative of silting, that measured up to 0.17m in thickness. An undated and heavily concreted fragment of iron was recovered from this deposit. Deposit 1006 was in turn overlain by two make-up/levelling deposits, 1005 and 1001. The latest of these deposits, 1001, contained fragments of modern concrete and ceramic drain pipe. Make-up/levelling deposit 1001 was cut by modern pits 1003 and 1011 the fills of which, 1004 and 1012 respectively, contained fragments of concrete and plastic. These deposits were in turn sealed by modern gravel car park surface 1000.

Trench 10, showing surface 1007 and ditch 1008, looking north-west (1m scales)

- 7.10 Ditch 1008, identified in Trench 10, yielded a single fragment of glazed later medieval (14th to 15th-century) ridge tile and it may represent a continuation of undated ditch 1107, identified in Trench 11, due to the similarities in their respective profiles and fills. The function of these ditches remains unclear; however they may relate to land management, drainage or division. It is possible, based on the limited dating evidence available, that they pre-date the early 16th-century rebuilding of Thornbury Castle (see *archaeological background* above), although the possibility that the tile recovered from ditch 1008 is residual within a later feature should not be overlooked.

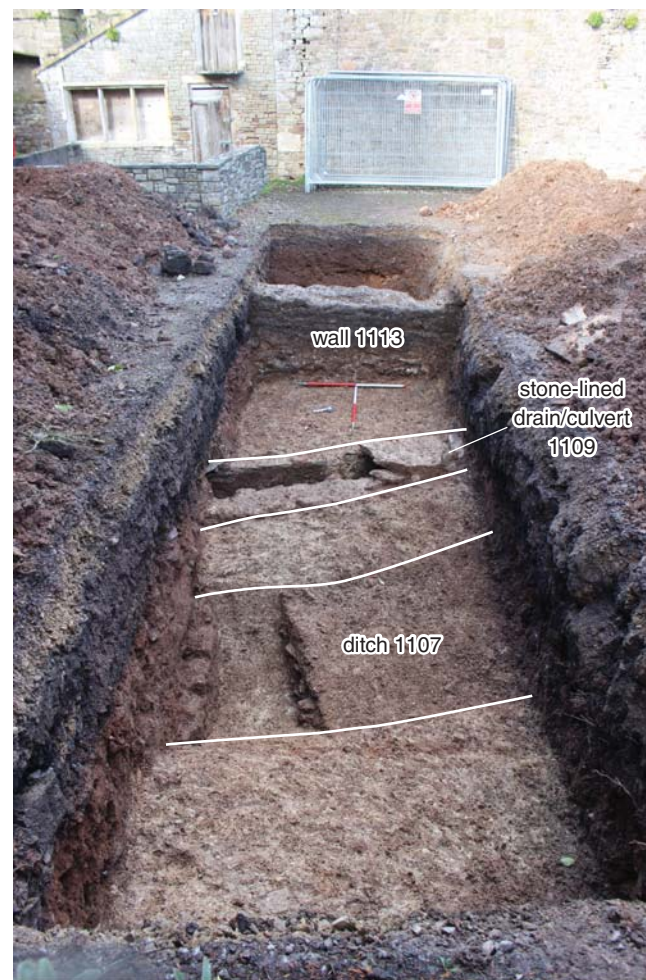
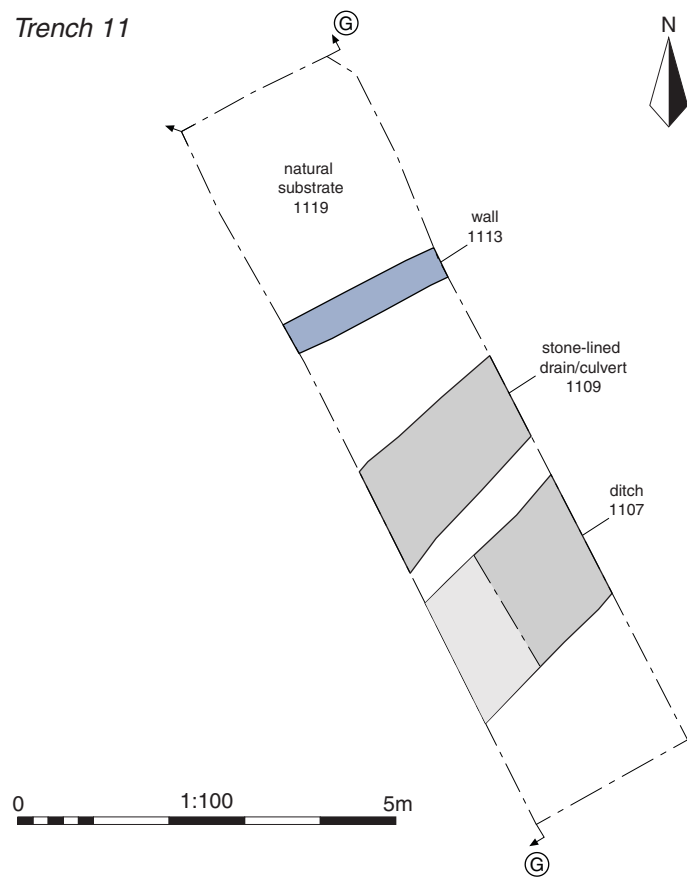
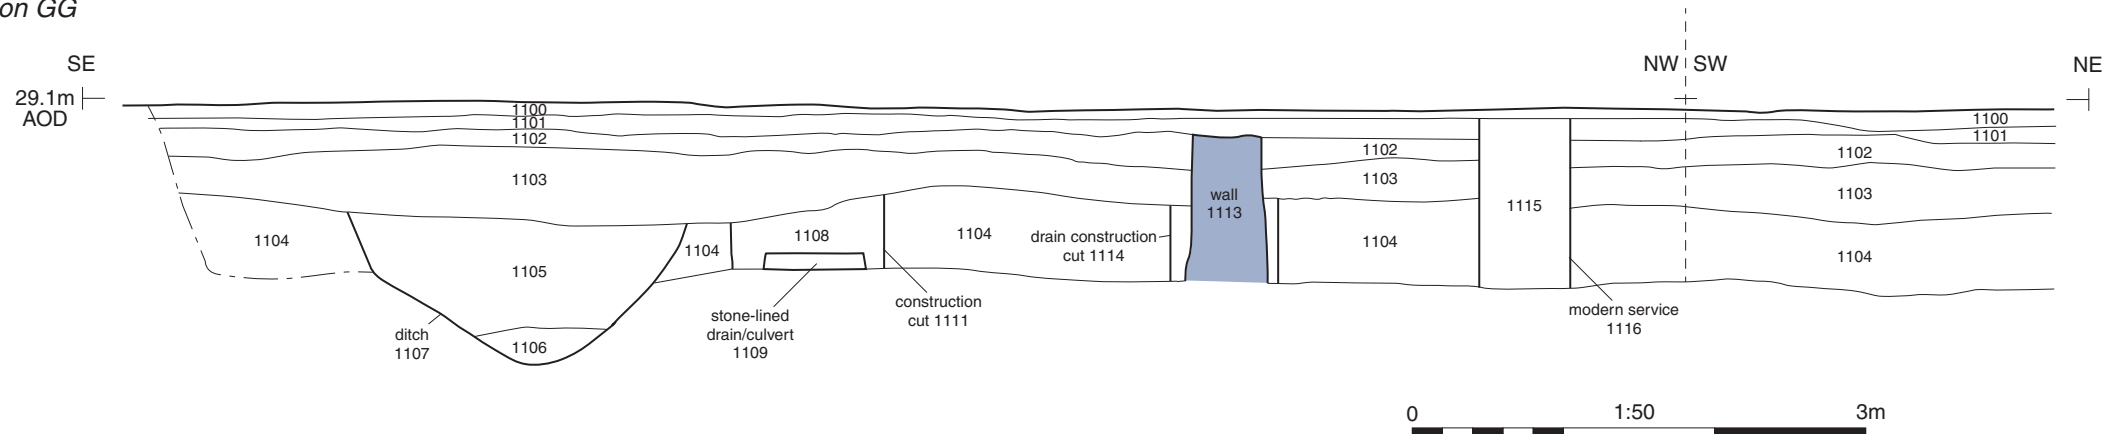
Trench 11

- 5.14 The natural substrate was identified at a depth of 1.2m bpgl was sealed by undated make-up/levelling deposit 1104. Deposit 1104 was cut by ditch 1107, construction cut 1111 for stone drain/culvert 1109, and construction cut 1114 for wall 1113.

- 5.15 Ditch 1107 was identified towards the south-eastern end of the trench. It was aligned north-east/south-west, had a 'U'-shaped profile and contained two undated fills, 1105 and 1106. Stone-lined drain/culvert 1109 was located immediately to the north-west, broadly parallel to ditch 1107, and was constructed from flat, rough-hewn mudstone slabs. North-east/south-west aligned wall 1113 was located towards the north-western end of the trench. It was 0.46m in width, survived to a depth of at least 0.8m and was constructed from rough limestone blocks bonded by a friable blue-grey mortar.

- 5.16 The latest fill of ditch 1107 and the fills of construction cuts 1111 and 1114 were sealed by undated make-up/levelling deposit 1103. Deposit 1103 was in turn overlain by modern bedding deposits 1102 and 1101. The latest of these deposits, 1101, was cut by modern service trench 1116. The fill of this service trench was sealed by modern gravel car park surface 1100.

Trench 11, showing ditch 1107, stone-lined drain/culvert 1109 and wall 1113, looking north-west (1m scales)

- 7.12 Wall 1113 appears to form part of a square-shaped structure or partition, identified by a preceding Ground Penetrating Radar survey (Stratascan 2016) and shown on the 1881 OS map. Its function is unclear; however it does not feature on the 1932 edition of the OS map and was therefore presumably demolished by this time. The mortar bonding of wall 1113 was very similar to that observed on wall 813, identified in Trench 8, and these walls are therefore likely to be broadly contemporary.
